THE BANGING BOLT SYNDROME

Unexpected loud noises can cause high anxiety for building owners and tenants

By Robert L. Schwein

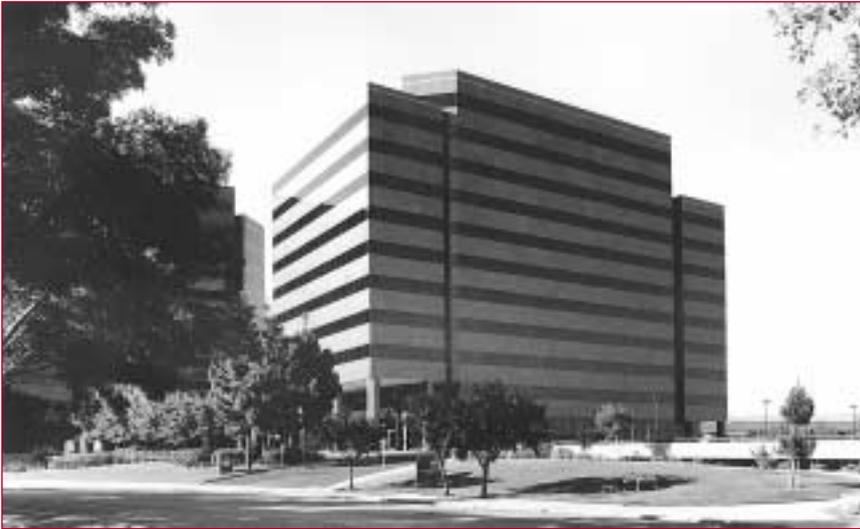
Exterior view of an office building in Santa Clara, CA, exhibiting the banging bolt phenomenon

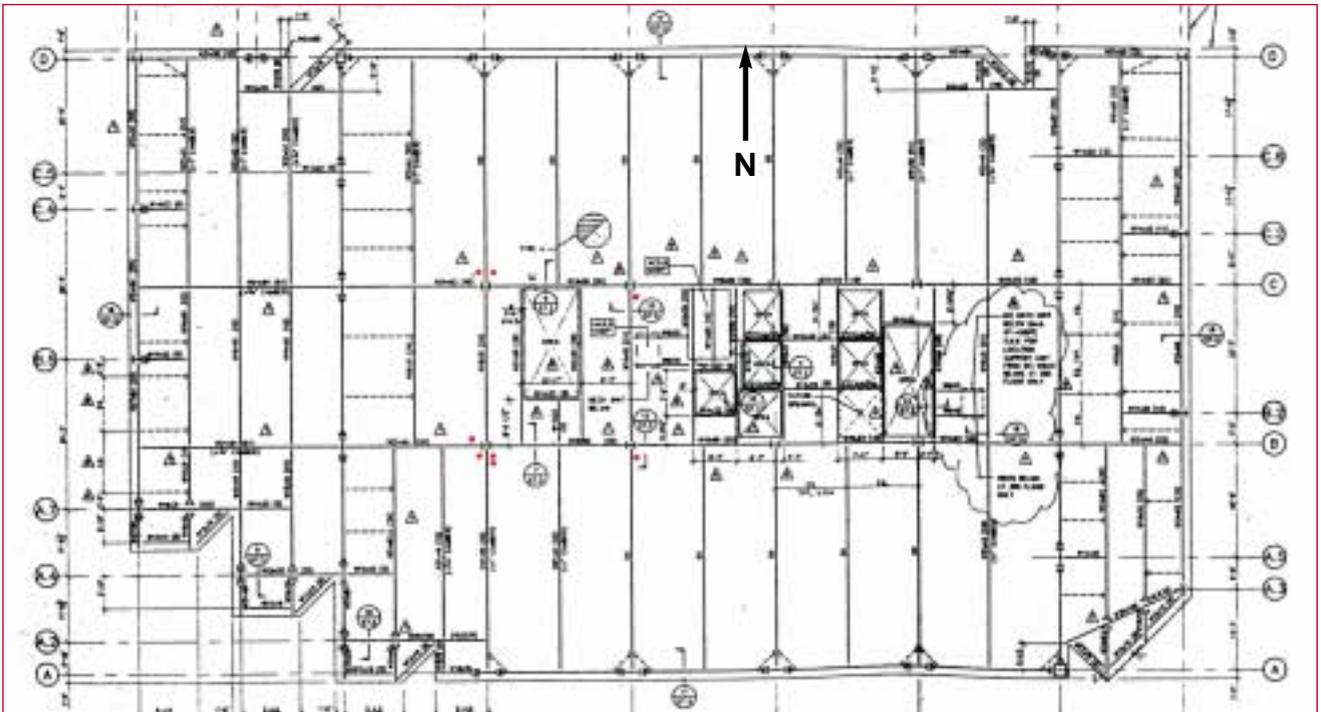
Figure 1: Fifth floor framing (red dots indicate de-torquing noise events)

ed with either a ping or a bang of varying magnitude. The majority of the noises were detected on the long bay (40' dimension) north-south members in the building. Figures 1 and 2 show the events graphically. The torque values averaged approximately 350 lb.-ft. to 400 lb.-ft. One typical bolt was removed from a joint. It was a $\frac{7}{8}$ " diameter by $2\frac{1}{4}$ " long ASTM A325, high strength type. It was a button-head twist-off type bolt. It carried an upset "n" symbol on the head along with the A325 marking. The "n" is believed to be the mark of the Nucor Fastener Company. Hardened washers were present beneath the nuts. All of the bolts were re-installed to a 200 lb.-ft. torque level using a calibrated wrench, which represents a nominal snug-tight condition.

The non-moment resisting shear connections are the most likely to experience this phenomenon. The moment resisting connections with welded flanges and bolted webs would be less prone to this bolt slip because the flange welds, being stiffer, would attract and resist most of the strain before the load would cause bolt slips in the web. Based on the plots of noises from the tests shown in Figures 1 and 2, it is apparent that most of the slips occurred on the longer span members (40') running in the north-south direction. This

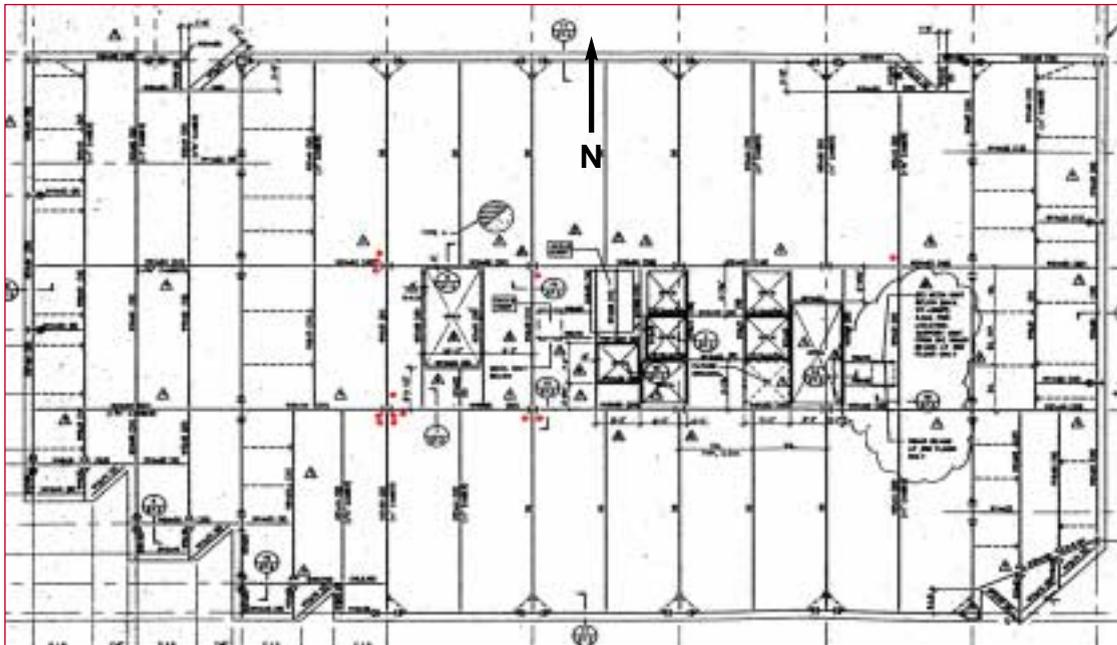
Figure 2: Ninth floor framing (red dots indicate de-torquing noise events)

The third through ninth floor steel framing is virtually identical in plan; however, the members vary in section size as the building ascends. The concentration of the events at the fourth and ninth floors with a lack of reported events on the intermediate floors suggests that the concrete may have been placed at a higher water/cement ratio, hence increasing the amount of drying shrinkage and attendant stress in the steel members.
