BANGING BOLTS— ANOTHER PERSPECTIVE

A look at the what and how of this noisy phenomenon

By **R.H.R. Tide, P.E., S.E.,
D.Sc.**

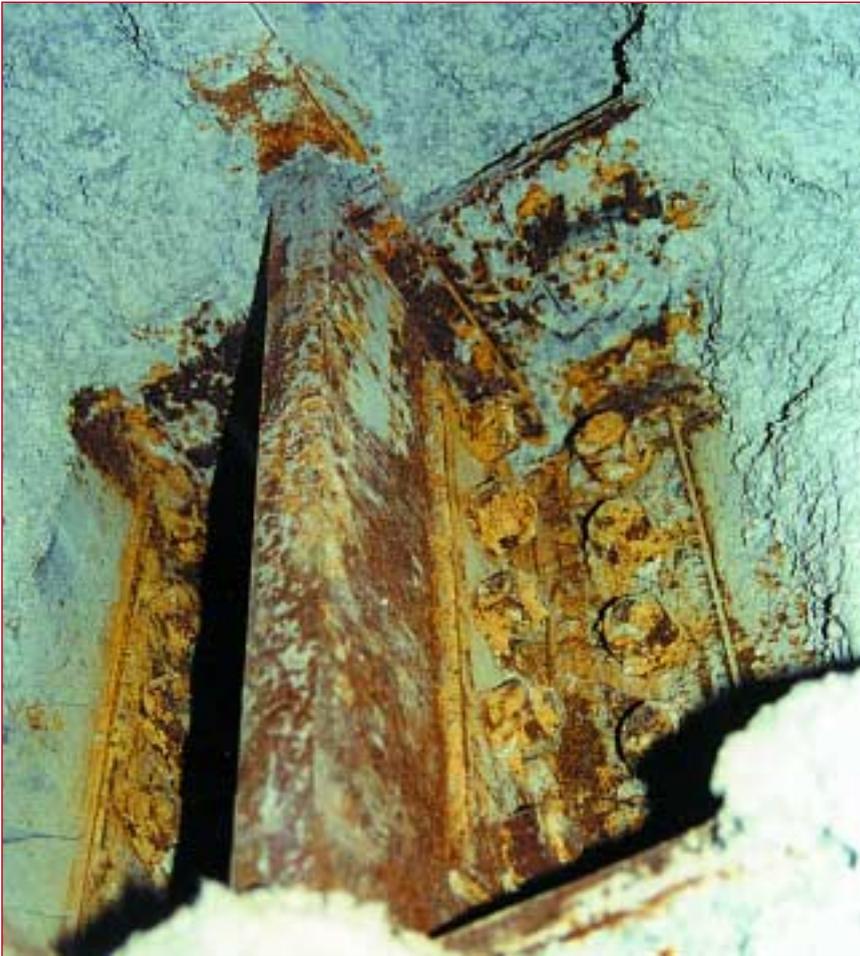
Figure 1: Typical exposure of fire protected moment connections.

In several projects where the banging noise was reported, investigations were performed to find actual connection movement. It was observed that the sprayed on fire protection corroded the surface of the beam web and shear tab as shown in Fig. 1. Removal of the fire protection and corroded mill scale obliterated any evidence of joint movement having a magnitude of only a couple of hundredths of an inch. Subsequent wire brushing as shown in Fig. 2 further hindered detection of any joint movement but allowed examination of the joint to verify that weld fractures had not occurred.

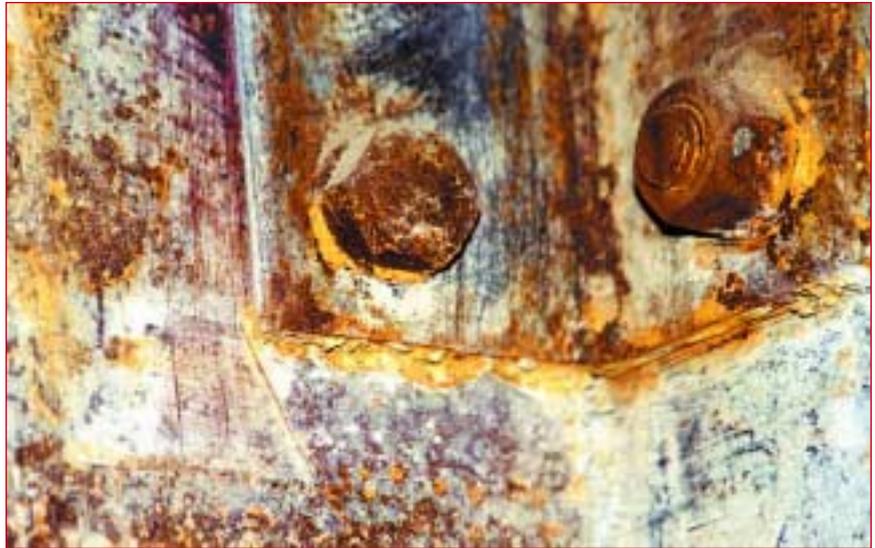
Figure 2: Complete removal of fire protection at edge of bolted connection.
