# **POPLAR STREET BRIDGE REHABILITATION AND WIDENING**

## **SUMMARY**

# POPLAR STREET BRIDGE REHABILITATION & WIDENING

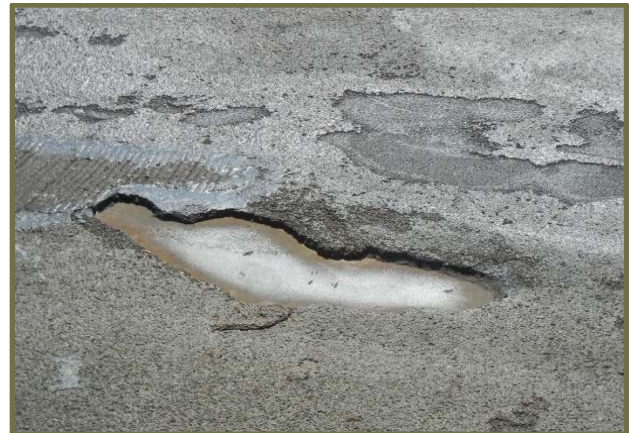
**Figure 11: Failed Overlay**

The original wearing surface on the bridge was 2.5" thick although for recent overlays it was 2.5" thick at the expansion joints at the end piers and transitioned to 0.5" for the majority of the bridge. A 0.5" polymer concrete overlay was installed in 2006 and in 2013 it began to fail, de-bonding from the orthotropic steel deck in many locations. When saturated in hot conditions the overlay was extremely flexible and could be easily pulled off the steel deck plate. Figure 11 shows this failed overlay system.

Numerous overlay failures like this over the years have contributed to near-continuous extreme congestion on the bridge and safety issues with drivers riding directly on the orthotropic steel deck plate. These overlay failures have also led to the overall reduction in the stiffness of the deck system which may have contributed to fatigue cracking in the

orthotropic steel deck plate, ribs and floor-beams.

overlay materials: A 4" steel fiber reinforced lightweight concrete overlay with a layer of mild steel mechanically connected to the steel deck plate using end welded shear studs. The 4" thickness was needed because a 2.5" overlay without mild steel is susceptible to failure in high tensile areas and if mild reinforcement were added then there would be clearance and concrete consolidation issues. Since the proposed overlay is thicker than the original and existing overlays the existing superstructure and substructure capacities were checked for the additional dead load. The additional dead load was mitigated somewhat by using lightweight concrete with a density of 120 pounds per cubic foot. A benefit of using this concrete overlay is that it utilizes conventional analysis and construction methods. The steel fibers were included for durability to provide an improved riding surface and ensure sufficient deck stiffness for a 30-40 year life with minimal maintenance.

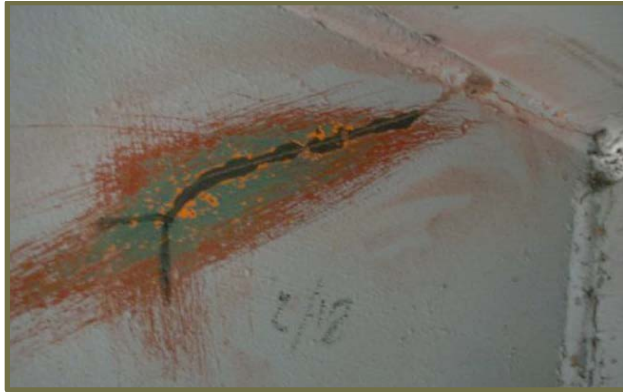
**Figure 14: Fatigue Cracking**

paint system and substructure units. One of the critical findings of the inspection was the numerous (over 100) fatigue cracks observed in the orthotropic steel deck plate to rib weld. Some of these had propagated into the web of the rib, with most occurring near floorbeam locations. While the average crack length was about 6", some had grown up to 60" maximum in length. Figure 14 shows a large fatigue crack that began in the deck plate to rib weld and propagated into the web of the rib.

The chart seems to indicate the locations of the cracks generally correspond to the wheel line locations. There is more widespread cracking seen on the eastbound bridge likely due to additional weaving movements. The location of the cracks at the deck plate to rib welds near the wheel lines indicate that the flexibility of the deck system between the ribs is contributing to the cracking. The previous thin and de-bonded overlays were contributing little or no

stiffness to the deck system. Without stiffening the deck system with a thicker and more reliable overlay, the cracks would likely continue to develop and progress. As stated previously, HDR proposed a 4" steel fiber reinforced lightweight concrete overlay mechanically connected to the deck to stiffen up the deck system to aid in preventing further crack development. The 4" overlay was installed on the westbound lanes in 2015 but not until 2017 on the eastbound lanes. The existing cracks were not repaired until 2018. During the 2016 inspection there was significantly more crack development on the eastbound bridge compared to the westbound bridge. This may indicate that the thicker overlay and stiffer deck system is helping to contribute to the reduction of crack development and progression.

HDR proposed repairing these cracks by drilling arrest holes and fabricating bolted cover plates connected to the underside of the steel deck plate and the rib web via welded threaded studs. HDR then investigated possible causes of this cracking. Figure 15 shows a chart of the crack locations plotted transversely along the width of the bridge. The length of the bars is relative to the number of observed instances of cracking.

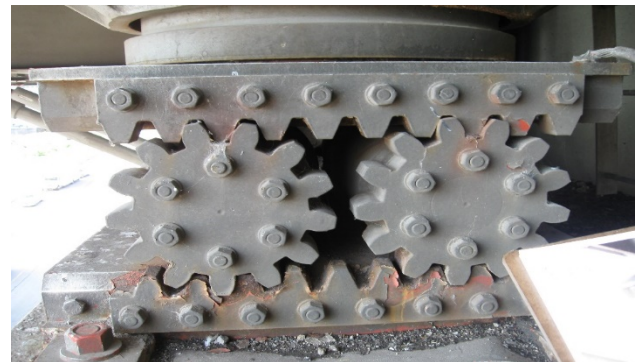
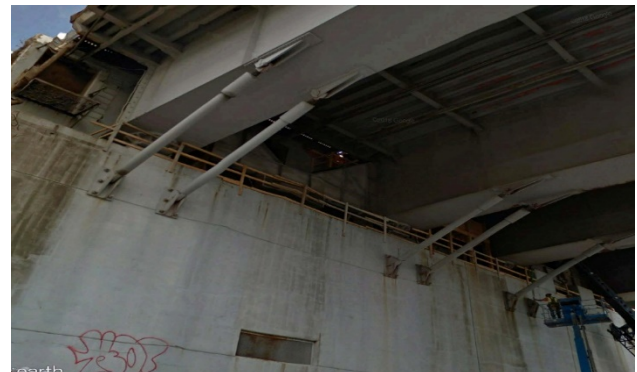
**Figure 16: Existing Bearing and STU's**

Another important rehabilitation need was the existing geared bearings. The inspection observed little evidence of paint wear on the gears indicating the bearings were not performing as intended, they weren't moving under thermal displacements. Also, the shock transmission units (STU's) installed as part of the 2000's seismic retrofit project showed signs of leaking fluid. Figure 16 shows the existing geared bearings and installed STU's.

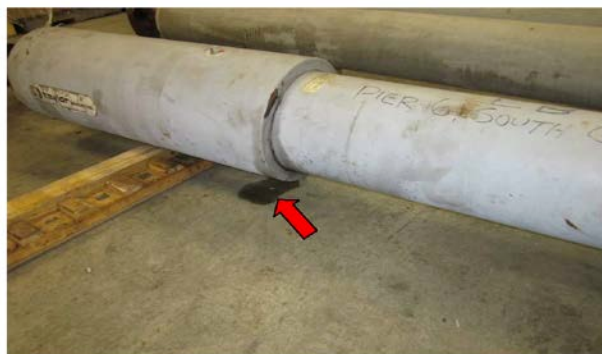
**Figure 17: Existing Leaking STU**

STU's led MoDOT to remove 4 of the in-service units to send to the manufacturer's lab for verification testing with third party observation. The testing confirmed that 1 of the 4 STU's had leaking fluid and did not pass verification testing resulting in the potential for a lack of adequate response under seismic loading. Figure 17 shows the leaking STU in the lab prior to verification testing.

There were 64 existing individual STU's on the bridge located at expansion Piers 1, 2, 4, 5 & 6, with two for each girder in each span adjacent to the particular pier. Since 25% of the tested STU's failed verification, there was concern that costly laboratory or field testing of every STU would result in the in-service replacement of 16 units. HDR proposed instead to remove the all of the existing STU's and replace the existing bearings with lead core seismic isolation bearings. The thermal and seismic stiffnesses of the isolation were specified in the contract documents with prototypes developed for verification. The existing pier and foundation capacities were checked for wind, thermal and seismic forces based on the specified bearing stiffnesses.
