**TESTS OF FULL-SCALE BEAM-TO-COLUMN
CONNECTIONS**

Reidar Bjorhovde
The Bjorhovde Group, Tucson, Arizona

August 1999

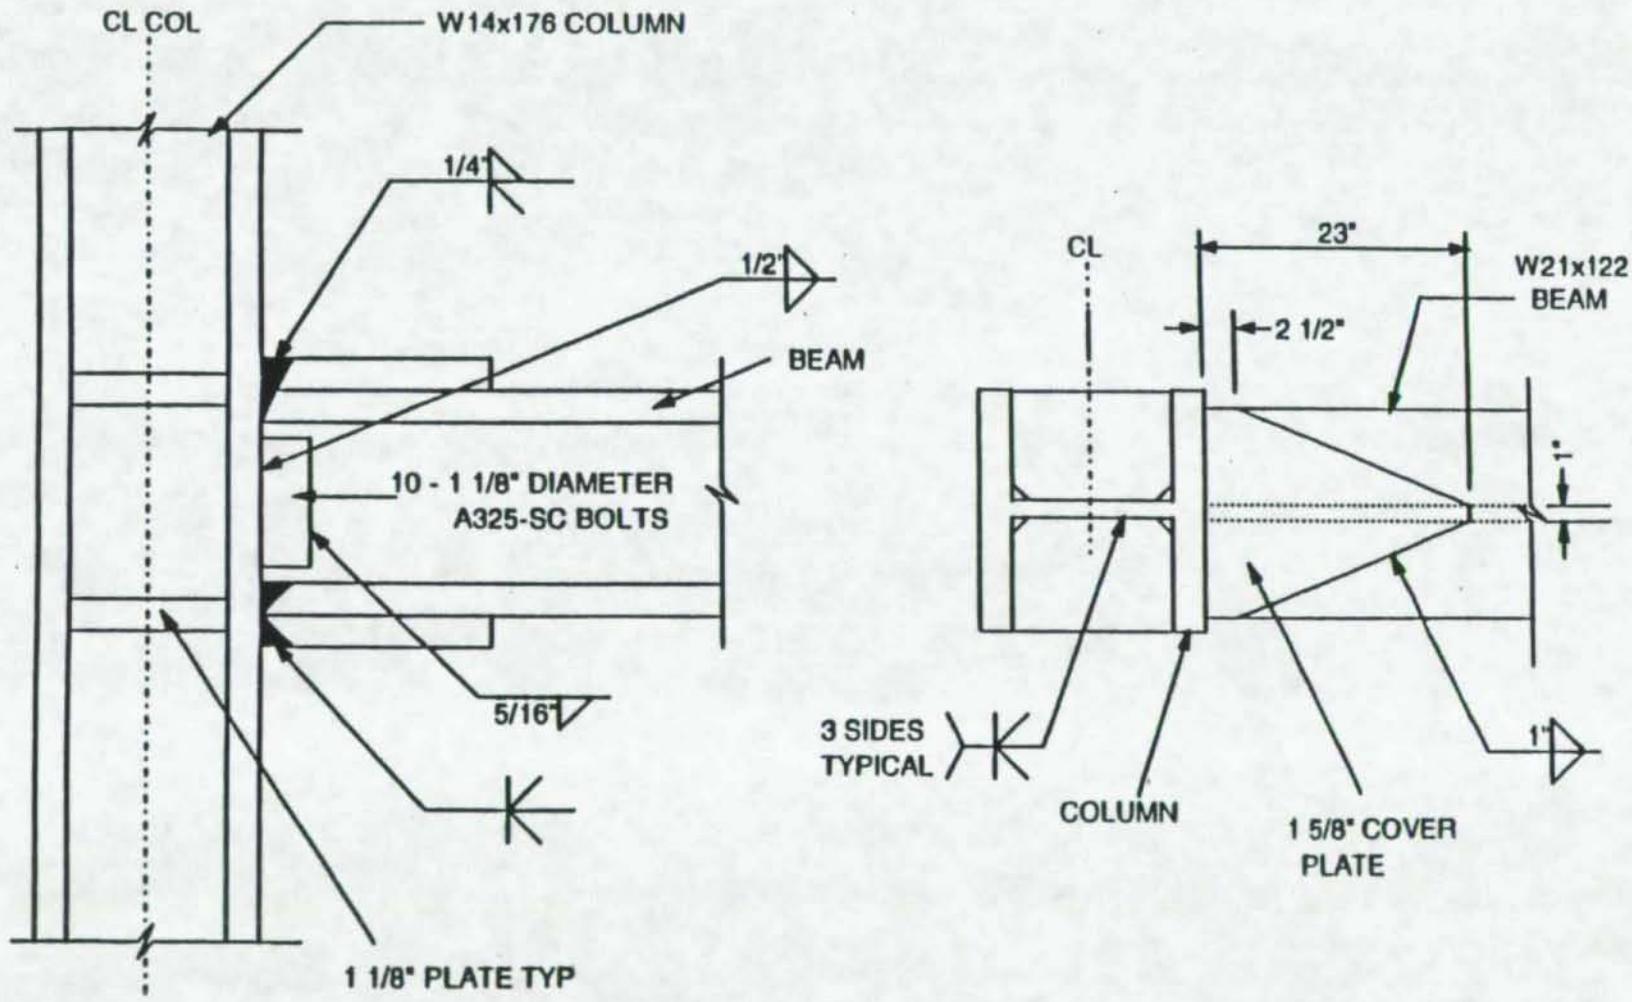
Figure 1 As-Built Connection

The cracks in the connection shown in Fig. 1 were found in the web of the column, in the region of the cross section now commonly known as the "k-area" or "k-region". This is a small area of the wide-flange shape surrounding the location where the transition fillet from the flange enters the web. The k-dimension measures the distance from the outside of the flange to the end of the transition fillet. Figure 2 illustrates these terms.

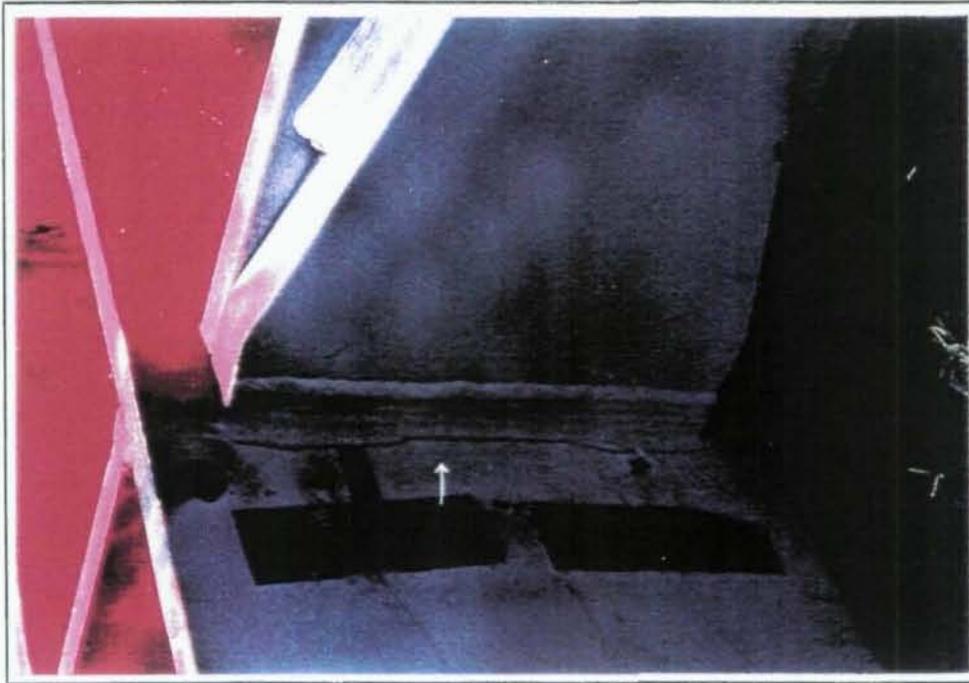
Figure 22 Photographs of Cracks in Specimen A1

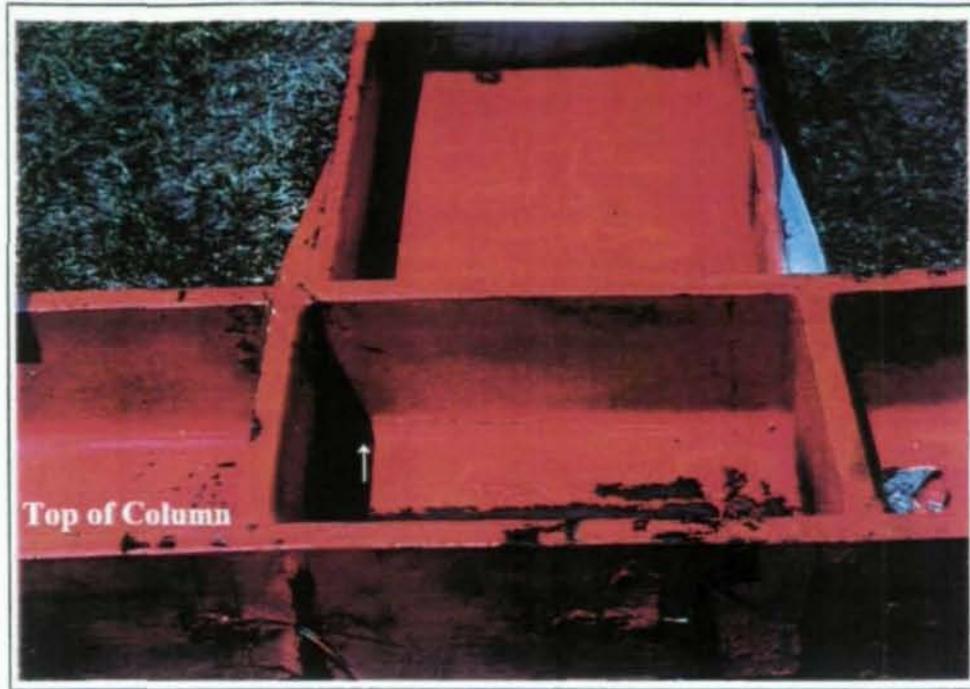
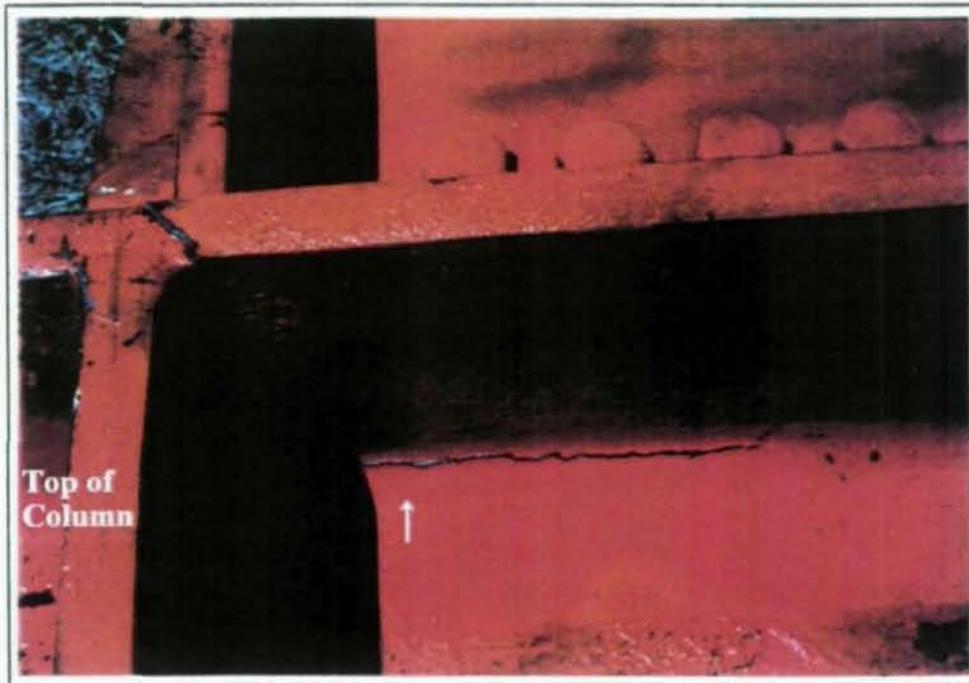
Figure 23 Photographs of Fractured Specimen A2

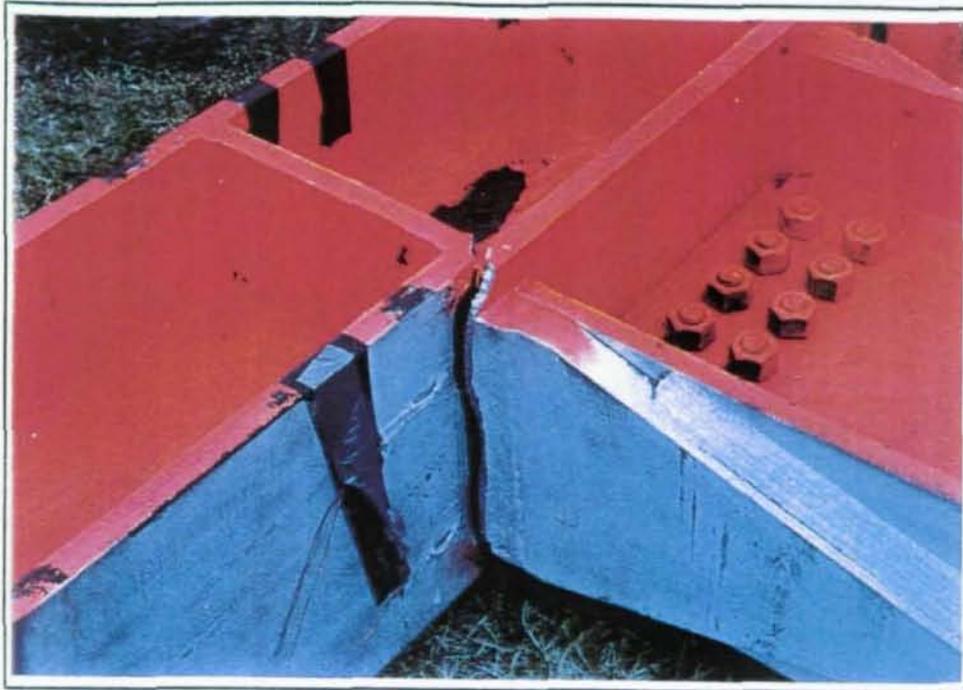
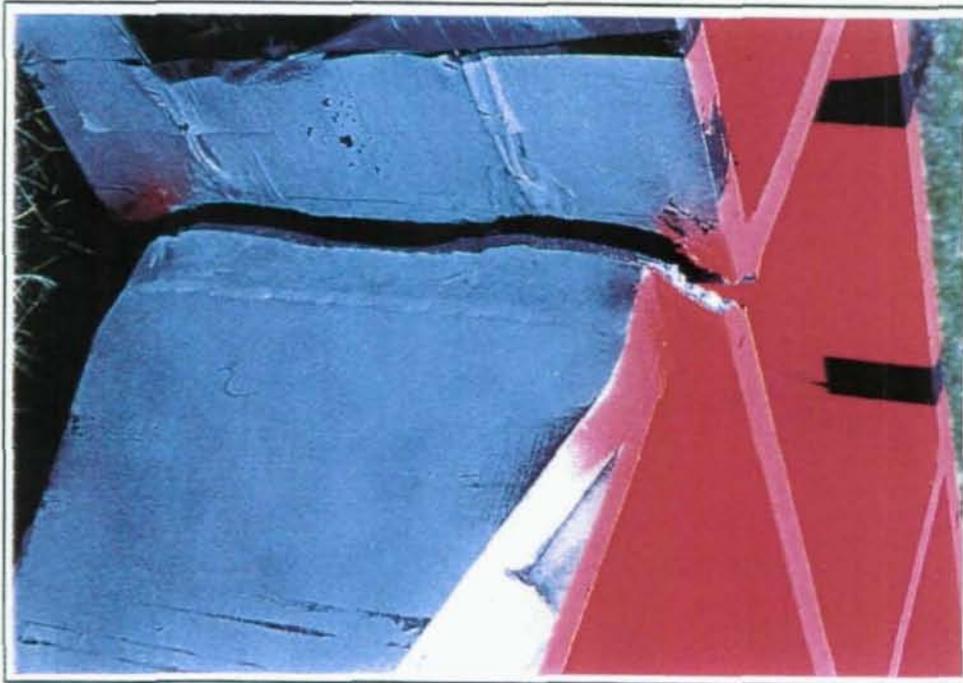
Figure 24 Photographs of Crack Adjacent to Weld in Specimen A3

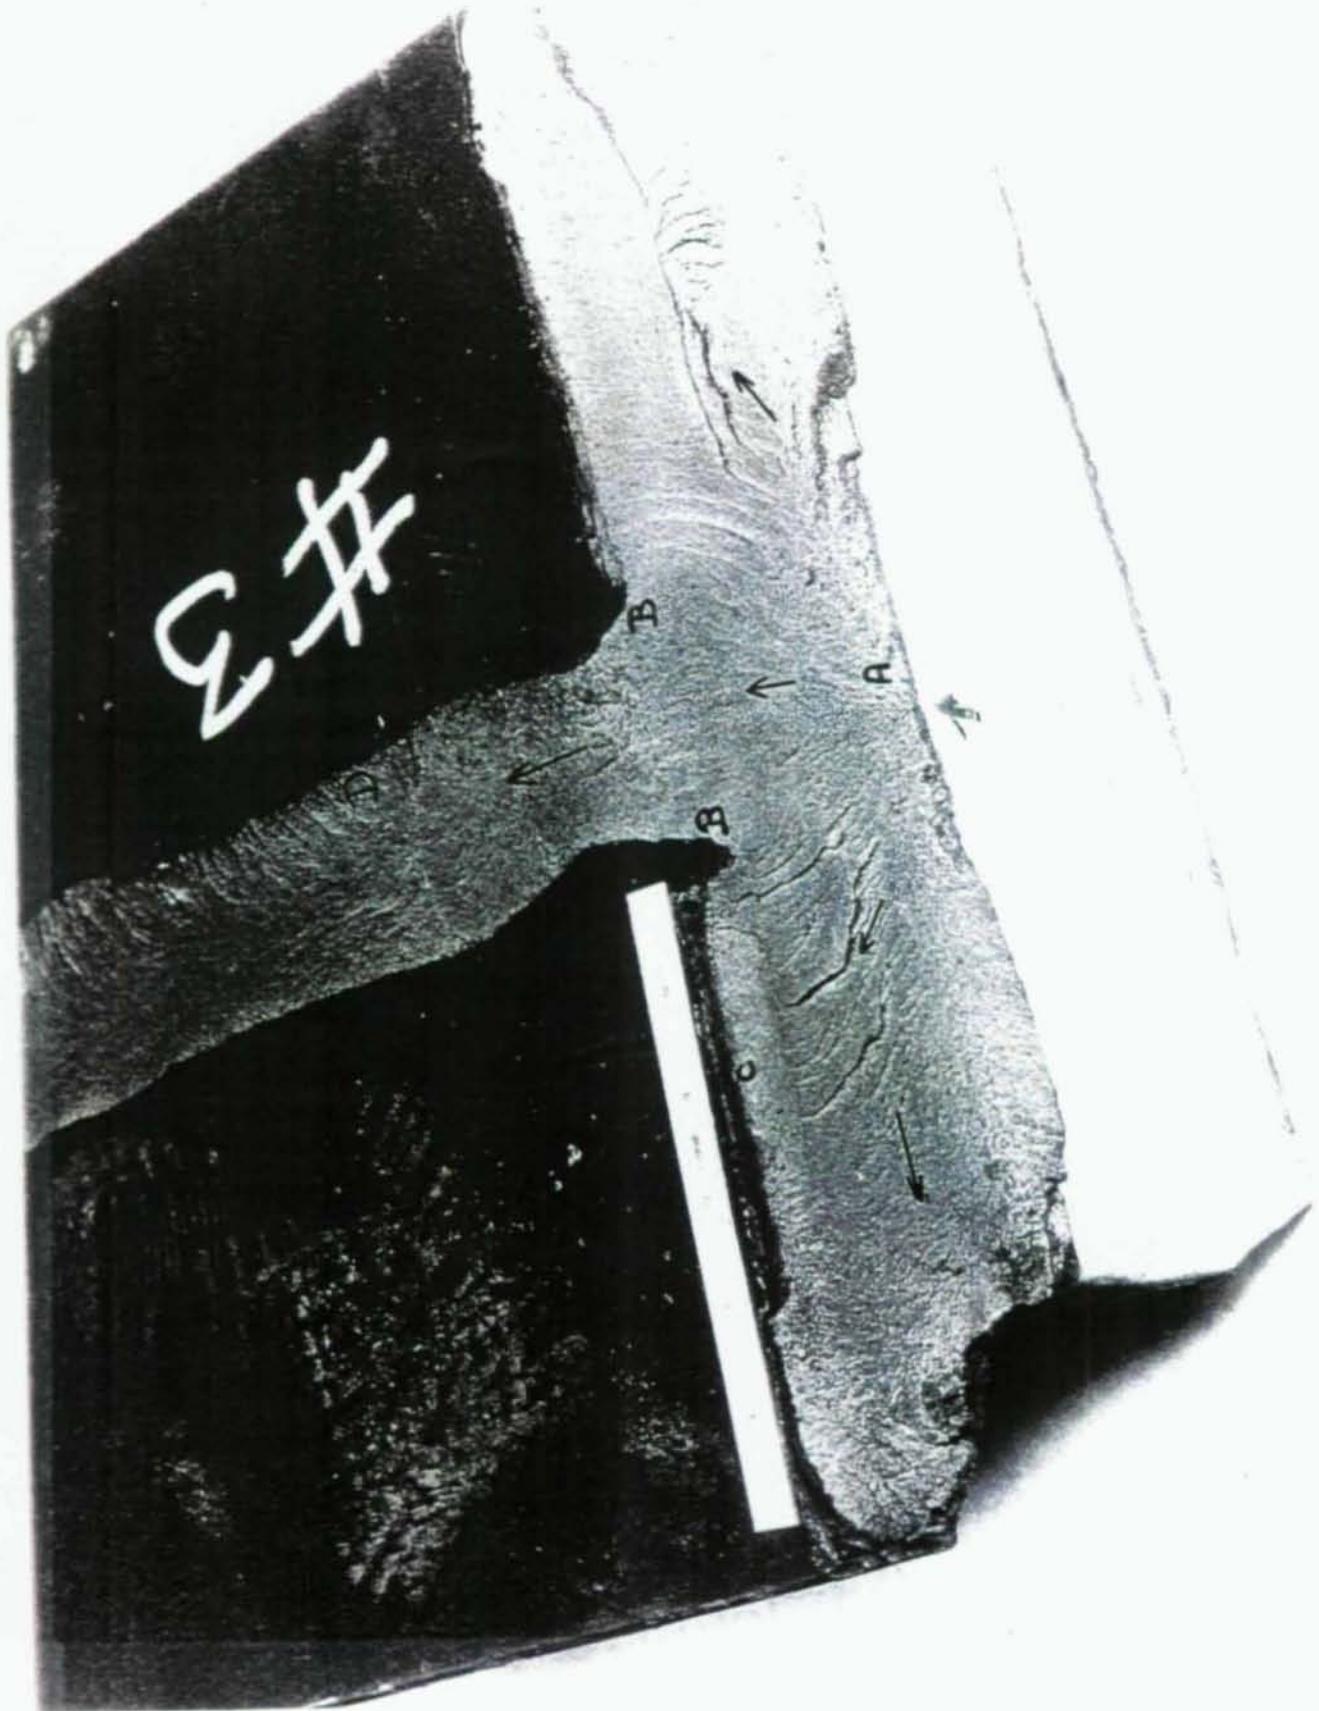
Figure 25 Photograph of Fracture Surface for Specimen A3

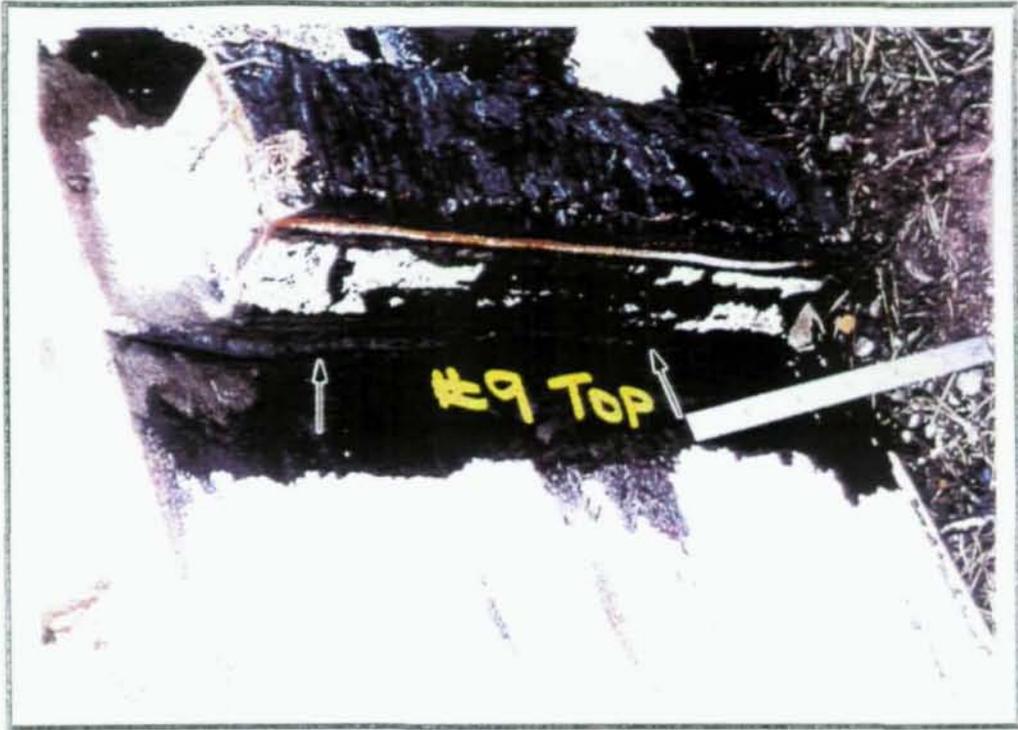
Figure 31 Photographs of Top and Bottom Fracture Locations for Specimen A4

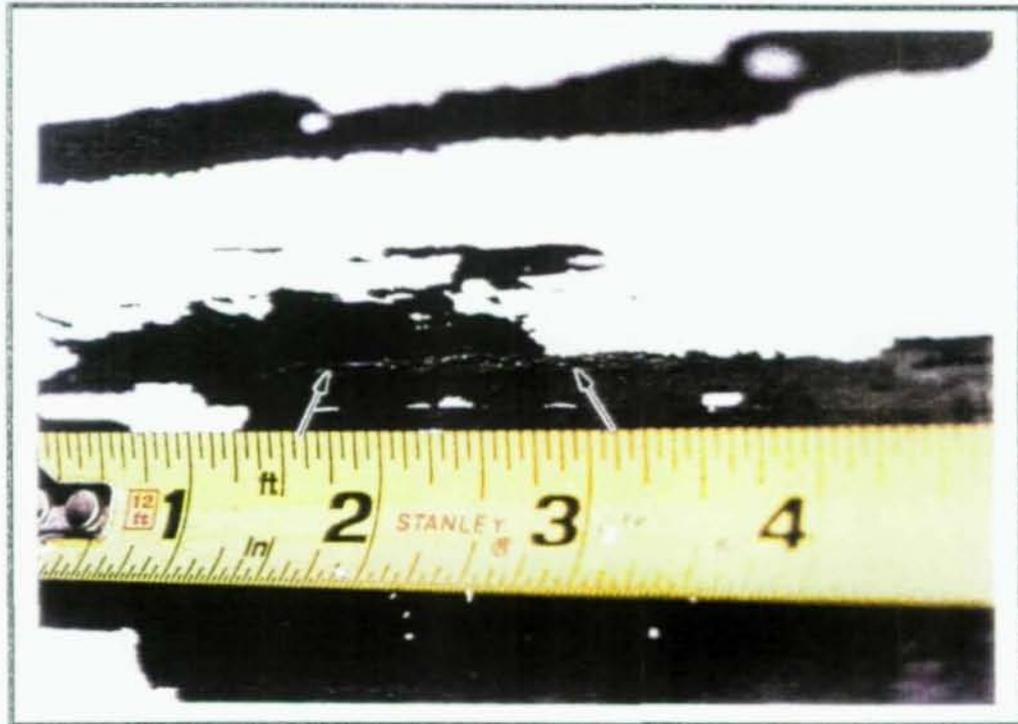
Figure 32 Photographs of Bottom Location for Specimen A5, Showing Crack at Toe of Cover Plate to Column Weld

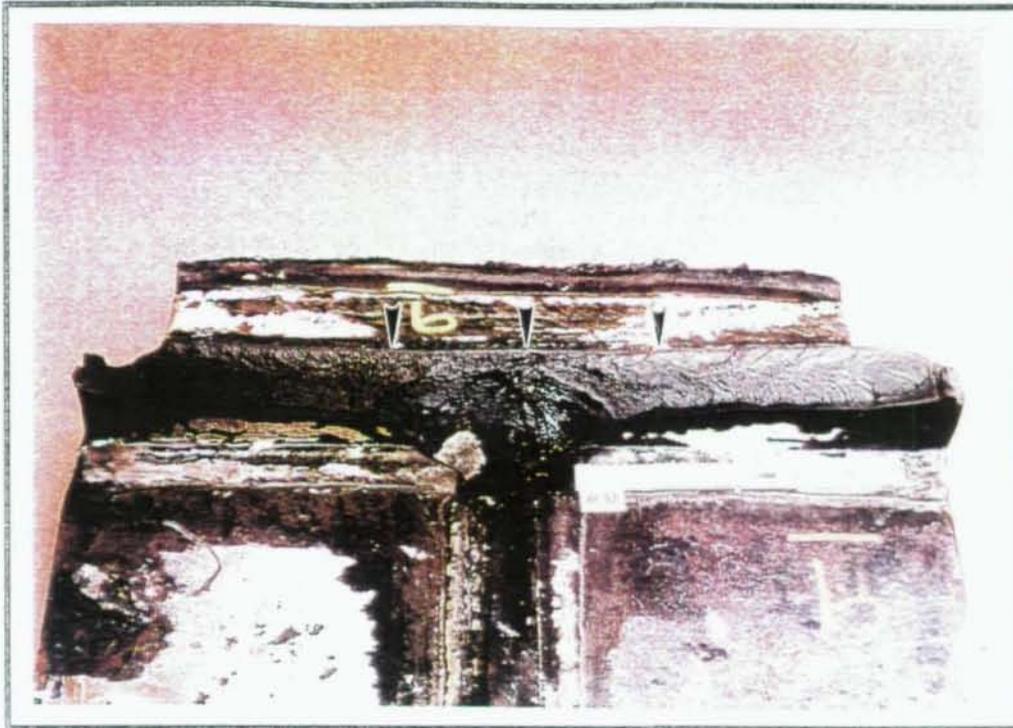
Figure 33 Photographs of Fracture Origin with Shear Lip at Cover Plate to Column Weld for Specimen A4

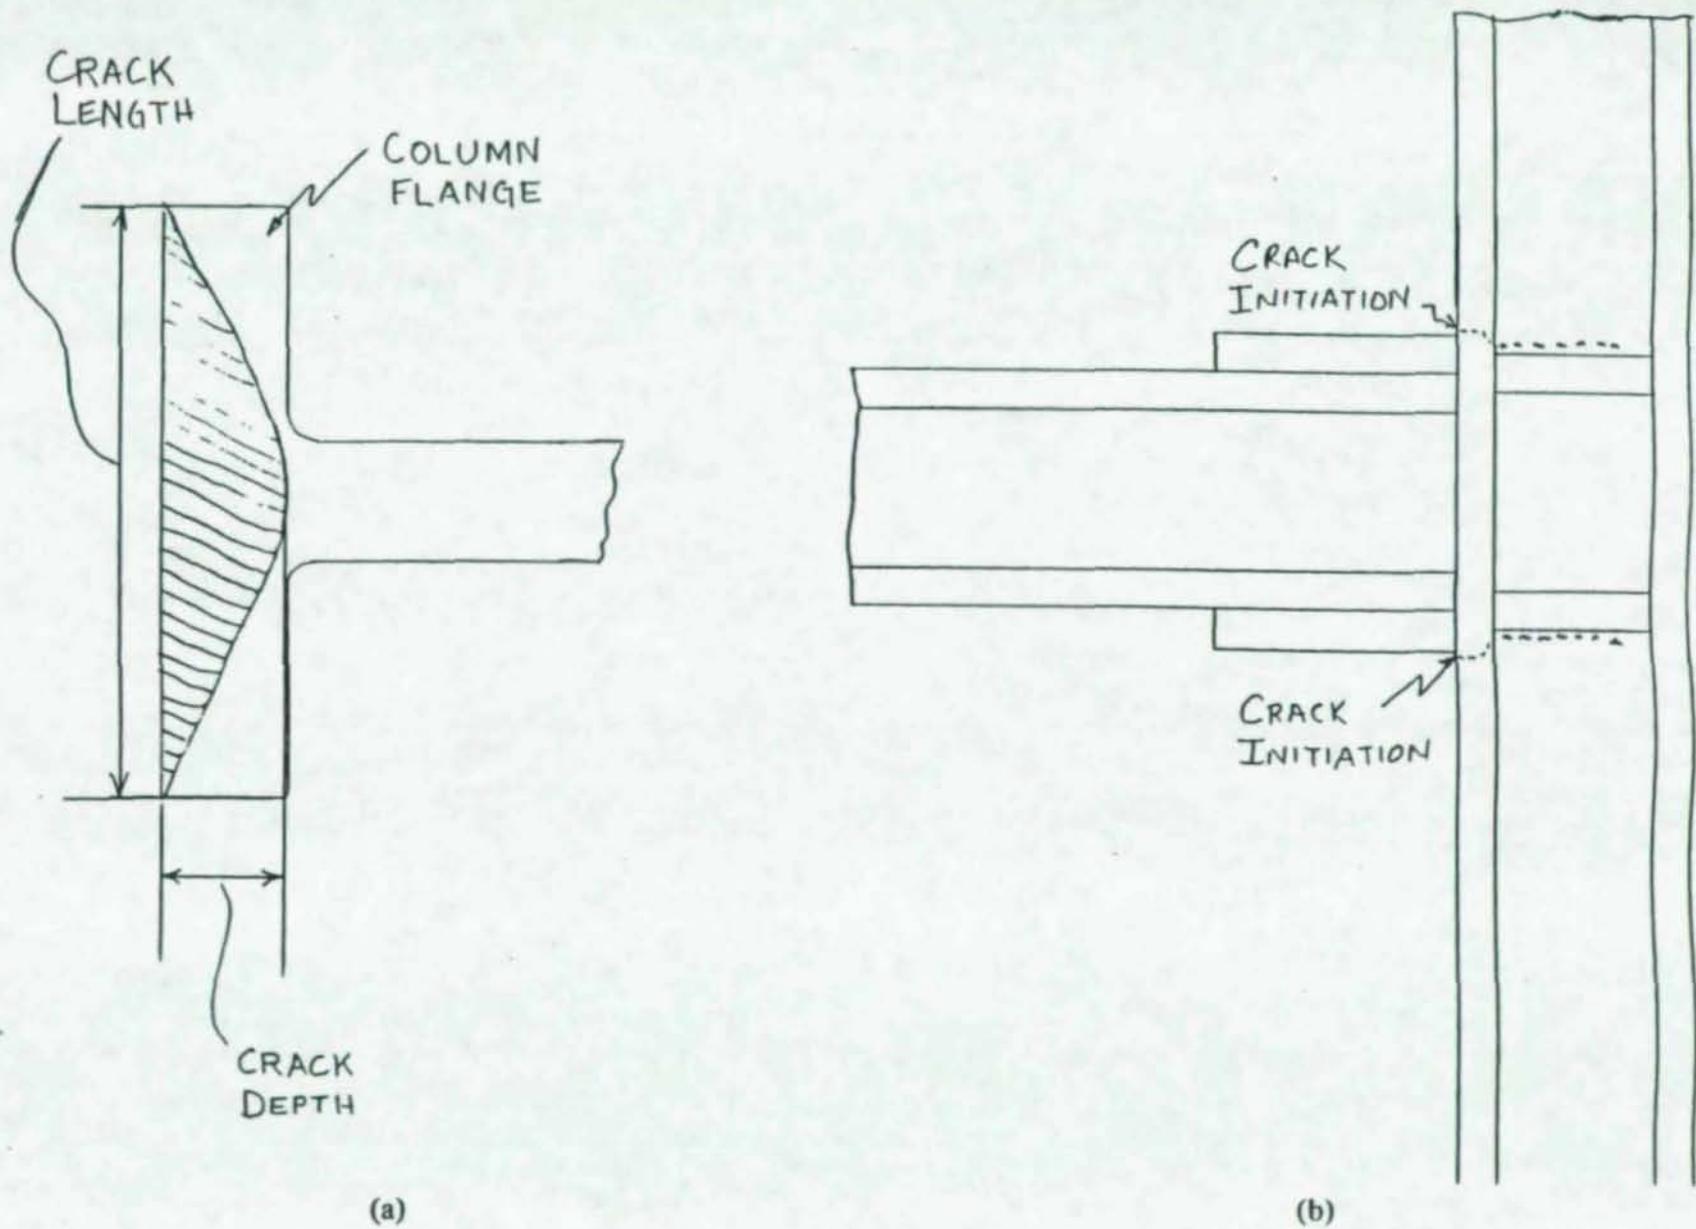
Figure 34 Schematic Illustration of Crack Locations, Depths and Lengths for Specimens A4 and A5

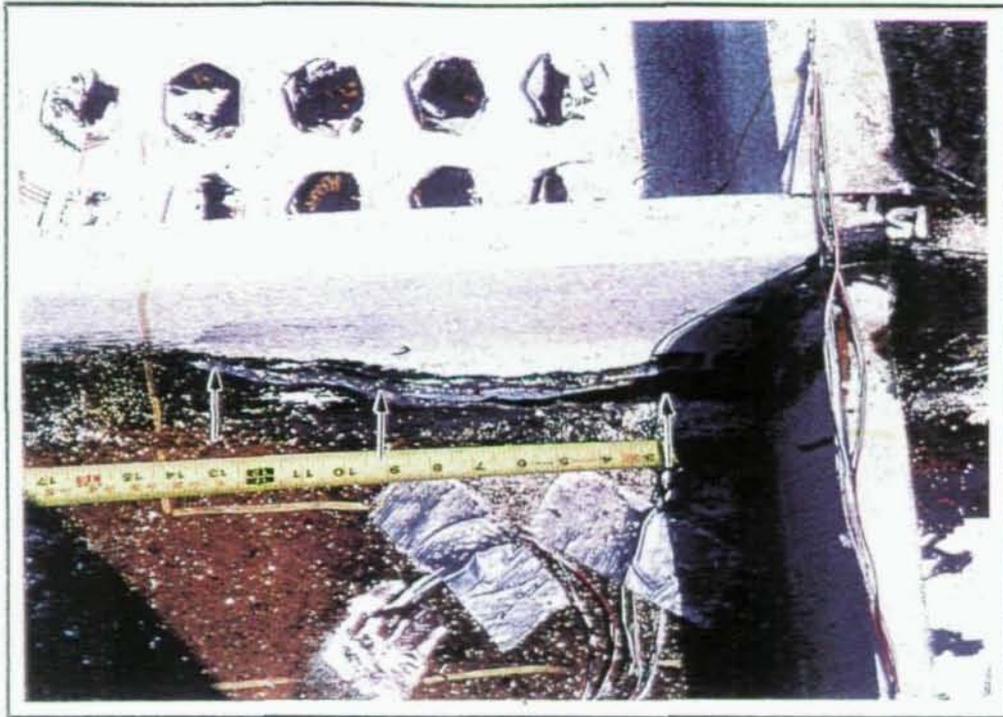
Figure 38 Top Location of Specimen A6, Showing (a) Crack in k-Region and (b) Separation of Continuity Plate from Column Flange

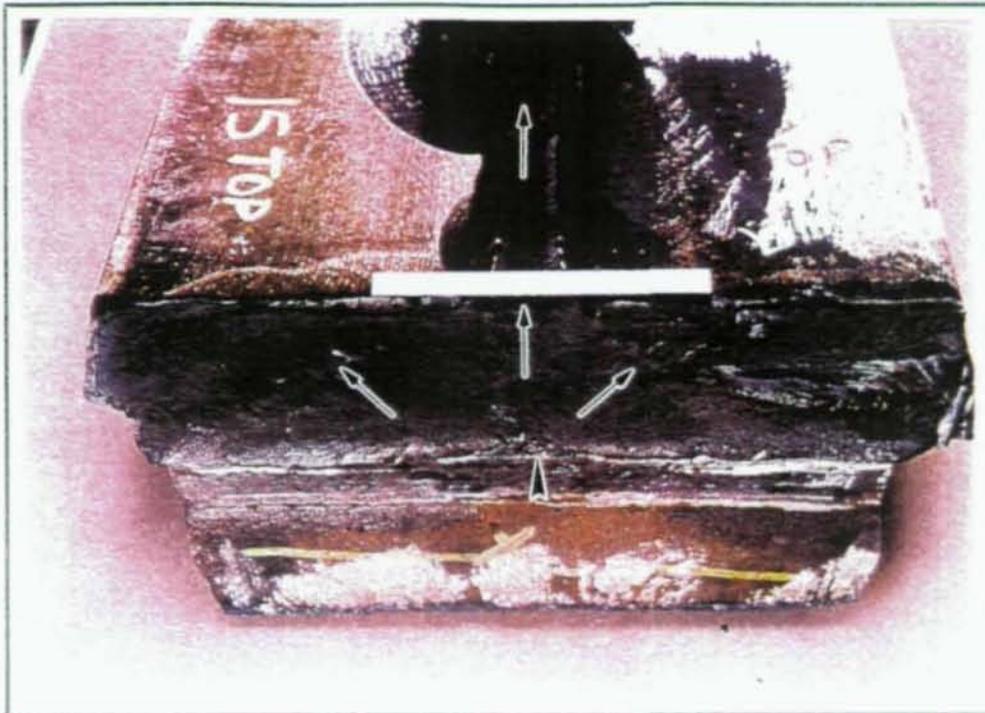
Figure 39 Fracture Origin at Top Cover Plate to Column Weld for Specimen A6. Short Arrows Indicate Origin; Long Arrows Show Crack Propagation Direction

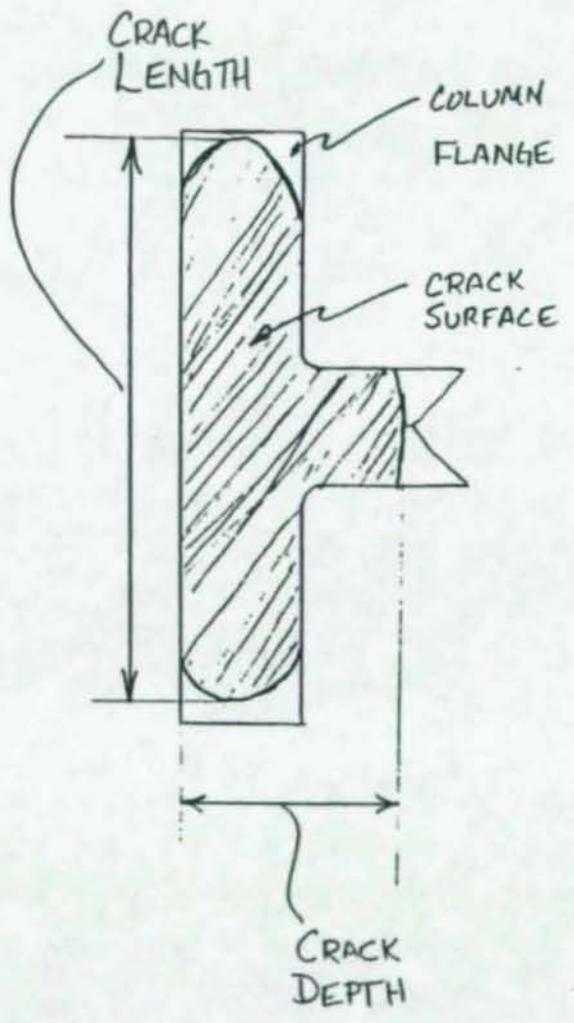
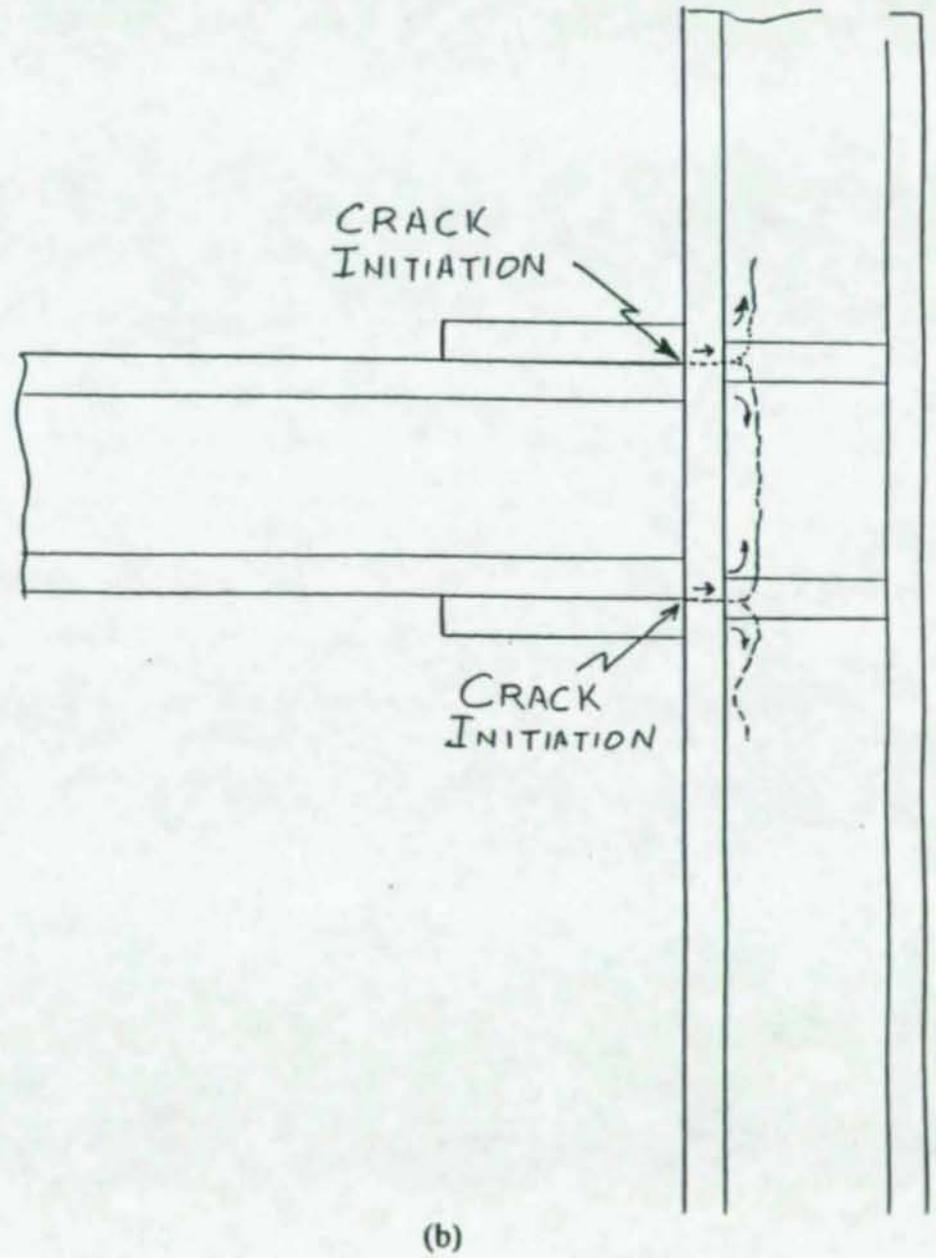
Figure 50 Schematic Illustration of Crack Locations, Depths and Lengths for Specimens R1-4 and R1-5

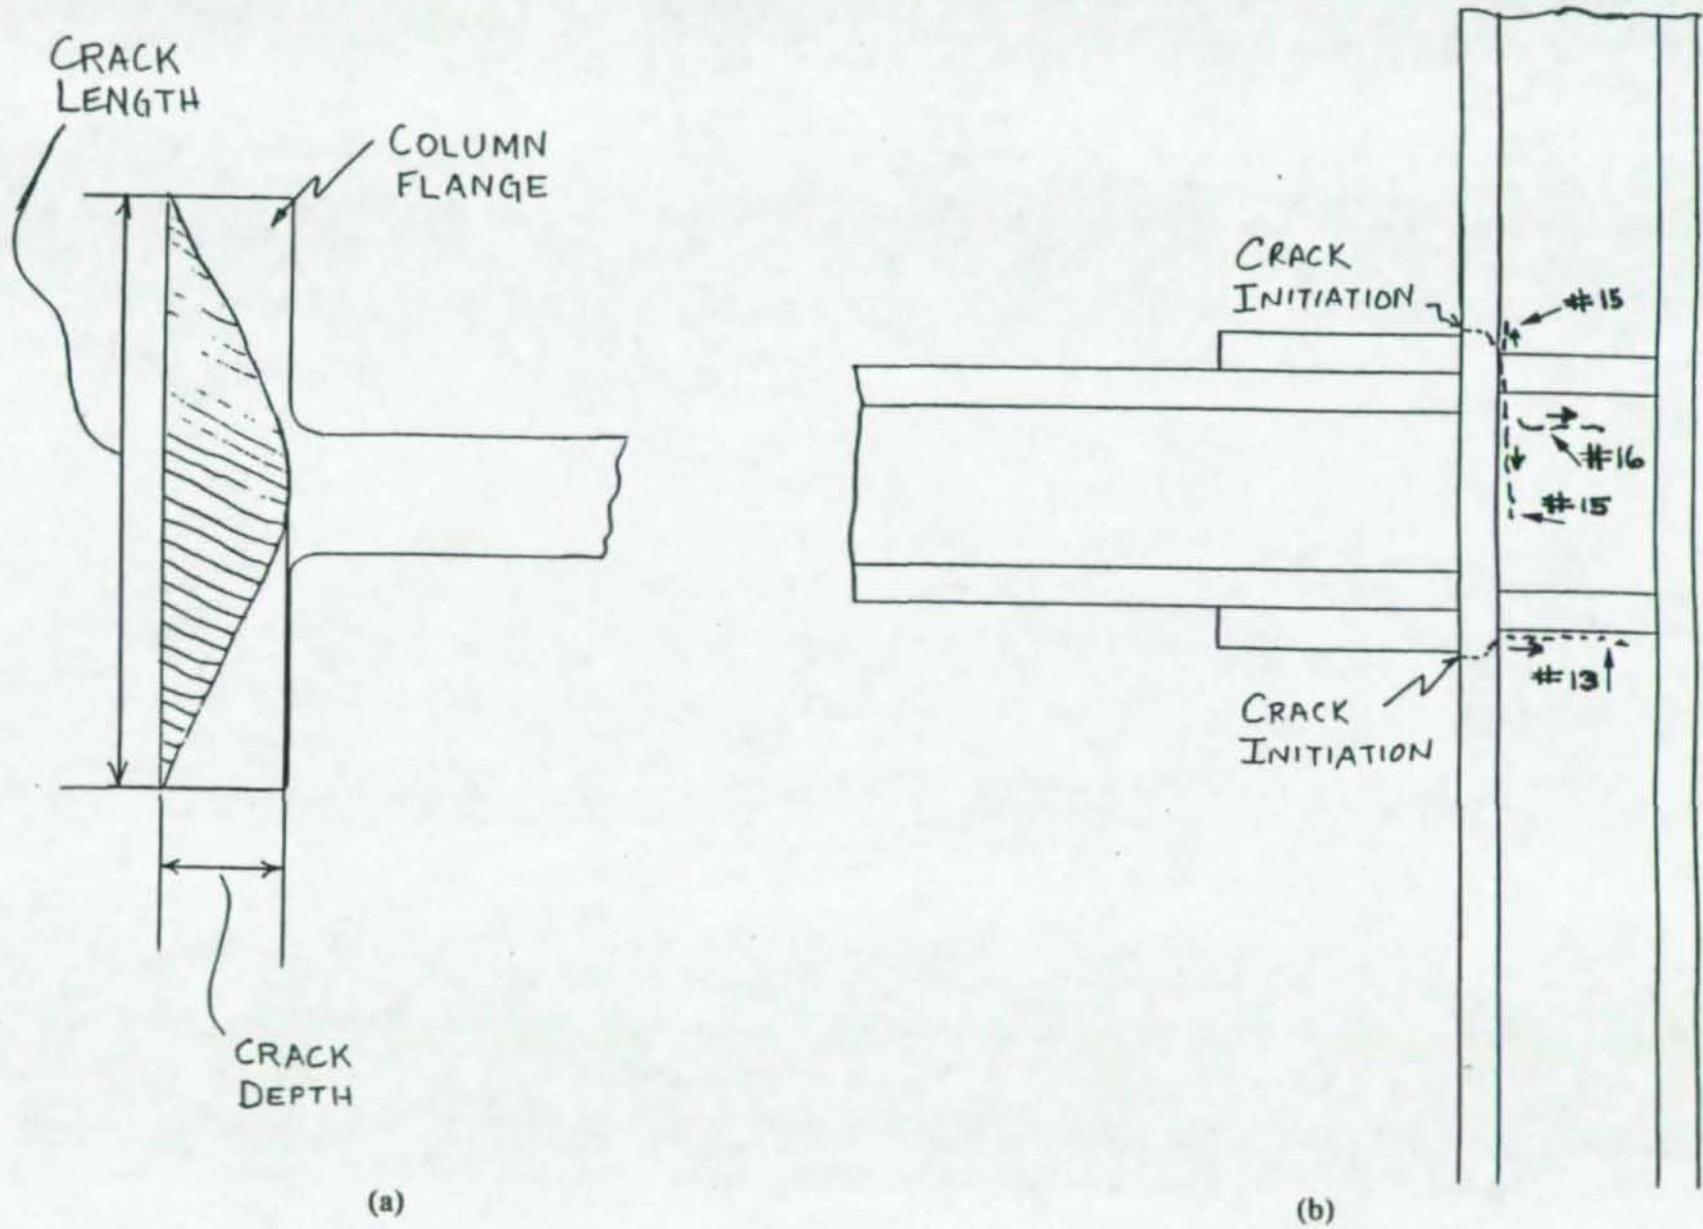
Figure 52 Schematic Illustration of Crack Locations, Depths and Length for Specimens R2, A6 and A7

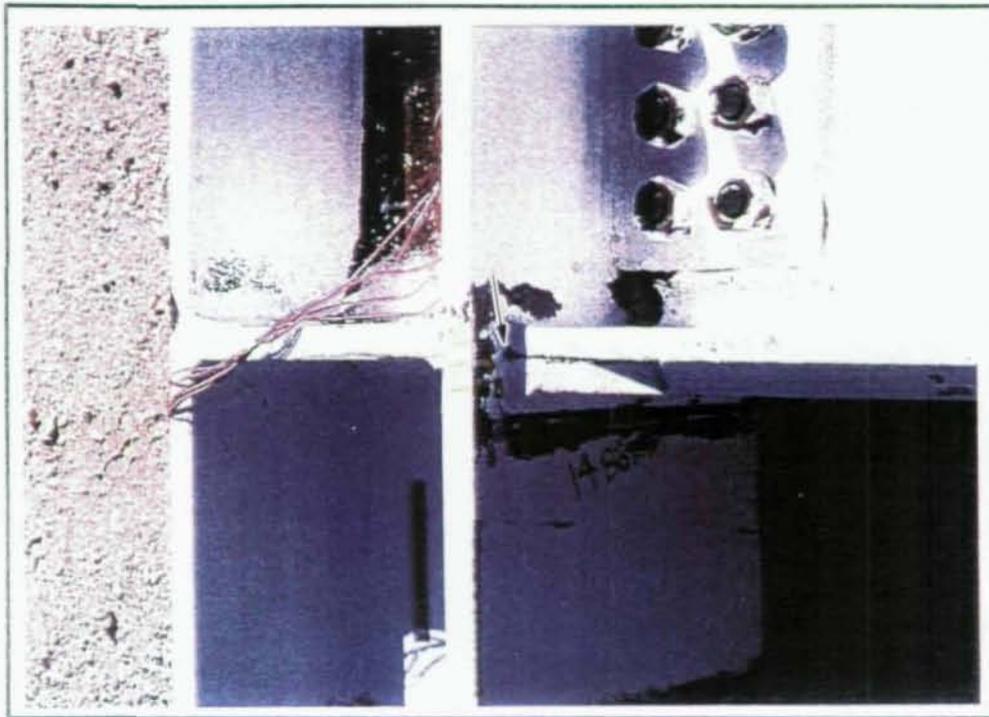
Figure 56 Column Flange near Bottom Cover Plate for Specimen R3-1, with Small Crack Extending into Column

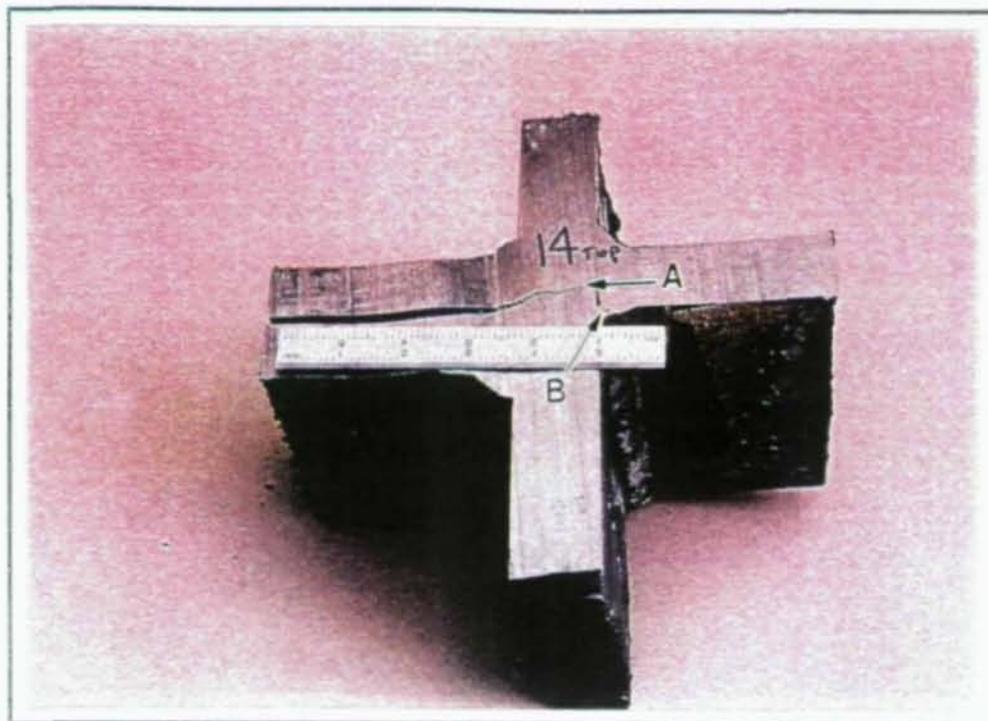
Figure 57 Photographs of Sectioned Top Cover Plate Location for Specimen R3-1, with Arrow A Showing Crack between Cover Plate and Beam Flange, and Arrow B Showing Crack in Continuity Plate Fillet Weld

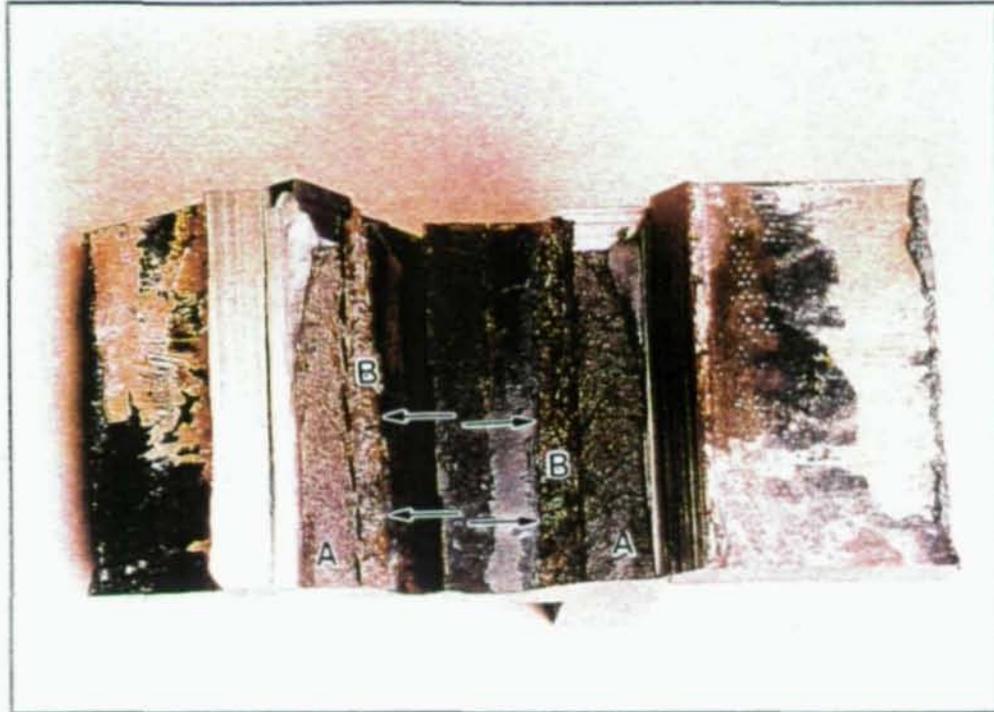
Figure 58 Photographs of Exposed Crack for Specimen R3-1. Arrows show Crack Origin along Weld Root. Dashed Line Separates Flange (A) from Weld (B).

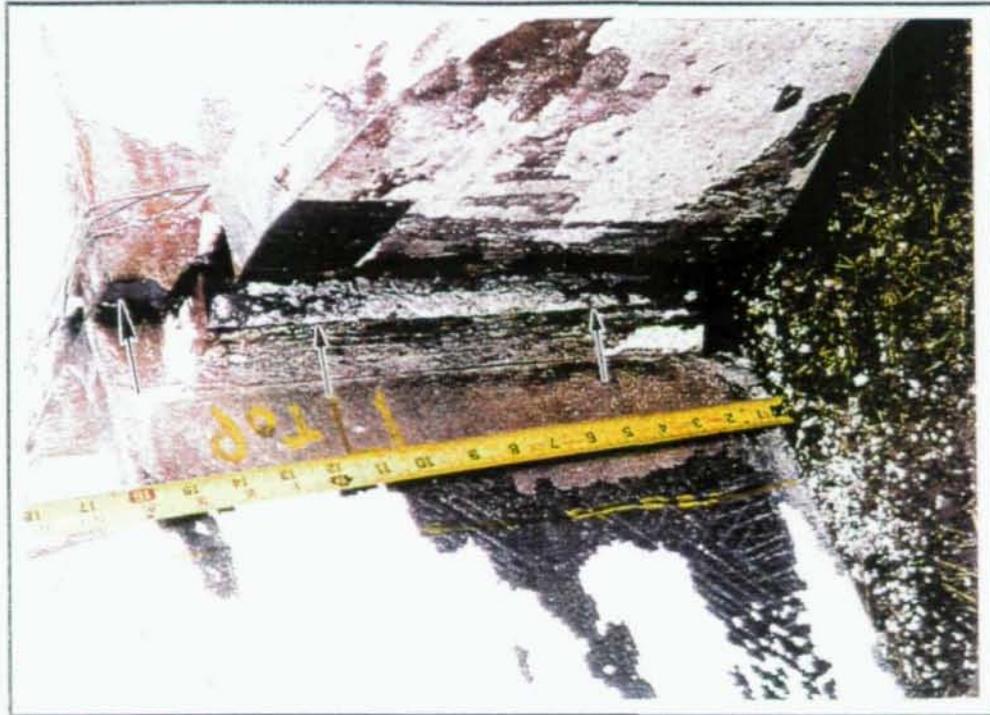
Figure 59 Top Cover Plate to Column Weld for Specimen R3-2.
Arrows Show Fractured Cover Plate and Flange

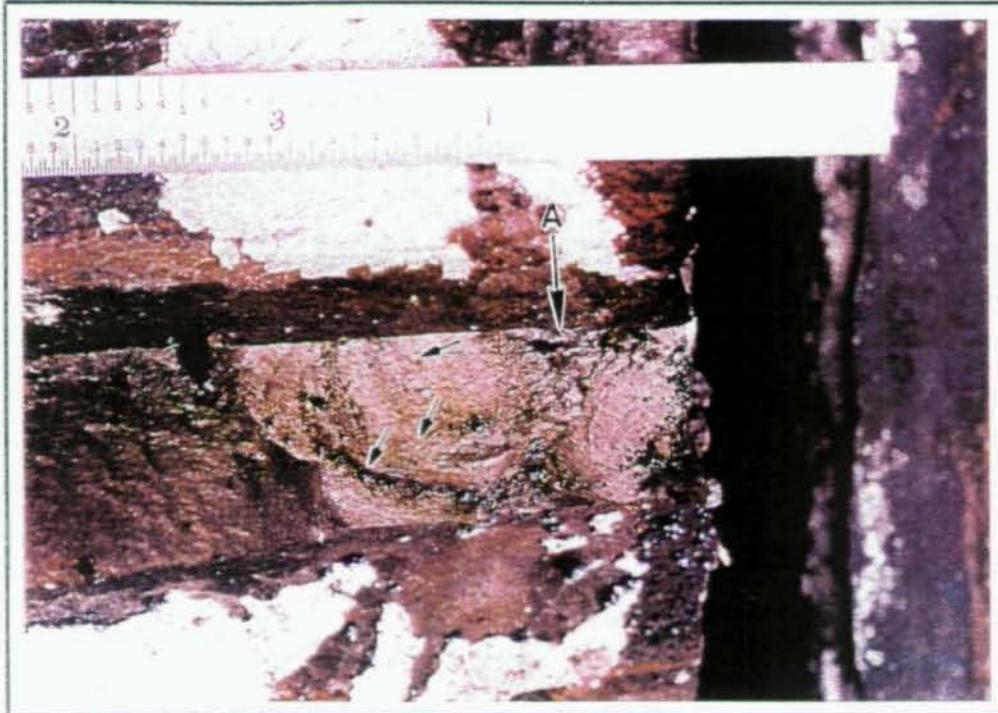
Figure 62 Fractured k-Region for Specimen R3-2. Arrow A Shows Origin at Edge of Continuity Plate Weld. Small Arrows Show Crack Arrest Marks.

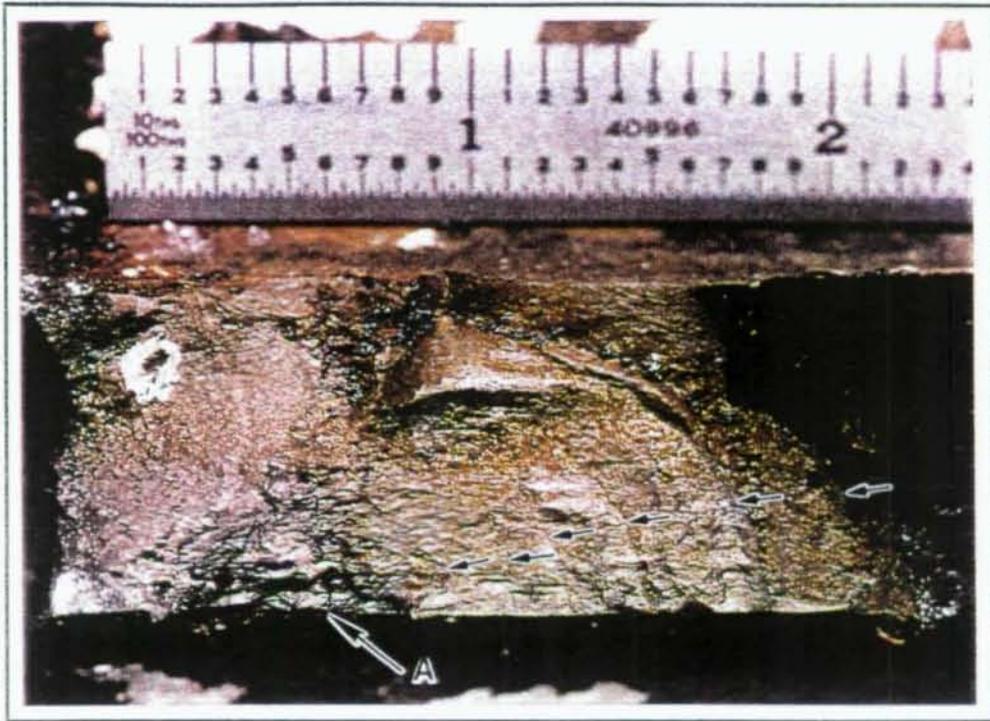
Figure 63 Fractured k-Region for Specimen R3-2. Small Arrows Show Six of the Seven Crack Arrest Marks. Arrow A Shows Continuity Plate Fillet Weld Origin

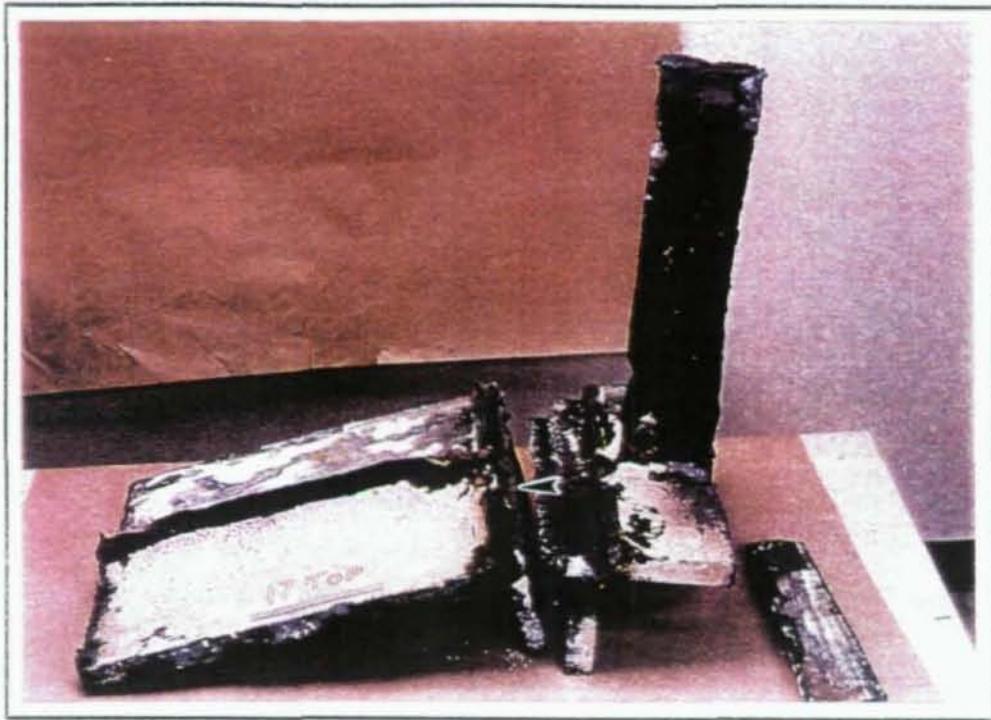
Figure 64 Top Cover Plate Fracture Surfaces for Specimen R3-2. Arrows Indicate Fracture Origin at Weld Root between Cover Plate and Beam Flange. Arrow A Indicates a Crack Arrest Mark in the Flange

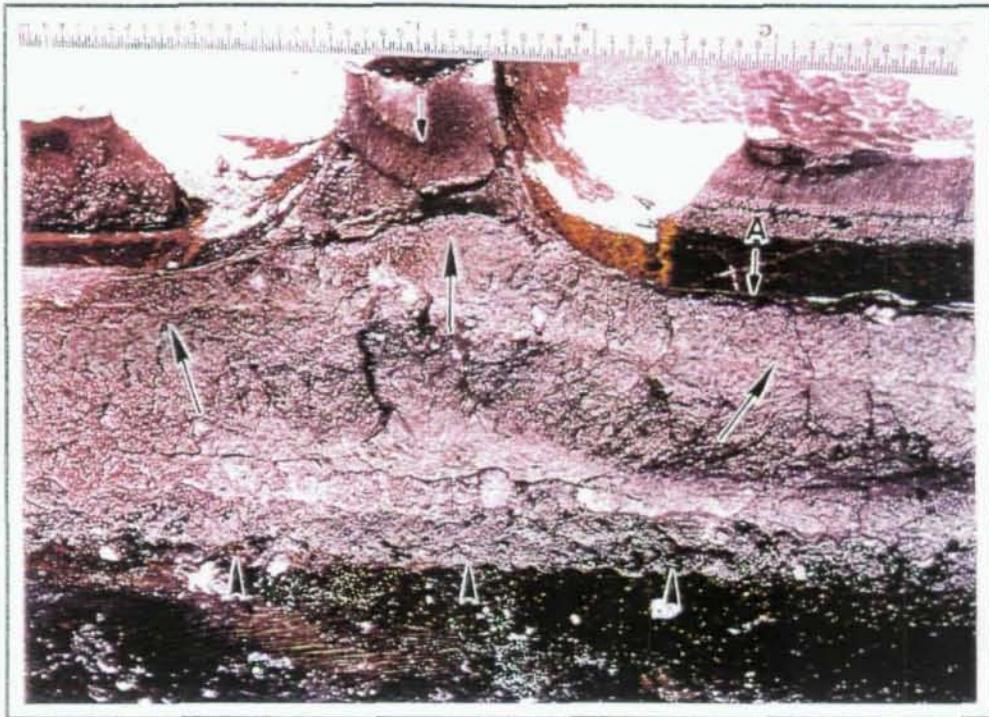
Figure 65 Fractures of Specimen R3-2: (a) Shows Origin at Weld Root between Cover Plate and Flange; (b) Shows Fracture Transition near k-Region. Arrows Show Crack Propagation Direction. Arrow A Indicates Shear Lip on Flange.
