**TESTS OF FULL-SCALE BEAM-TO-COLUMN
CONNECTIONS**

Reidar Bjorhovde
The Bjorhovde Group, Tucson, Arizona

August 1999

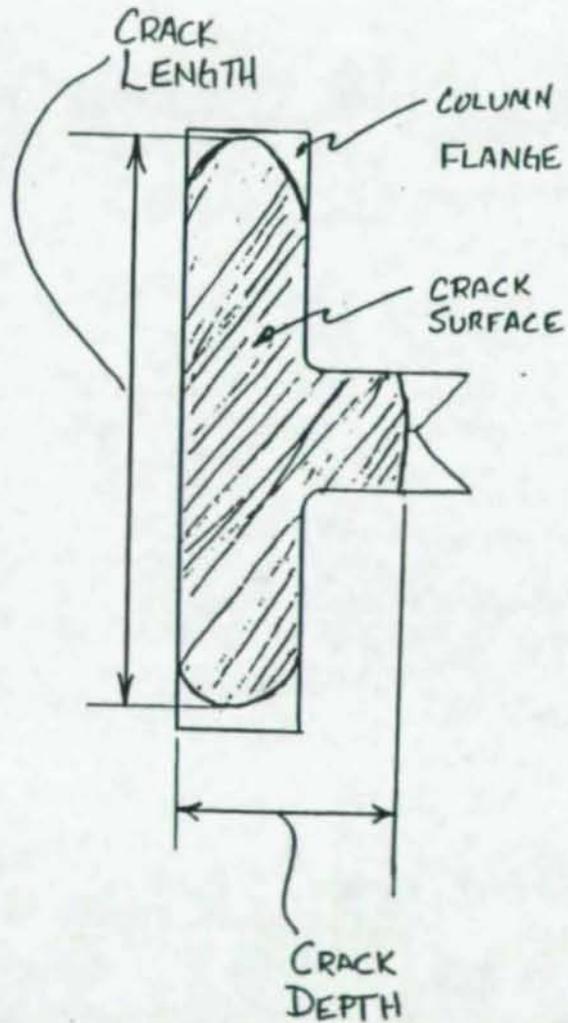
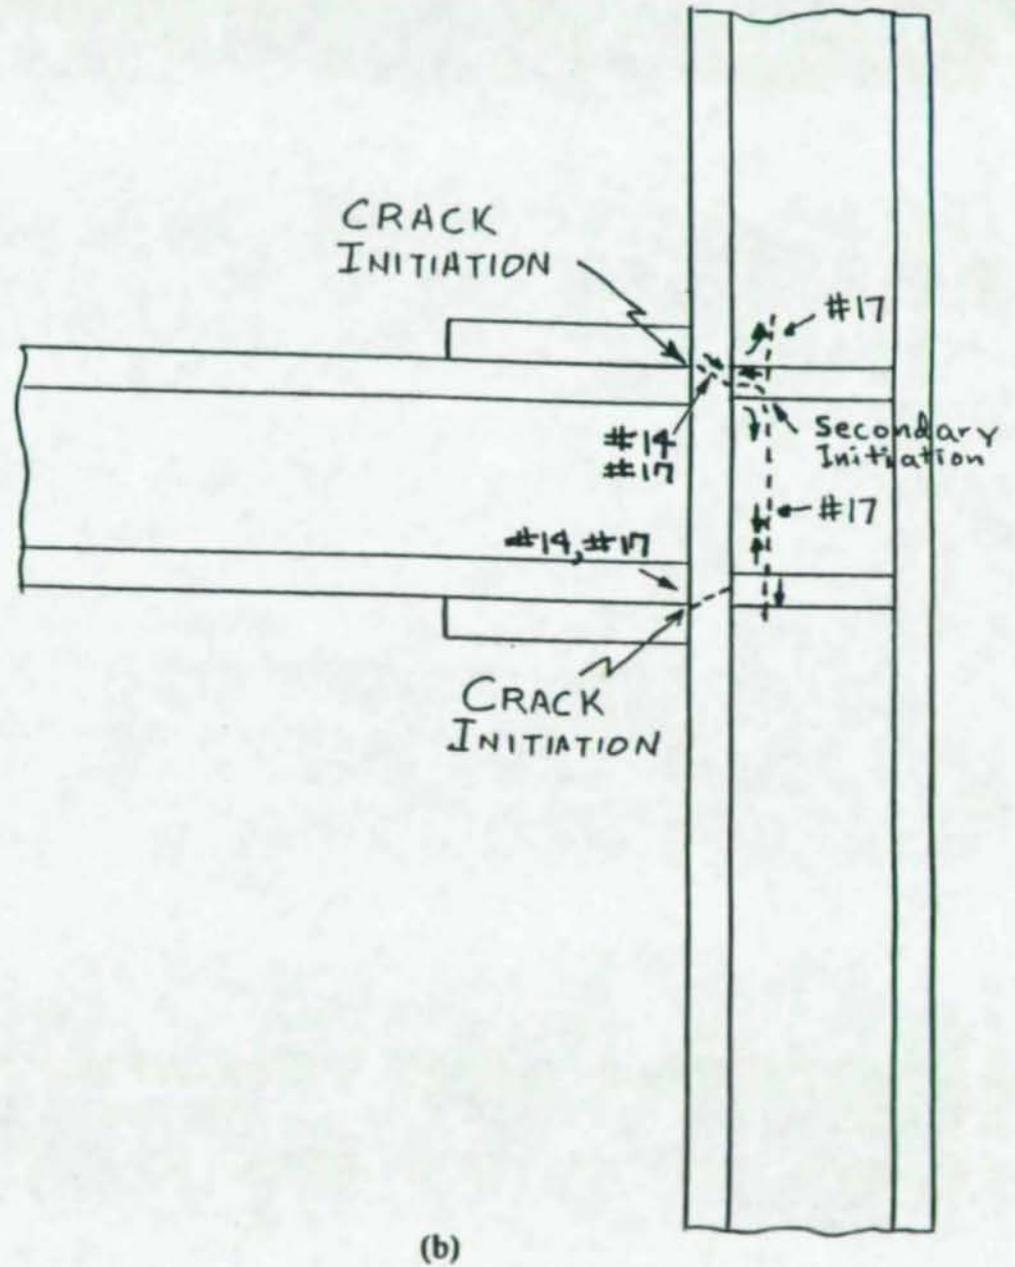
Figure 66 Schematic Illustration of Crack Locations, Depths and Lengths for Specimens R3-1 and R3-2
