**STRUCTURAL SYSTEMS
RESEARCH PROJECT**

Report No.
SSRP-2001/05

**EFFECT OF STRAIGHTENING METHOD
ON THE CYCLIC BEHAVIOR OF k AREA
IN STEEL ROLLED SHAPES**

Final Report on a Research Project Funded by the American
Institute of Steel Construction

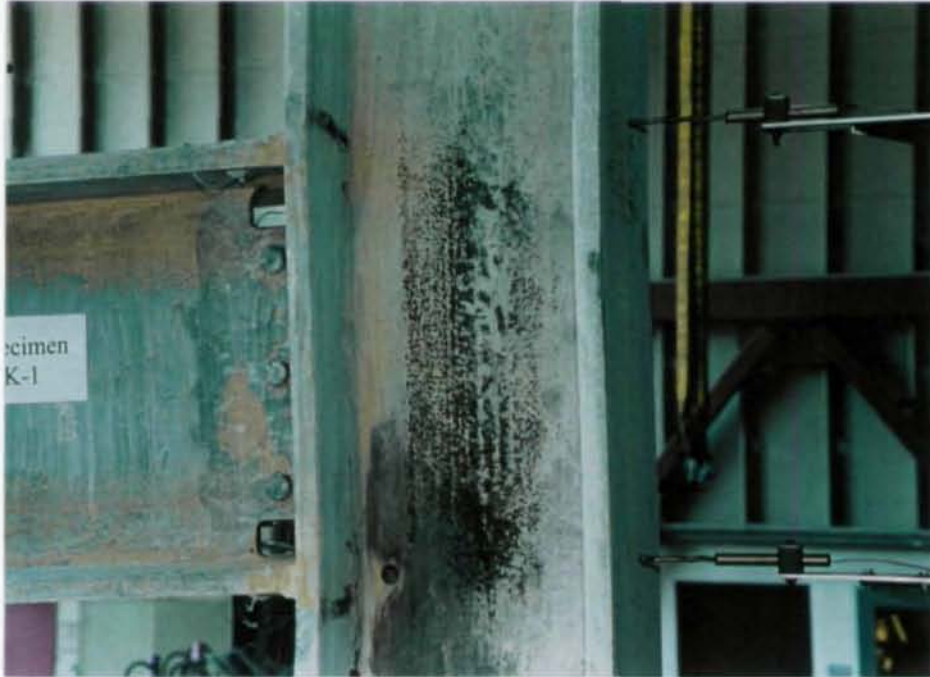
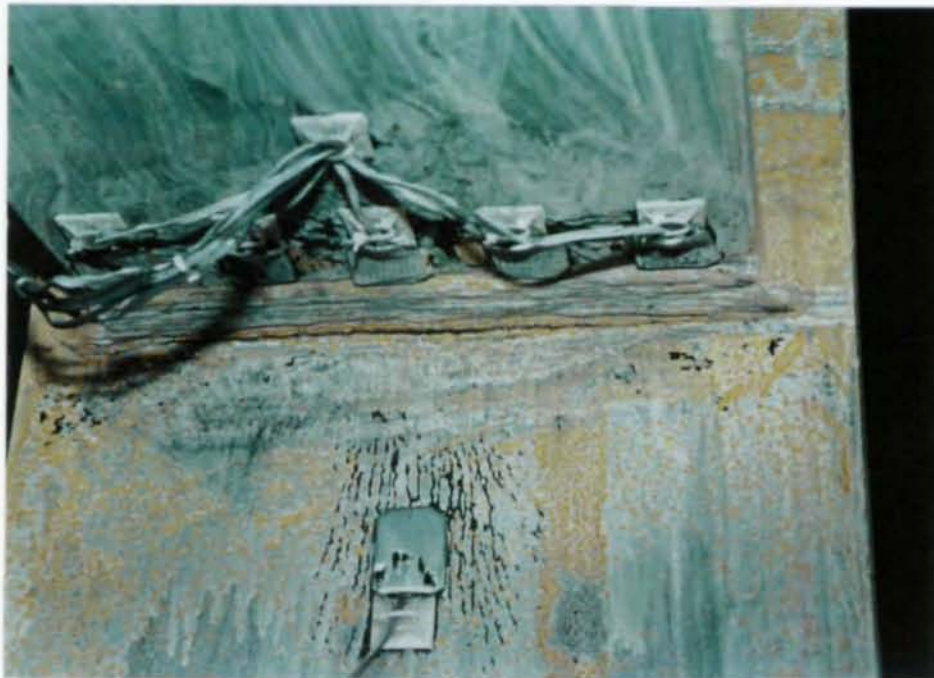
Figure 3.1 Specimen K1: Panel Zone Yielding and Crack Initiation at Toe of Bottom Flange Groove Weld (3% Drift)

Minor flaking of the whitewash was observed in the panel zone during the 1% drift cycles. At 2% drift, kinking of the column due to panel zone yielding was noticed. Figure 3.1(a) shows the column kinking at 3% drift. Notice the flaking of whitewash in the column flange that occurred just above the top flange and below the bottom flange of the beam. At this drift level, a hairline crack developed at the toe of the groove weld connecting the beam bottom flange to the column flange [see Figure 3.1(b)]. During the first positive excursion of 4% drift, the column flange at the bottom flange level was almost completely fractured [see Figure 3.2(a)]. Figure 3.2(b) shows that the fracture extended into the column web and propagated upward near the k area by about half the beam depth. Before the test was stopped, it was decided to reverse the direction of loading and to displace the beam to 10 in. Figure 3.3 shows the deformed configuration with severe column kinking. Only minor crack at the toe of the top flange groove weld was observed (see Figure 3.4); column fracture at the top flange level could not be developed.

(a) Panel Zone Yielding and Column Kinking

(b) Crack Initiation at Toe of Bottom Flange Groove Weld

All three specimens performed and failed in a similar way. But the presence of the 1-inch diameter drilled hole was not the cause of failure. Significant yielding in the panel zone occurred first. Hairline cracks developed at the toe of the beam flange groove welds at 3% drift; significant kinking of the column flange was also observed at this drift level. Local flange bending of the column produced stress concentration and crack initiation at the center of the column flange. The crack then propagated outward to fracture the column flange across its width. Complete fracture of the column flange occurred at 4% drift for Specimen K1 and 5% drift for Specimens K2 and K3.

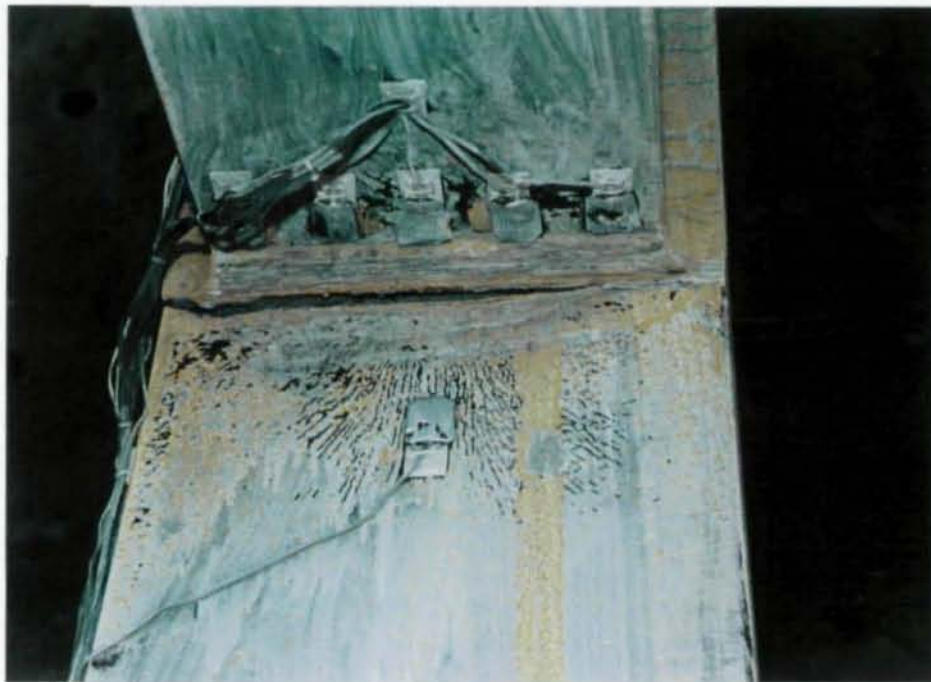
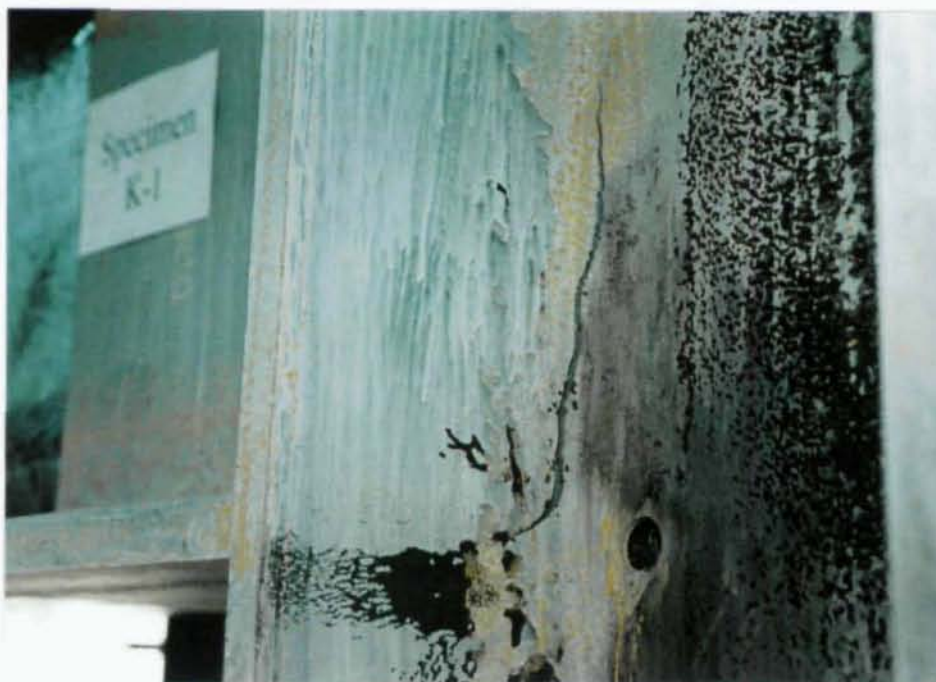
Figure 3.2 Specimen K1: Fracture of Column Flange at Bottom Flange Level and Propagation near k Area (4% Drift)

The column flange tended to bend out of plane (i.e., "warp") because continuity plates were not used; the flaking pattern of the column in Figure 3.2(a) shows this effect. A displacement transducer (L9) was placed at the top flange level of the beam to monitor the relative out-of-plane deformation between two column flanges. Prior to column fracture, the symmetric response in Figure 3.9(a) shows that the deformation was about the same under both tension and compression forces. To measure the amount of transverse strain induced by the out-of-plane bending, a strain gage (S16) was placed transversely on the inside face of the column flange connecting to the beam. Figure 3.9(b) shows that the transverse strain reached the yield strain at 4% drift.

(a) Fracture of Column Flange

(b) Propagation of Column Fracture near k Area

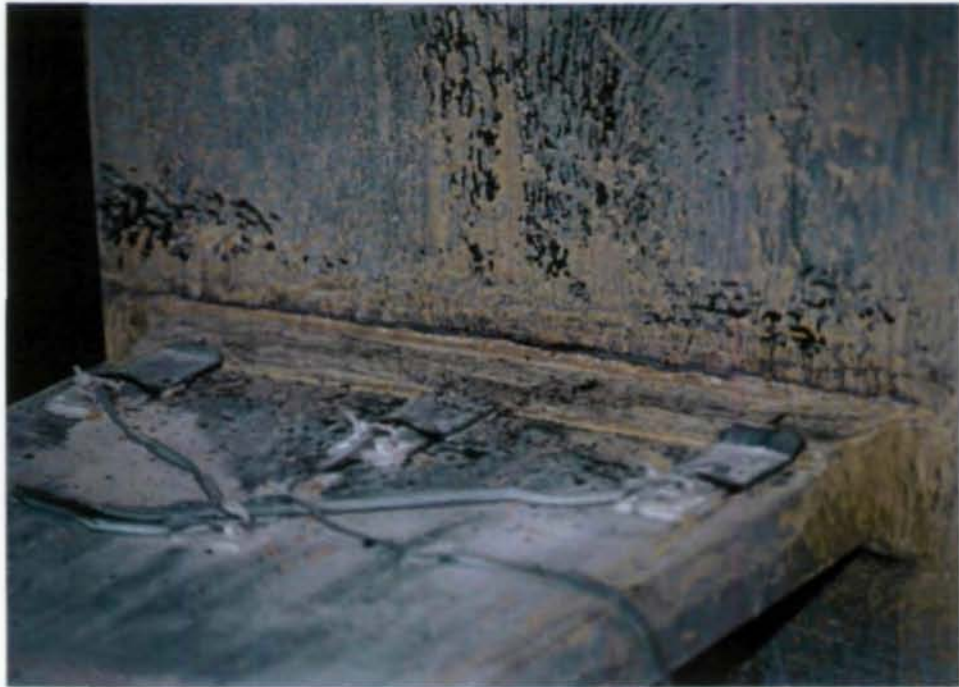
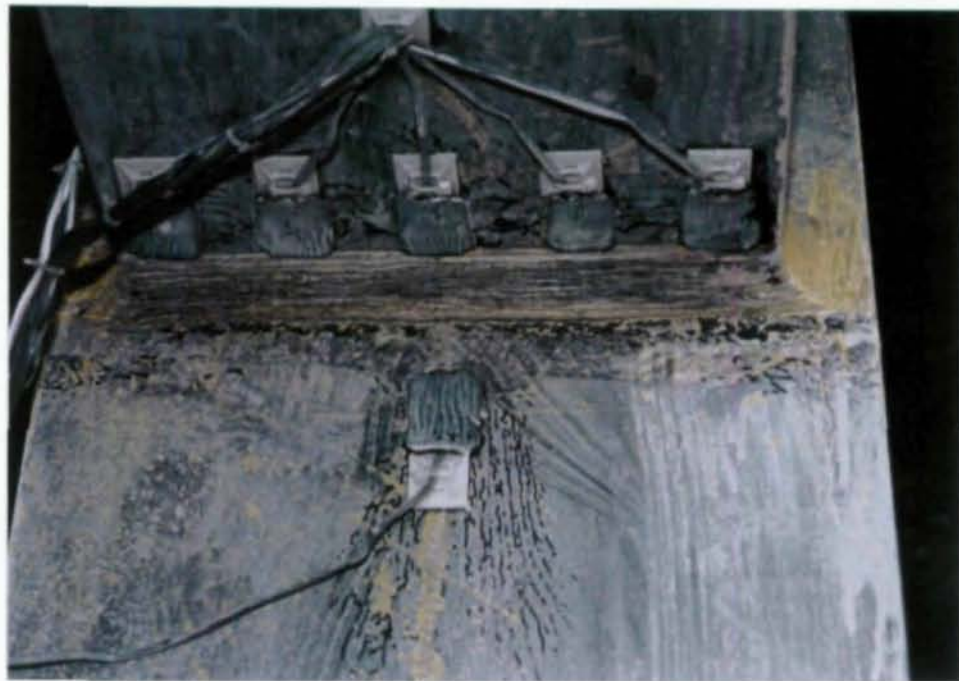
Figure 3.14 Specimen K2: Fracture of Column Flange (4% Drift)

Flaking of the whitewash around the hole, an indication of stress concentration, occurred at 0.5% drift. Flaking in the panel zone was observed at 0.75% drift. Figure 3.13 shows the yielding pattern at 1% drift. Kinking of the column due to panel zone yielding was obvious at 2% drift. At 3% drift level, hair-lines cracks developed at the weld toe of both flanges of the beam. Figure 3.14 shows the extent of crack that propagated into the column flange at the top and bottom flanges at 4% drift. The column flange at the top flange level fractured completely at 5% drift [see Figure 3.15(a)]. Fracture in the column flange also led to a separation in the column web [see Figure 3.15(b)]; the fracture extended into the column web and propagated downward near the k area for about one-fifth of the beam depth. At this point it was decided to reverse the loading direction to test the column at the bottom flange level. Figure 3.16 shows the tearing of the hole at different displacement levels. The fracture propagation was gradual, leading to a slow degradation in strength. The test was stopped at 12 in. beam deflection (8.6% drift). This specimen performed better than Specimen K1. While the latter one was not able to complete one cycle at 4% drift, Specimen K2 was subjected to one complete cycle at 5% drift before the column flange fractured completely.

(a) Top Flange Level

(b) Bottom Flange Level

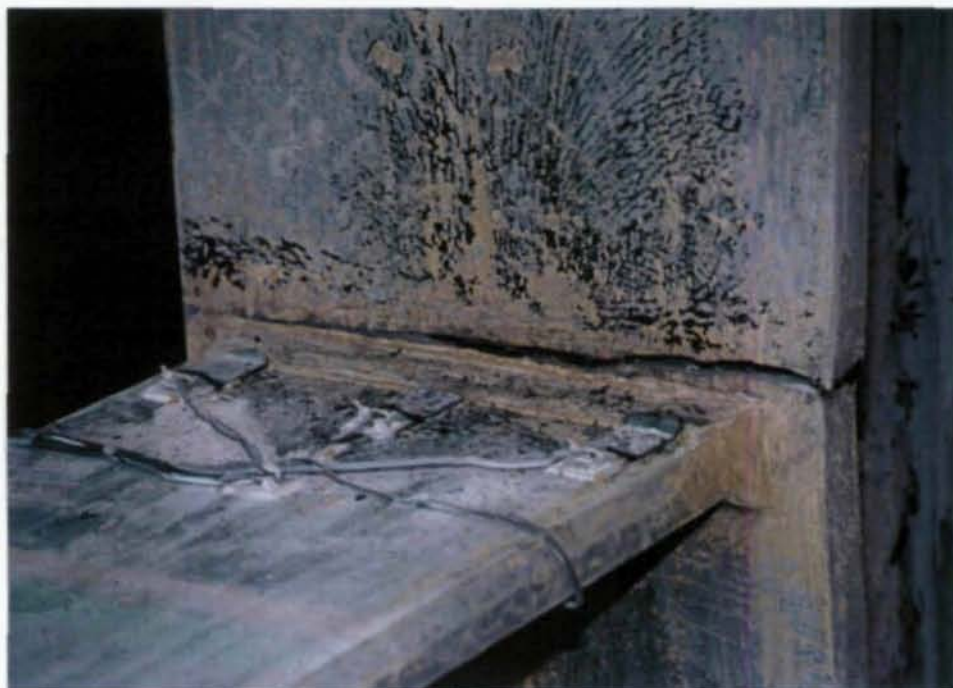
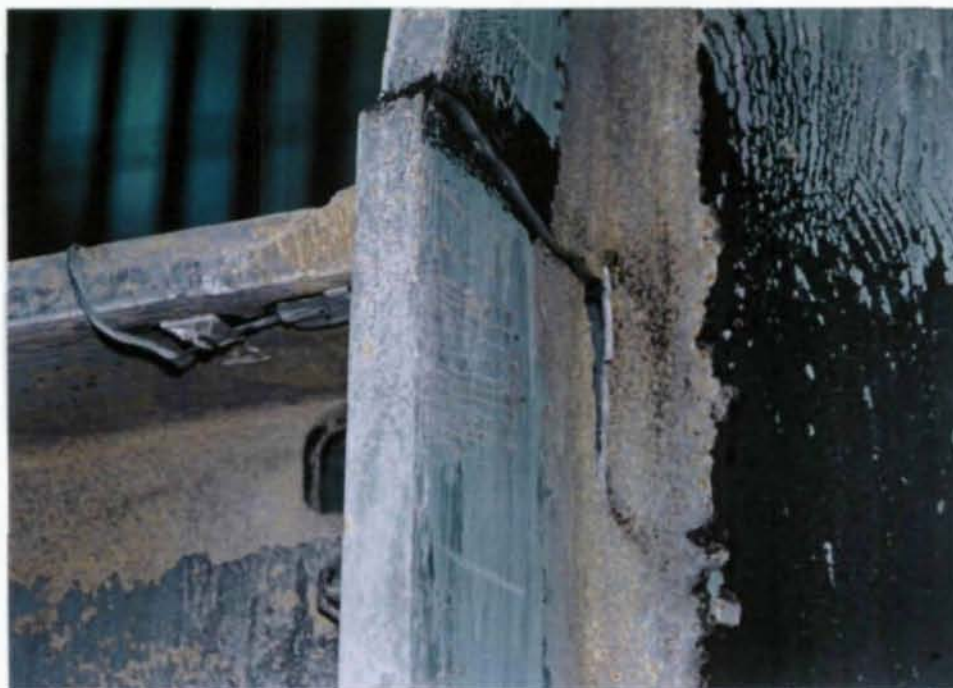
Figure 3.15 Specimen K2: Fracture of Column at Beam Top Flange Level (5% Drift)

(a) Fracture of Column Flange

(b) Propagation of Fracture into Column Web near k Area

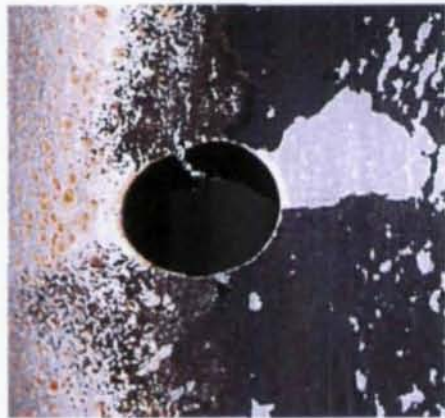
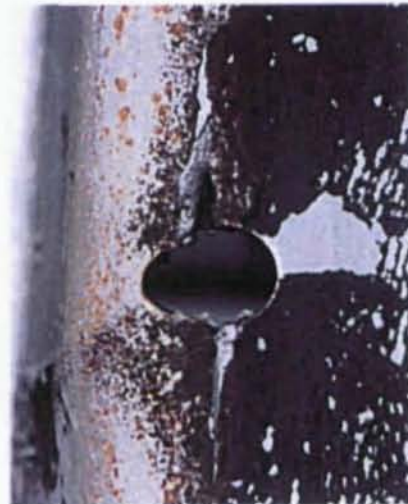
Figure 3.16 Specimen K2: Fracture Propagation in Hole Region

(a) 7 in. Drift

(c) 9 in. Drift

(d) 10 in. Drift

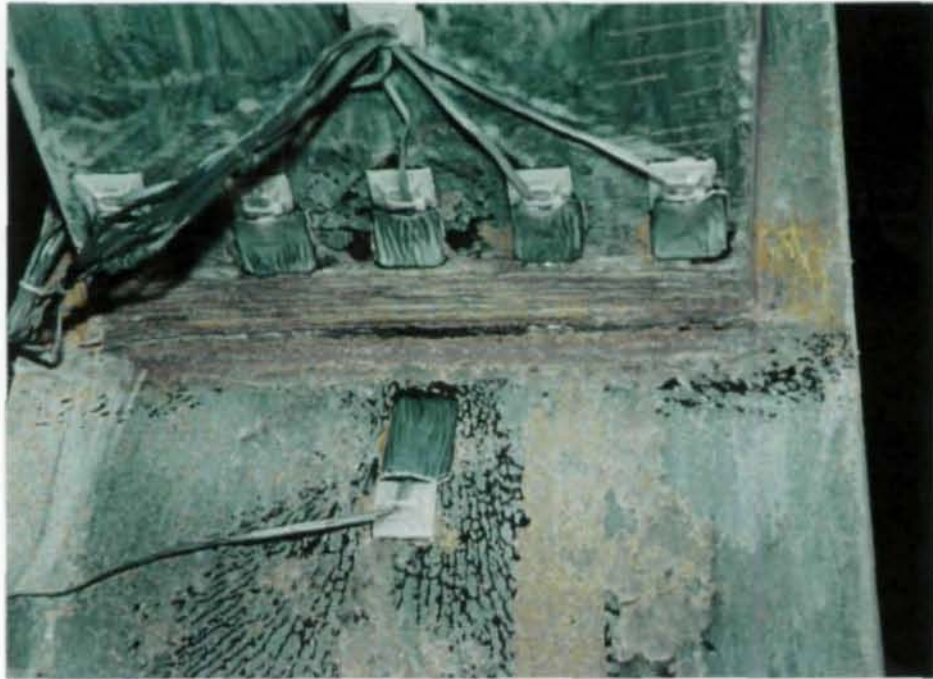
Figure 3.26 Specimen K3: Column Flange Fracture at Beam Bottom Flange Level
(5% Drift, 1st Cycle)

Figure 3.26 shows the extent of column fracture during the first cycle at 5% drift. Shown in Figure 3.27 is the complete fracture of the column flange during the second cycle of 5% drift. The extent of fracture propagation around the hole during the 5% drift cycles is presented in Figure 3.28. Although the propagation of cracks along the k line was relatively fast, the behavior was not brittle and the strength degradation was limited. The specimen was able to experience one excursion at 6% drift before it failed in the reverse excursion. While the fracture in the column flange propagated into the column web near the k area for Specimens K1 and K2, this was not the case for Specimen K3. The latter one also performed better than the other two specimens; Specimens K1, K2, and K3 experienced complete fracture of the column at 4%, 5%, and 6% drifts, respectively.

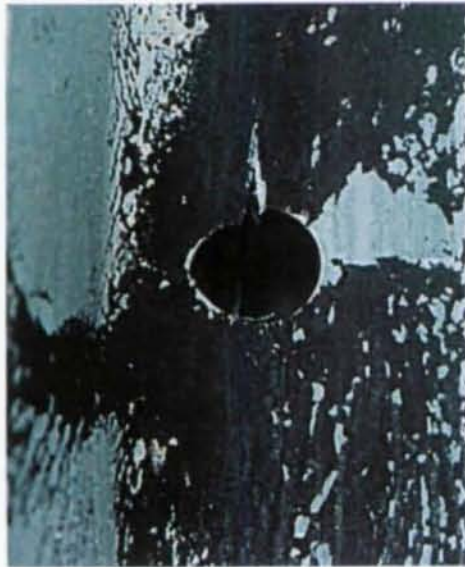
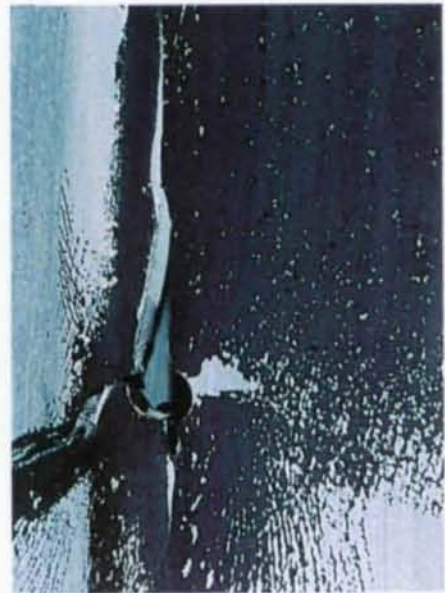
Figure 3.28 Specimen K3: Fracture Propagation in Hole Region

(a) 5% Drift, 1st Cycle

(c) 5% Drift, 2nd Cycle at 3.14 in

(d) 5% Drift, 2nd Cycle at 6 in

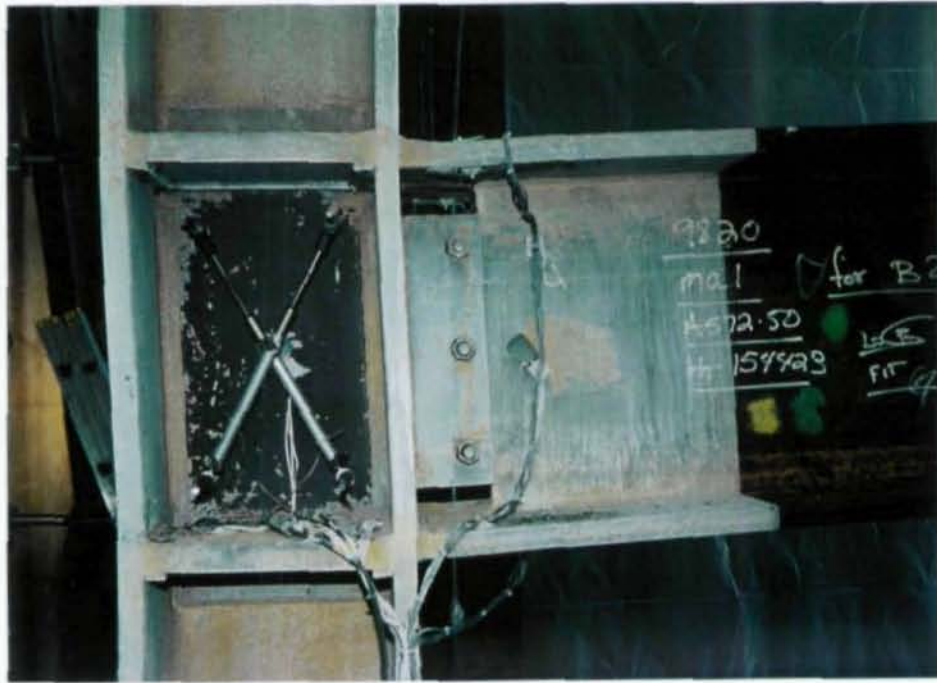
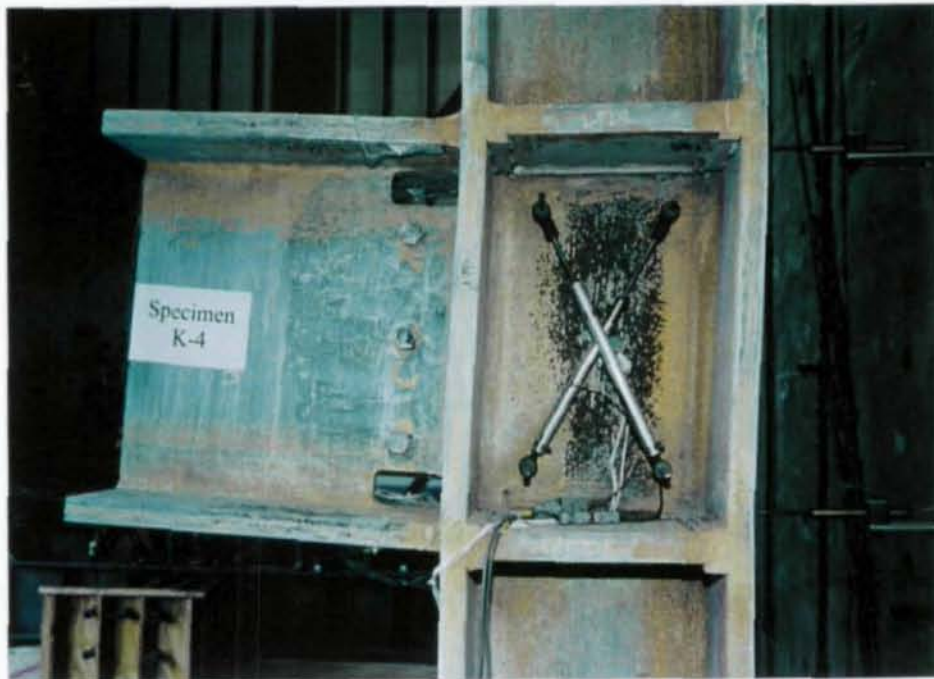
Figure 4.2 Specimen K4: Column Kinking due to Significant Panel Zone Yielding at 5% Drift

(a) Doubler Plate Side

(b) Column Web Side

Significant kinking of the column due to panel zone yielding did not cause fracture. Instead, since the bending moment in the beam was higher, the beam flange strains ($\approx 15\epsilon_y$) were about twice the values ($\approx 7\epsilon_y$) recorded in the first three specimens. Brittle fracture eventually occurred in the beams, initiating at either the top or bottom flange from the weld access hole. Stress concentration that occurred in the k area of the beam was responsible for the crack initiation. To prevent this type of failure, providing a smooth profile for the weld access hole is very important.

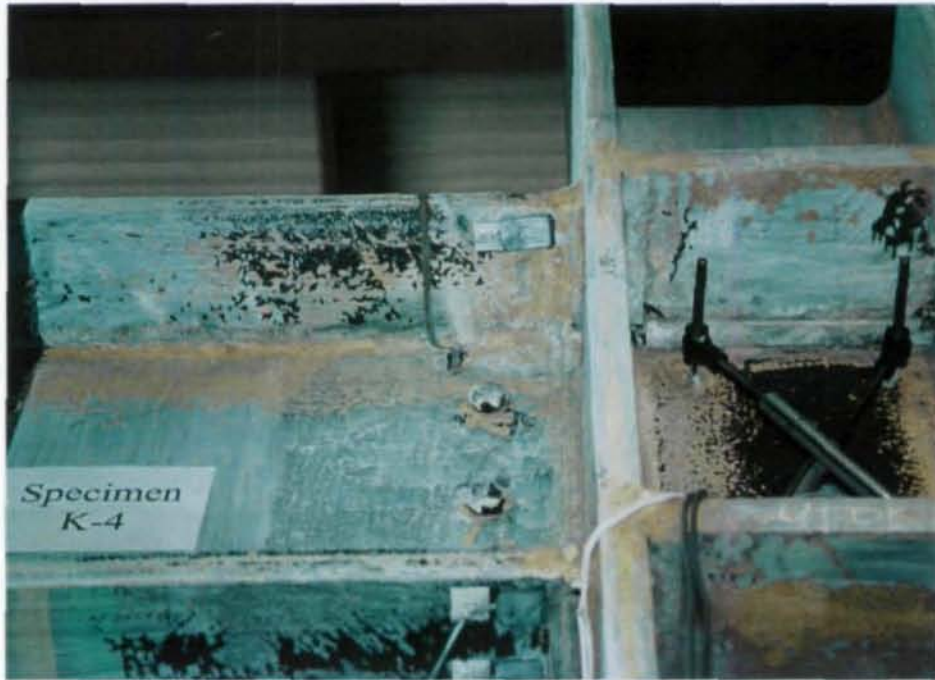
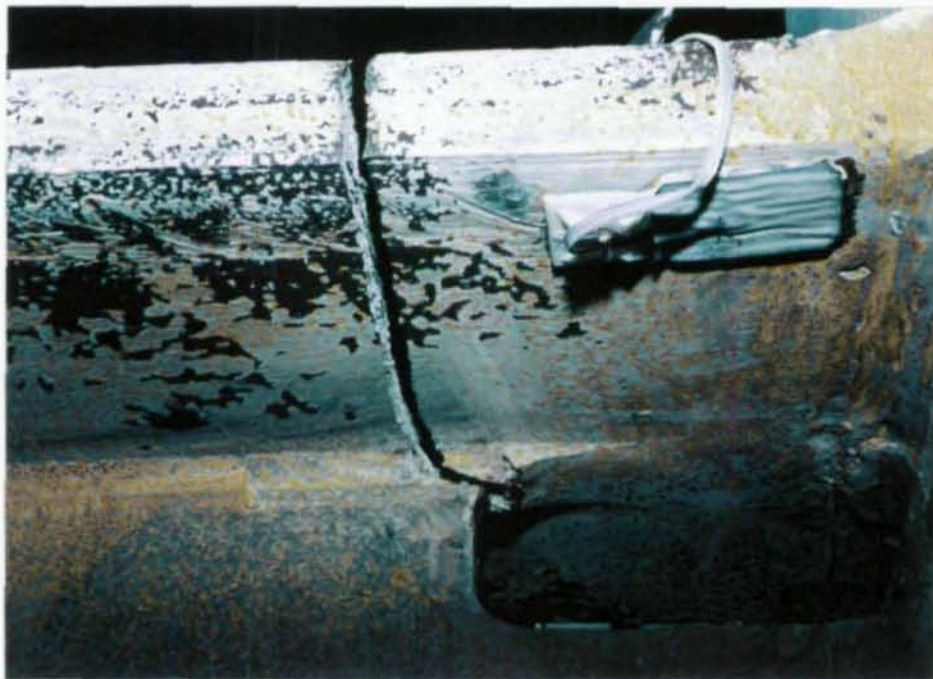
Figure 4.3 Specimen K4: Brittle Fracture of Beam Top Flange at 6% Drift

Minor flaking of the whitewash in the panel zone (both the column web and doubler plate) was first observed at 1% drift. Flaking in the beam flanges was observed at 3% drift. Figure 4.1 shows that, at 4% drift, the yielding of the test specimen was concentrated in the panel zone. The doubler plate experienced more yielding than that in the column web because a lower grade of steel (A36) was used. Figure 4.2 shows the kinking of the column due to significant yielding in the panel zone during the first cycle at 5% drift. After completing one cycle at 6% cycle, the beam top flange experienced brittle fracture during the second cycle. Figure 4.3 shows that the fracture initiated from the weld access hole in the k area of the beam web and was due to stress concentration. The test was then stopped.

(a) Brittle Fracture of Beam Top Flange

(b) Close-up View of Fracture

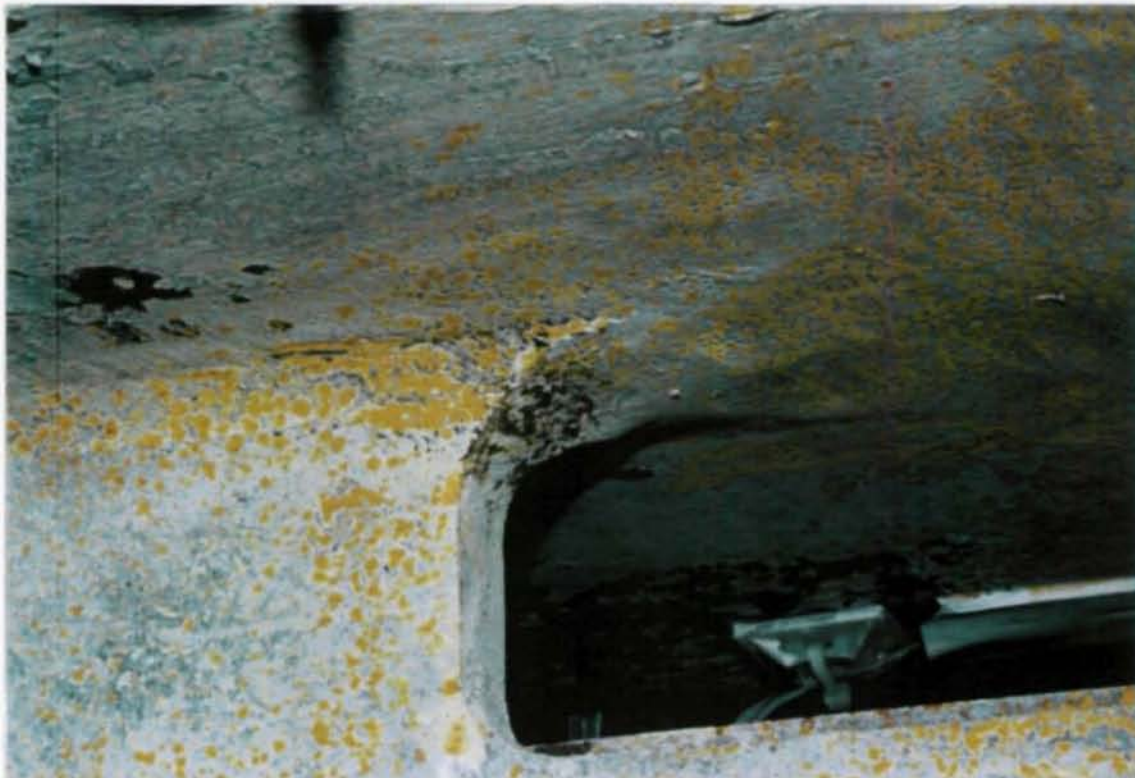
Figure 4.13 Specimen K5: Crack Initiation in Top Flange Weld Access Hole at 5% Drift

The performance of this specimen was very similar to Specimen K4. Figure 4.9 shows the yielding in the panel zone at 3% drift. Figure 4.10 shows that the beam flange had yielded, but no local buckling was observed. Figure 4.11 depicts the column kinking due to yielding in the panel zone at 5% drift. At this drift level, sign of stress concentration at the weld access hole started to show (see Figure 4.12). The curvature of the beam bottom flange in the weld access hole region, shown in Figure 4.13, was an indication that a significant amount of beam shear was transferred through the beam flanges to the column. Brittle fracture of the beam bottom flange occurred during the first cycle at 6% drift (see Figure 4.14), and the test was stopped. The fracture occurred in the k area of the beam web due to stress concentration in the weld access hole.

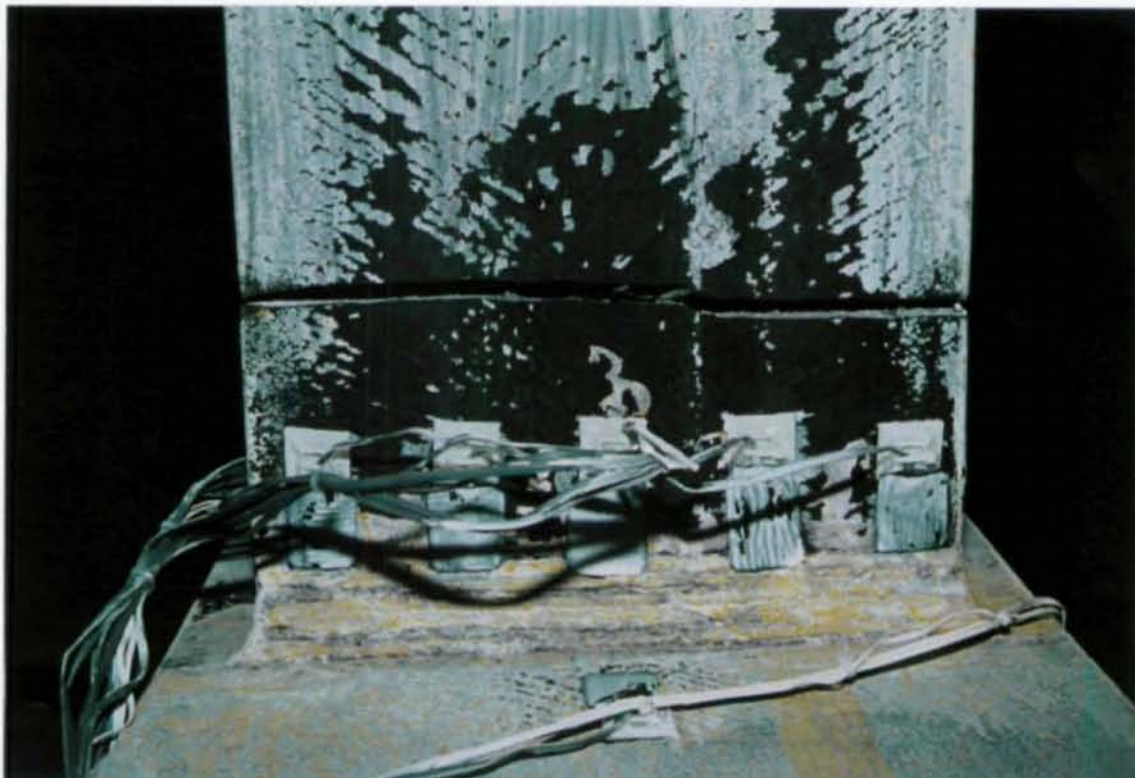
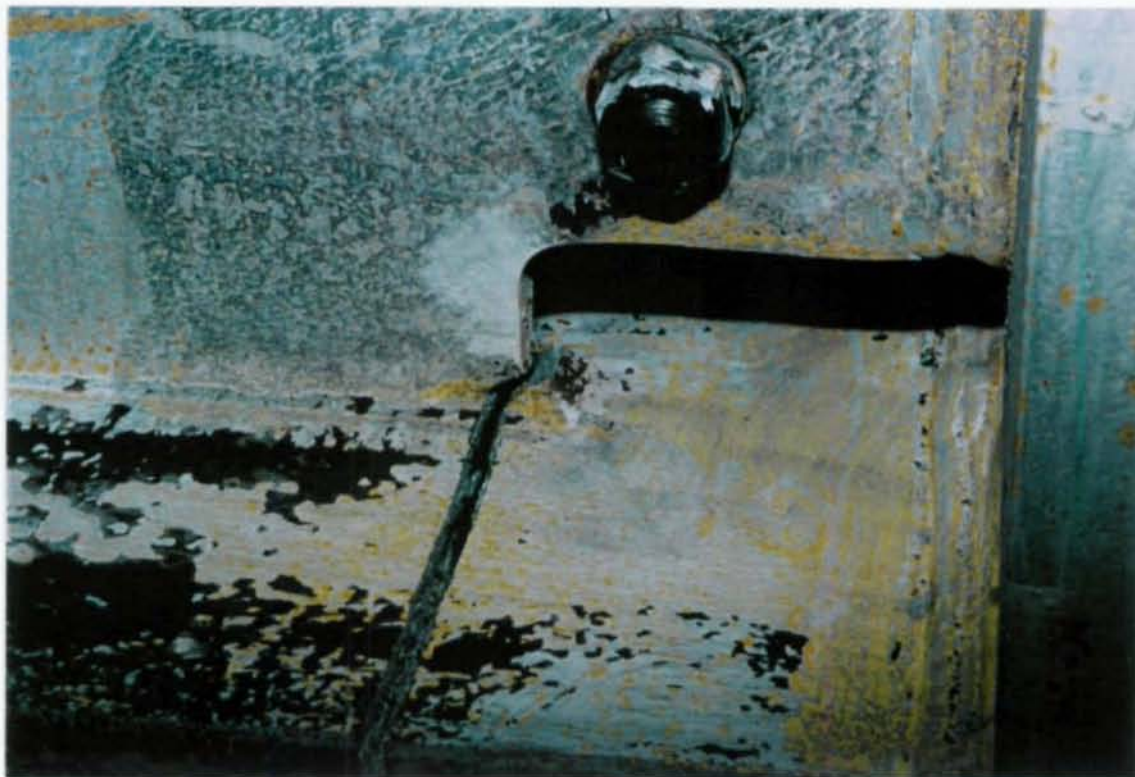
Figure 4.16 Specimen K5: Brittle Fracture of Beam Bottom Flange during the 6% Drift Cycle

(a) Bottom View

(b) Top View
