**FAILURE ANALYSIS OF A WELDED
MOMENT-RESISTING INTERIOR CONNECTION**

By
John. M. Barsom
and
James V. Pellegrino Jr.

Submitted to:
AISC
Chicago, IL

September 15, 2001

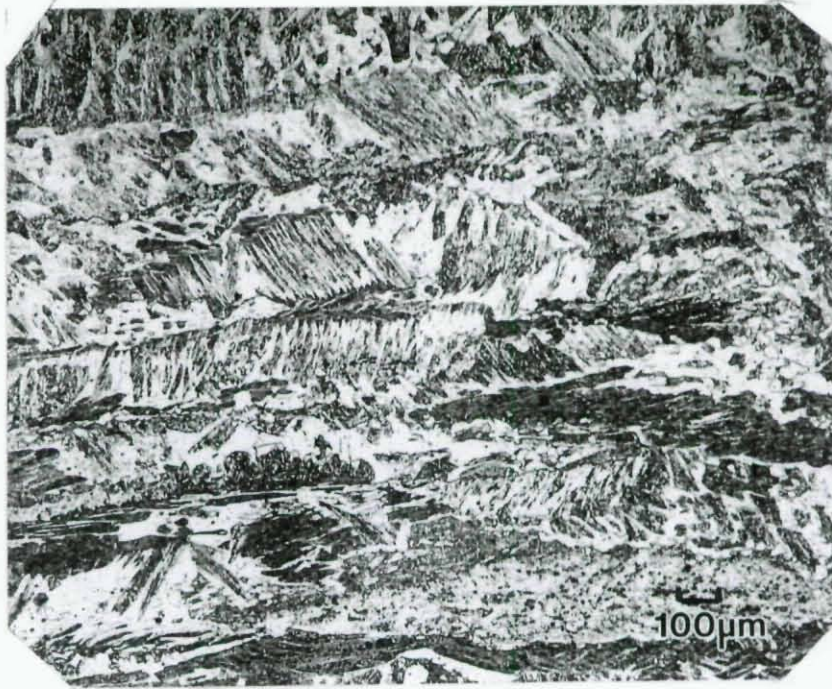
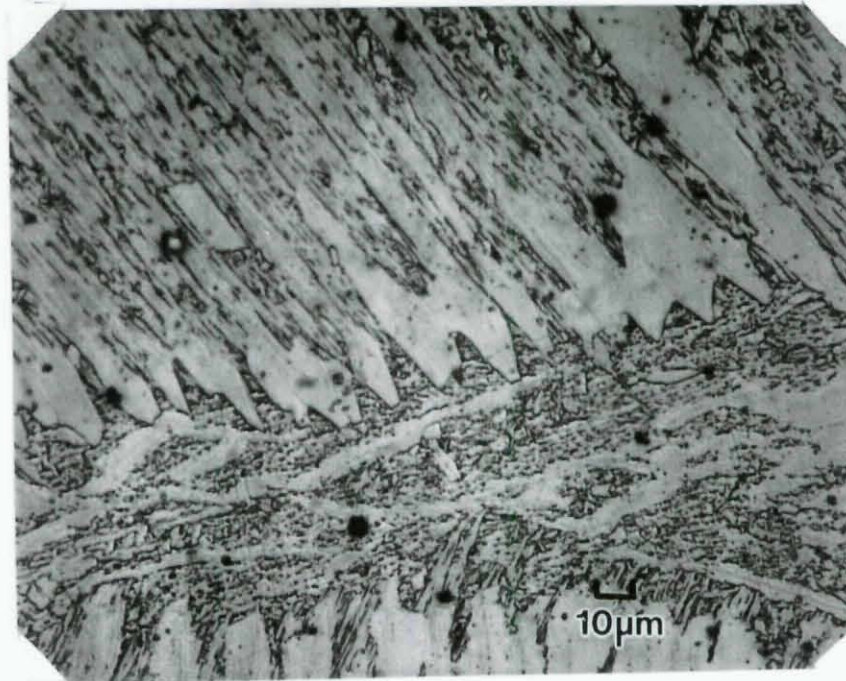
The microstructure of the deposited weld metal is shown in Figures 4 and 5. The micrographs in Figure 4 show the as-deposited solidification microstructure within a deposited weld bead at 50X and 400X magnification. The microstructure within a weld bead was composed of retained delta ferrite, ferrite, and ferrite/carbide aggregate. Figure 5 shows the recrystallized equiaxed ferrite microstructure between passes.

Figure 4. Microstructure within a deposited weld bead.

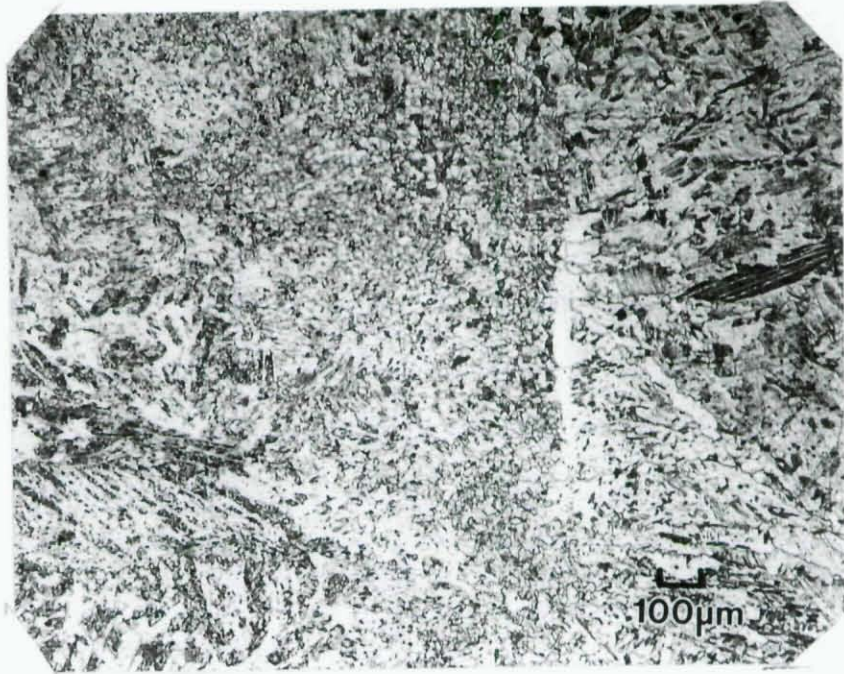
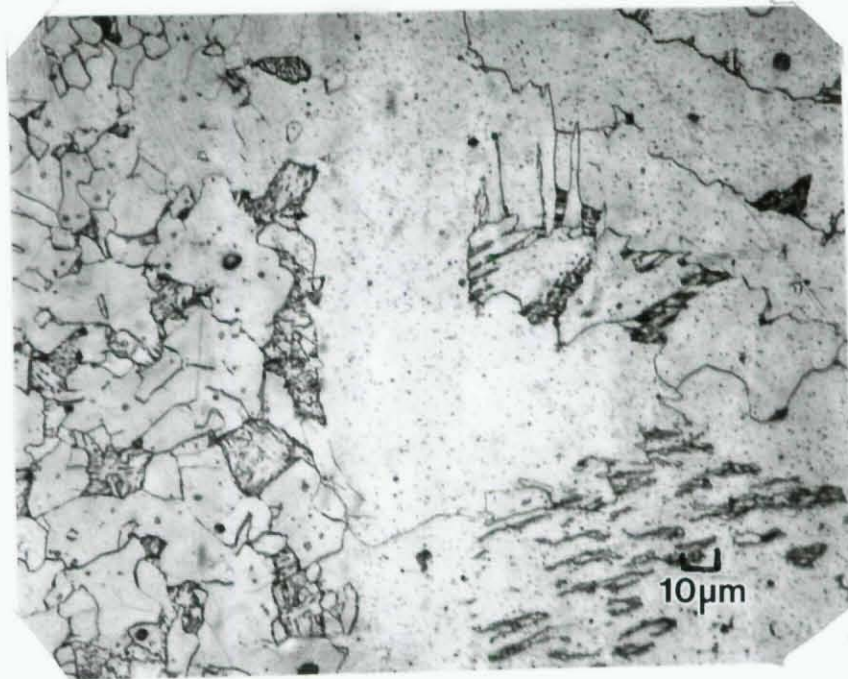
Figure 5. Microstructure between weld beads.

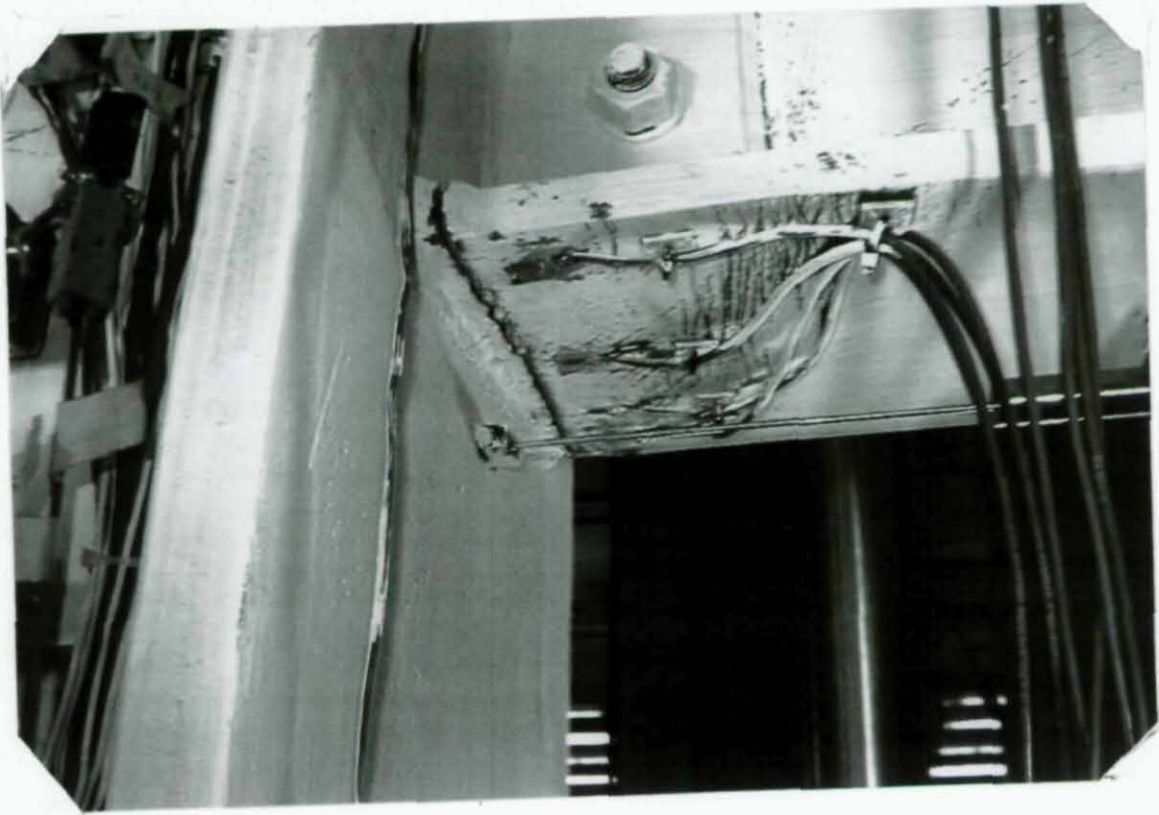
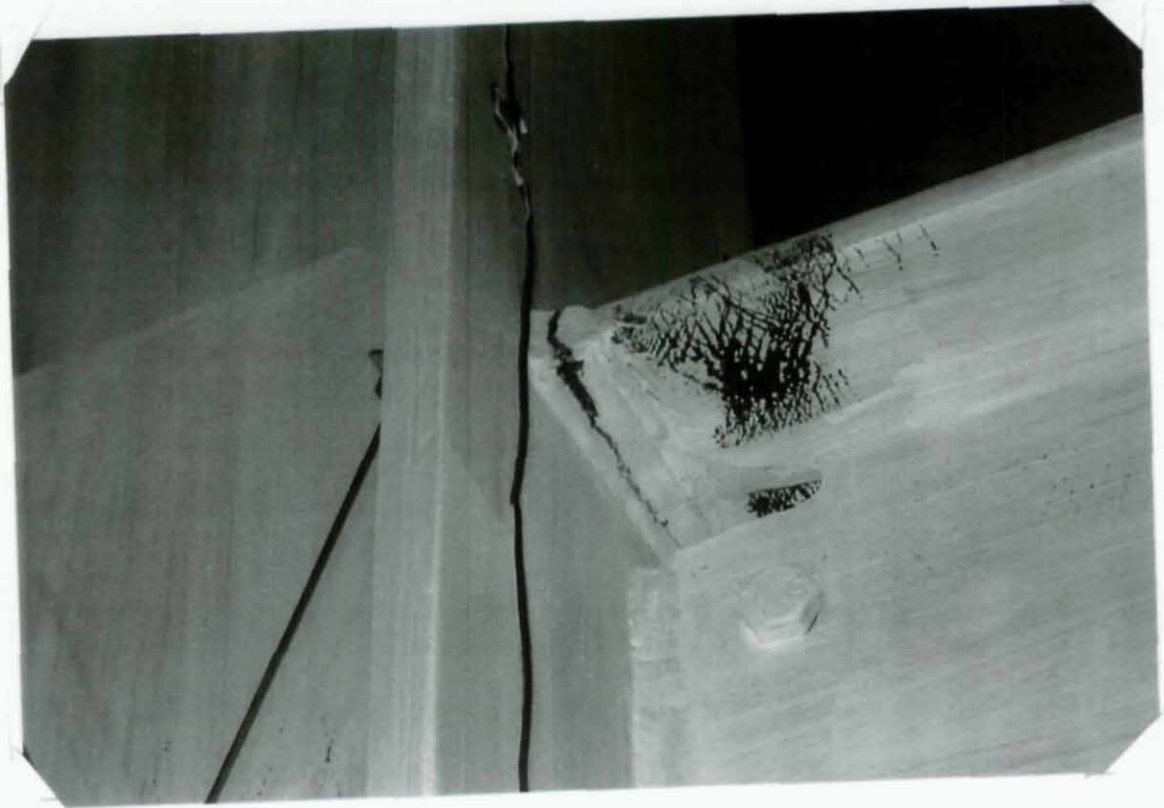
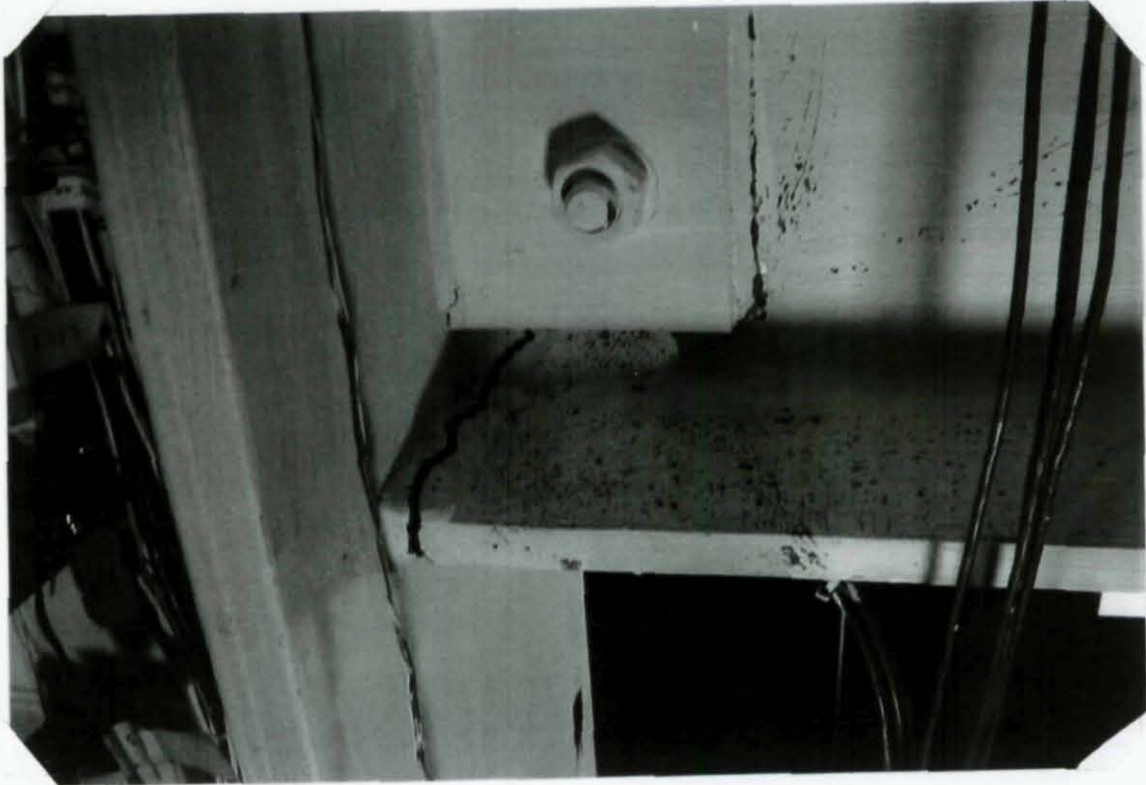
Figure 6 shows the fractured WB joint in the test frame. The photographs demonstrate that the bottom flange adjacent to the CJP weld was subjected to forces equal to or higher than the yield stress of the bottom beam flange. The fracture of the joint was along an irregular line, Figure 6-b, which is not typical of a single crack propagating in a brittle manner.

Figure 6. Fractured west-beam bottom flange.

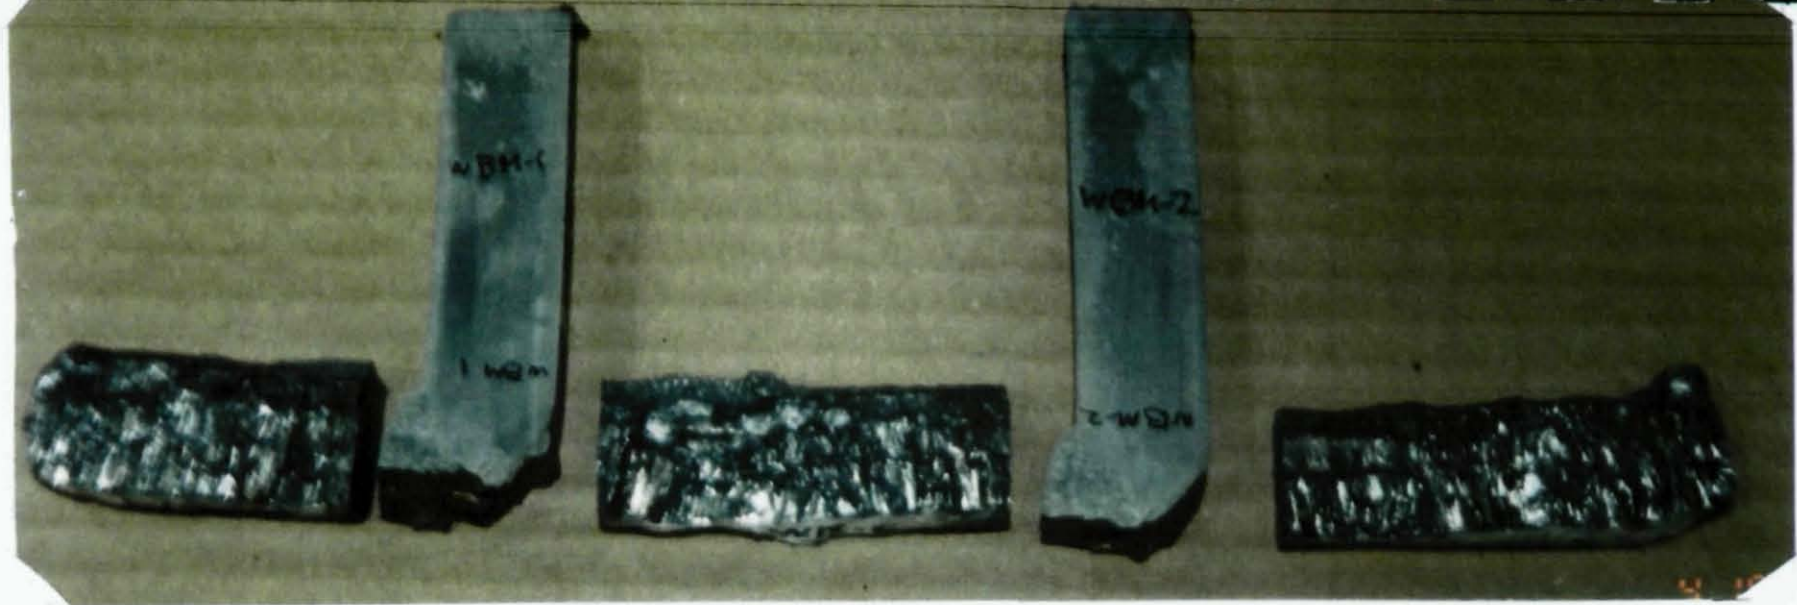
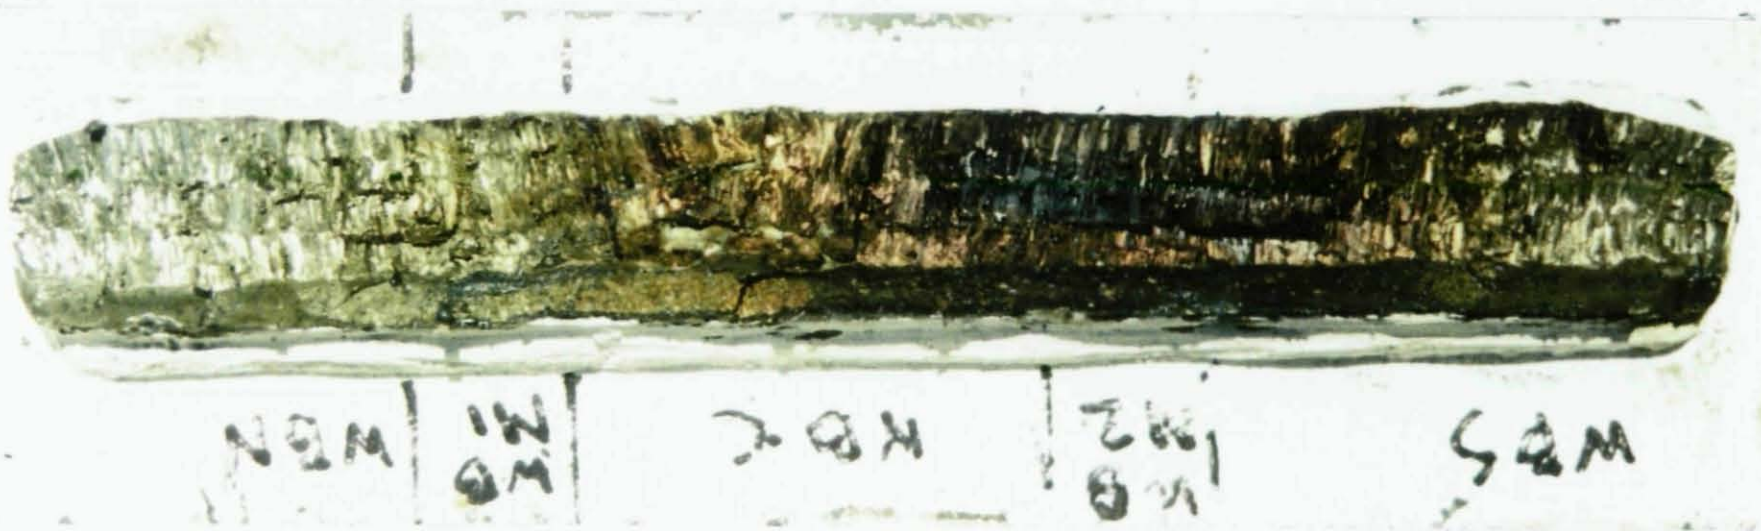
The as received fracture surfaces from the fractured WB joint are shown in Figure 7. Figure 7-a is the fracture surface on the beam side. This sample was sectioned at UM prior to shipping. Figure 7-b is the matching fracture surface on the column flange. Most of the high temperature oxide (HTO) on this fracture surface occurred during thermal cutting the piece from the column flange. The fracture propagated in brittle manner and exhibited a coarse crystalline (cleavage) fracture. The crack propagated, primarily, in the deposited weld metal. At about the mid-length of the CJP groove weld, the fracture surface revealed large slag inclusion, porosity and lack of fusion.

Figure 7. As received fracture pieces from the west-beam bottom-flange joint.

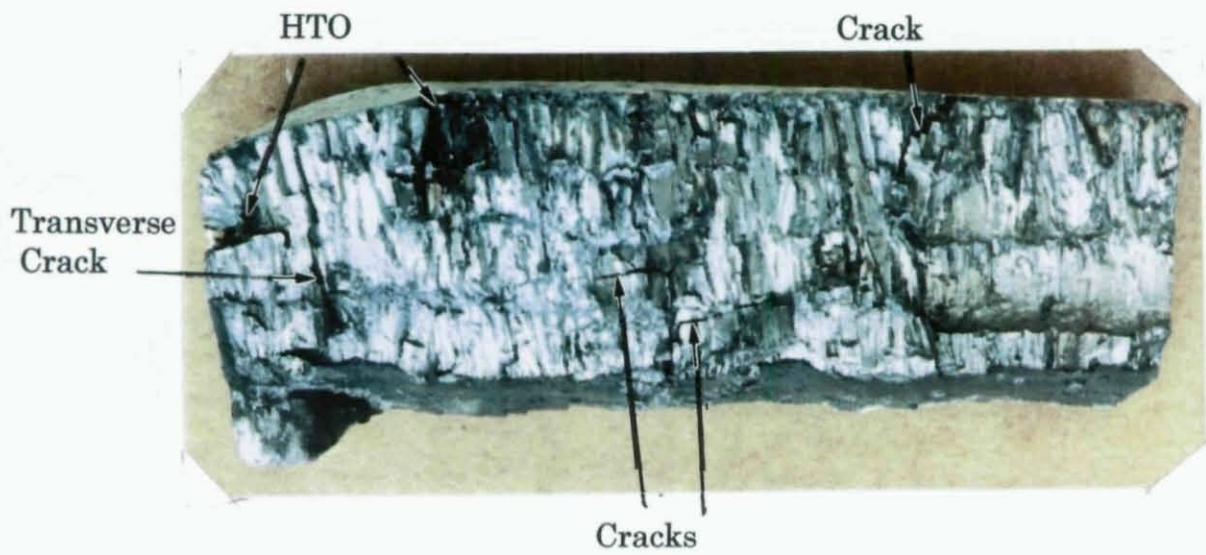
The south, center and north pieces from the fracture surfaces on the beam side of the WB connection are presented in Figures 8, 9, and 10, respectively. The fracture surface in Figure 8 shows the presence of a few transverse cracks that are oriented at different angles to the deposited weld metal. The figure shows also two longitudinal cracks that have HTO on their surfaces. The fracture surface at mid-length of the CJP weld, Figure 9, shows a large weld defect, two longitudinal cracks that were covered with HTO, a transverse crack, and several cracks that were parallel to the surface of the deposited weld metal. The fracture surface of the north piece shows a few cracks two of which were longitudinal surface cracks that were covered with HTO.

Figure 8. Fracture surface of the south end from the west-beam bottom-flange joint

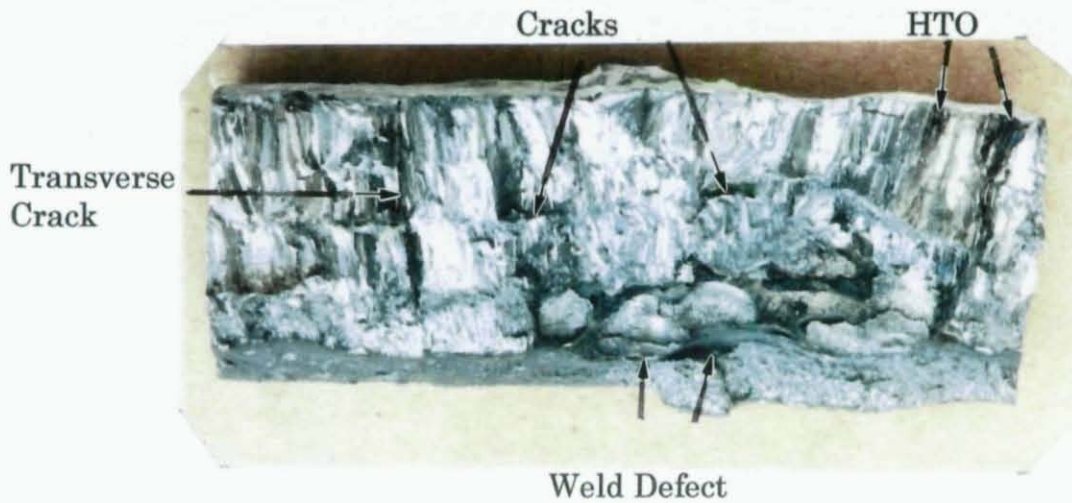
Figure 9. Fracture surface of the center section from the west-beam bottom- flange joint.

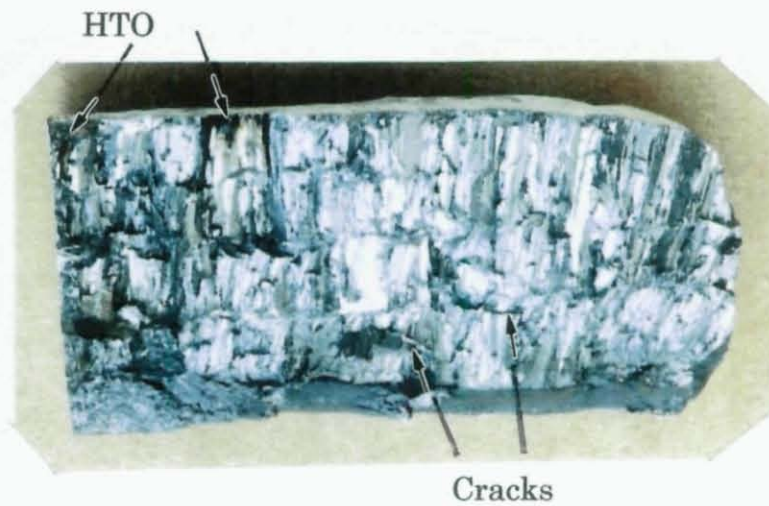
Figure 10. Fracture surface of the north end from the west-beam bottom-flange joint.

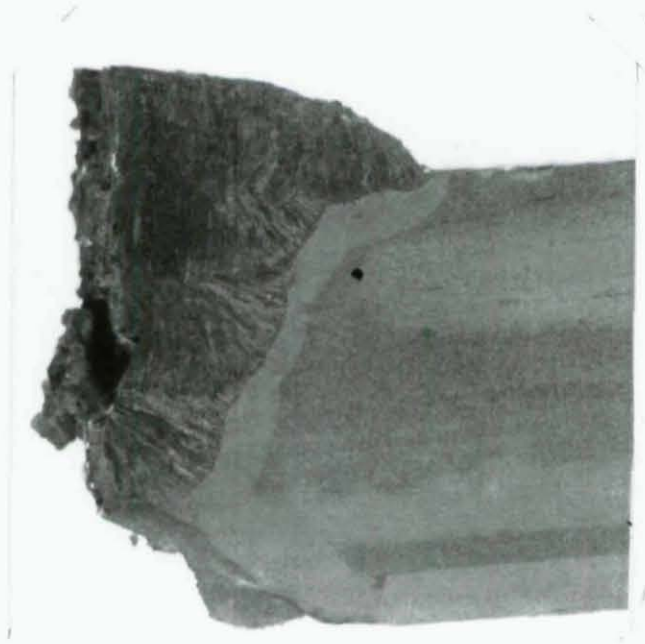
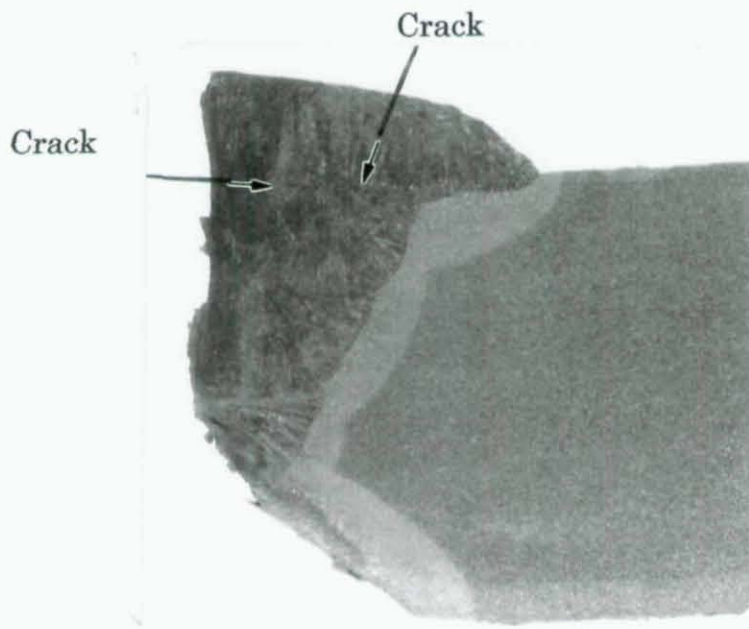
Polished and etched cross sections through the CJP groove weld of the WB joint are shown in Figure 12. Very few cracks are visible on the surface of the cross section.

Figure 12. Macro sections from the west-beam bottom-flange joint.

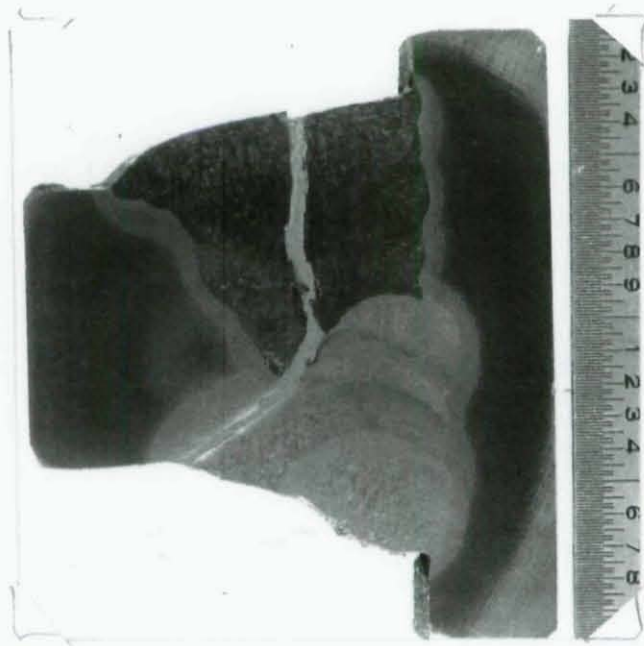
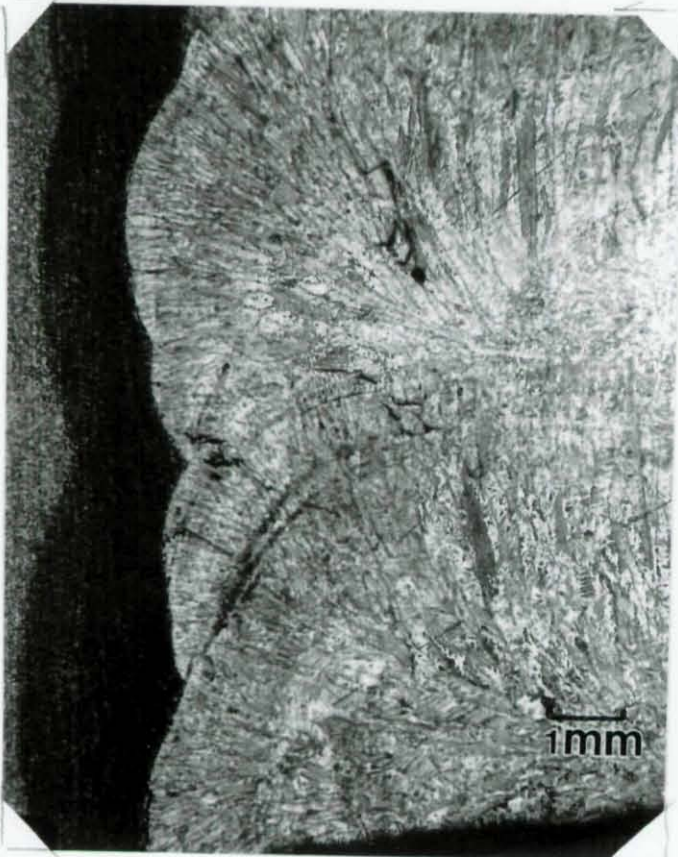
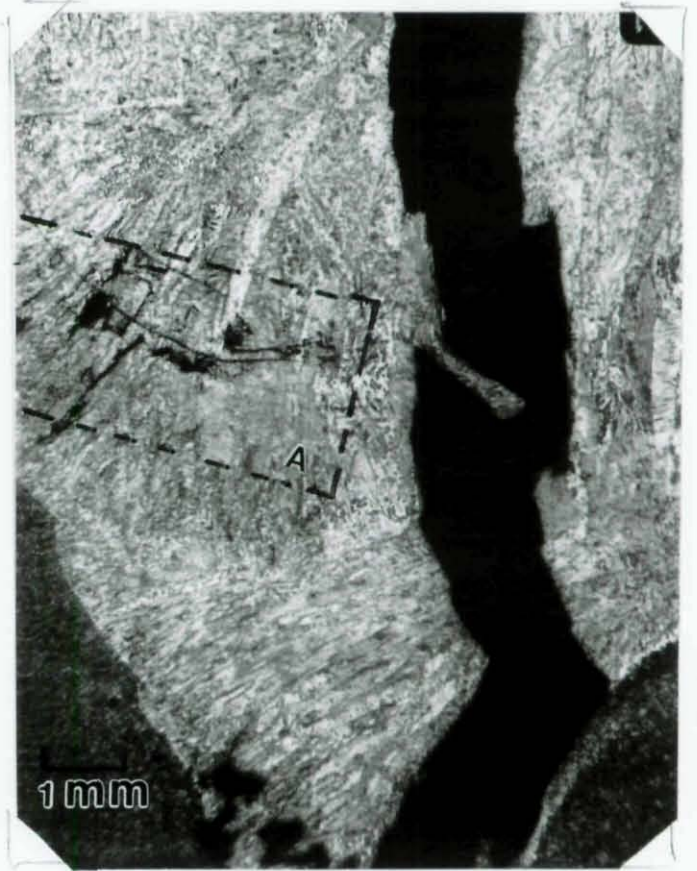
Figure 13-a is a polished and etched section through the column flange, the CJP groove weld and the west bottom flange. The macro section indicated that the crack propagated in the E70T-6 deposited weld metal and along the fusion plane between the reinforced fillet and the beam flange. The crack did not propagate into the E71T-8 (Lincoln NR-232) deposited weld metal of the reinforcing fillet. The amount of back gouging and the large depth, the large volume and the number of weld passes of the reinforced fillet, were unexpected.

The macro section in Figure 13-a had two small areas that contained very small cracks. The cracks in these two areas are shown in Figures 13-b and 13-c. Some of the cracks appeared to be along solidification grain boundaries, while other cracks crossed the solidification grain boundaries at various angles. The semi-circular crack in Figure 13-c intersected the solidification grain boundaries within a single weld pass at 90 degrees. The cracks in Figures 13-b and 13-c were studied at increasing

Figure 13. Macro sections from the west-beam bottom-flange joint.

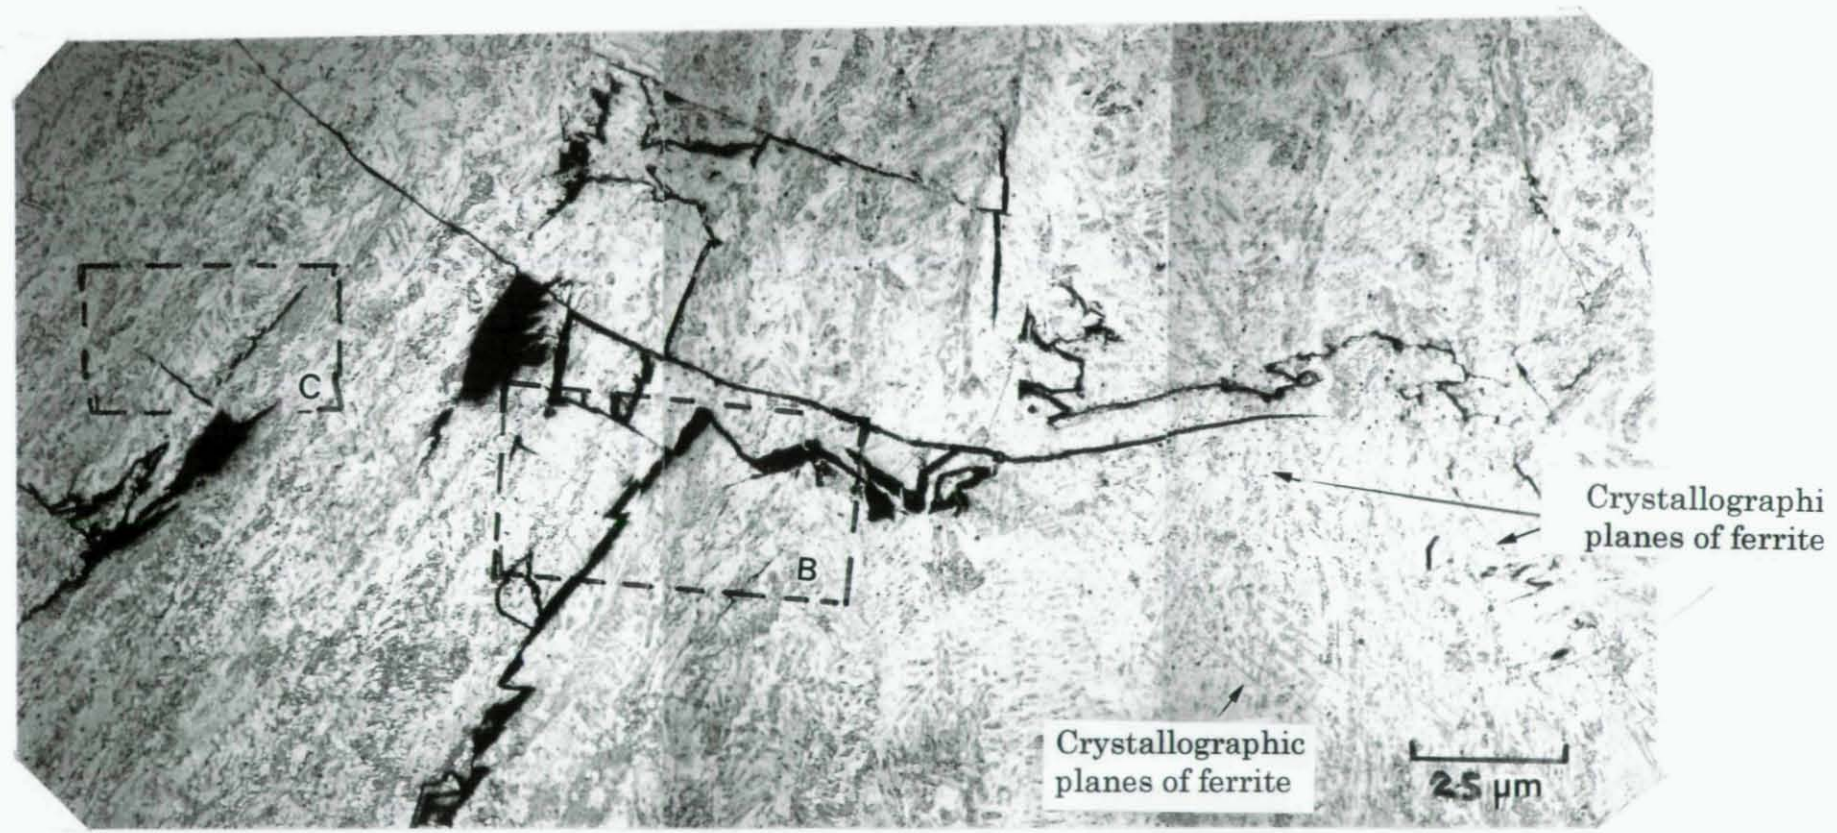
magnifications. The cracks in Figure 13-c that are in the vicinity of the semi-circular cracks are presented in Figures 14 and 15. These figures show cracks that propagated perpendicular to each other in steps and cracks that appear to propagate in a random manner. The black areas in Figure 14 are locations where small pieces of the weld metal were surrounded by cracks causing them to fall out of the polished and etched surface. Figure 15 shows the crystallographic planes of ferrite that extended from the end of the cracks or that were perpendicular to the cracks. Figures 14 and 15 show clusters of intersecting crystallographic planes of ferrite that had not yet developed into cracks when the joints fractured.

Figure 14. Cracks and crystallographic planes in ferrite in the deposited weld metal of the west-beam bottom-flange joint (enlarged area A in Figure 13-c).

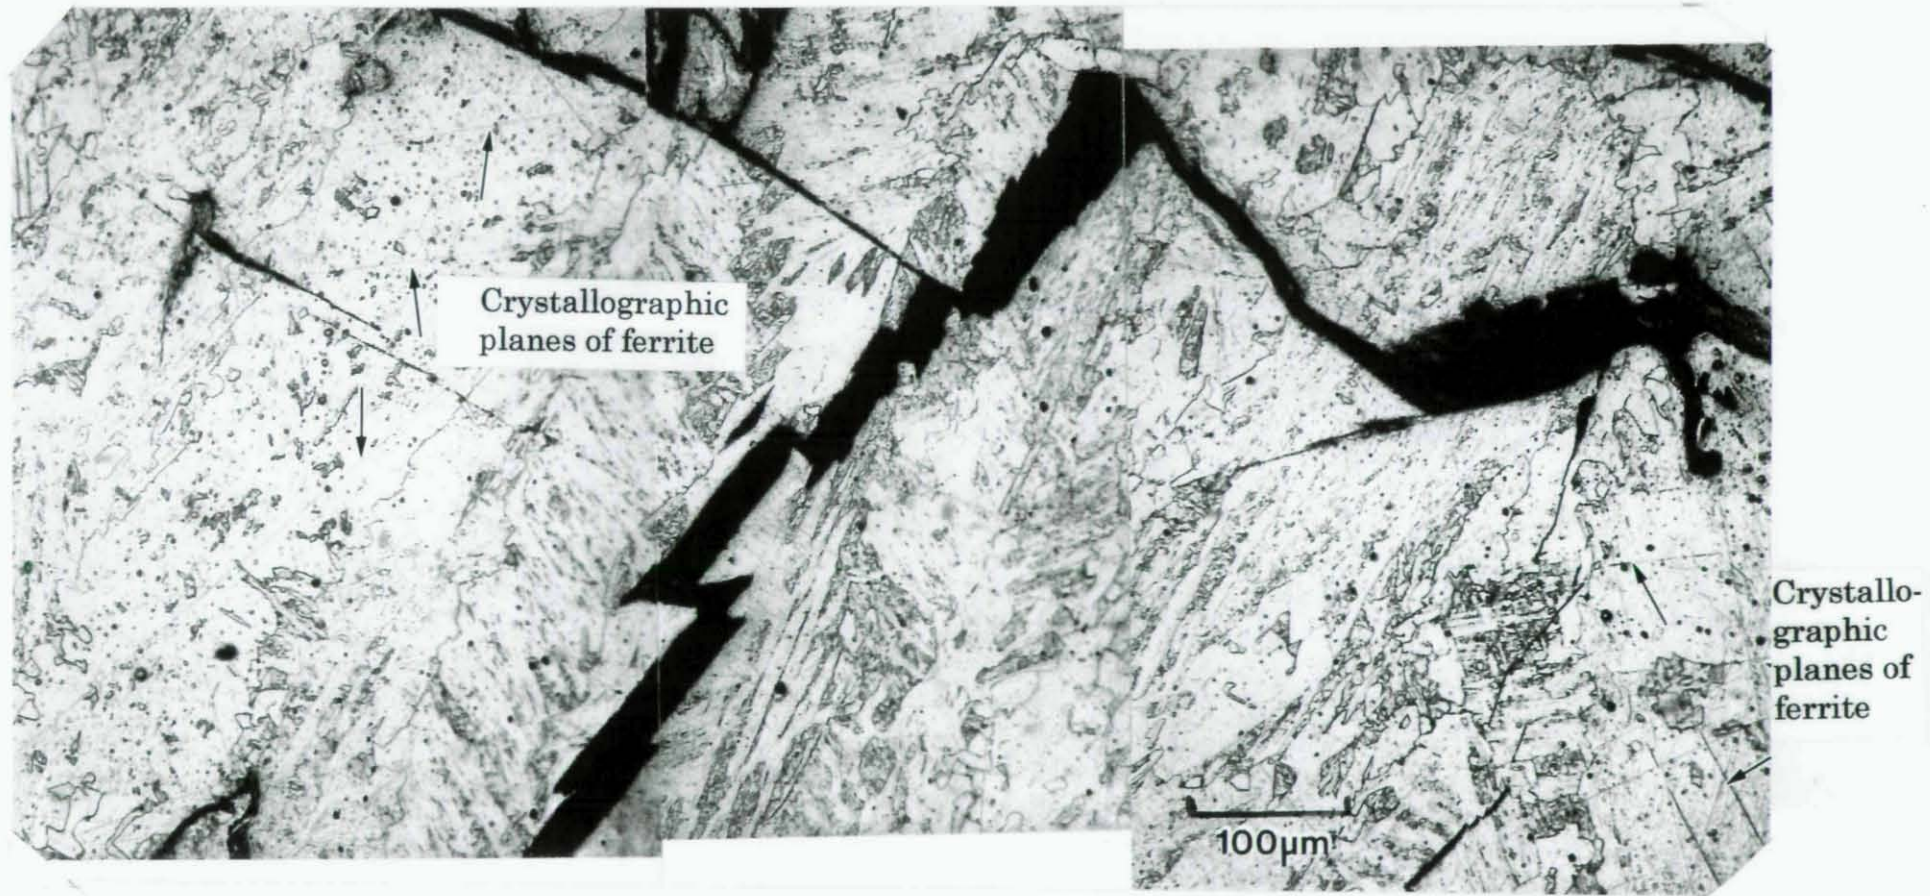
Figure 15. Cracks and crystallographic planes in ferrite in the deposited weld metal of the west-beam bottom-flange joint (enlarged area B in Figure 14).

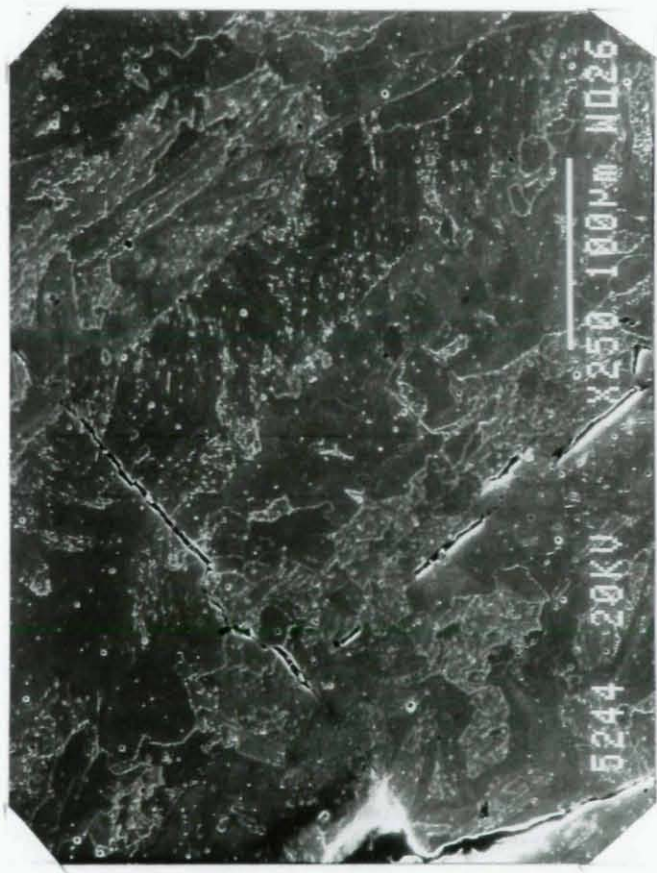
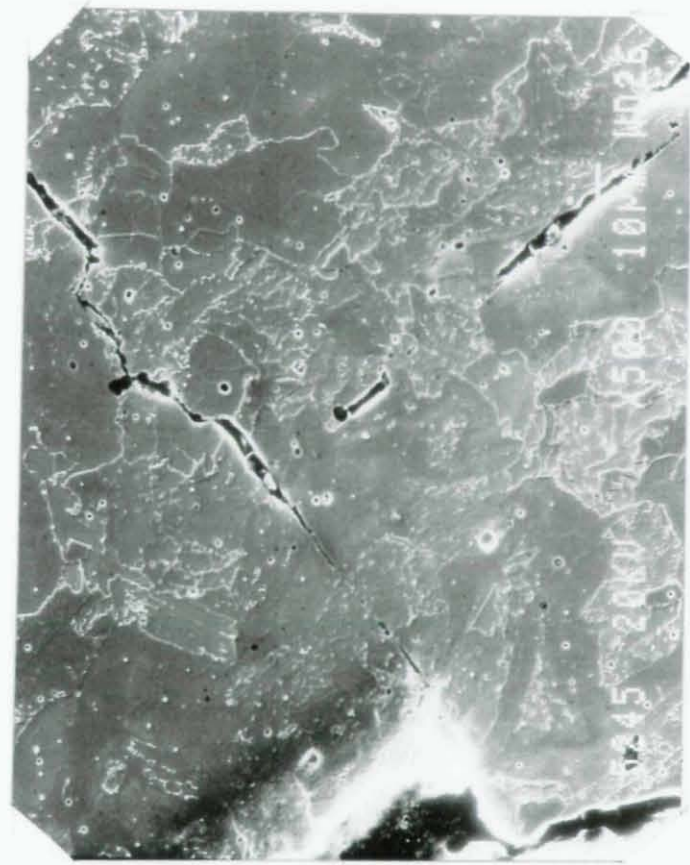
The two perpendicular cracks in the area marked C in Figure 14 are presented in Figure 16 at higher magnifications. Figure 16-a shows that the cracks were discontinuous and that some of the crack segments contained particles. The particles could have caused crack initiation within these segments. Most crack segments investigated, however, did not contain particles. The crack on the left side in Figure 16-a and 16-b deviated temporarily from a straight-line path to propagate along the boundary of a microstructural obstacle. Both ends of this crack had very fine cracks that were in the process of coalescing with the larger cracks. This feature and the presence of crystallographic planes of ferrite at different stages of development to becoming cracks, Figure 17, demonstrate that the cracks shown in Figure 13 initiated and propagated during cyclic loading of the joint.

Figure 16. Cracks in the weld metal of the west-beam bottom-flange joint (enlarged area C in Figure 14).

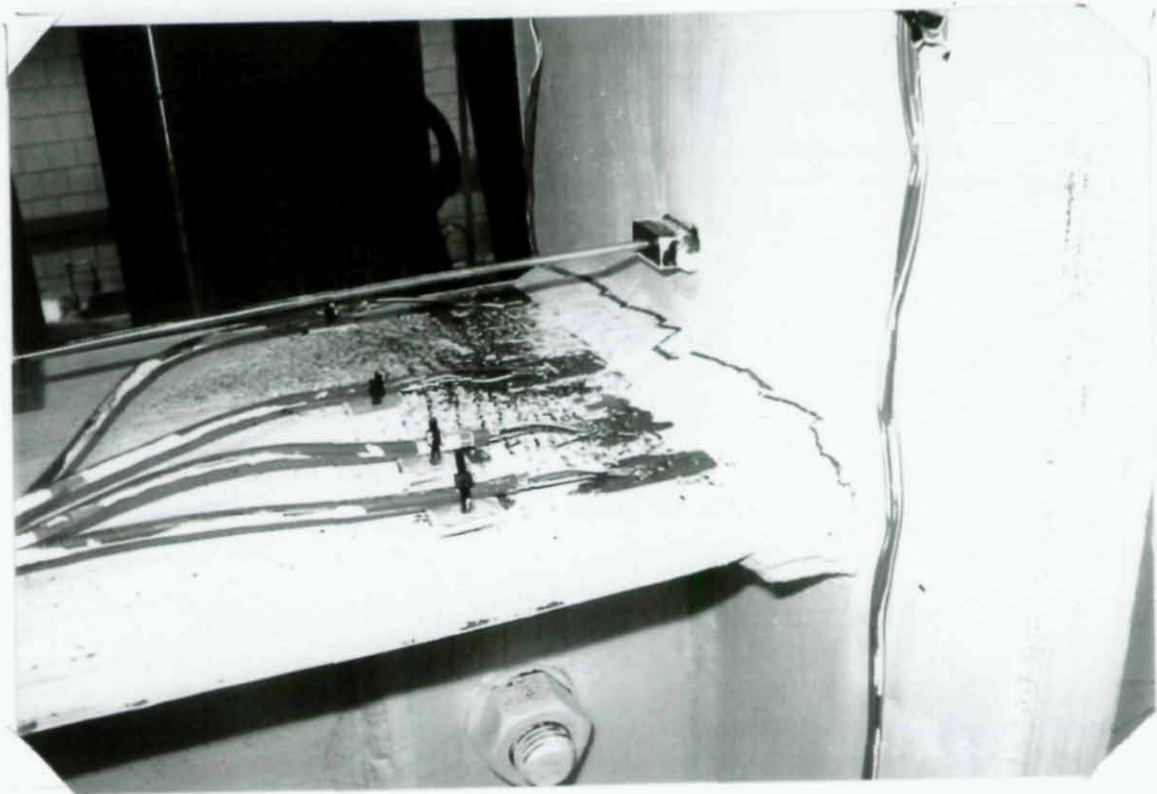
Figure 19 shows the fractured ET joint in the test frame. The photographs demonstrate that the beam adjacent to the CJP groove weld was subjected to forces equal to or higher than the yield stress of the base metal. The fracture of the joint was along a meandering line that is not characteristic of a single crack propagating in a brittle manner.

Figure 19. Fractured east-beam top flange.

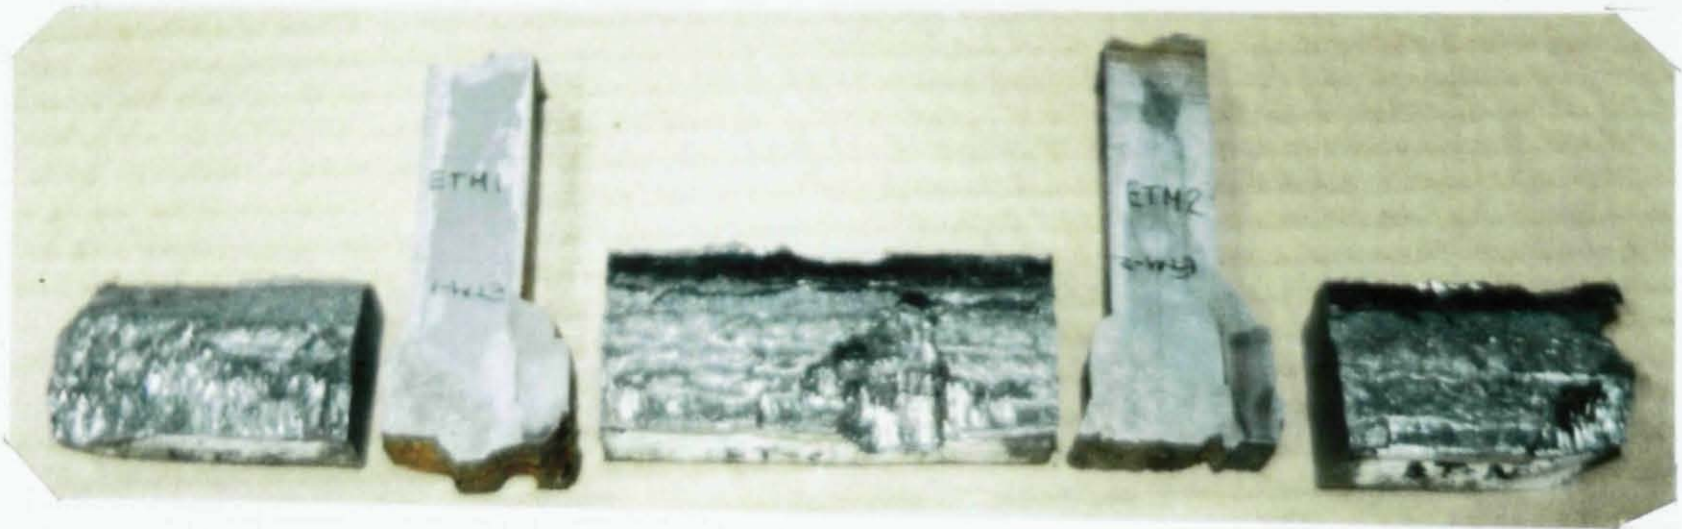
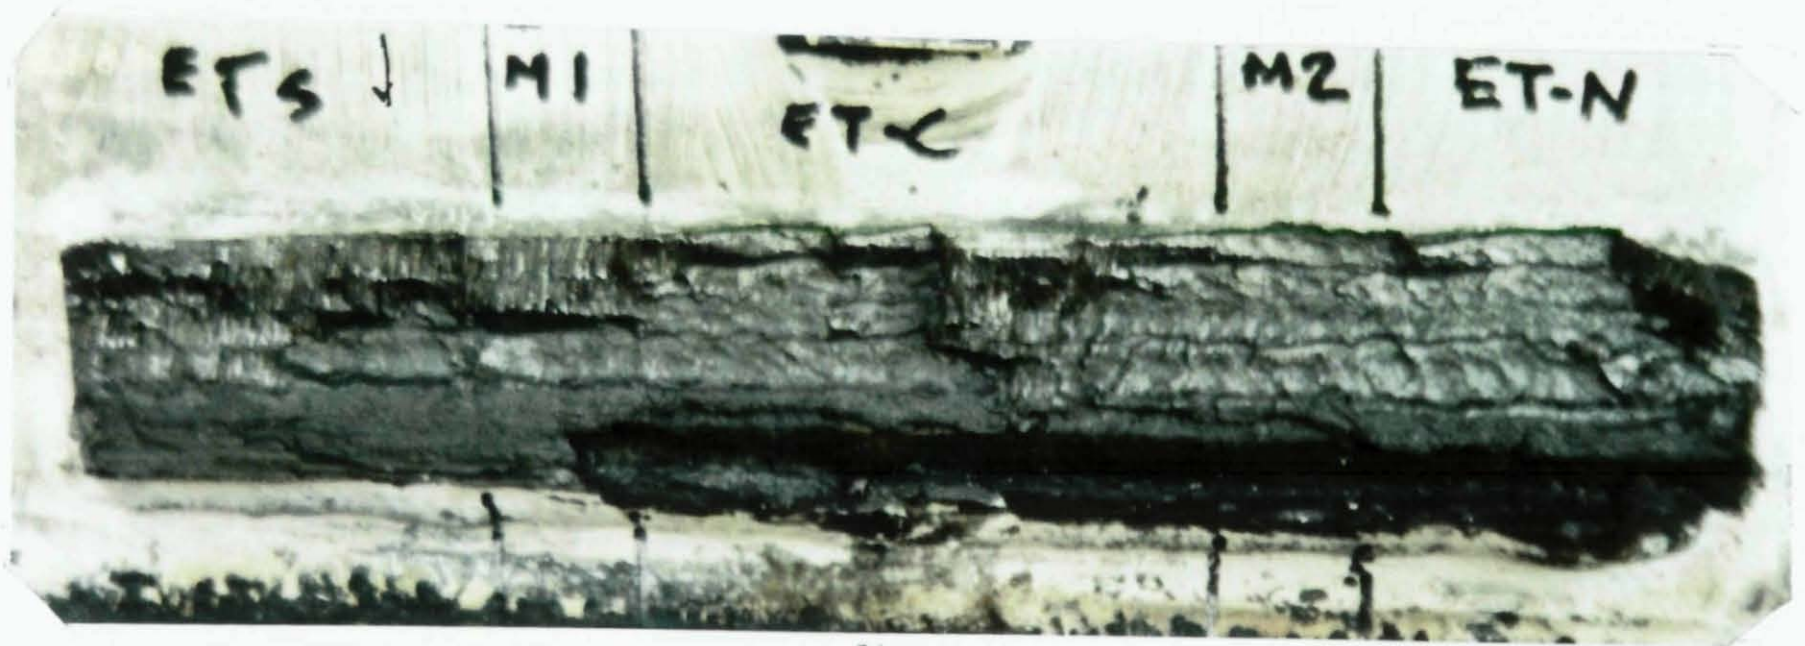
The as received fracture surfaces from the ET joint are shown in Figure 20. Figure 20-a is the fracture surface on the beam side. This sample was sectioned at UM prior to shipping. Figure 20-b is the matching fracture surface on the column flange.

from the beam-side fracture surface. Figure 20 shows this piece to be attached to the column-side of the fracture. This piece was formed by cracks that were present in the weld metal prior to fracture of the joint. The cracks initiated from a lack-of-fusion defect between the root pass and the backing bar and propagated into each subsequent weld pass up to the surface of the deposited weld metal. Crack propagation occurred at high temperatures as each deposited weld pass was cooling. The cracks propagated along and transverse to the deposited weld metal and intersected at about 90 degrees on the weld surface. An extension of one of the transverse cracks that formed the wedge is visible in Figure 24. The north piece of the beam-side fracture surface, Figures 23, shows a lack-of-fusion defect between the backing bar and the root pass and between the root pass and the subsequent pass.

Figure 20. As received fracture pieces from the east-beam top-flange joint.

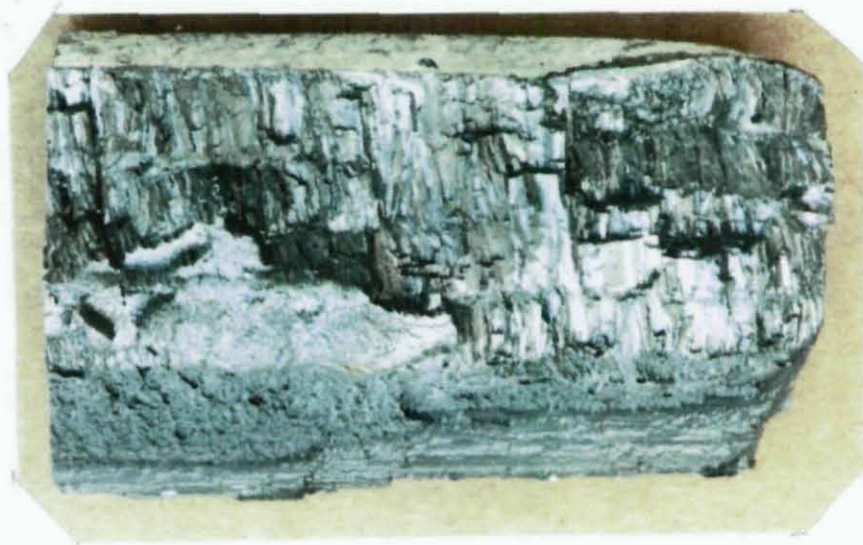
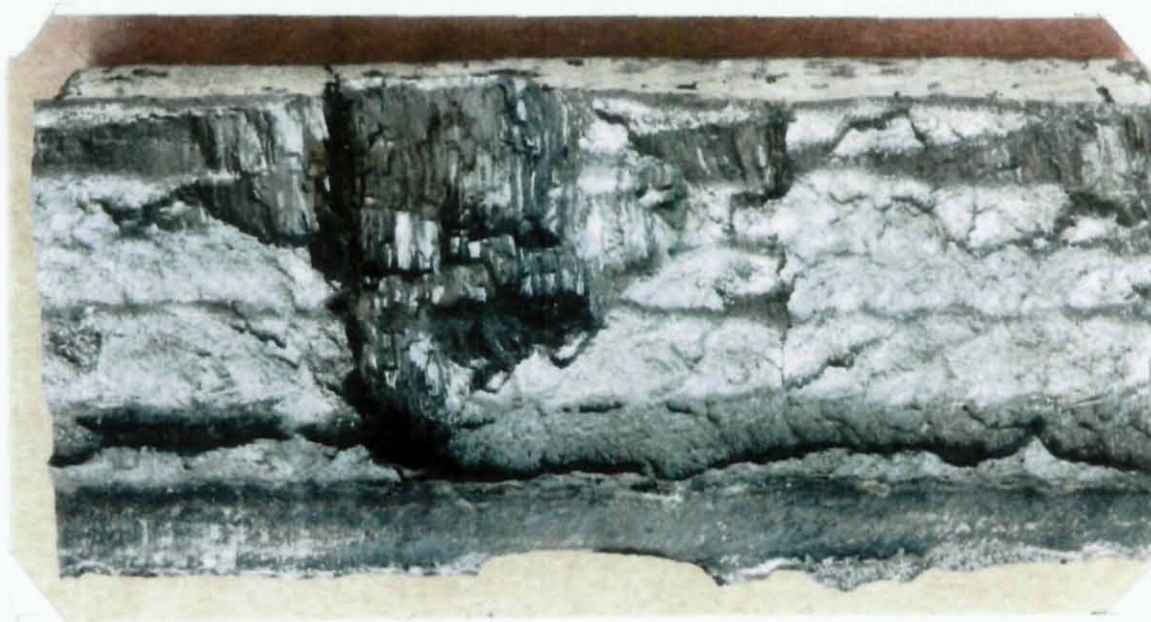
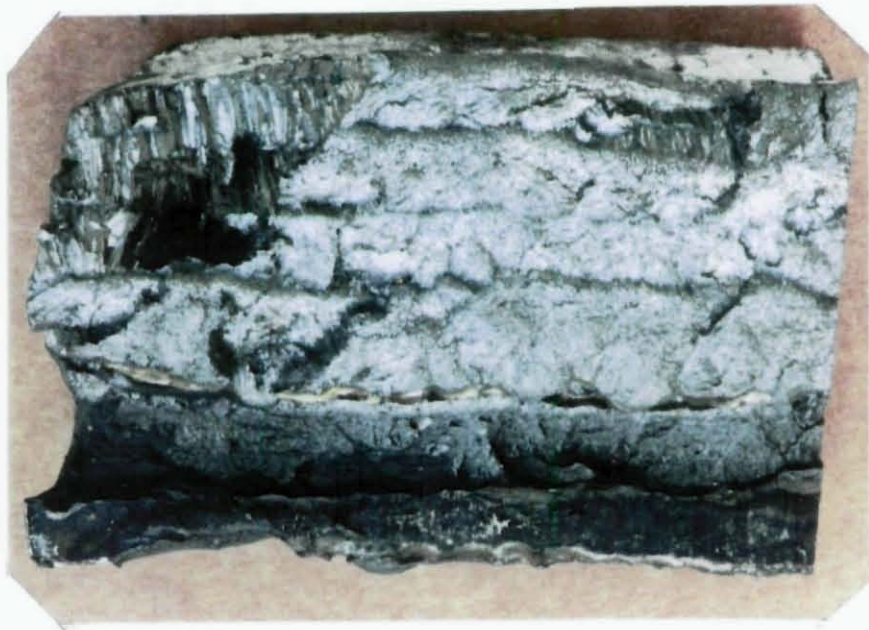
The south, center and north pieces from the fracture surface on the beam side are represented in Figures 21, 22 and 23, respectively. These figures show the presence of a few cracks that were oriented along, transverse, through thickness and inclined to the CJP groove weld. The cracks occurred at various depths from the root pass to the top passes of the deposited weld metal. Some of the cracks formed at high temperatures. The surfaces of these cracks were covered with HTO. Figure 24 is another view of the center piece. It shows a wedge of weld metal that was separated

The fracture surfaces in Figures 21 through 23 show some areas having a rough texture and some areas having a smooth texture. These figures and Figure 20 show that the fracture of the ET joint occurred, primarily in the smooth-textured area. Further analysis demonstrated that the rough-texture fracture was in the weld metal and the smooth-texture fracture was in the fusion plane between the weld metal and the column flange. Thus, the fusion plane was the region least resistant to the fracture under the applied load and deformations. Further evidence of crack propagation along the fusion plane is presented in the next section.
