**FAILURE ANALYSIS OF A WELDED
MOMENT-RESISTING INTERIOR CONNECTION**

By
John. M. Barsom
and
James V. Pellegrino Jr.

Submitted to:
AISC
Chicago, IL

September 15, 2001

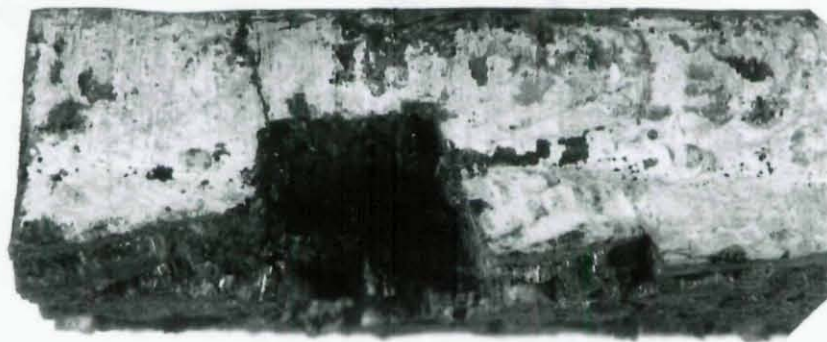
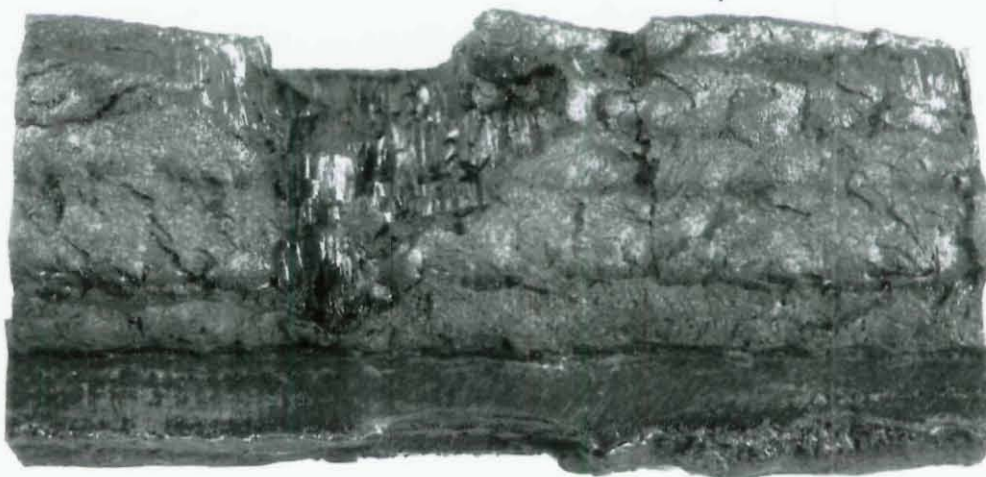
from the beam-side fracture surface. Figure 20 shows this piece to be attached to the column-side of the fracture. This piece was formed by cracks that were present in the weld metal prior to fracture of the joint. The cracks initiated from a lack-of-fusion defect between the root pass and the backing bar and propagated into each subsequent weld pass up to the surface of the deposited weld metal. Crack propagation occurred at high temperatures as each deposited weld pass was cooling. The cracks propagated along and transverse to the deposited weld metal and intersected at about 90 degrees on the weld surface. An extension of one of the transverse cracks that formed the wedge is visible in Figure 24. The north piece of the beam-side fracture surface, Figures 23, shows a lack-of-fusion defect between the backing bar and the root pass and between the root pass and the subsequent pass.

Figure 24. A wedge of weld metal separated from the center piece of the beam side fracture surface of the east-beam top-flange surface.

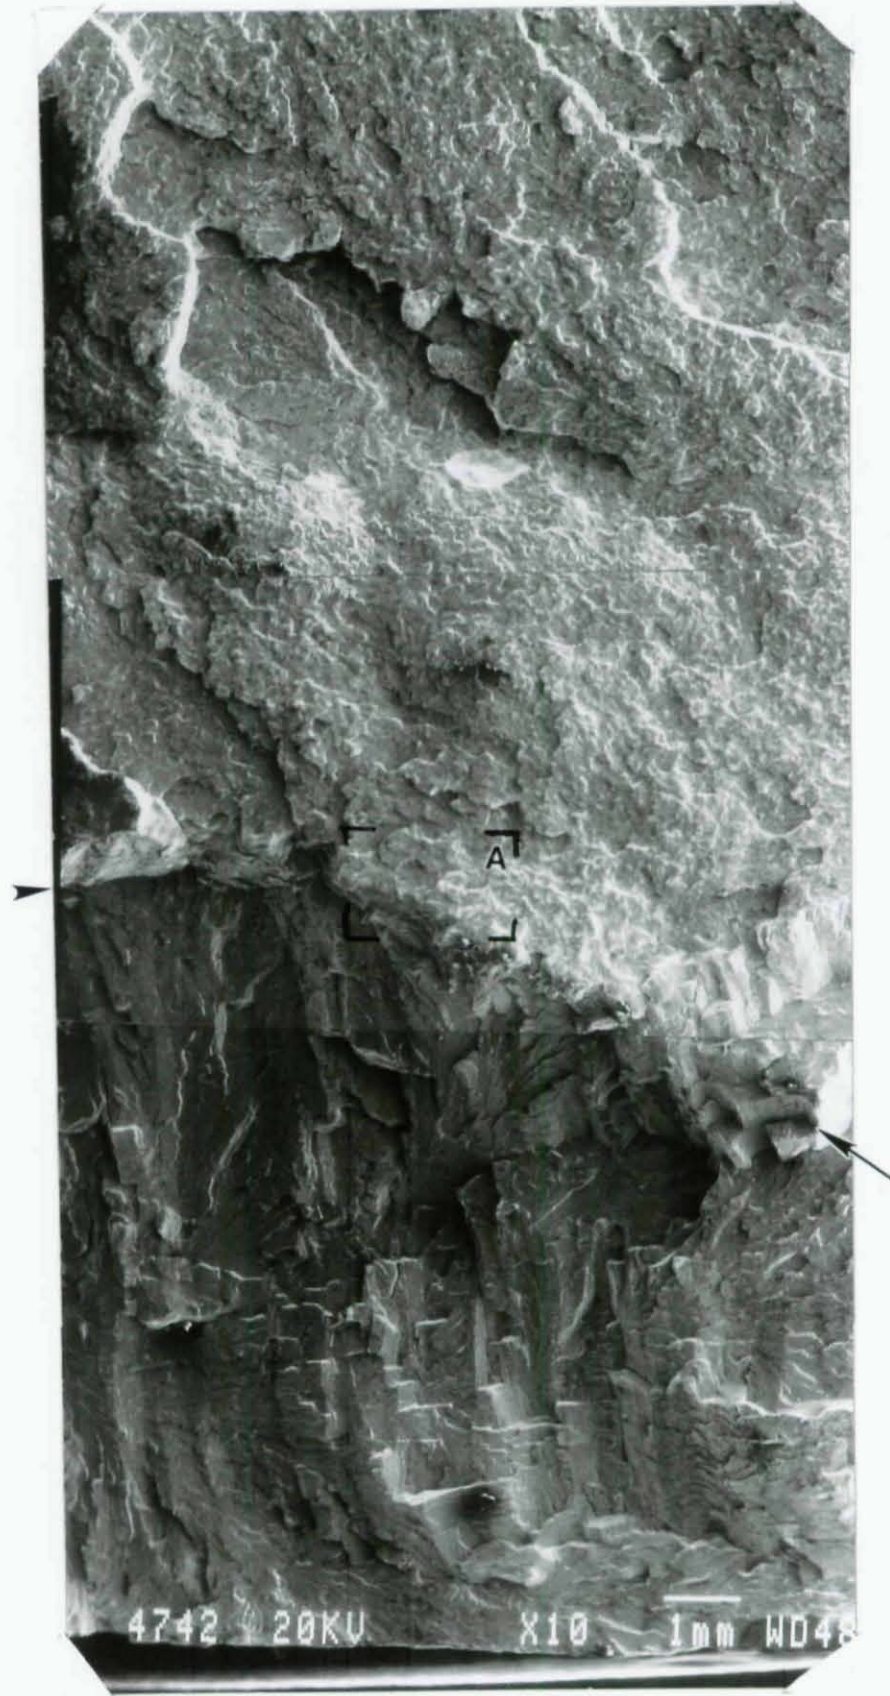
Figure 25 shows an area of the fracture surface at a boundary between weld-metal and fusion-plane fracture surfaces. The features on the fracture surface in the weld metal demonstrate that the crack propagated in a brittle manner by cleavage. The mode of crack propagation along the fusion plane are not clear at this magnification.

Figure 25. Boundary between weld-metal and fusion-plane fracture surfaces.

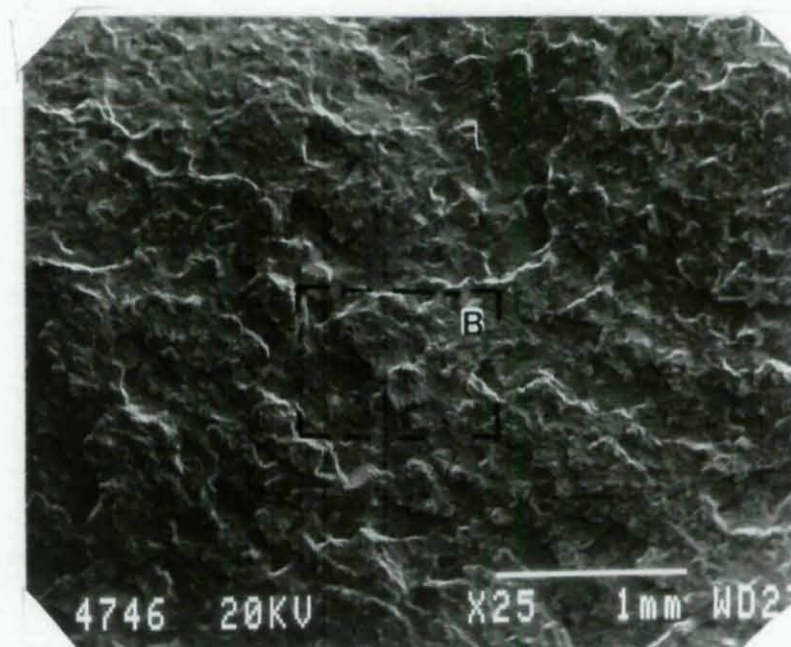
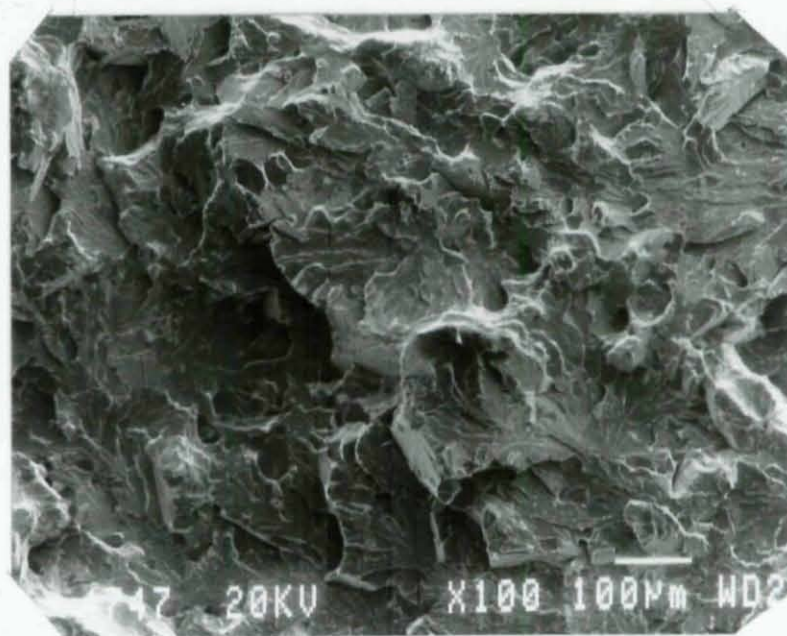
At higher magnification, the fractographs in Figure 26 demonstrate that the fracture propagated along the fusion plane, also, in a brittle manner by cleavage.

Figure 26. Cleavage fracture along the fusion plane on the column-side fracture surface of the east-beam top-flange joint.

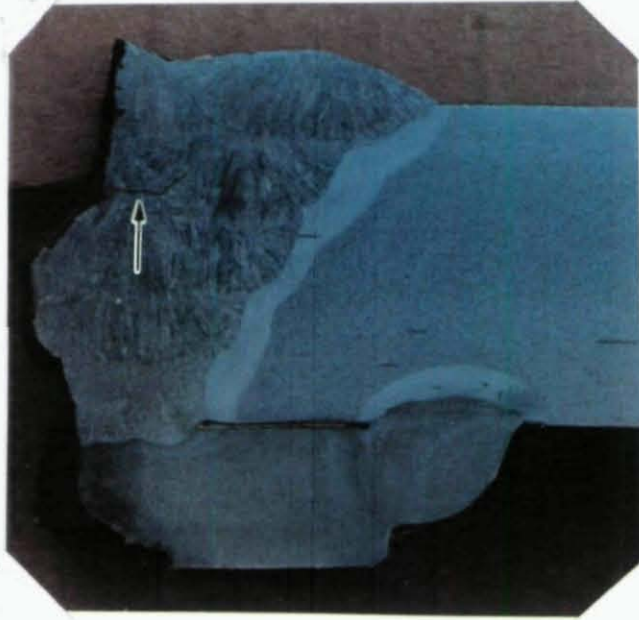
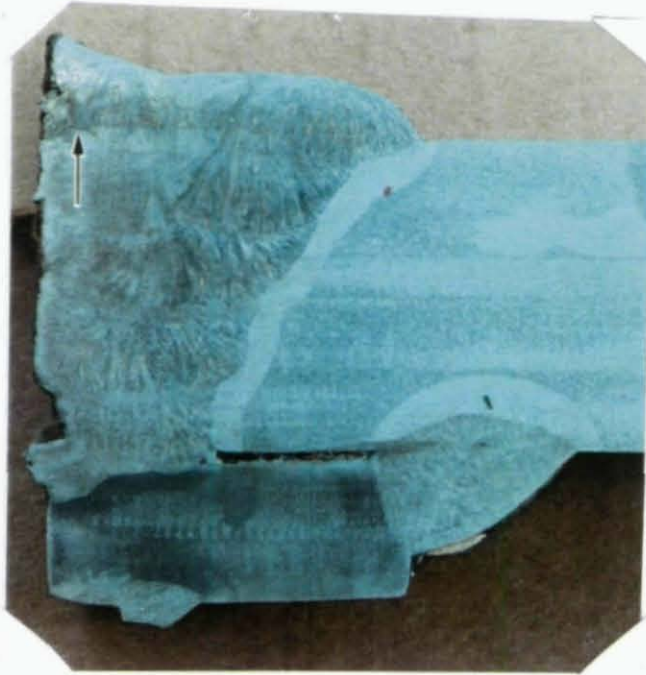
Polished and etched macro cross-sections through the CJP groove weld of the ET joint are presented in Figure 27. The cross sections show the presence of a few cracks that are at different orientations to the CJP groove weld. Figure 28-a shows a polished and etched surface of a macro cross section through the column flange, the deposited weld metal and the beam flange. This macro section was formed by gluing two matching fracture surfaces. The cross section demonstrates that the fracture was primarily along the fusion plane. Figure 28-b presents an example of pre-existing cracks in the ET joint. Two of the cracks were about 0.1-inch long; the other two cracks were about an order of magnitude shorter. One crack extended from the toe of the root pass on the beam flange, the other three were along solidification grain boundaries. The cracks shown in Figure 27 were longer than those in Figure 28-b and propagated along and transverse to the solidification grain boundaries.

Figure 27. Macro sections from the east-beam top-flange joint.

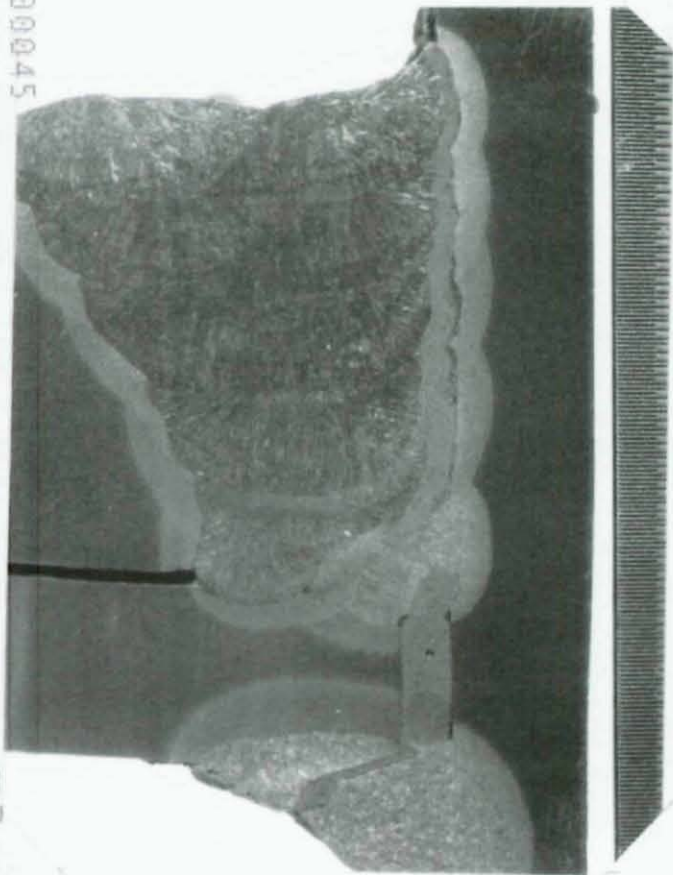
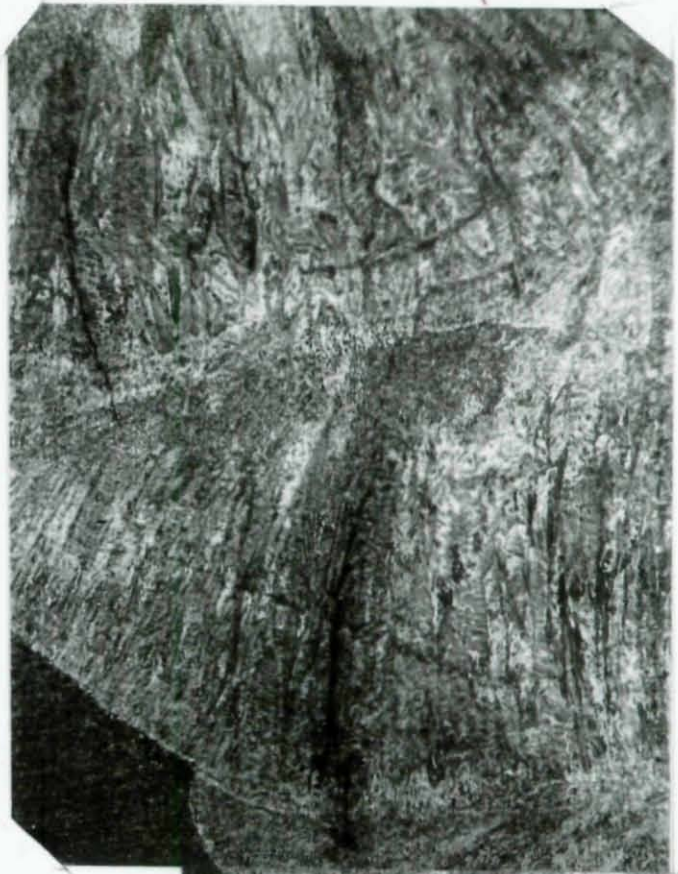
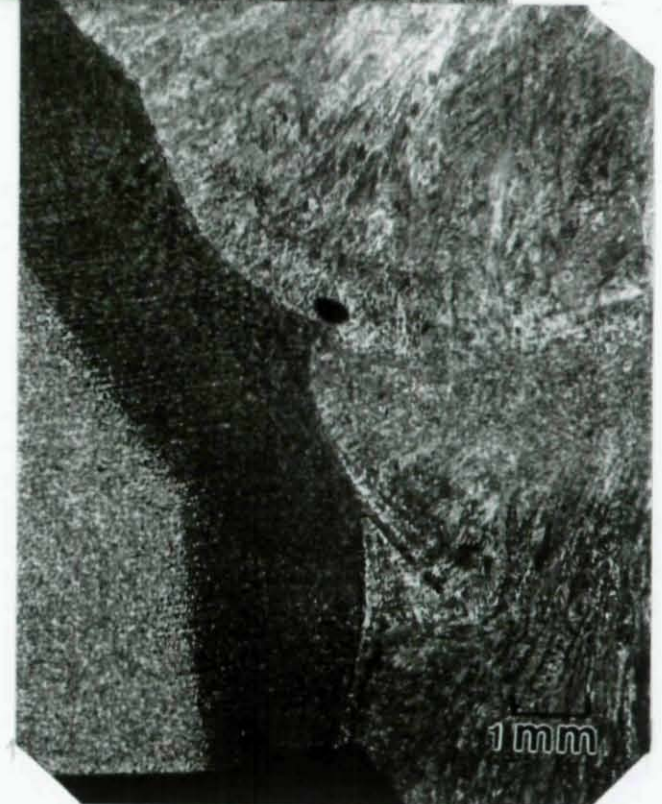
A close examination of the fracture path in Figure 28-a demonstrated that the crack propagated along the fusion plane between the deposited weld metal and the column

Figure 28. Macro section across the east-beam top-flange joint.

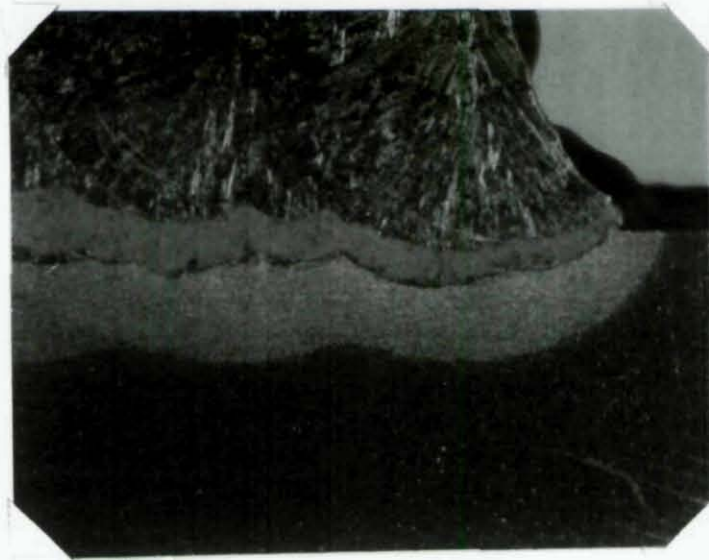
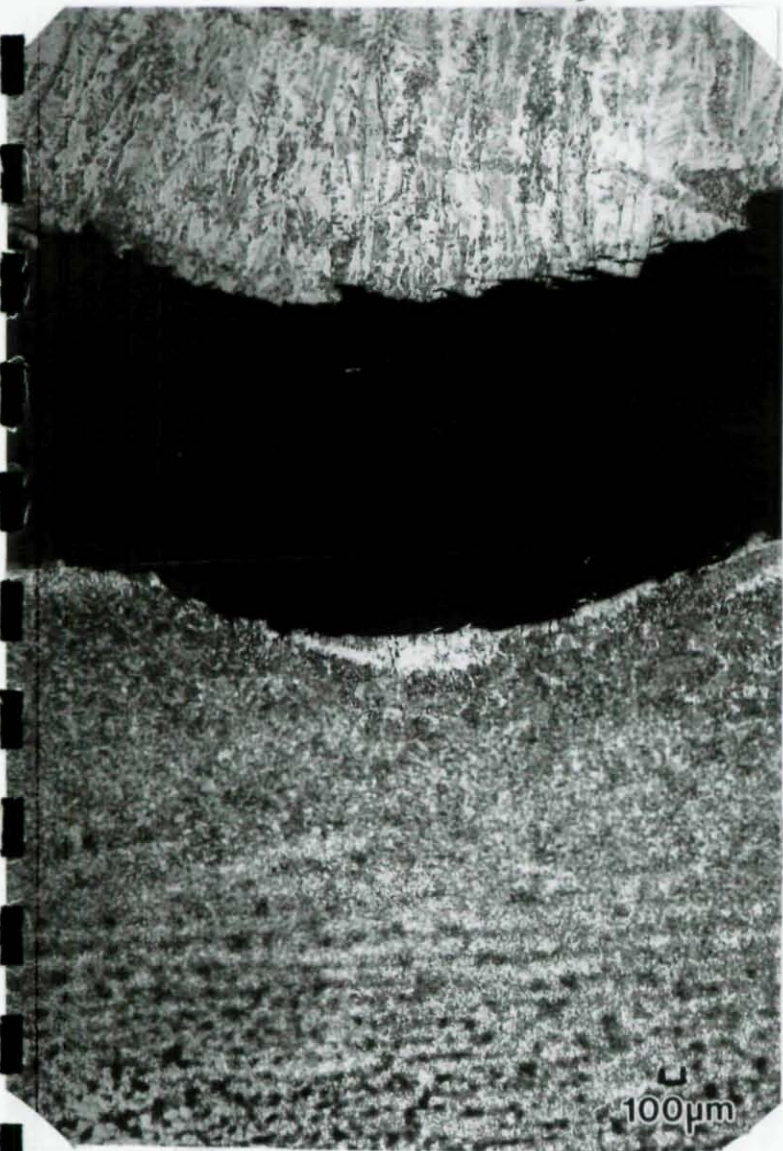
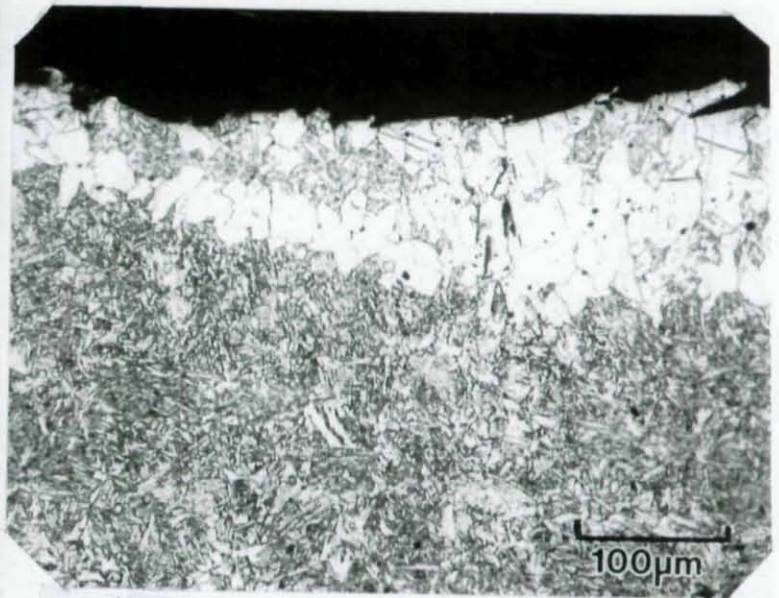
flange. The features along the fracture path demonstrated that the crack initiated from the top of the deposited CJP groove weld towards the backing bar. These features are demonstrated in Figure 29 which is a close-up of the fracture initiation region corresponding to the upper right hand corner of the CJP groove weld in Figure 28-a.

Figure 29. Close up of the fracture along the fusion plane in the east-beam top-flange joint.

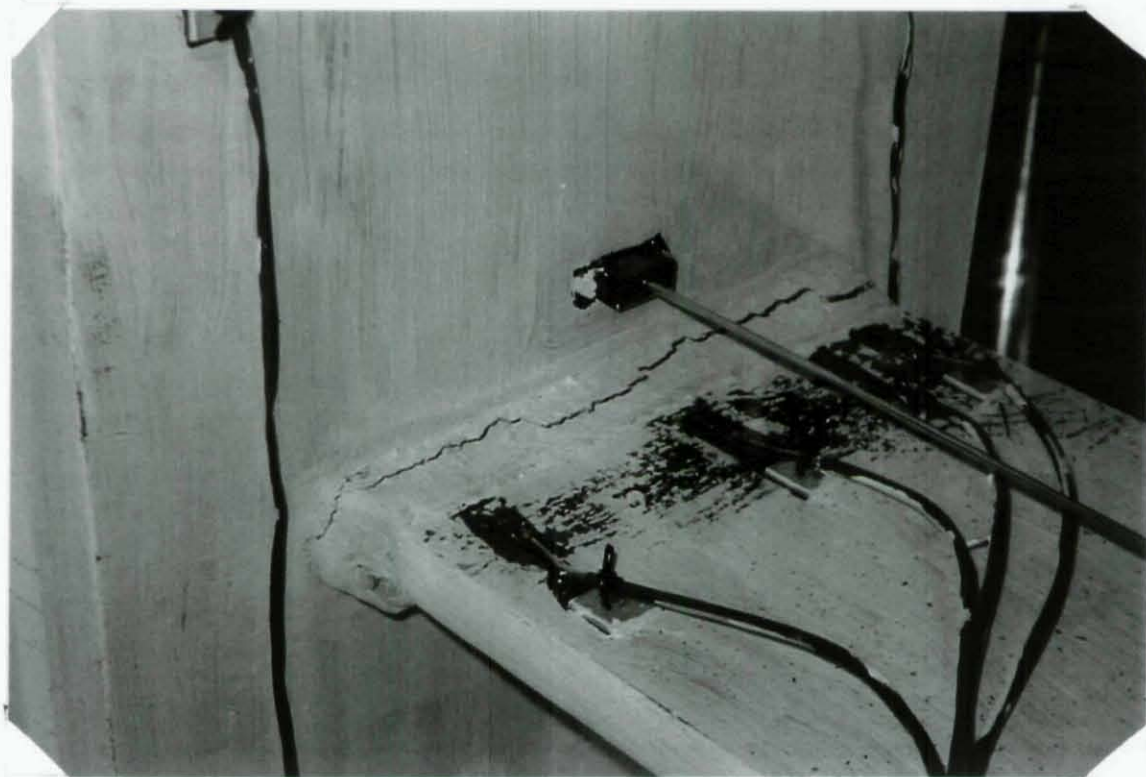
Figure 30 shows the fractured WT joint in the test frame. The photographs demonstrate that the beam flange adjacent to the CJP groove weld was subjected to forces equal to or higher than the yield stress of the beam flange. The fracture of the joint was along an irregular line which is not a characteristic of a single crack propagating in a brittle manner.

Figure 30. Fractured west-beam top flange.

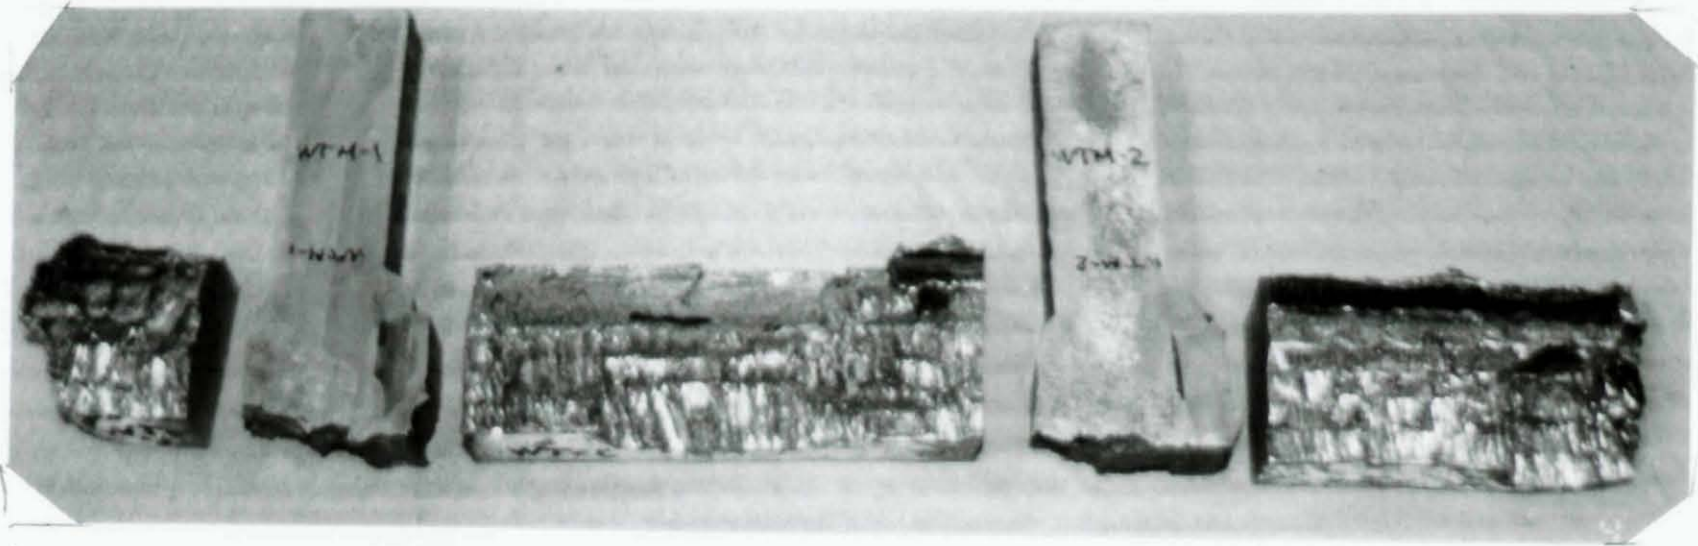
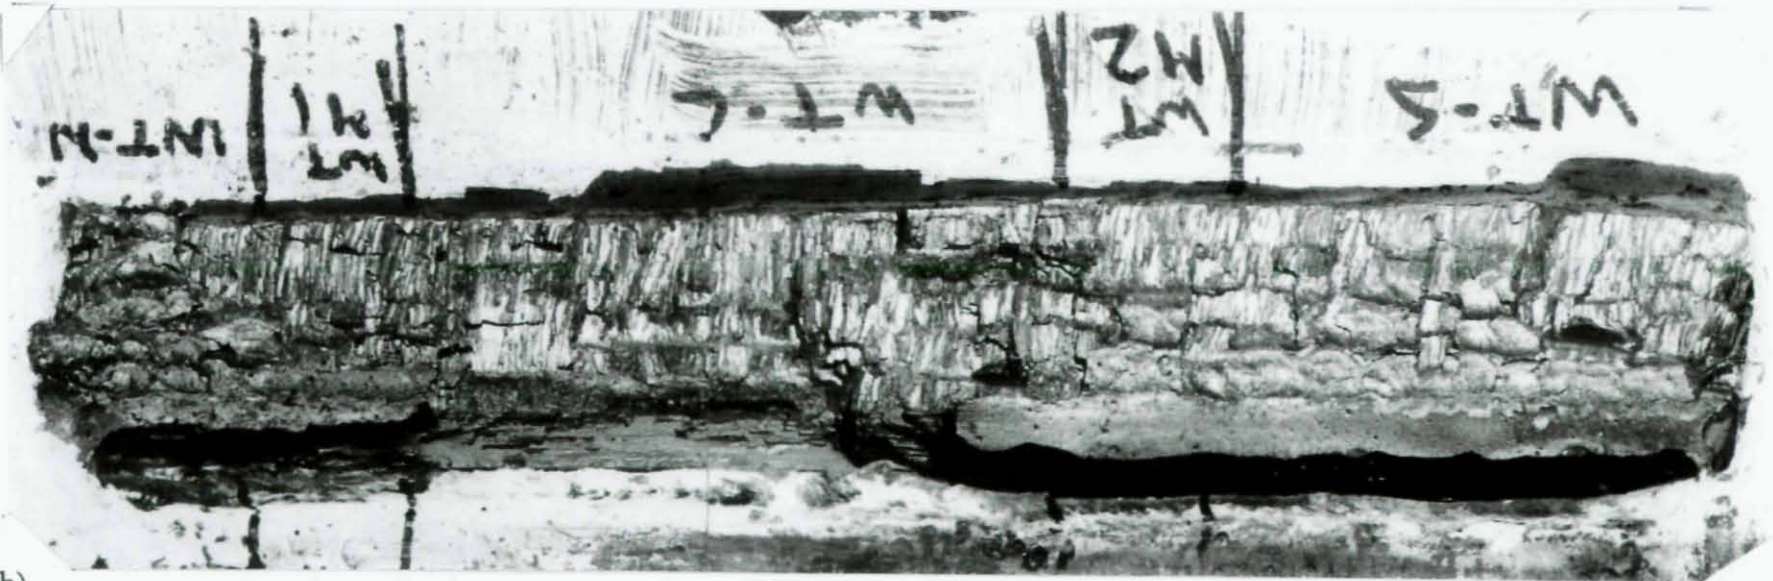
Figure 31 shows the as-received samples of the fracture surfaces from the WT joint. The top samples in the figure were from the fracture surface on the beam side. This sample was sectioned by the UM researchers prior to shipping. The bottom sample is the fracture surface on the column flange. This fracture shows an extensive network of cracks that are at different orientations within the deposited weld metal. The fracture surface indicated that the final fracture propagated along pre-existing cracks in the weld metal then along the fusion plane on the column flange.

Figure 31. As received fracture pieces from the west-beam top-flange joint.

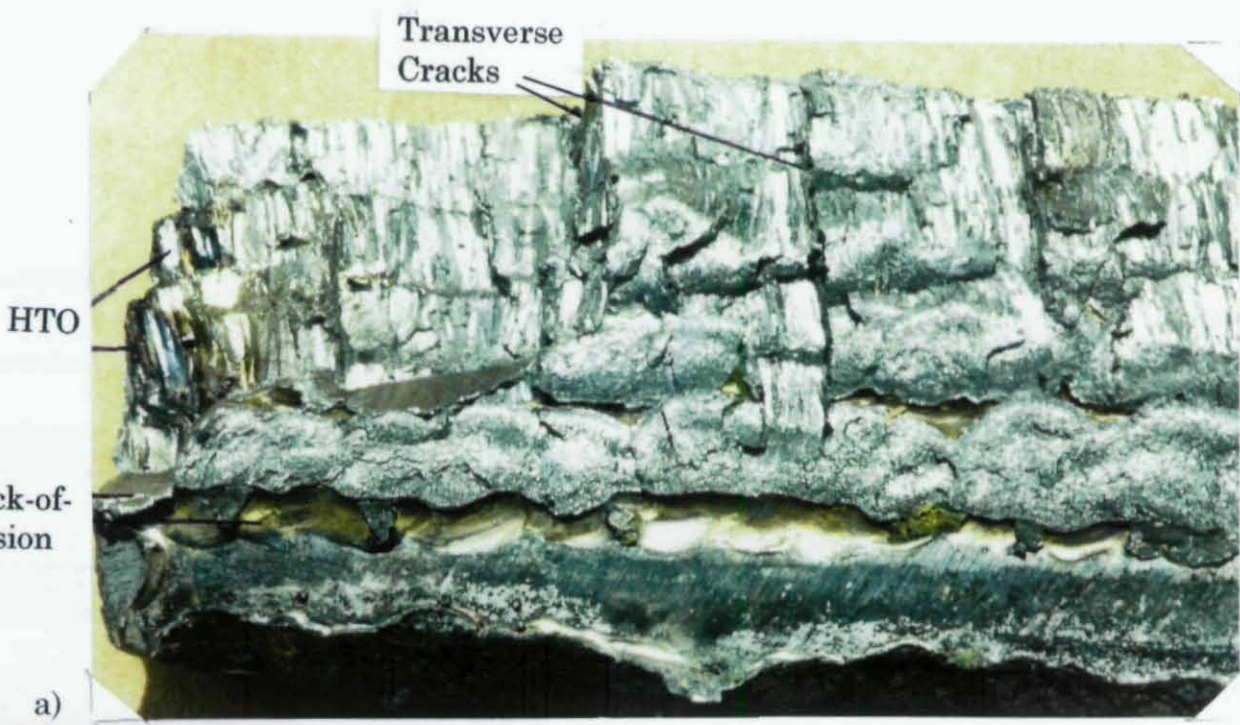
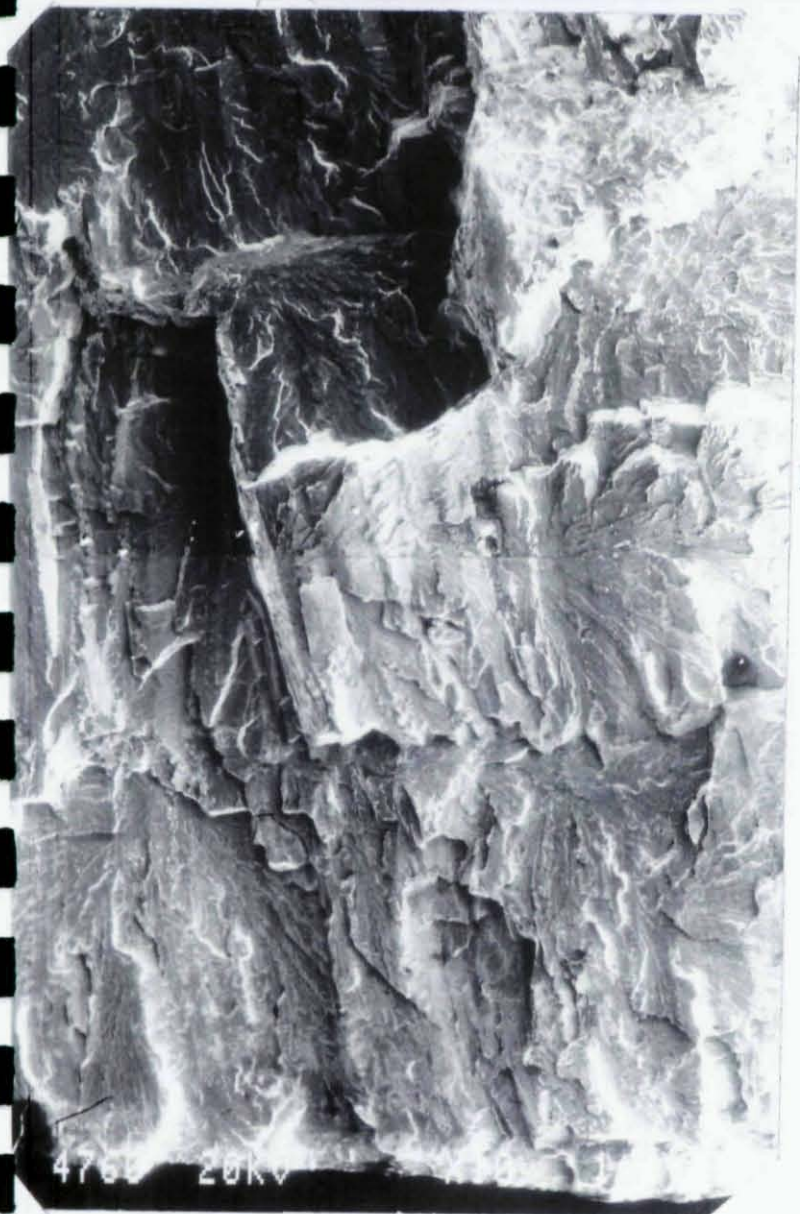
The south, center and north pieces of the fracture on the beam side are shown in Figures 32, 33 and 34, respectively. The south piece, Figure 32-a, shows lack-of-fusion defects at the weld root and within the CJP groove weld, and pre-existing cracks. A

crack at the edge of the piece was coated with HTO. Most likely, the HTO formed when the run-on and run-off tabs were removed and the edges of the CJP groove weld were ground smooth.

Figure 32. South piece from the beam-side fracture surface of the west-beam top-flange joint.

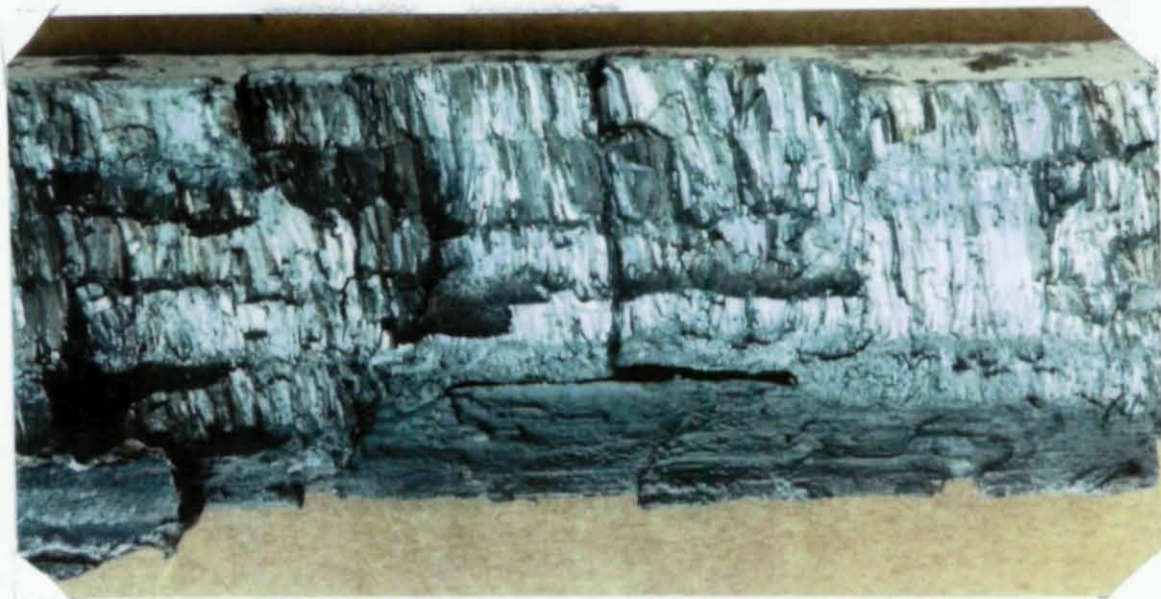
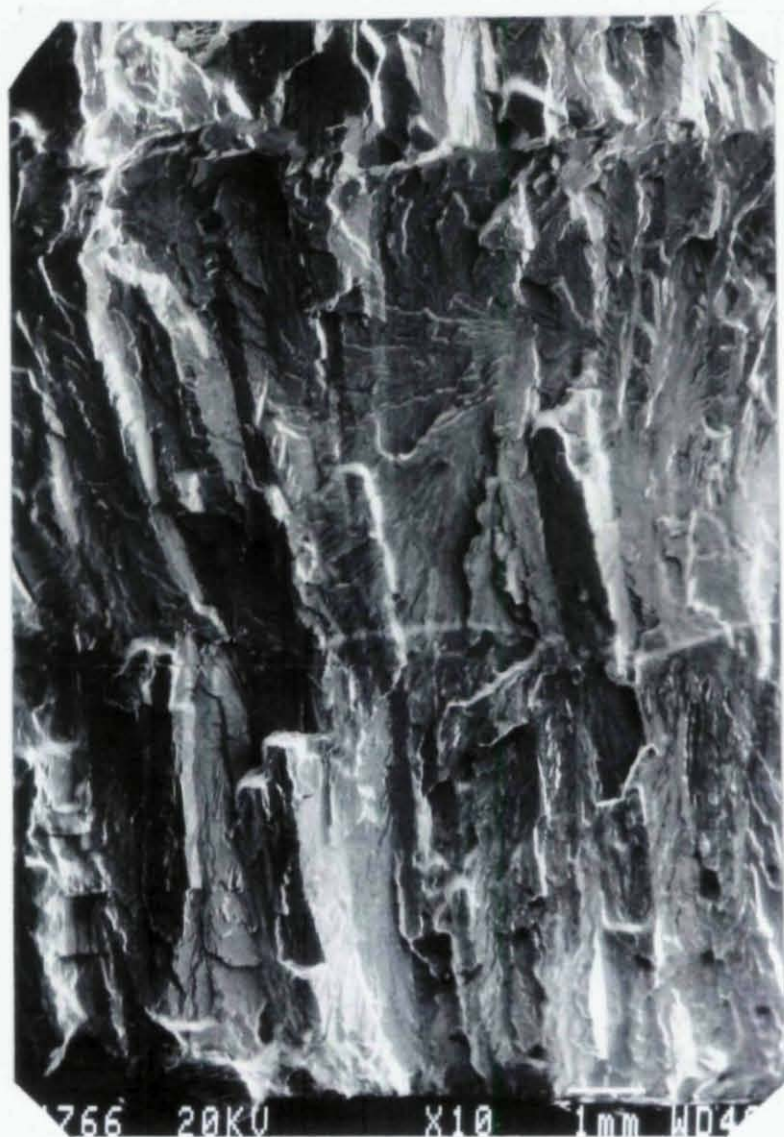
The center piece, Figure 33-a, shows lack-of-fusion between the root pass and the backing bar and an extensive network of discontinuous cracks. The surfaces of two cracks were coated with HTO. Figure 34 presents an example of the many discontinuous cracks along the crystallographic planes in ferrite that were present on the fracture surface. The figure shows also, that the mode of microscopic crack propagation at this location was a mixture of cleavage and ductile dimples. The north piece, Figure 35-a, shows severe slag and lack-of-fusion defects and cracks that were parallel to the top of the deposited weld metal. Some of these cracks are shown in Figure 35-b at higher magnification.

Figure 33. Center piece from the beam-side fracture surface of the west-beam top-flange joint.

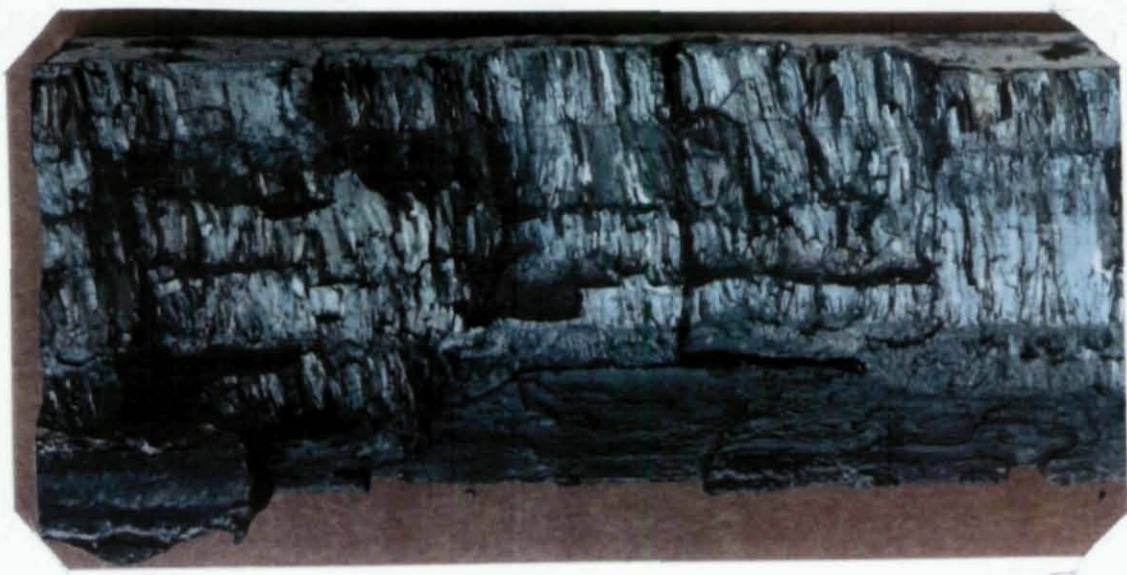
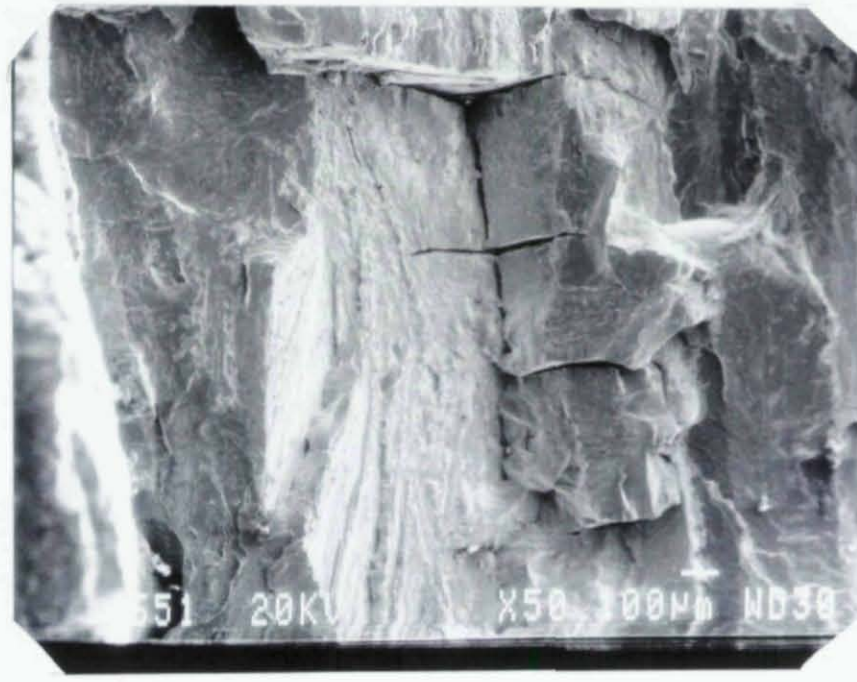
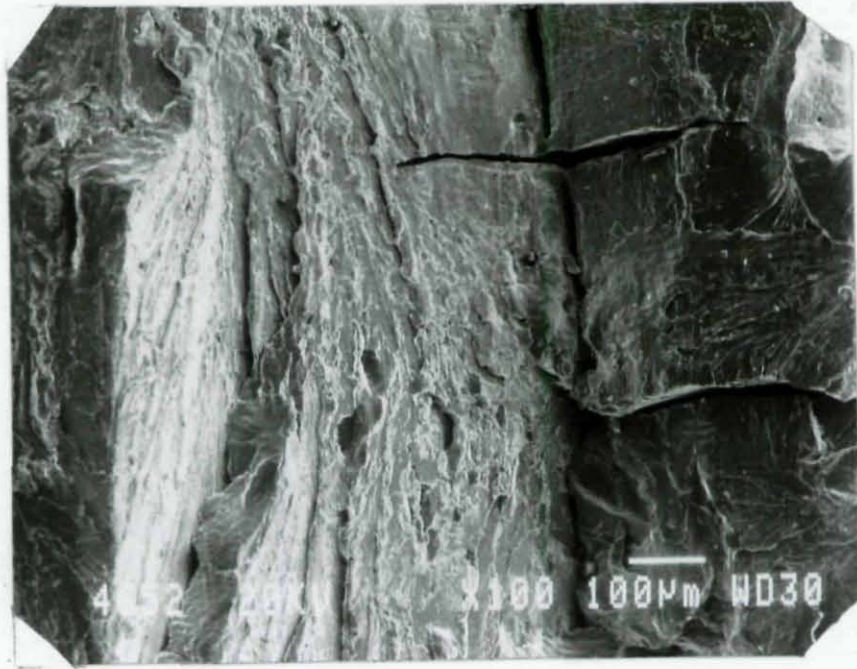
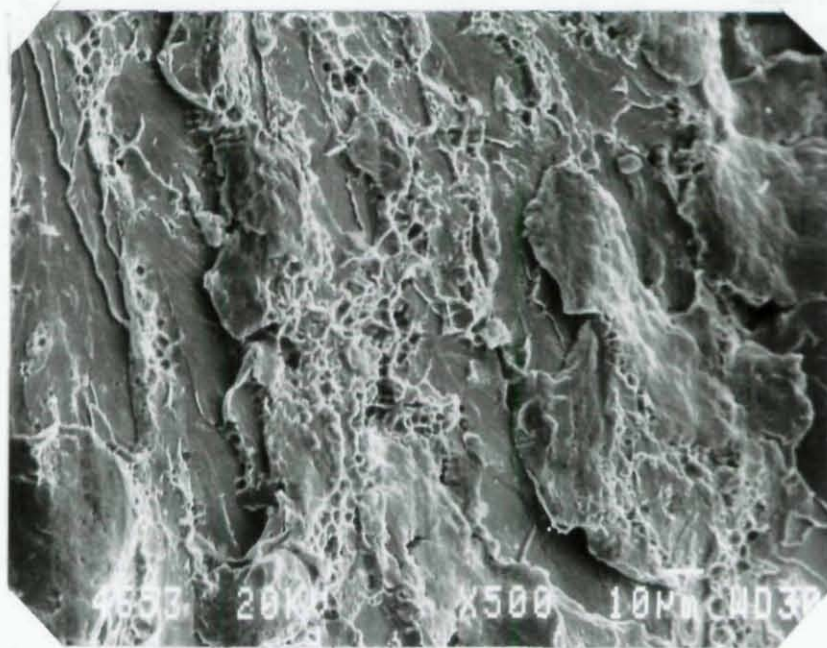
Figure 34. An example of discontinuous cracks on crystallographic planes in ferrite.

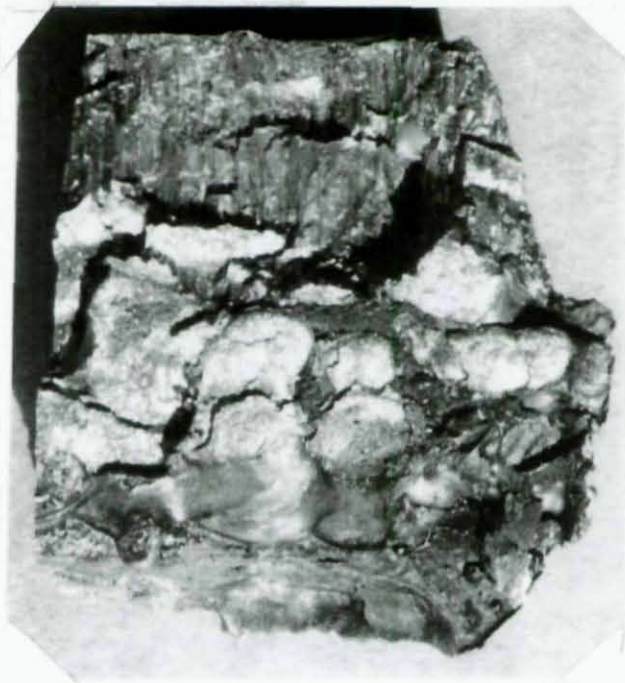
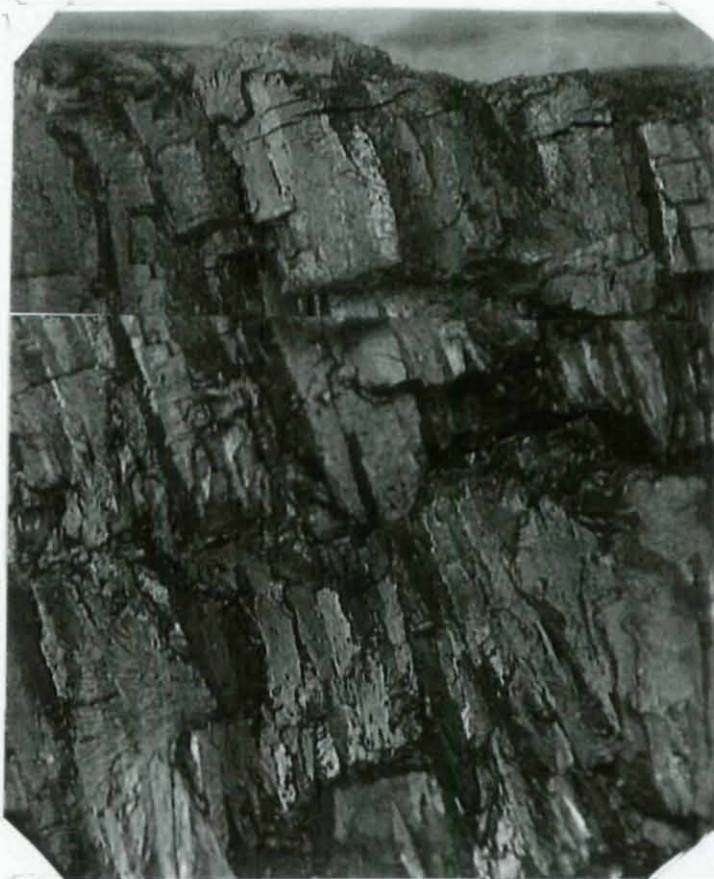
Figure 35. North piece from the fracture surface on the beam side of the west-beam top-flange surface.

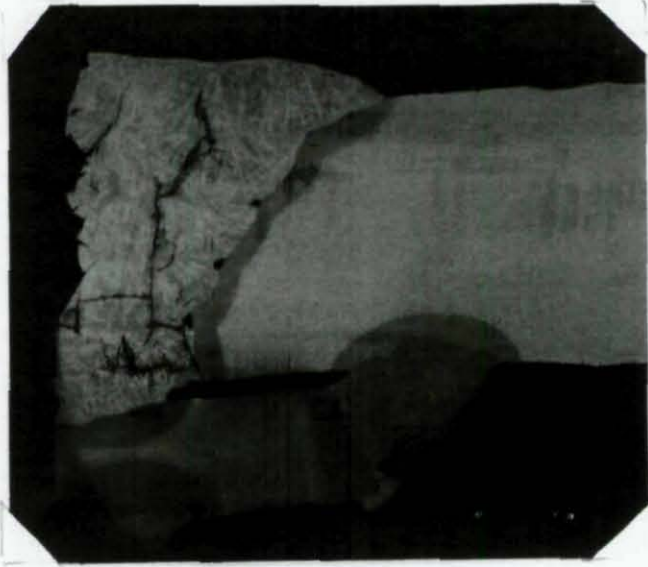
Two cross sections of the WT joint are shown in Figures 36. The polished and etched surfaces of the cross sections show the presence of an extensive network of cracks that were present prior to fracture. The cracks were randomly oriented

throughout the weld metal. The fracture path indicated that the fracture propagated along an irregular network of cracks.

Figure 36. Macro sections from the west-beam top-flange joint.

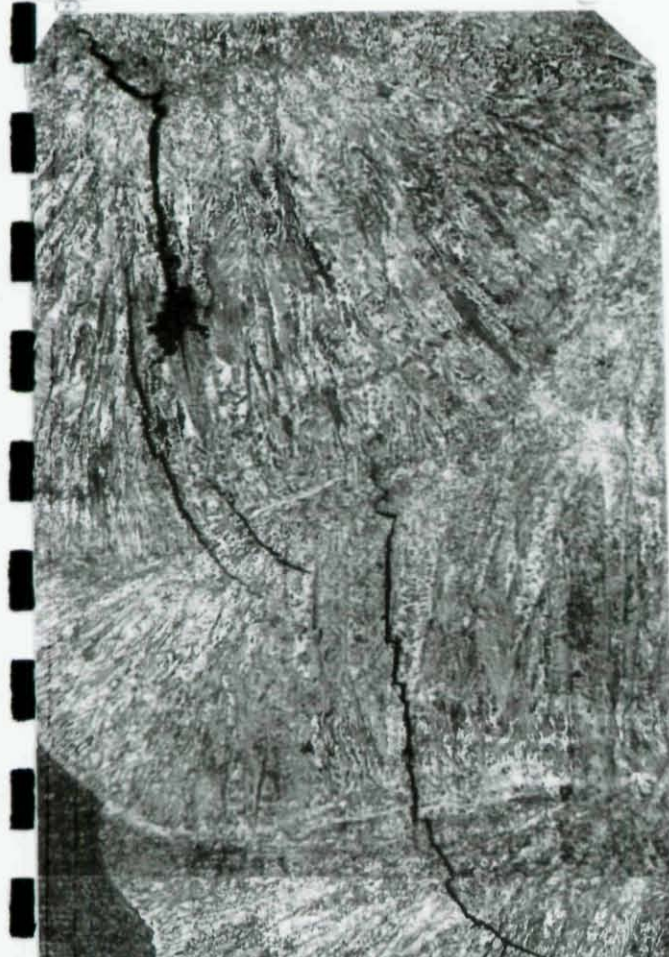
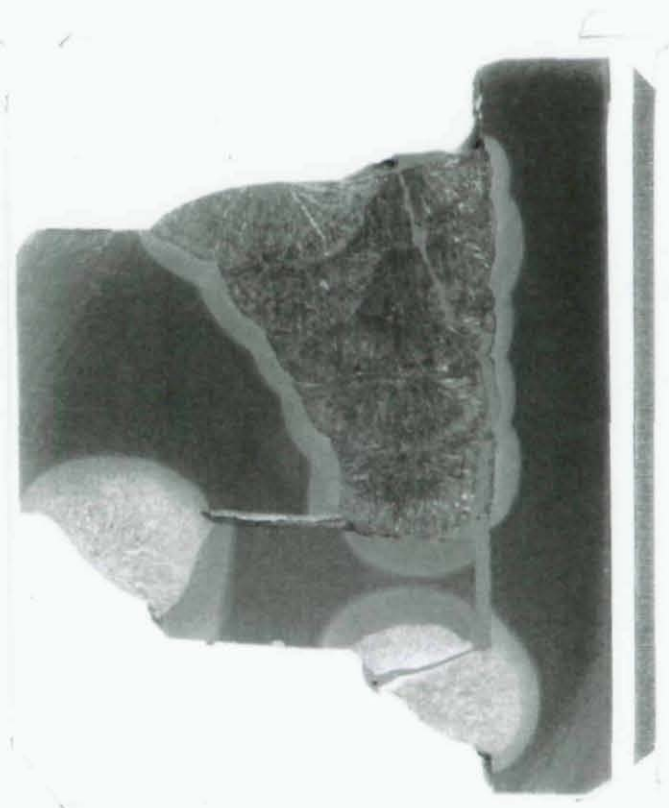
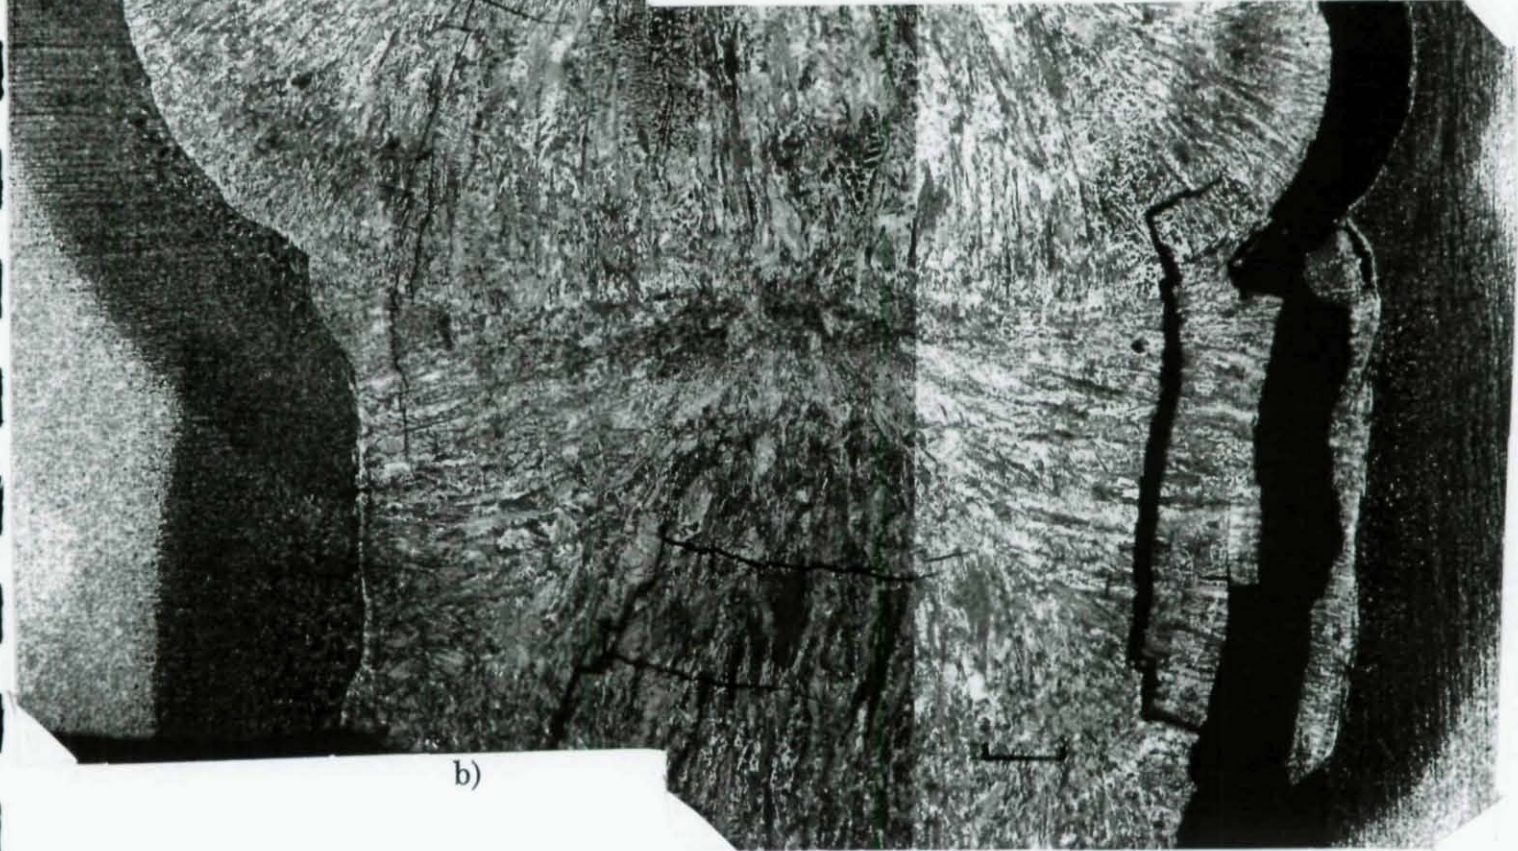
Figure 37-a is a macro cross section through the column flange, the CJP groove weld and the west top flange. The features along the fracture path indicated that the fracture propagated from the top surface of the deposited weld metal and along the fusion line into the gap between the backing bar and the column flange. The extensive network of cracks within the weld metal is not clearly visible in this cross section because the cracks were filled with wax to prevent crack "bleeding" from etchant that was entrapped within the cracks. Figure 37-b shows some of the cracks that were present in the weld metal. The weld metal in this WT joint contained significantly more cracks than either the WB or the ET joints.

Figure 37. Macro section across the west-beam top-flange joint.
