**FAILURE ANALYSIS OF A WELDED
MOMENT-RESISTING INTERIOR CONNECTION**

By
John. M. Barsom
and
James V. Pellegrino Jr.

Submitted to:
AISC
Chicago, IL

September 15, 2001

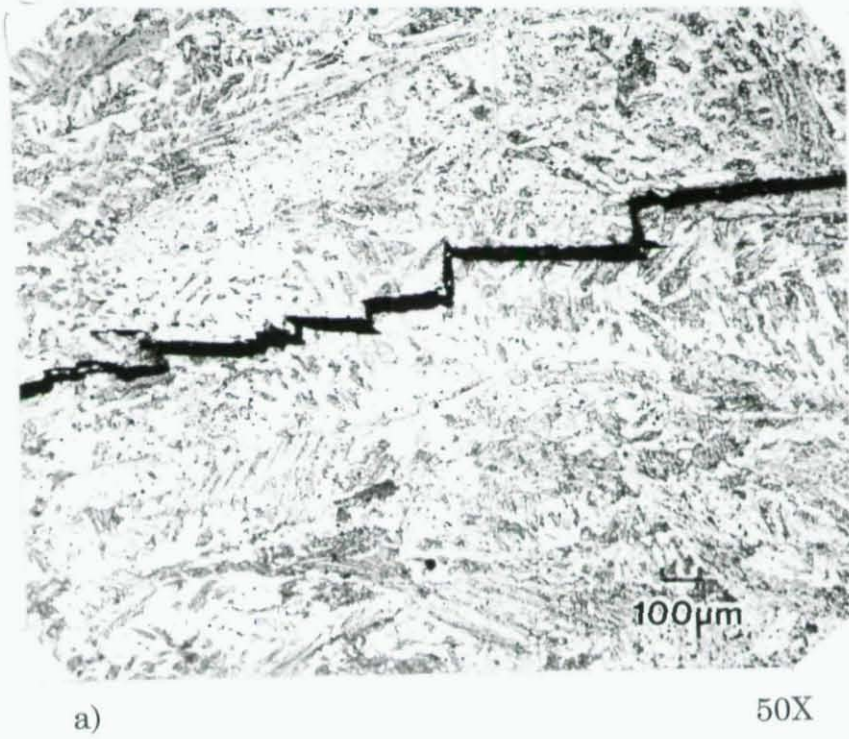
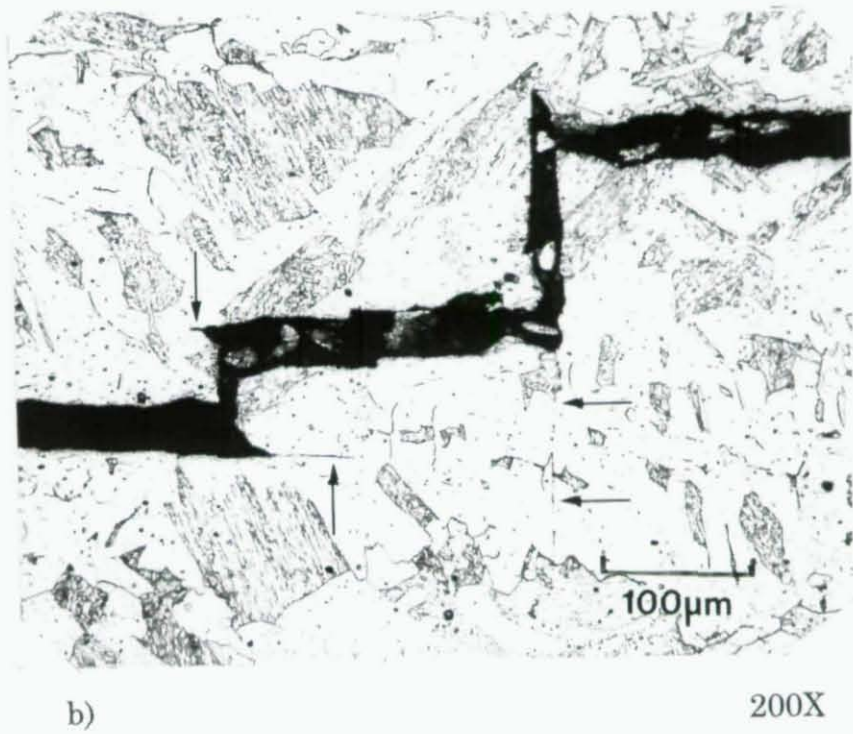
Figures 38 and 39 present two examples of cracks in cross sections from the WT joint. Figure 38-a shows a step crack that formed along perpendicular crystallographic planes in the ferrite. Crystallographic planes extending from the tips of the step cracks are indicated by arrows in Figure 38-b. Figure 39-a shows a meandering crack that propagated along crystallographic planes of the ferrite. Figure 39-b and 39-c show crystallographic planes at different stages of development towards becoming cracks

Figure 38. Step crack on a cross section from the west-beam top-flange joint.

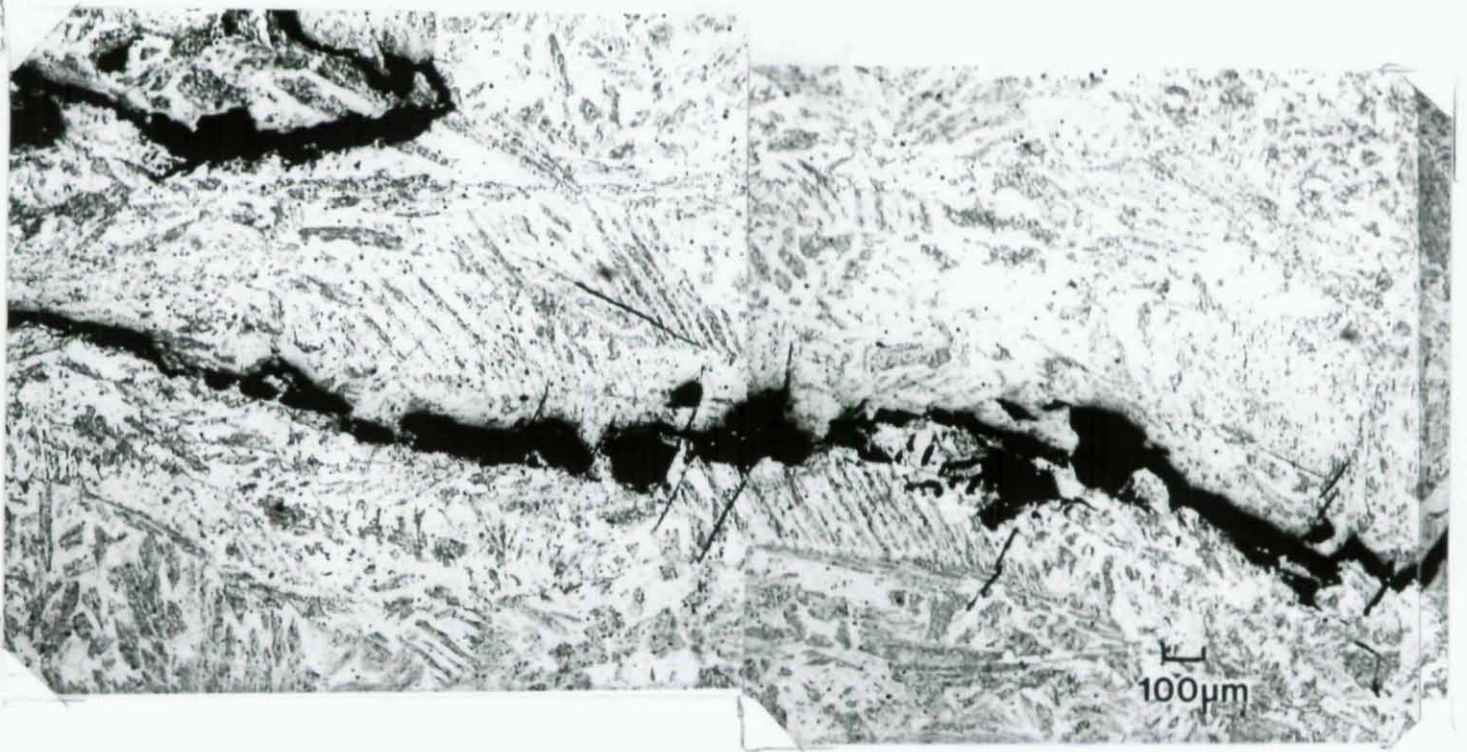
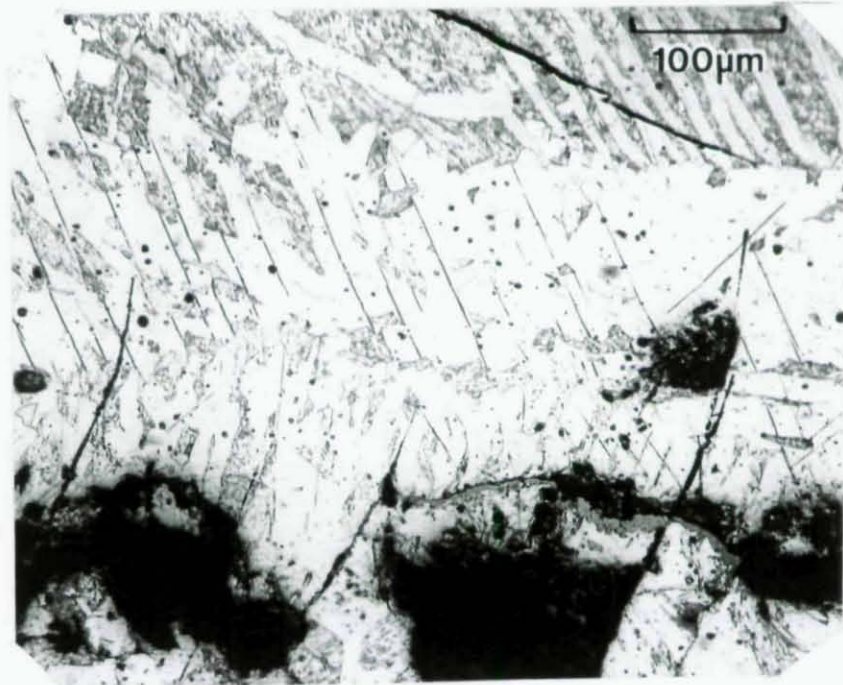
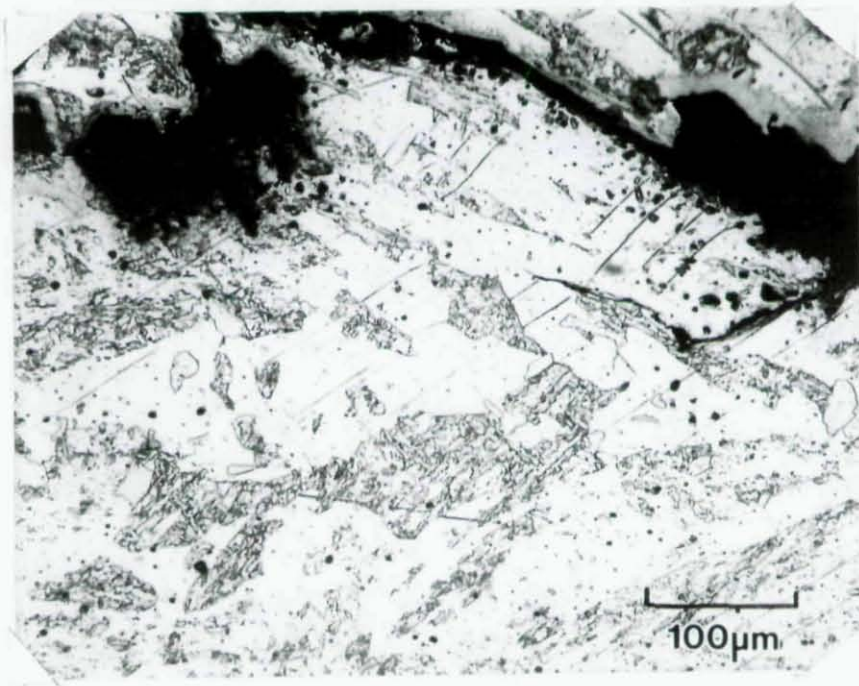
Figure 39. A meandering crack in a cross section from the west-beam top-flange joint.

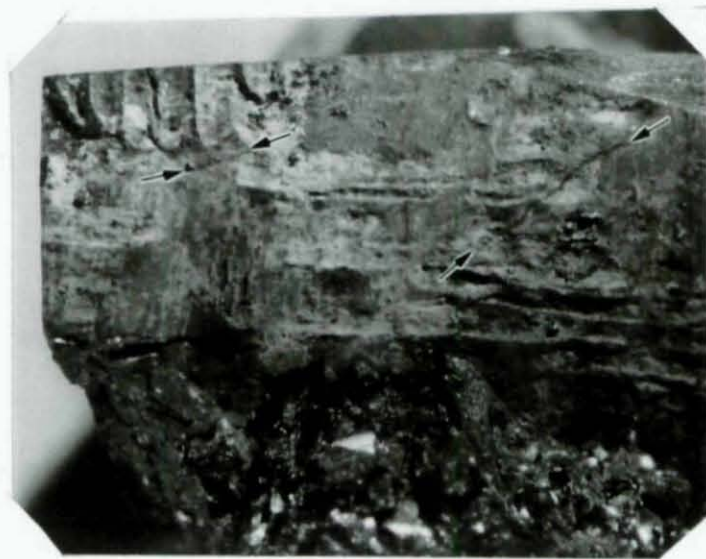
Some crack surfaces were coated with HTO. For the crack surfaces to be coated with HTO, the cracks would have had to be present when the temperature of the surrounding metal reached about 600°F or higher. The HTO coated cracks that were located at the edges of the CJP groove welds occurred, most likely, when the run-on and run-off tabs were removed and the edges were ground smooth. The large pre-existing HTO coated crack in the ET joint initiated at a weld defect between the root pass and the backing bar and extended into subsequent weld passes as the weld metal in each pass solidified and contracted. One of the HTO coated surface cracks in the WB

joint appeared to form in an area on the top surface of the deposited weld metal that had been altered after the top weld pass was deposited, Figure 40. Another HTO surface crack appeared to have originated as a crater crack. The remaining HTO coated cracks could not be investigated within the limits of the present study.

Figure 40. Cracks emanating from a conditioned area on the top surface of the deposited weld metal in the west-beam bottom-flange.
