# PROGRESSIVE COLLAPSE RESISTANCE OF STEEL BUILDING FLOORS

FINAL REPORT

REPORT NUMBER: UCB/CEE-STEEL-2001/03  
DEPARTMENT OF CIVIL AND ENVIRONMENTAL ENGINEERING  
COLLEGE OF ENGINEERING  
UNIVERSITY OF CALIFORNIA AT BERKELEY

Report to the Sponsors: American Institute of Steel Construction  
and General Services Administration  
September 11, 2001

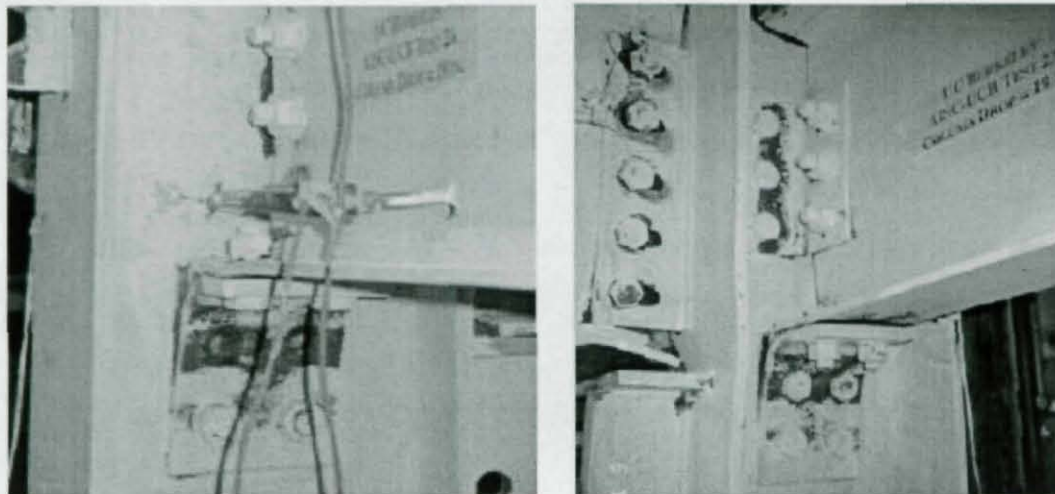
As the column displacement exceeded 14 inches, failure occurred of the top two bolts on the lower leg of the seat angle that holds the longitudinal beams. This is identified as spike "A" in both the force time history and force displacement plots in Figure 3.1. The end of the bolts, including the nuts, violently shot through the air while the head of the bolts remained in place. Four bolts held the angle to the displacing column, leaving only two bolts to resist the vertical load of the beams. As the bolts were failing, the seated angle itself was undergoing local yielding and deformation. See Figure 3.2 for a photograph of the local damage.

Figure 3.2. Failure of Top Two Bolts in the Seat Angle

Next, the two bolts that failed at the loaded column were replaced. Due to the seated angle deformation noted above, a  $\frac{1}{4}$  inch gap remained along the shaft of the bolt after the nut was tightened.

1. Connection bolts should be strengthened to improve structure behavior in a loss of column scenario. The bolt failures observed in the experiments led to greater specimen

deformations and resulted in failure of a beam-to-column angle connection. High-strength bolts and/or larger sized bolts would improve the behavior of the system with little additional cost.

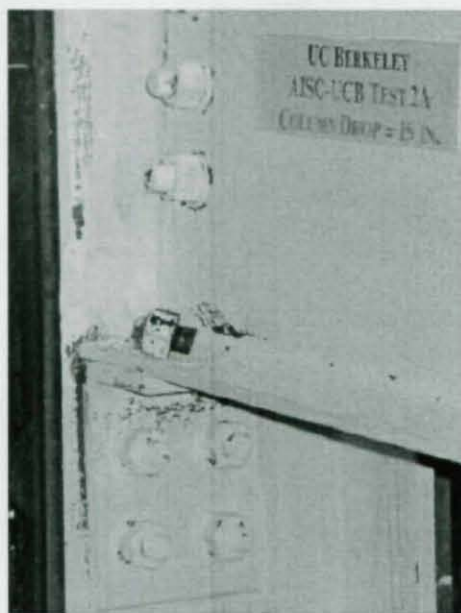
As the displacement approached 15 inches, at the other end of one of the longitudinal beams, west of the displaced column, the two bolts that secured the beam to the top of the seated angle also failed and "popped" (Figure 3.3). Spike "B" in Figure 3.1 clearly shows the loss of strength because of the bolt failures. The shear tab that supported the transverse beam also underwent local yielding.

Figure 3.3. Failure of the Two Bolts on the Seat Angle

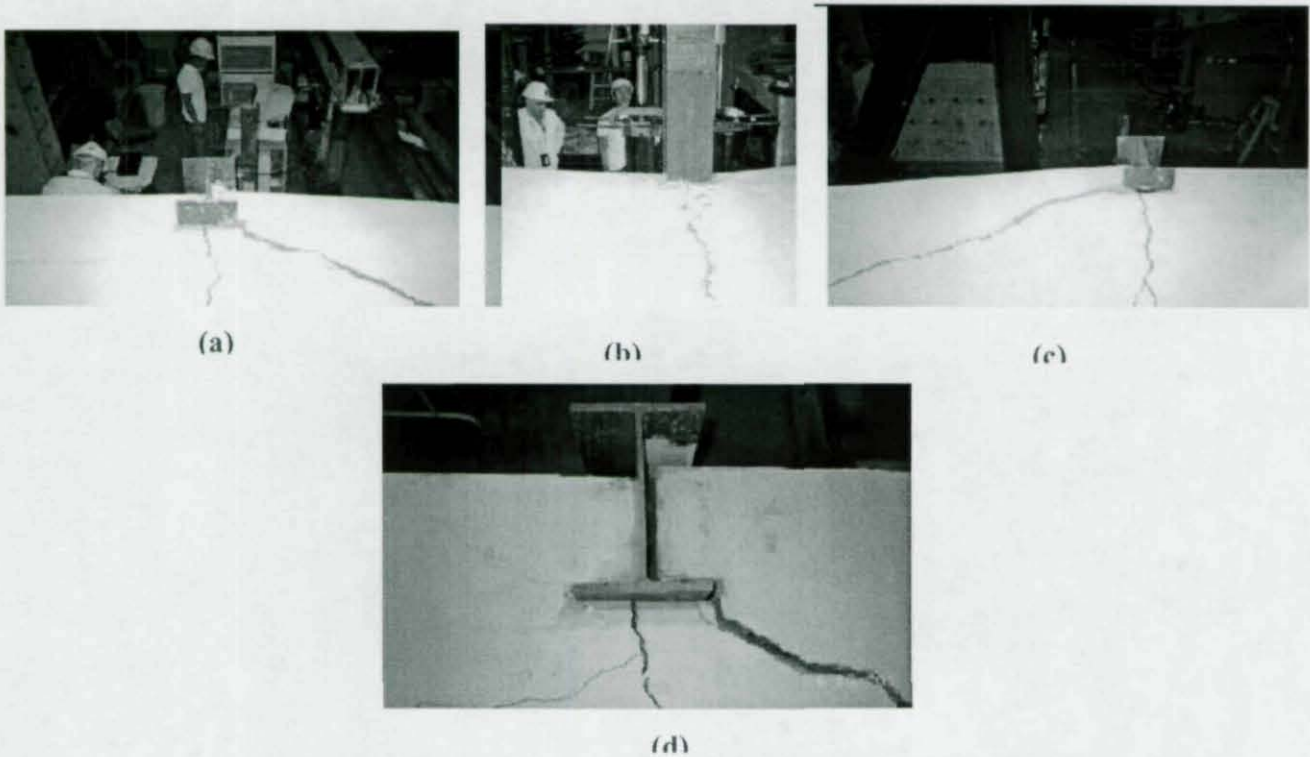
The concrete slab separated from certain columns as the displacement increased. At the final displacement of 19 inches, a gap of approximately 1 inch had opened between the slab and column B2. Photographs of the local damage surrounding columns B2, C2 and D2 are included as Figures 3.4(a), 3.4(b) and 3.4(c) respectively. Figure 3.4(d) shows close-up of the cracks around column B2.

Figure 3.4. Cracking of the Concrete Slab at Column B2 at the End of 19-inch Drop Test

2. Placing reinforcement bars within the concrete slab could postpone and possibly eliminate complete cracking of the slab. The bars could be placed along the column lines of any frames susceptible to blast loads. The additional steel cross section should prevent complete shear fracturing of the floor slab.
3. The connections should be designed for combined effects of bending and axial load due to Catenary forces. Guidelines for design of such connections can be developed upon further research, experimental or analytical, and better understanding of magnitude of forces and rotations involved. The first author will continue efforts in that direction.

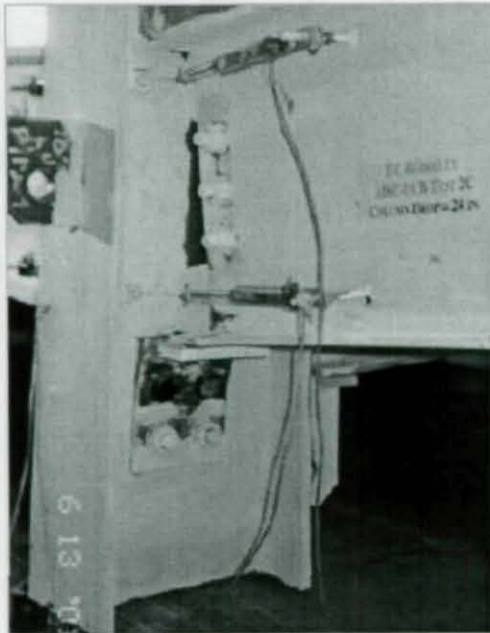
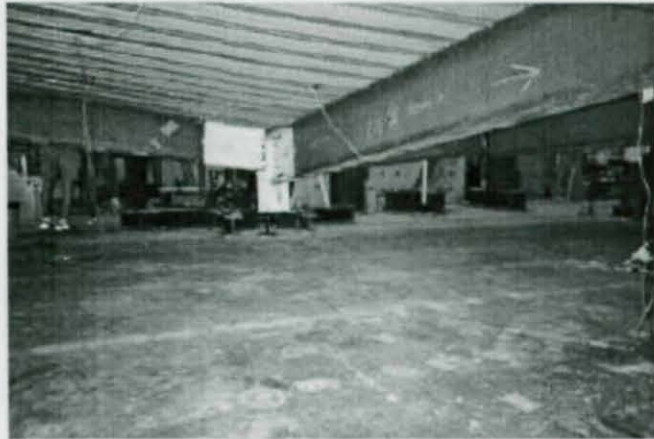
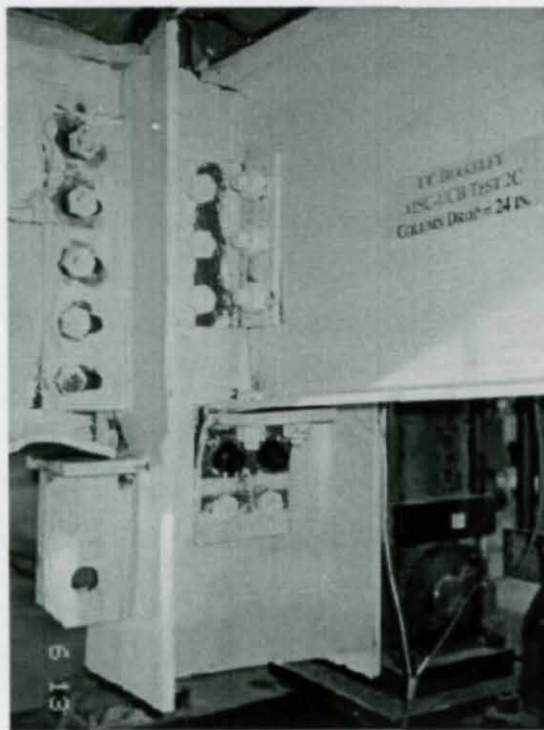
Figure 3.6. The Two Replaced Bolts on the Top Half of the Bottom Leg of the Seat Angle Remained in Place.

While attempting to replace the same top two bolts on the seated angle connection that were replaced before, it was noticed that the bolts did not fail, but underwent large deformations. The bolts were removed, but could not be replaced with new bolts due to the large deformations.

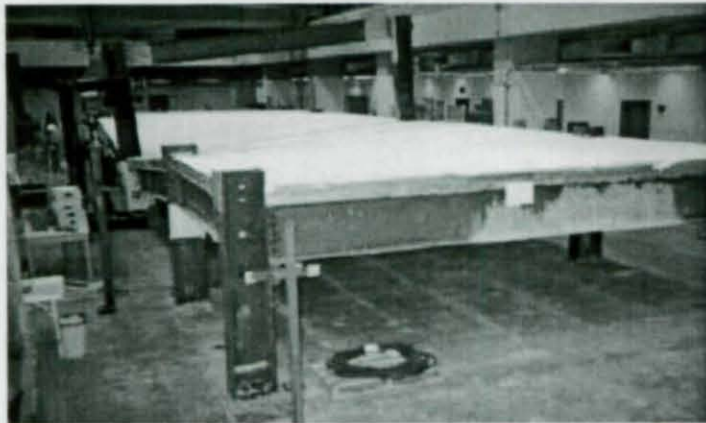
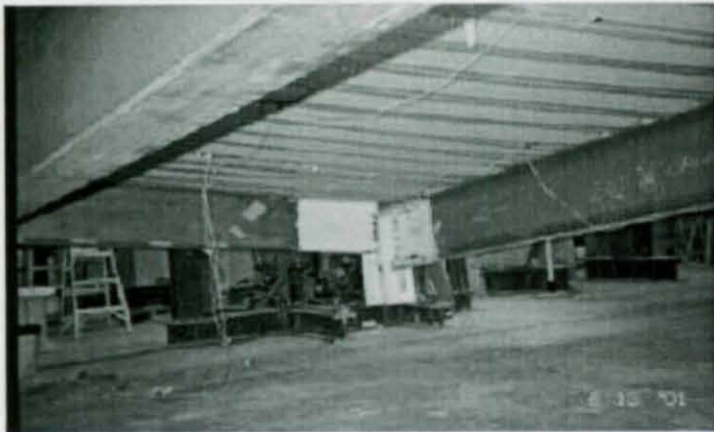
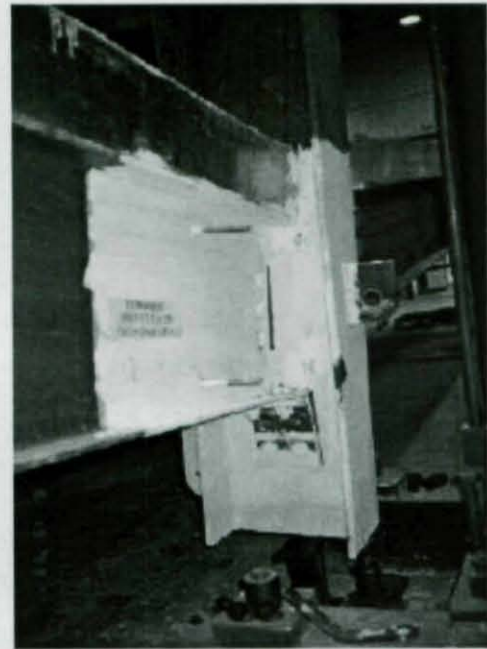
The steel deck suffered noticeable damage. Major deformations were noted along the column line of the displaced column, with concentrated damage occurring near the beam to column connections. The steel deck was ripped near columns B2 and D2, while bending was widespread.

Only one failure occurred during the column displacement to 24 inches. The pair of bolts failed that secured the longitudinal beam directly east of the displaced column to the seated connection. Unlike the beam west of the column, this failure occurred at the end connecting into the test column. Both failures left the bottom flanges of the beams free to move at one end. As a result of the asymmetrical failure, the structure was no longer behaving in a symmetrical manner. The east actuator was actually applying a 10 kip upward force to the column even though the column was being displaced downward. Strengthening the bolts to eliminate their failure should produce a more balanced, well-behaved failure mechanism.

Figure 3.7. Specimen at the End of Test2C (24 inch Column Drop)

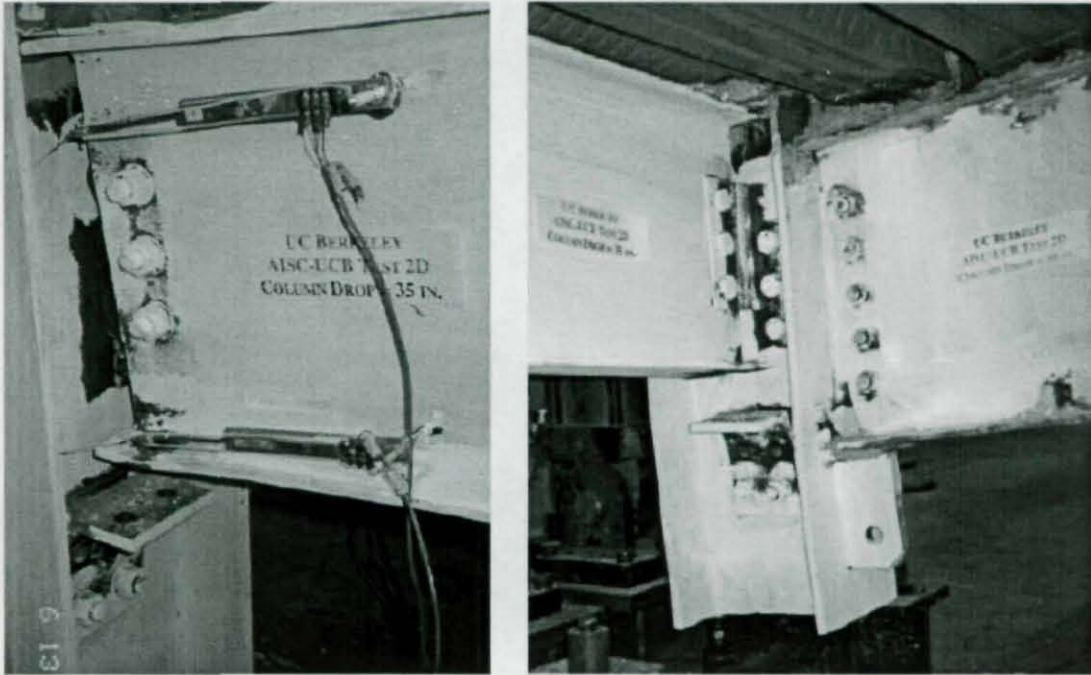
In addition to the above noted behavior, as the column displacement approached 26 inches, complete failure occurred at the connecting angle between the loaded column and the longitudinal beam directly east (Figure 3.8). Spike "F" in Figure 3.8 shows the sudden drop in load after the angle failure. The preceding spike, labeled "E," is the evidence of slippage within the structure, possibly within the angle before complete failure.

Additionally two component failures occurred during the 35-inch displacement. First failure was at the connecting angle between the test column and the longitudinal beam directly east. The concrete slab was left as the only remaining component to transfer the applied force of the actuators to the east side of the structure. Unable to provide this force transfer, the concrete slab failed in shear.

Figure 3.9. Complete Failure of the Shear Angle on the Web of Column
