## **Stability of Tapered Wood Utility Poles under Extreme Loading**

### **Abstract**

### **1. Introduction**

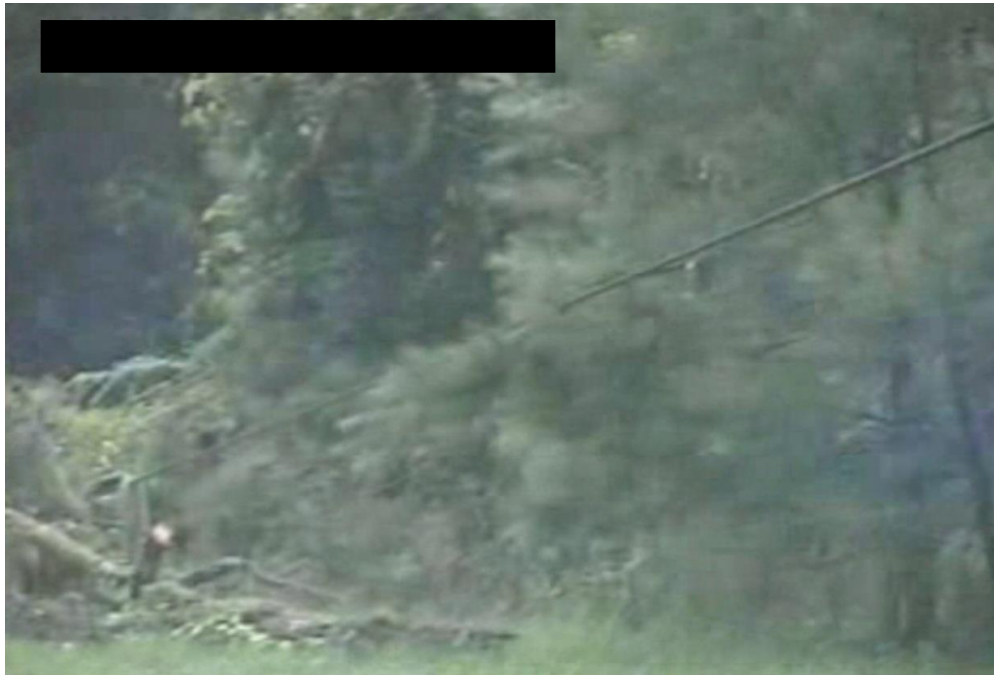
Figure 1: Taught communication lines beneath fallen tree

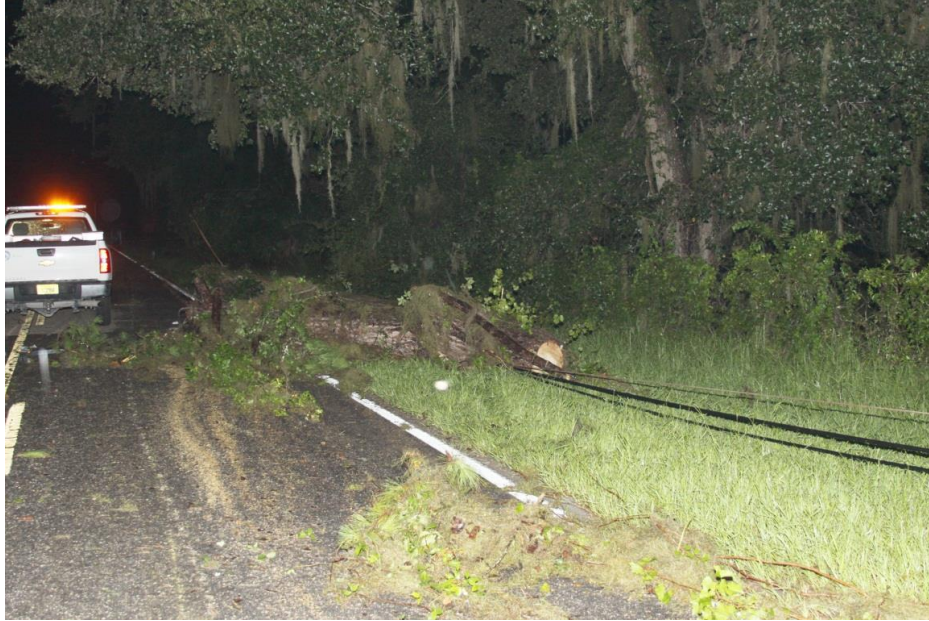
Two county employees began to clear the fallen tree from the roadway around 8:00 P.M. Tree branches were first removed and then the main trunk was cut into several segments, which were dragged to the west, off the road, using a strap attached to the hitch of a pick-up truck. The fallen trunk was cut just south of the pinned communication lines, creating a trunk segment 14'-8" long, so that this trunk segment (south segment) could be removed from the road without disturbing the lines. Another cut was made through the trunk to the north of the lines, creating a trunk segment 5'-3" long (north segment). A nylon tow strap was then attached to the south end of the south segment and dragged to the west. Unbeknownst to the driver of the pick-up truck, the cut had not fully separated the south and north trunk segments and, as a result, both segments were dragged to the west. Post-incident photographs of the two displaced trunk segments indicate that the communication lines remained below the north segment as it was dragged to the west (Figure 2).

Figure 2: Communication lines still below tree segment that had been dragged from roadway

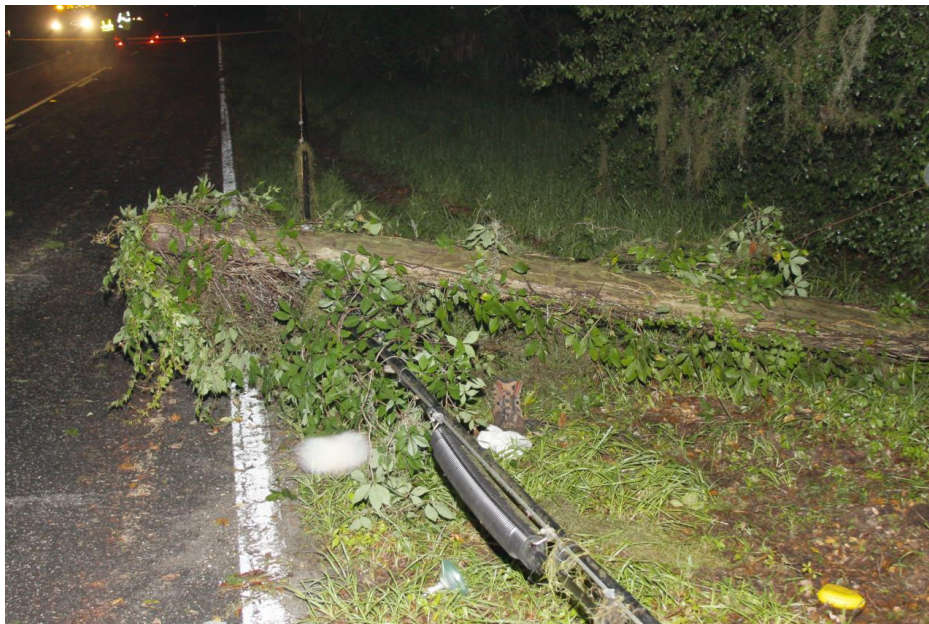
A county employee who was involved with the tree removal operations was standing to the west of the north segment when the two segments were dragged to the west. The county employee ran to the west and shouted to the driver of the pick-up truck when he realized that the south and north segments were being dragged together along with the communication lines that were snagged by the north segment. Subsequently, a sheriff's deputy reported hearing a "snap," caused by the failure of the wood utility pole to which the west end of the pinned messenger wire was attached. The subject pole fell toward the roadway, injuring the county employee. The pole in its failed position is shown in Figure 3. The accident was reported around 8:45 P.M.

Figure 3: Failed utility pole

force associated with the messenger wire in its final position corresponds to a bending stress at the base of the subject pole that is more than double the nominal modulus of rupture of a new Southern Pine utility pole. As the tree segment was dragged to the west, the subject pole could not withstand these increased stresses and eventually failed in bending at the ground-line.

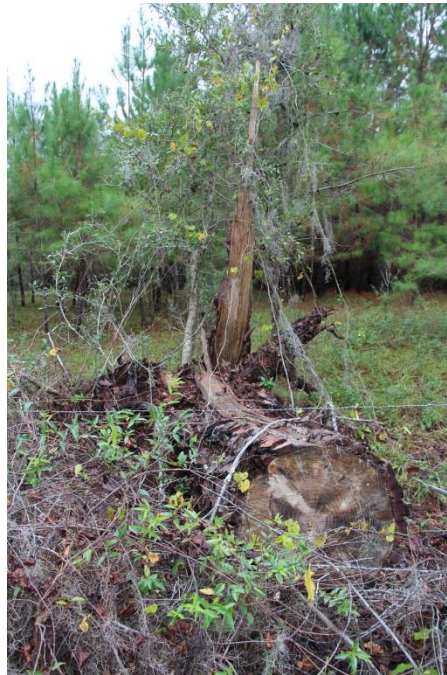
Figure 4: Segment of fallen tree

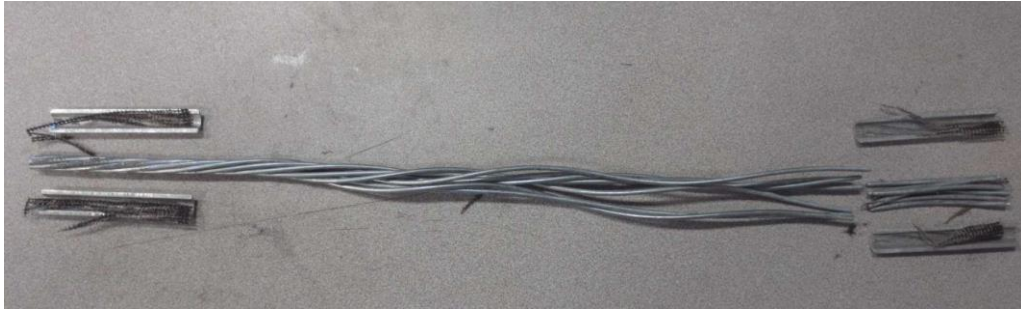
In order to better understand the force-deformation behavior of the messenger wire, and therefore the forces imparted by the wire to the subject pole, testing on exemplar samples of the wire were performed. Results of the testing indicated a breaking strength ranging from 7,680 to 7,730 pounds, and a modulus of elasticity ranging from 15,800,000 to 16,900,000 pounds per square inch. Failure of the exemplar samples was associated with fracture and unraveling of the strands forming the messenger wires. A photograph of one such failure is shown in Figure 5. Given the relatively close grouping of the results, the average test data was used to create the messenger wire tension-strain relationship shown in Figure 6. This relationship was used in the analyses described below.

Figure 5: Fracture and unraveling of messenger wire during testing

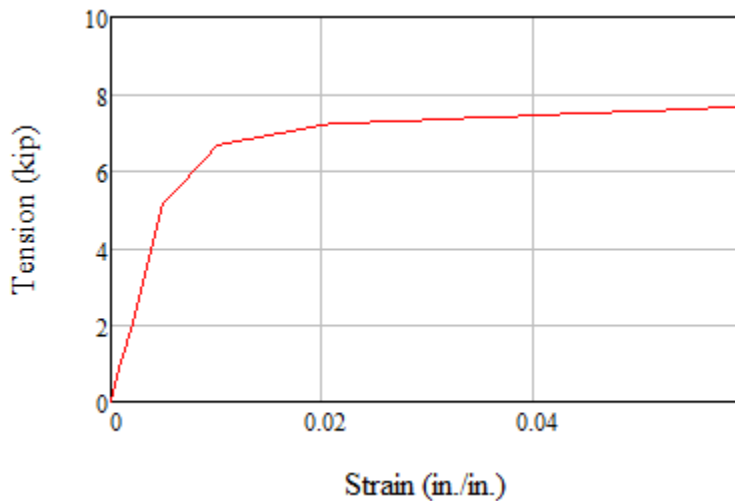
Figure 6: Messenger Wire Tension-Strain Relationship

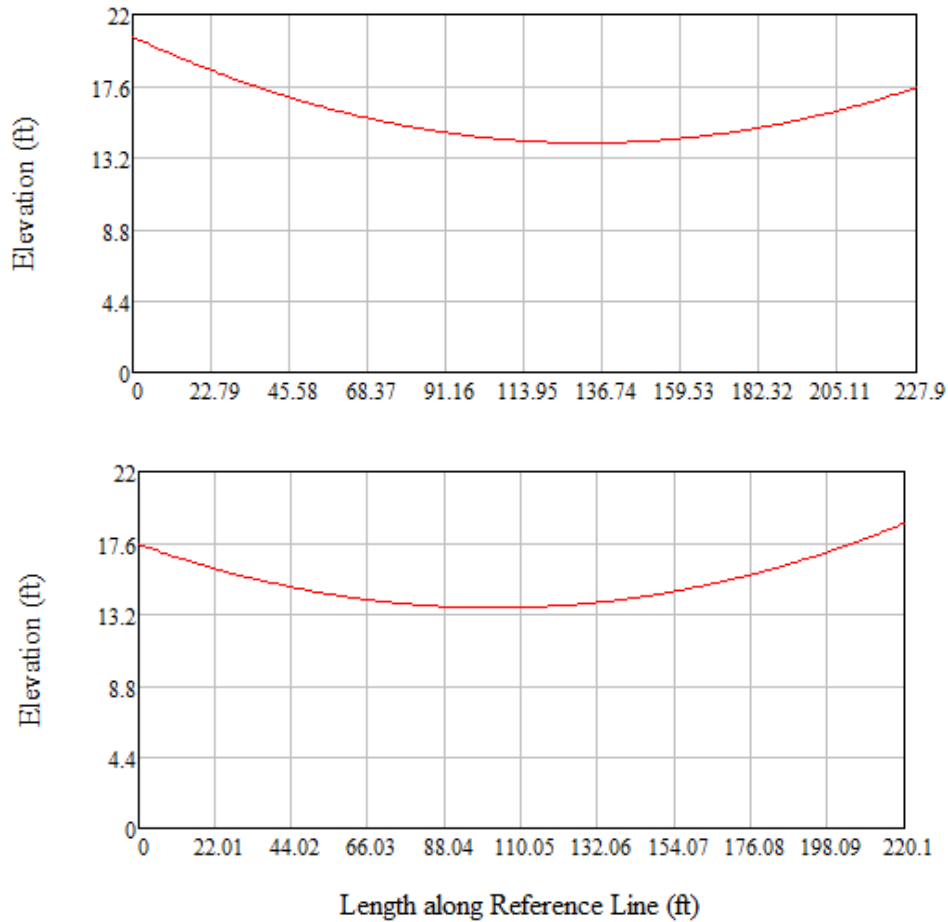
The catenary equations were solved in an iterative manner, until the shape of the messenger wire along the span to the west of the subject pole (noted as W to 0) and along the span to the east of the subject pole (noted as 0 to E) matched the shape of the spans as depicted in publicly-available photographs taken prior to the tree fall. The results are shown in Figure 7 for the west and east spans, respectively. Messenger wire tensions associated with these shapes were applied to the subject pole to determine its stress state prior to the tree fall. Note that in the pre-tree fall configuration, the tension in the spans west and east of the subject pole are approximately equal and opposite, resulting in minimal bending moment on the pole, and therefore minimal deflection of the pole.

Figure 7: Elevation of Messenger Wires from W to 0 (top) and 0 to E (bottom)

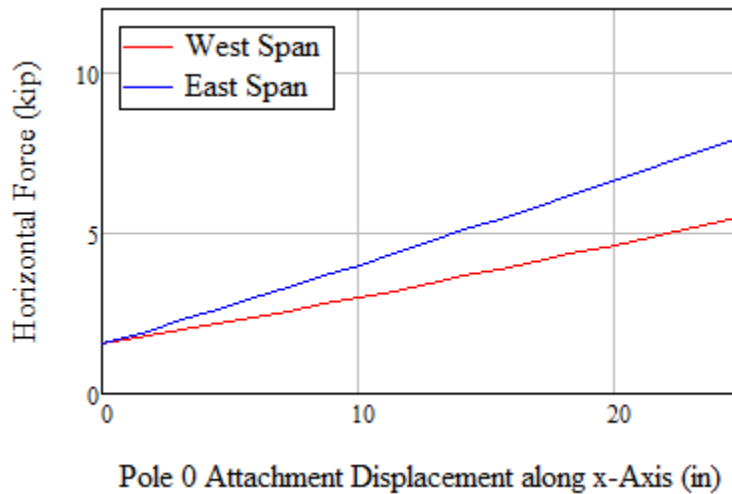
The scaled deformed shape (including a silhouette of the un-deformed shape) of the east and west spans subject to these unit displacements are shown in Figure 8 and Figure 9. A plot of the west and east span stiffness effect on the subject pole is shown in Figure 10. As indicated in the figure, the effect is essentially linear within the relevant range of pole behavior, and could therefore be easily incorporated into the rigorous hand calculations described above.

Figure 10: East span and west span stiffness

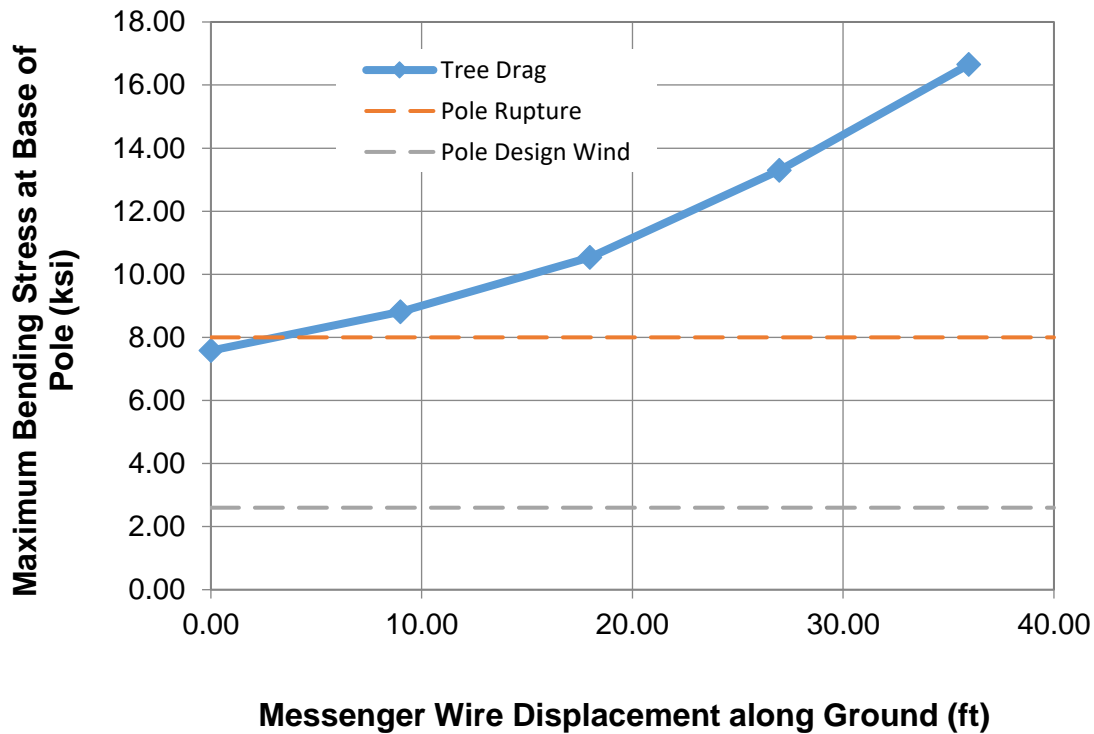
The results of the rigorous hand analysis, including the contribution from the east and west spans as determined from the computer model, are shown in Figure 11. The results indicate that just after the communication lines were pinned by the fallen tree, the bending stress on the pole was approximately 7.6ksi. This is 95% of the nominal modulus of rupture for the pole and almost 3

times the stress associated with the design wind load. The pole remained upright and intact despite the stress state associated with the initial tree fall.

As the tree was dragged along the ground (represented as total distance from the initial messenger wire position in Figure 11), the stresses increased at the base of the pole, quickly exceeding the nominal pole capacity. In the final position of the messenger wire (i.e., when the truck finally stopped), the bending stress on the pole would have been approximately 16.7ksi, which is more than double the nominal modulus of rupture of the pole, and approximately 6.5 times the stress associated with the design wind load.

Figure 11: Results from hand calculations of tree drag
