# REBUILDING A LANDMARK

An extensive reconstruction salvaged a beloved courthouse after it was devastated by fire

By Mark B. Peterman, P.E.

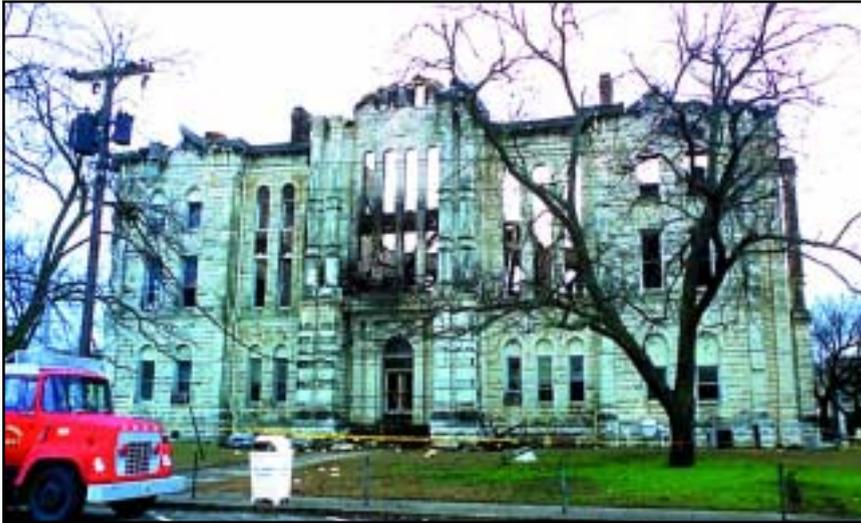
*The Hill County Courthouse (shown circa 1990 bottom right) was severely damaged in a New Year Day fire in 1993.*

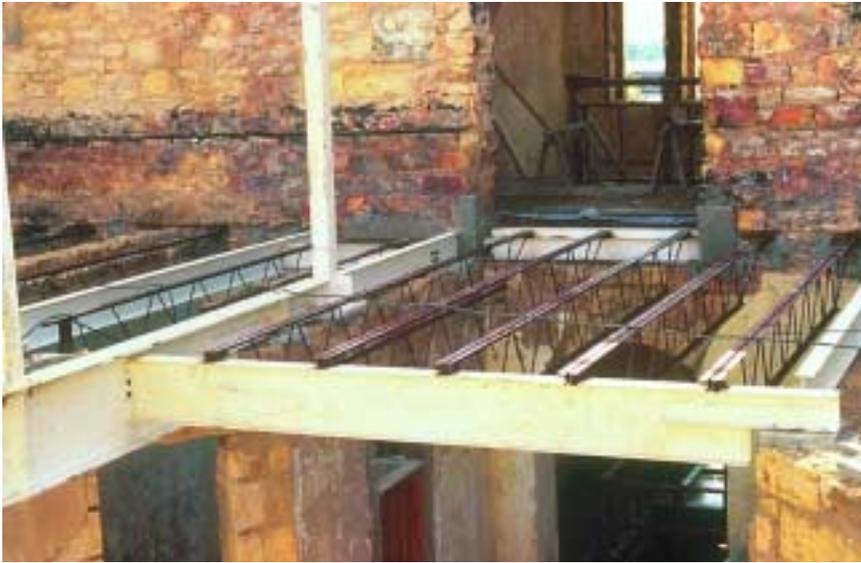
*Shown above is the new second floor framing during construction. Pictured opposite is a view of some of the diagonal ridge and valley trusses, along with the stone chimney in the background.*

New second floor framing consists of steel beams and bar joists spanning between load-

bearing masonry walls. The exterior walls and two main north-south walls extend from the foundation to the roof. However, numerous interior masonry walls terminate at the second floor. Above these walls, tubular steel columns were added where required to support the new third floor framing. Bar joists and beams bear on top of the lower walls and in pockets in the taller walls. Existing masonry pockets constructed originally for the existing wood joist framing were spaced at 16-in. on center. Existing pockets were enlarged for the new steel joists and reused (at 32-in. on center). Unused pockets were filled in with masonry and grout.
