# EFFECT OF NOTCHES IN THE FLANGE

After a bridge collapse, a finite element analysis was performed to determine the effects of notch cuts in the flange of steel plate girders

By M. Ala Saadeghvaziri, Ph.D., P.E.

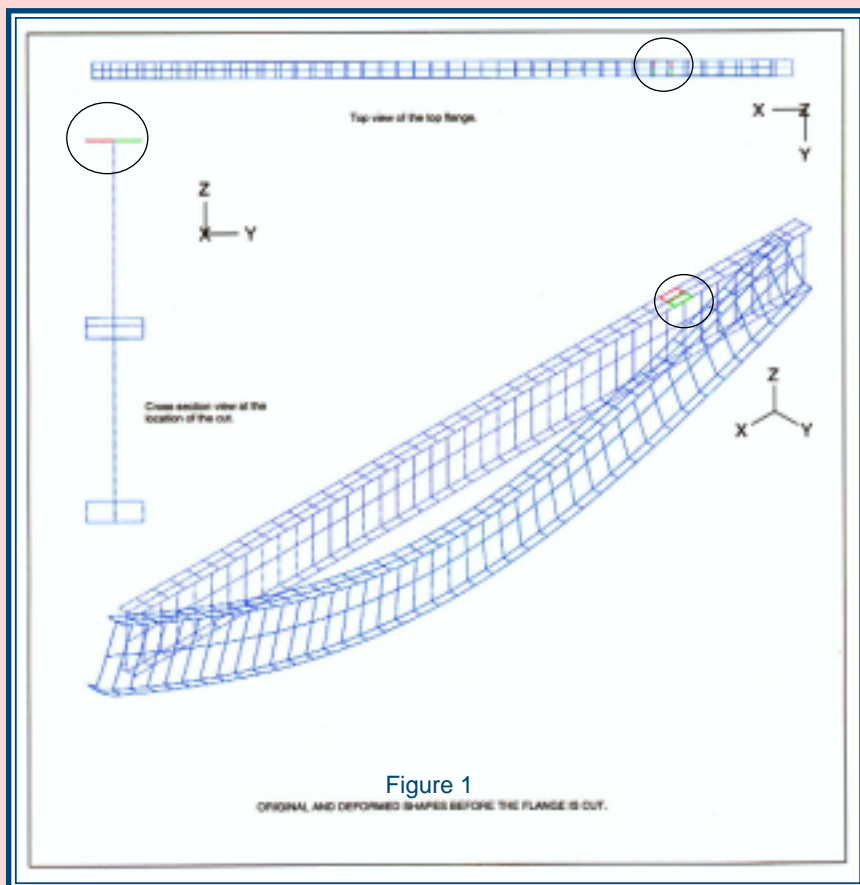
ORIGINAL AND DEFORMED SHAPES BEFORE THE FLANGE IS CUT.

Figure 1 shows the original and deformed shapes before the cut in the flange were made, where displacements are symmetric with respect to the web plane. Note that the elements being removed (notches in the flange) are shown in red and green on the original mesh. Shown in Figure 2 are various views of the deformed and original shapes of the model after half of the flange is cut. The out-of-plane deformation of the girder due to lack of symmetry resulting from a cut in half of the flange is very significant. This can be observed by comparing Y-displacement to Z-displacement of the model by considering the cross section view of the girder as shown in Figure 2. The value of Y-displacement is more than half of the Z-displacement at the location of the cut. This result indicates that in a situation like this it is important to provide lateral support at the location of the cut too. Figure 3 shows similar views after removal of the entire flange (over a 30" length) where the displacements are again symmetric with respect to the plane of the web.

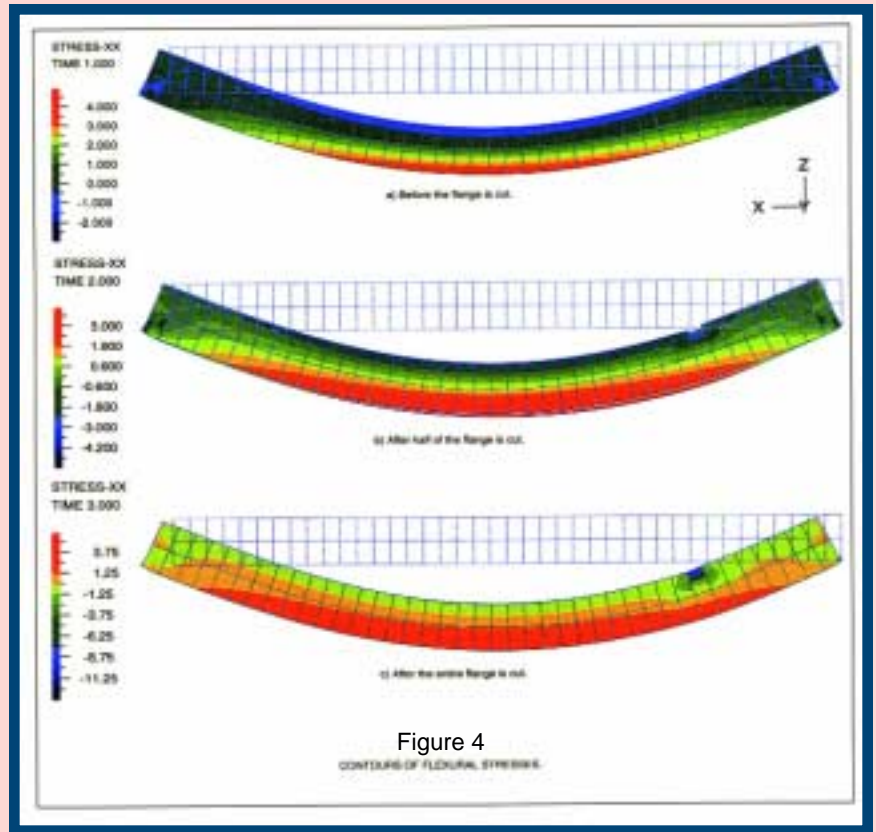
Contours of flexural stresses for all three stages are shown in Figure 4. Note that lack of symmetry in flexural stress through the height of the cross section (for case a) is due to the fact that the reactions are not located at the neutral axis of the girder. Cutting half of the top flange

increases the maximum compressive stress from -3 ksi to -5.4 ksi. Removal of the entire flange (over a 30" length) increases the maximum compressive stress to -13.75 ksi. For all cases the stresses are well below the yield stress of steel.

Therefore, initial instability due to lack of symmetry during removal procedures and not necessarily the size of the notch appears to be the more important cause of possible problems. As previously mentioned, providing lateral supports at the location of flange cuts should be considered in addition to bracing at other locations as needed.
