Double Take

Lifting Boston's McArdle Bridge to higher standards meant putting it back into working order and creating easy access for repairs down the road.

Constructed in 1953, the McArdle Bridge crosses the Chelsea River in Boston. Over the course of three years, critical repairs made to the McArdle Bridge restored its reliable operation as a vital link to the New England area. This double-leaf, rolling-lift through-truss spans 225' (center of roll-to-center of roll) and is 65' wide (out-to-out). The span opens about 1,500 times per year, due to heavy barge traffic delivery of heating oil for New England and jet fuel for Logan Airport. Because dependable operation of the bridge's movable span is vital to the region's economy, its recent rehabilitation was crucial in keeping the span running smoothly.

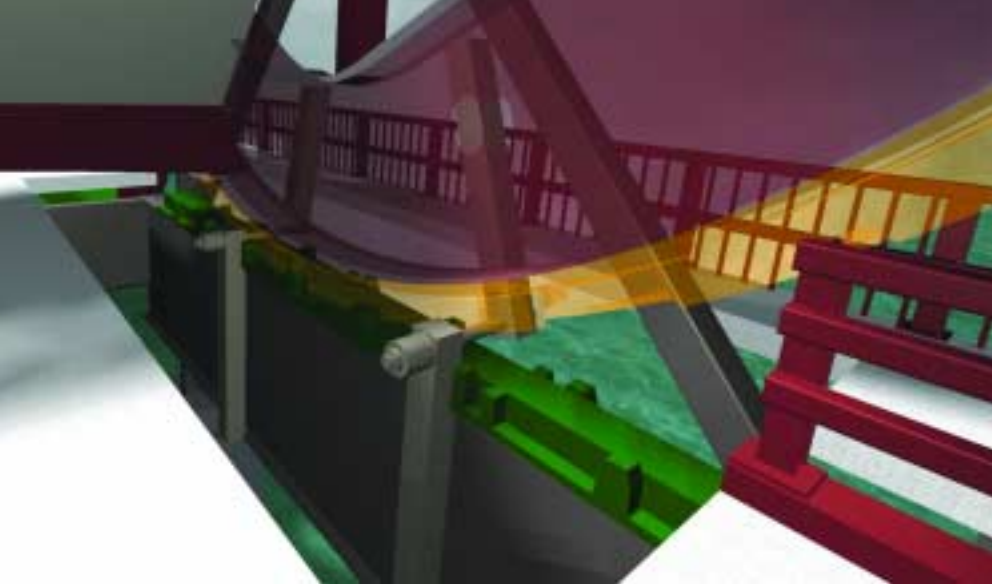
The misalignment—a result of the existing segmental and track assemblies' poor condition—caused poor contact between existing members. Large longitudinal and transverse loads from the movement of this 1,500-ton leaf caused the pintles, which maintain alignment on the track casting, to crack and break-off completely. In addition, the segmental girder angles completely cracked, resulting in poor contact with the segmental castings. The wear on these mating members also caused the span to drop, and as a result, the pinion teeth made contact

The span was realigned using jacks. Temporary supports were installed to allow for jacking against the inboard side of the track casting.

Prior to replacement of the segmental and track castings, the span was realigned using jacks and 2½"-diameter A449 studs. Temporary supports were installed to allow for jacking against the inboard side of the track casting. The contact area between the segmental and track casting was cleaned and greased with an extreme pressure lubricant with graphite additives to allow for sliding and to minimize the high transverse loads the span would experience during the jacking procedure.

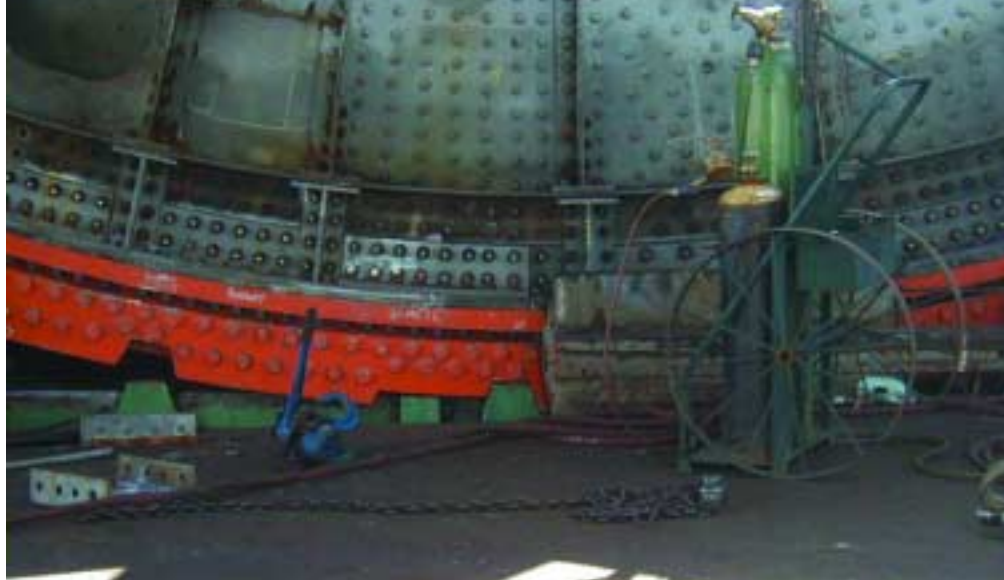
The new gear teeth were fastened independently to the segmental casting by tapping ASTM A449, 1¼" diameter, high strength cap screws into the casting.

Unlike the original design, these gear teeth were fastened independently to the segmental casting by tapping ASTM A449, 1¼"-diameter, high-strength cap screws into the casting. If necessary, future rehabilitation would simply require replacement of the gear teeth rather than the entire segmental casting. Both sets of castings were replaced sequentially, half with the span opened, and half with the span closed. All fixed and movable mating surfaces were machine-finished to 125 micro-inches to assure a smooth riding surface during operation.
