# Inspired Innovation

A job that begins as a routine inspection for façade restoration suddenly turns into a challenging structural replacement project when severe underlying structural failures are found.

**ELEVEN WAVERLY PLACE WAS BUILT IN 1929 AS A 12-STORY HOTEL WITH A BRICK AND TERRA-COTTA FAÇADE.** As with many historic New York buildings, its function has changed over the years, and it now houses commercial space on the first floor and residential apartments above. And also as with many vintage buildings, façade restoration work was inevitable.

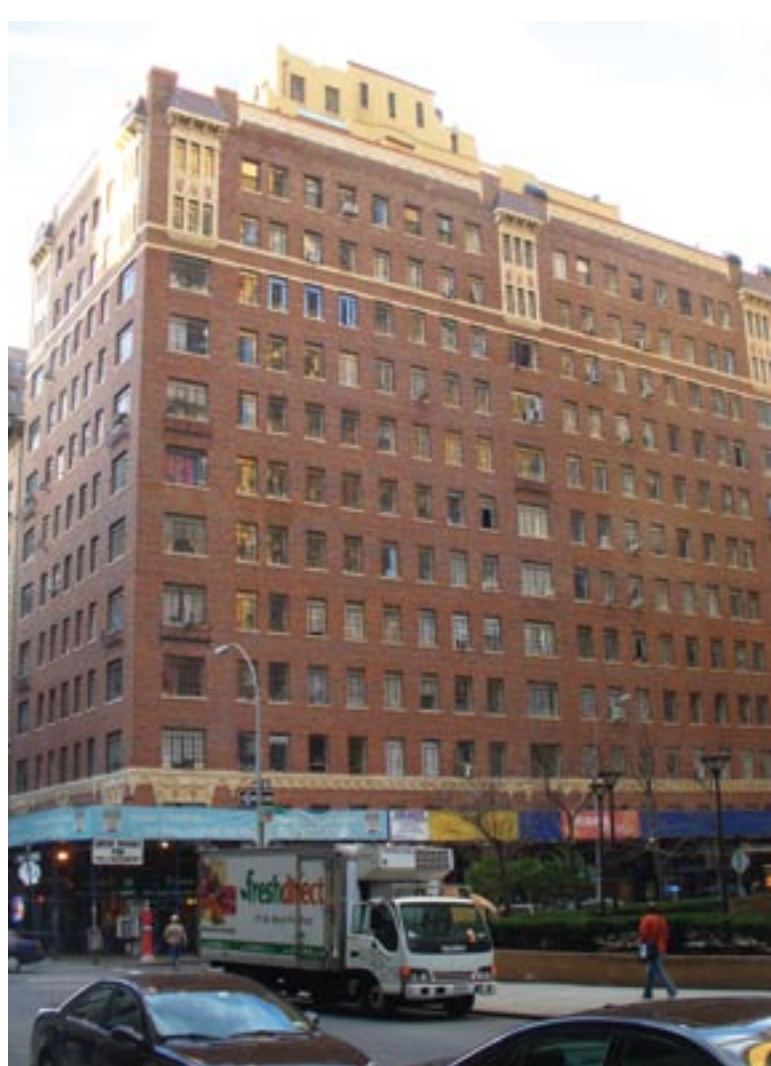
The façade of Eleven Waverly Place wasn't the only thing that needed attending to.

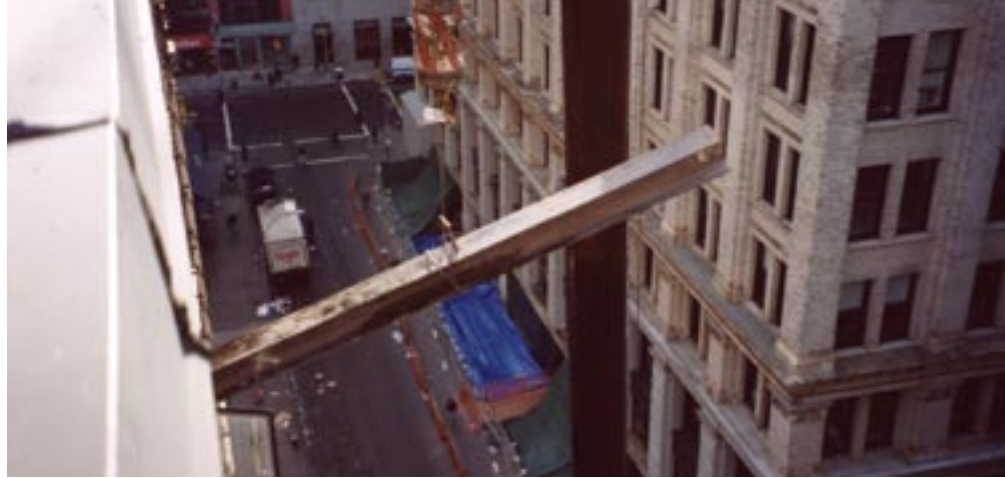
New steel members were lifted by a crane at street level and needled through a 12th-floor window for installation under the main roof.

Rather than placing a crane on the roof and swinging a boom over the building, the structural steel fabricator and erector used a crane at street level to haul all steel members to the 12th floor, delivering them through the windows and rolling them into place. Long steel members were cut into manageable 10-ft to 12-ft segments to be spliced in place during erection.

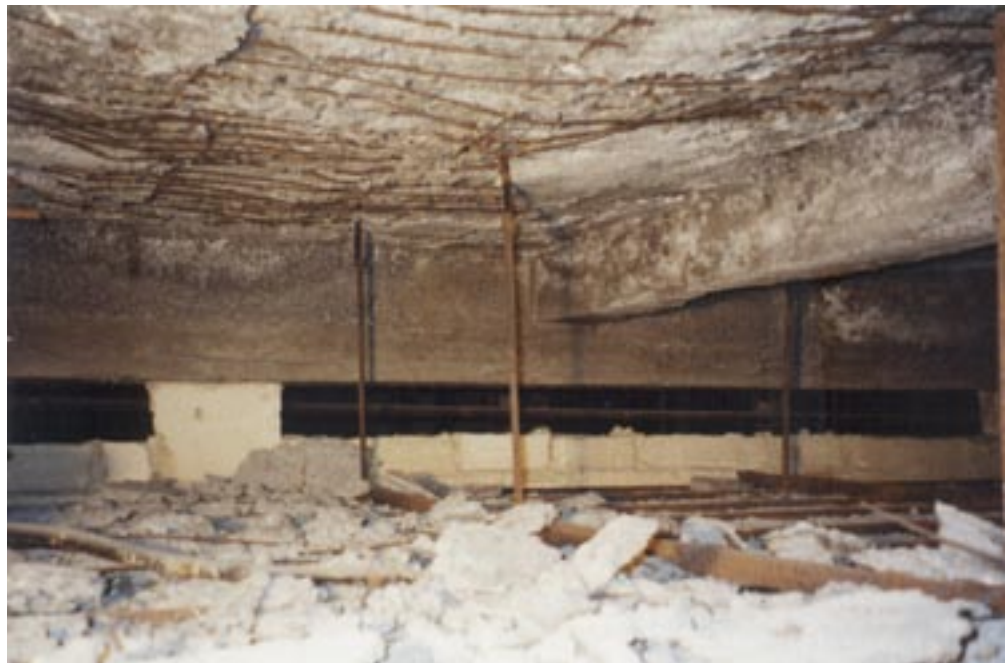
After this further exploration, we ascertained that the problems observed during the façade inspection were indeed widespread. Water leaks over the years had caused severe corrosion of the structural steel and reinforcing rods and non-reversible deterioration of the cinder concrete slab over the entire roof area. When we tried to core the slab, it simply crumbled. The deteriorated slab had little strength, if any, to support itself and the other rooftop loading. The flimsy 1-in. stucco ceiling that was hanging from the

deteriorated roof slab was the only barrier between the falling concrete debris and the occupants of the 12th floor—truly a disaster waiting to happen.

Chunks of the deteriorated cinder concrete roof slab landed on the flimsy stucco ceiling. The ceiling was hung from the same deteriorated roof slab.

Our first response to these discoveries was to address the safety of the building occupants. With the owner's complete cooperation we were able to vacate the entire 12th floor and the penthouse from the potentially dangerous situation. In order to protect the occupants of the 11th floor, the stucco ceiling of the entire 12th floor was completely removed, and all deteriorated roof slab sections were immediately shored as each apartment was vacated.
