Saved from the Wrecking Ball

A deteriorating parking deck in Atlanta gets some positive reinforcement from composite steel deck.

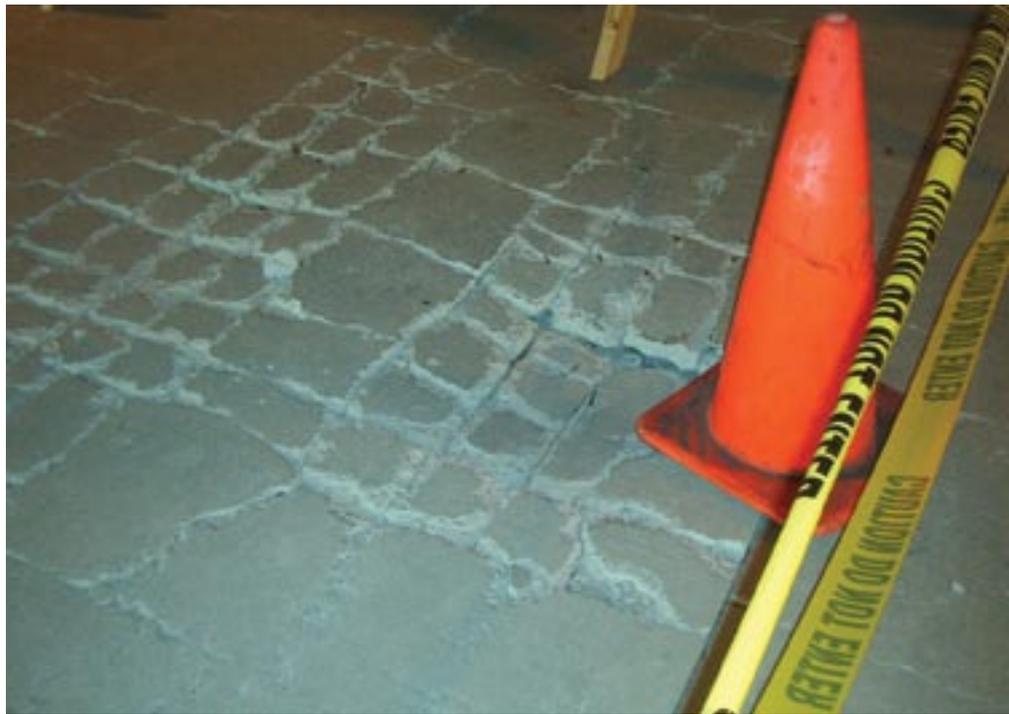
deflection in the deck, began to appear. The cracking got worse with time, and in some locations the slab even punched through the metal deck. Areas where the slab was badly cracked had to be barricaded, and in other locations steel plates and angles were placed under the slab.

The homeowners association hired a testing lab to analyze the situation. The lab's report stated that the design of the concrete slab did not meet load requirements at mid-span between the joists (per the 1994 *Standard Building Code*, the slab must support 50 psf live load or a concentrated load of 2,000 lb acting on an area of 20 sq. in.), and it recommended removing the slab and replacing it with a new, lightweight composite floor slab.

The original concrete slab was so badly cracked that it had punched through the deck in some places. Portions of the slab were barricaded.

The consensus was that the concrete slab was unsalvageable and needed to be replaced. Temporary repairs were made, consisting of inverted 1½-in.-deep 18-gauge type F metal roof deck over the slab, spanning between the joists and in the driving lanes only. Wood planks, 2 × 6, were cut to fit and added to fill in the valleys of the deck. The wood planks and decking were connected to the slab with ½-in.-diameter carriage bolts at close spacings.

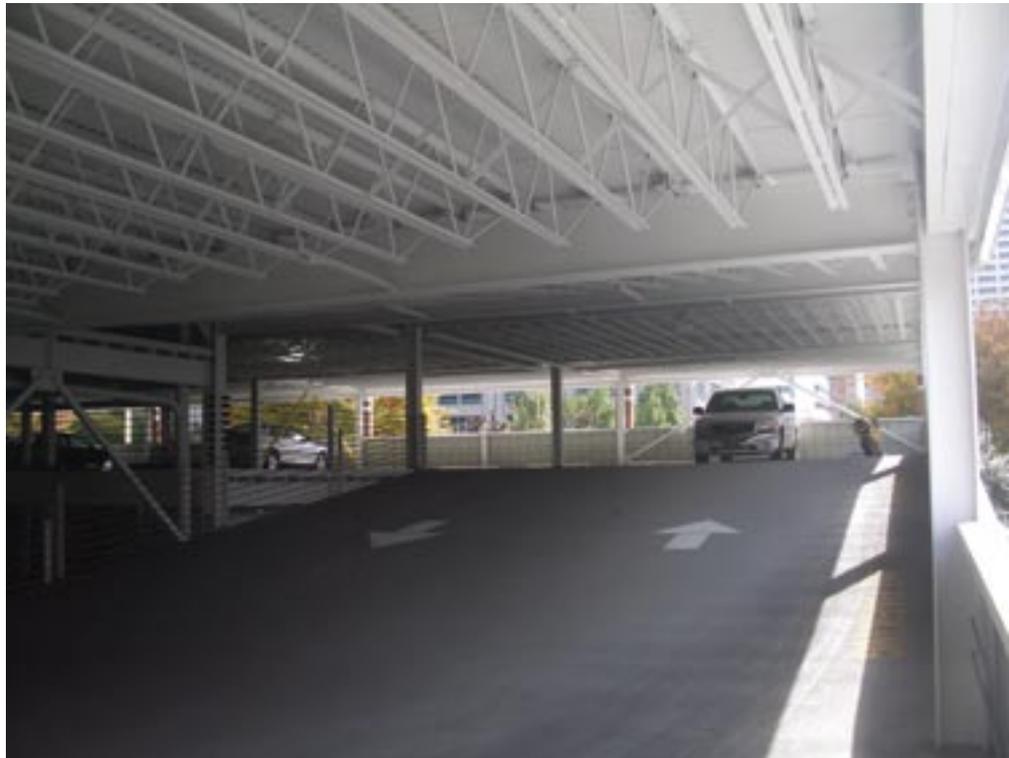
Throughout the garage, new joists were added in between the original joists to decrease the slab's span.

In the parking lanes, additional joists were placed between the existing ones. Since the deck was still in place, the joists were shipped with no camber and without bearing ends. After the new joists were in place, they were jacked up tight under the existing slab, and the bearing ends were placed. To provide lateral bracing to the top chord, ⅜-in.-diameter expansion bolts between the top-chord angles were anchored into the slab above. Three rows of cross bracing and joist bottom chord extensions were added to the bottom flange of the beam.
