On September 13, 2008, winds and debris from Hurricane Ike shredded the 20-year-old fabric roof of the Cynthia Woods Mitchell Pavilion north of Houston. The supporting steel survived intact.

The flexibility of structural steel and tensile fabric combine to allow the rapid replacement and expansion of a landmark amphitheater.

Steeling the Show

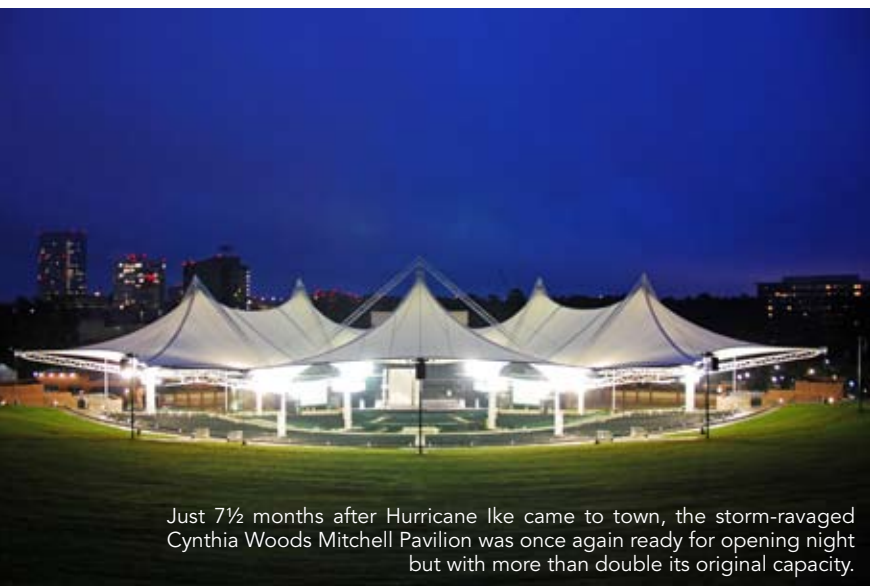
Just 7½ months after Hurricane Ike came to town, the storm-ravaged Cynthia Woods Mitchell Pavilion was once again ready for opening night but with more than double its original capacity.
