A Tampa-area bridge undergoes a rehabilitation involving the replacement of thousands of rivets with high-strength bolts.

# Changing of the Guard

◀ Originally opened in 1927, the Columbus Drive Bridge in Tampa was held together with 30,000 rivets.

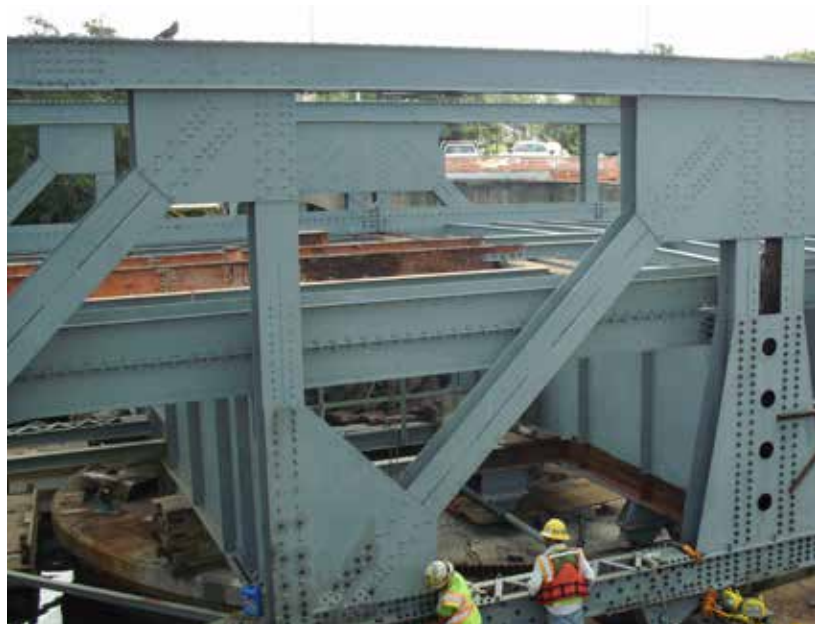
- ▲ The rehabilitated swing span, in place.
- ▼ Rivet replacement taking place on an H-pile shoring platform.

To perform the rivet replacement, the truss was lifted off its center bearing/pivot point and moved to H-pile shoring platforms immediately below the roadway; it was propped up with wood blocks to relieve dead load on the existing fasteners to facilitate the replacement process. Removing the rivets entailed grinding the battered end of the rivets, then applying a chisel to the ground head and striking the chisel with a pneumatic chipping hammer to pop off the head. Once the head was gone, a solid steel bar was matched up with the remaining rivet shank, which was then driven out of the hole by striking the steel rod with a sledge hammer. In all, 14,474 rivets were replaced (about 2,400 more than originally estimated).

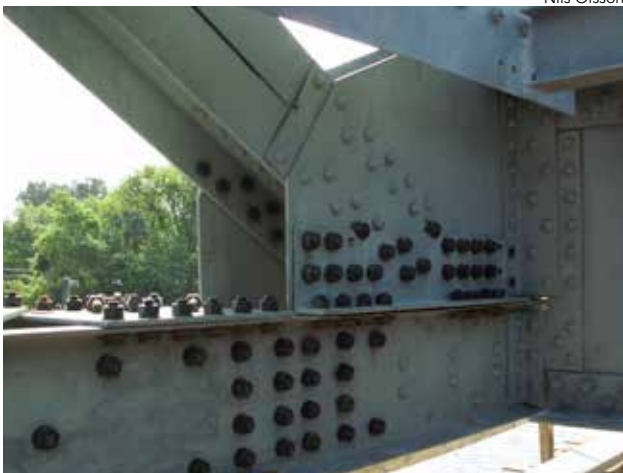
▼ A mixture of rivets and bolts.

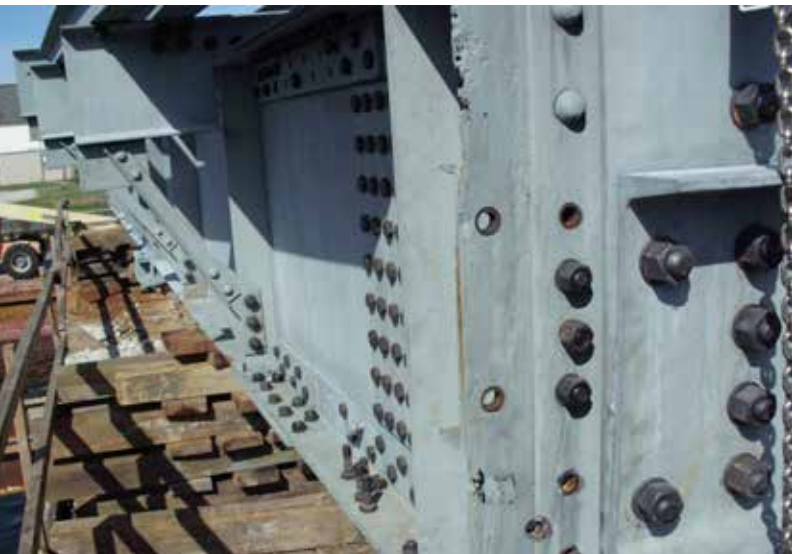
▲ Some of the new A325 high-strength bolts, which replaced a significant portion of the original rivets.

an upgrade; the rehabilitation began last year and concluded early this year. The scope of the project included replacement of 110 tons of corroded structural elements, such as gusset plates for the trusses and angles for the many built-up sections, with 128 tons of new steel. As a consequence, nearly half of the bridge's original rivets would also be replaced with A-325 high-strength bolts.

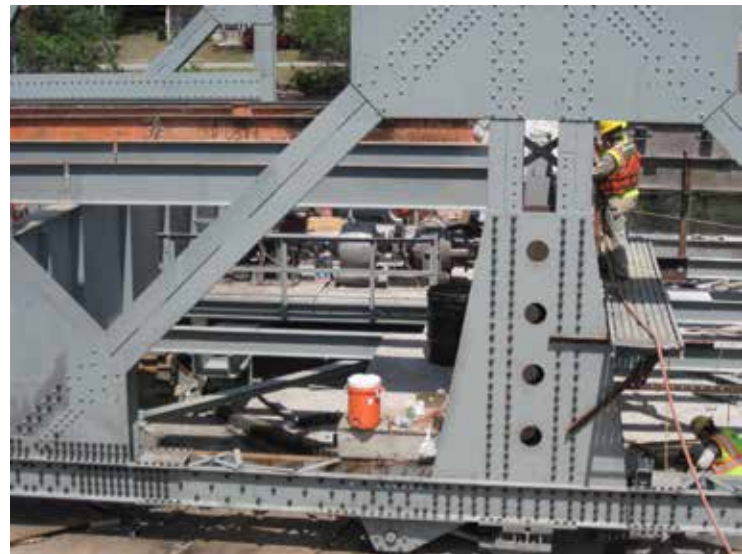
▲ The bridge incorporates 128 tons of new steel.
