Up and Running in No Time

A Tulsa highway bridge sustains major damage after taking a hit from a truck—and is back in business in just two weeks.

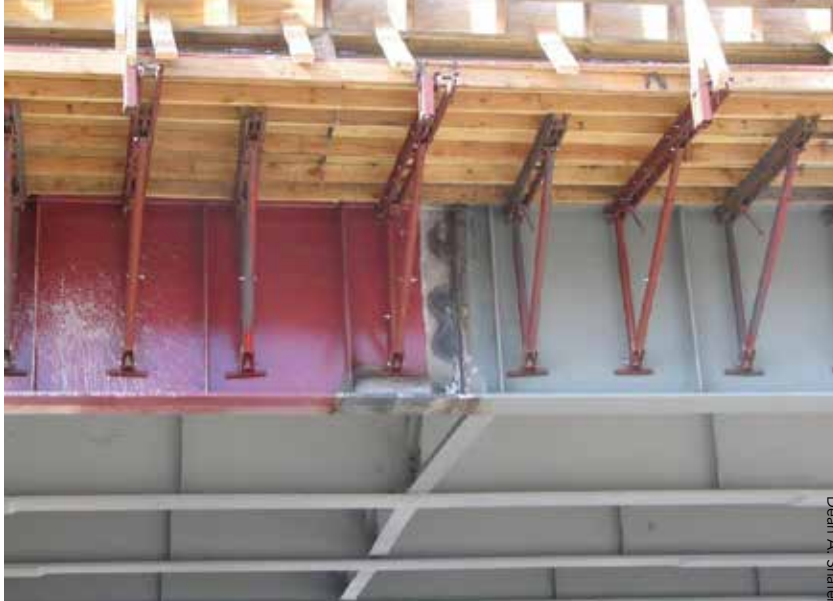
- ◀ The damage to the girder section just after the vehicle hit.
- ▶ The contractor field spliced the replacement girder to the existing girder, which only needed a finish coat to restore the structure to pristine condition.

plate girder rolled up and the web stiffeners crumpled, but the impact also caused the concrete deck to separate from the plate girder by several inches over a length of 80 ft. Their evaluation also involved checking the structural integrity of the bridge to see if it could continue to support itself once the vehicle was removed.

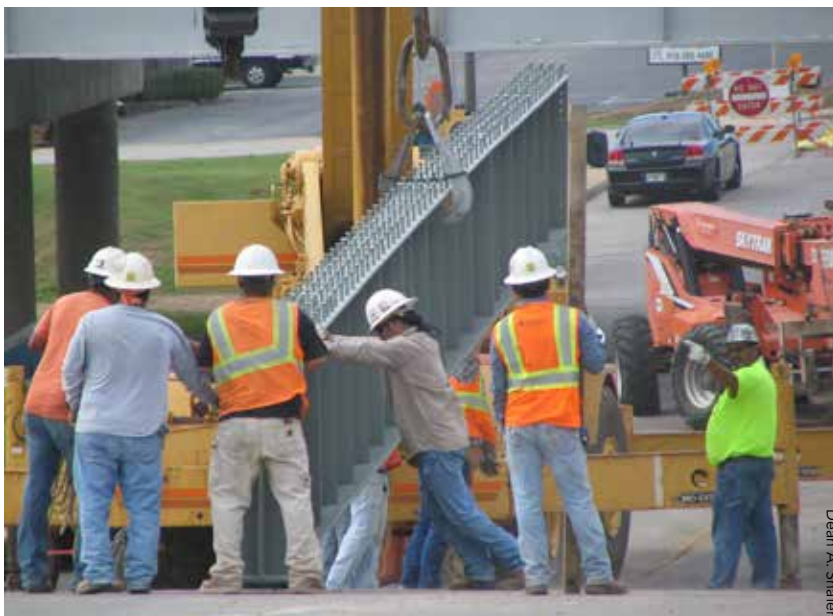
- ▶ Repairs were completed within 15 days of the crash and 20 days ahead of schedule.

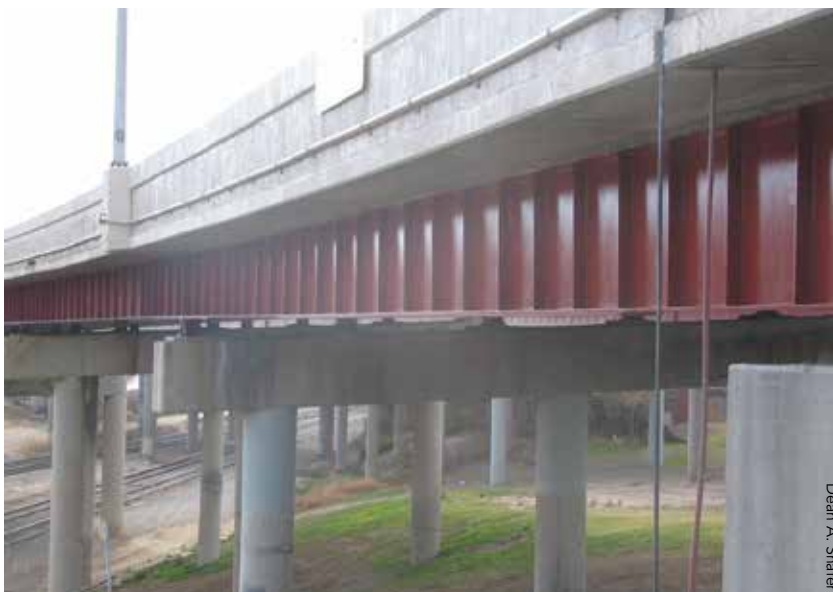
- ▶ W&W/AFCO Steel fabricated, prime painted and delivered a 61-ft replacement girder within 10 days.
