# RESCUE Mission

Carefully restoring  
a historic building  
in the wake of  
a devastating  
earthquake.

▲ The renovated Sherman Building, a piece of national history and a safe haven for veterans, was heavily damaged in a 2011 earthquake.

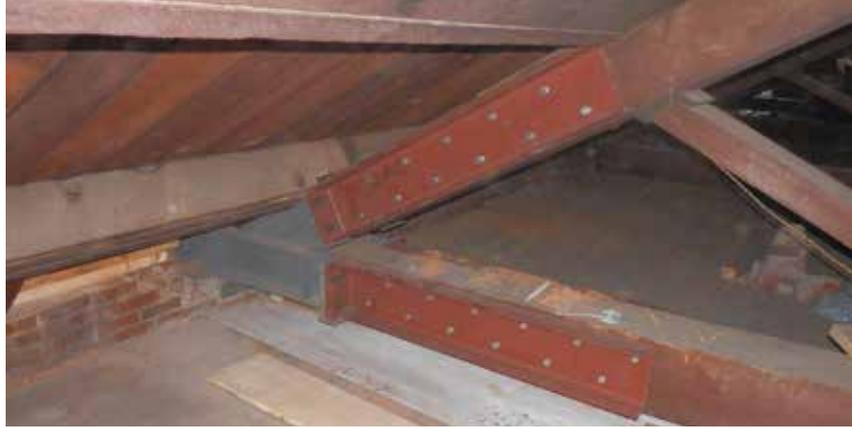
- Steel was used to reinforce damaged heel joints in the attic's timber roof trusses.

Within the attic, existing wooden roof truss distress was visually apparent, with damage related to both the earthquake and years of moisture decay and termite infestation. Heel joints at the exterior walls, already weakened by earlier deterioration, failed during the earthquake and caused wall separation. Structural steel again made a suitable intervention. The existing timber trusses required an in-depth review using non-destructive resistance drill testing. Since no two trusses were exactly alike, structural steel made a suitable intervention.

Taking cues from the firm's past historic intervention approaches, notably Philadelphia's Academy of Music, Keast & Hood engineers designed steel reinforcements that were carefully threaded into the attic to reestablish the truss heel-joint connections with the wooden trusses. The design necessitated a detailed survey by the fabricator and meticulous installation. Carpenters from Oak Grove Restoration Company worked in tandem with fabricator Crystal Steel to install each new piece of steel by hand.

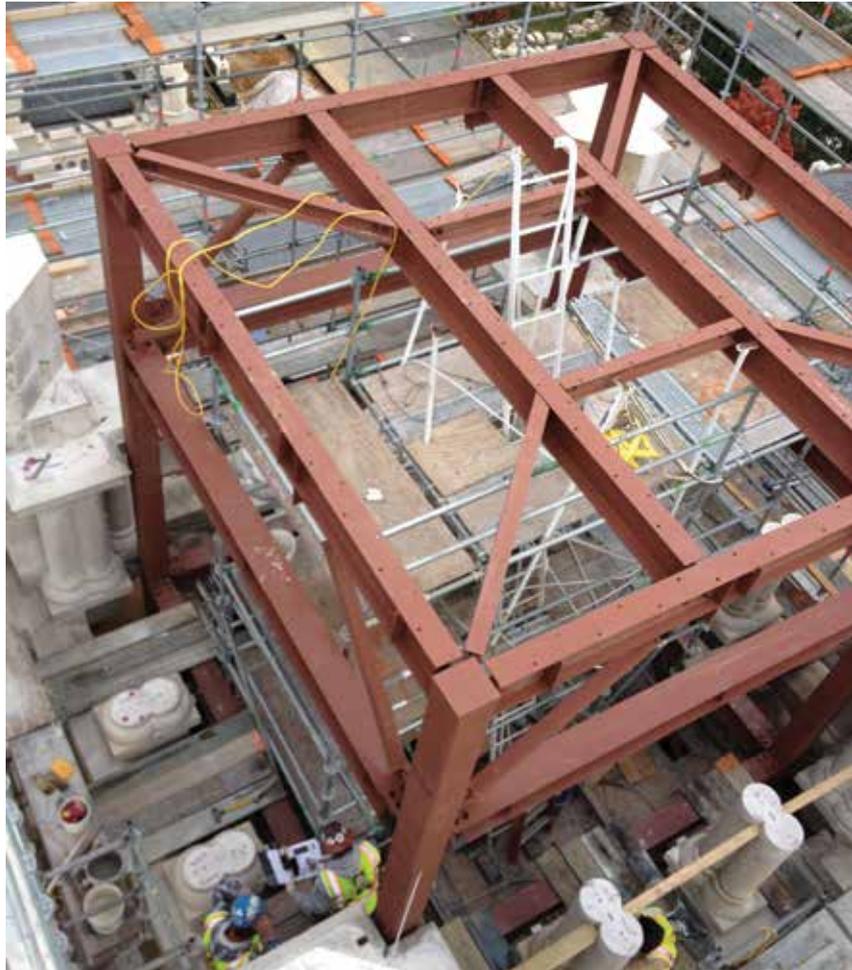
- New internal steel framing in the partially deconstructed tower.

In response to the extent and severity of the observed distresses, partial deconstruction of the tower was required. Over 20 courses (rows of bricks) of the masonry tower were dismantled and rebuilt around a new structural steel eccentric braced frame (EBF) assembly in conjunction with selective internal reinforcements. Existing conditions such

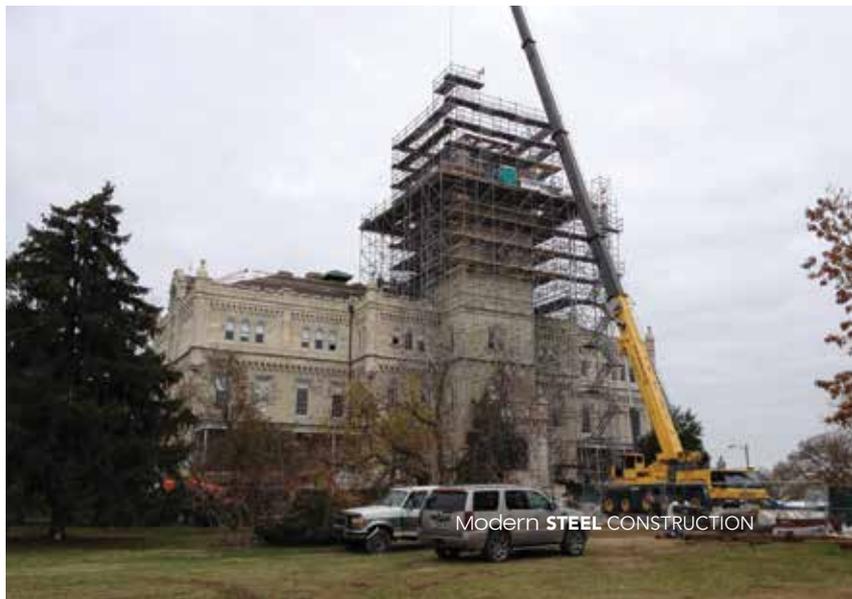
- The partially deconstructed clock tower and the new steel frame.

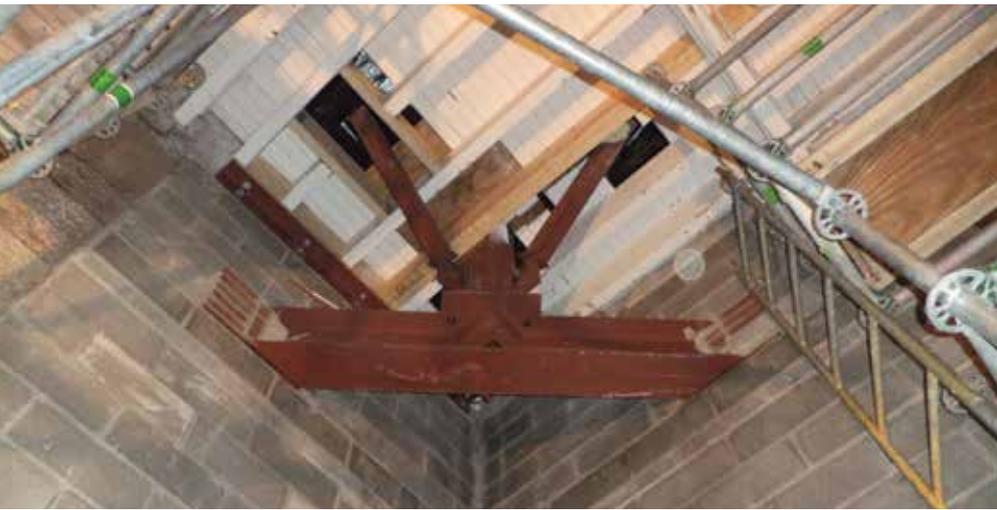
◀ Internal reinforcements within the reconstructed clock tower.
