A steel-framed office building
in Baghdad is successfully rehabilitated after a series of missile strikes.

Nabeel A. Ibraheem
(nabeelaiibraheem@yahoo.com) is a senior structural engineer with Iraq's Ministry of Science and Technology and a current Ph.D. student at the University of Technology in Baghdad.

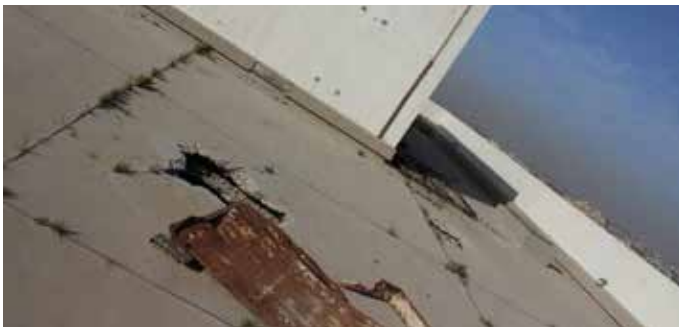
- ▲ The seven-story Almansour governmental office building in Baghdad, before renovation.
- ▼ Holes where missiles pierced the roof.

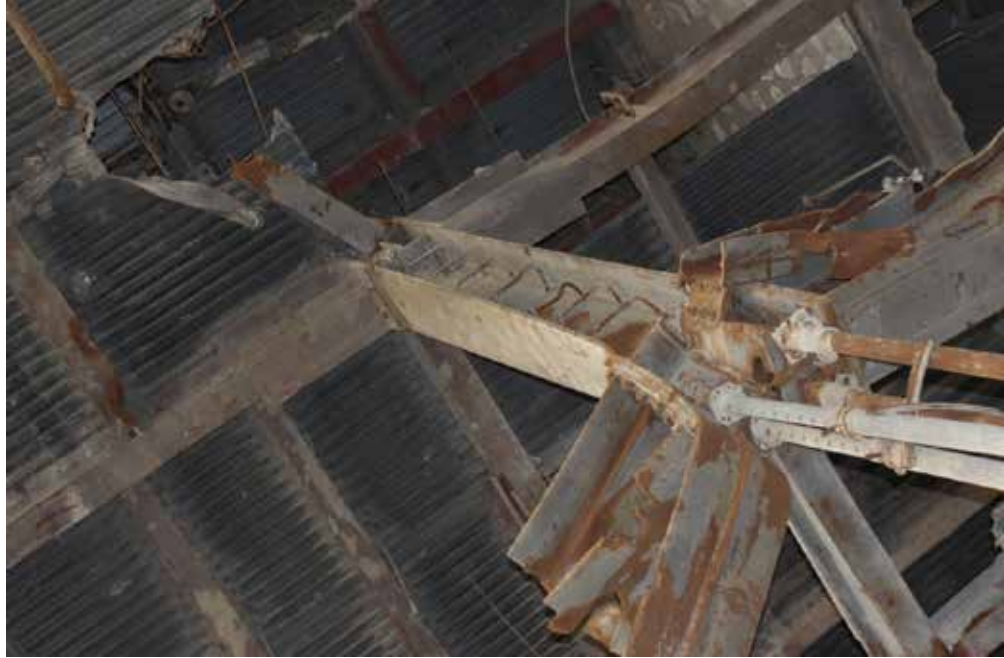
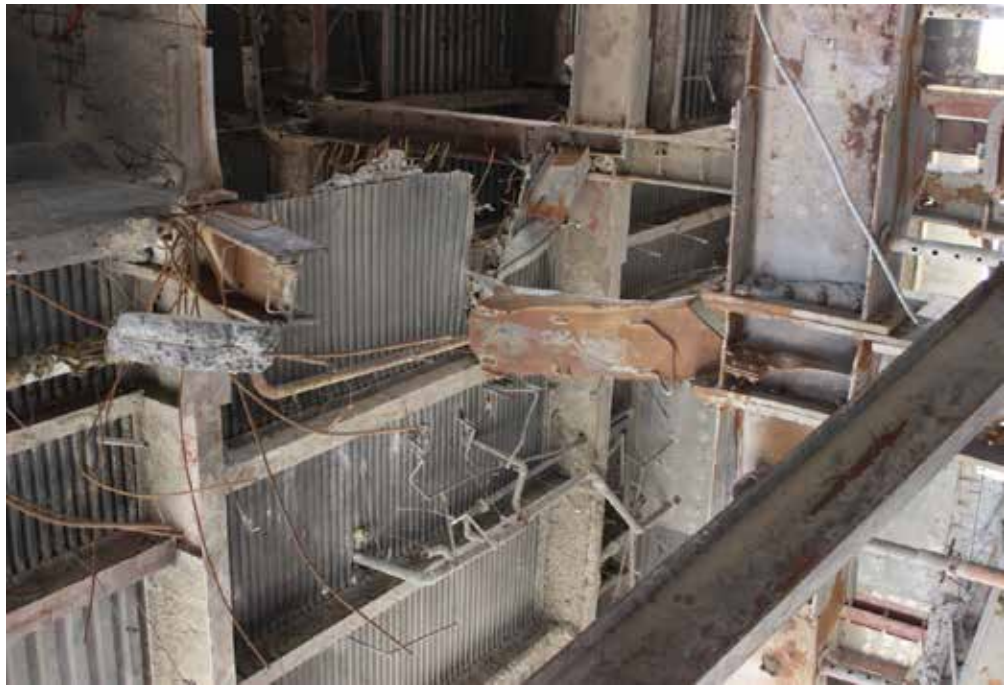
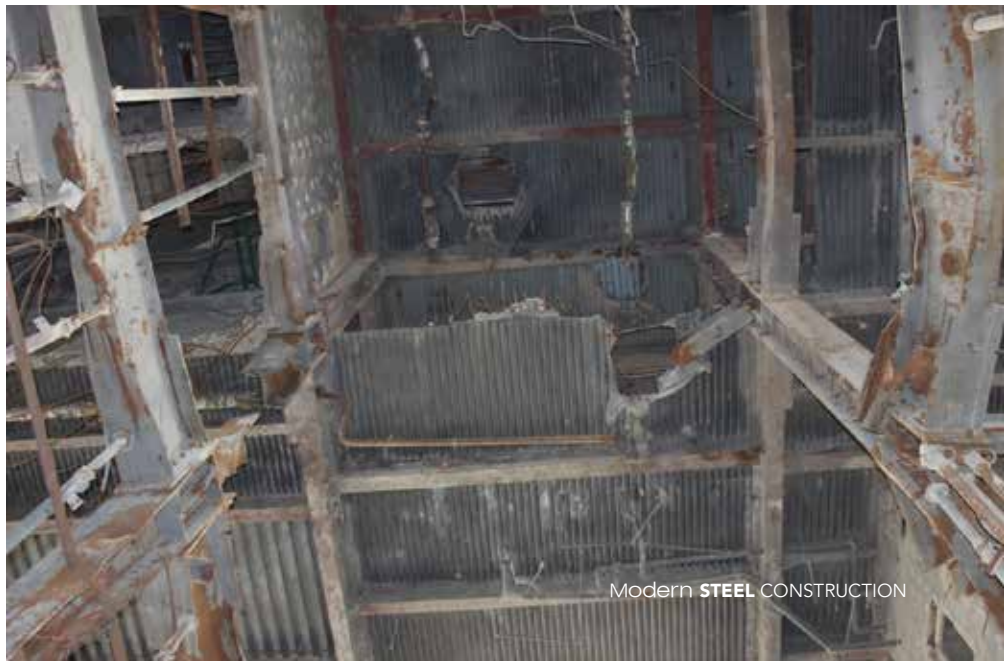
- Various views of the existing condition of the building's interior. Of the five smart missiles that penetrated the roof; two detonated on the second and third floors while the remaining three detonated in the basement.

crete floor panels and steel decks within the affected void from the first to the fourth floor, were damaged to some degree.

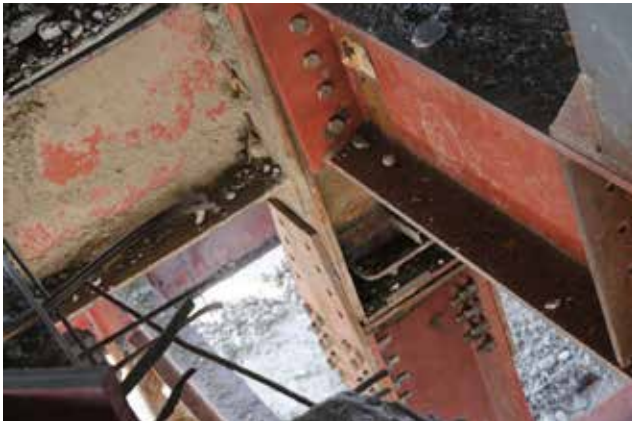
- ▲ The new column system was held together with a predesigned connection using both welding and bolts.
- ▼ A framing plan for the replacement of the two main columns and supporting steel.

force of 247 kips (1,100 kN) at each of the two points, slightly less than predicted by calculations. Following the lift, steel plates were inserted firmly in the two gaps, and a predesigned connection, using both welding and bolts, was used. At the same time, the damaged columns were dismantled and new ones were fabricated and erected in place starting at the bottom. When the new columns reached the remaining portions of the fourth floor columns, the hydraulic jacks were slowly released, transferring the cumulative loads from the upper floors (four through seven) into the new main columns. Afterwards, the remaining damaged steel members were removed and replaced with new members as necessary.

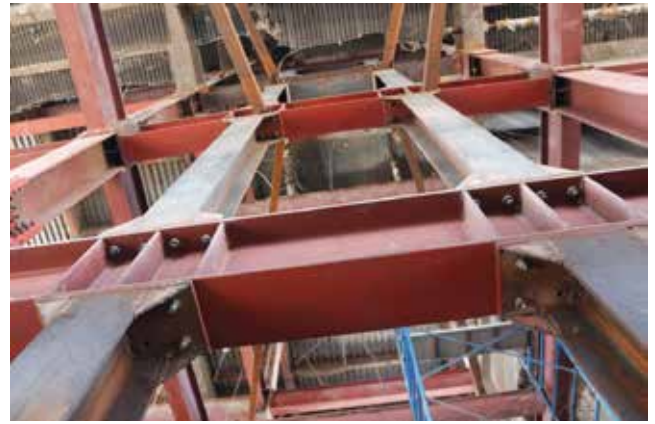
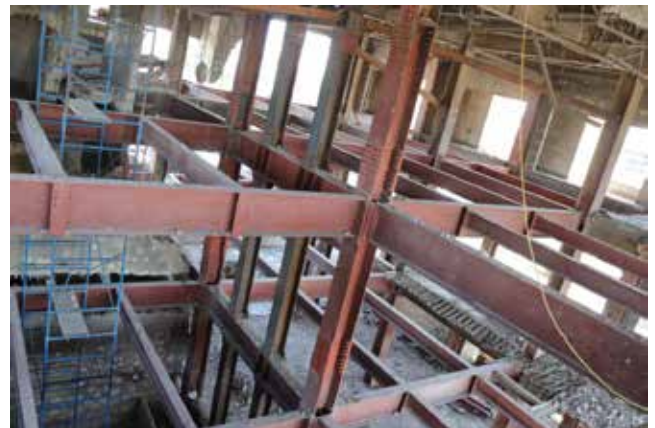
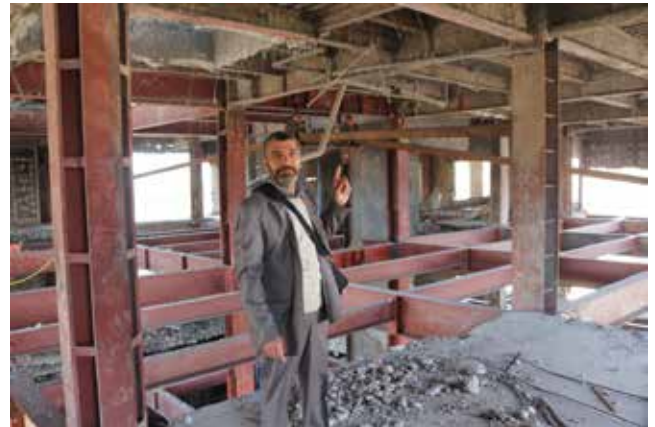
- ▲▼ New structural steel. Framing for the main columns was reinforced with HSS lateral supports at each floor.

supports (approximately HSS5×5×½) at each floor. But space was limited to fit the new main columns in to come in contact with the old ones. The solution was to raise the portion of the building above this main construction area—levels four through seven—in order to introduce enough of a gap to insert new columns to support the structure above. Two 200-ton capacity hydraulic jacks were used to lift these four floors through the supporting frame, leaving a gap between the new replacement column and the existing upper old column portion. The minimum required jacking force to lift the upper part of the building by about ½ in. could be as high as 337 kips (1,500 kN) at each of the two jacking points.
