NEW STEEL, Vintage Feel

New steel supports
an old bridge over a busy transit line
in Philadelphia.

The existing Willow Grove Avenue Bridge over South-eastern Pennsylvania Transportation Authority (SEPTA) tracks was a three-span, simply supported, shallow-depth, steel stringer bridge with asphalt deck. The bridge was rehabilitated in 1962 and incorporated the original stone masonry abutments and wing walls that dated to 1884. Located in the Chestnut Hill neighborhood of northwest Philadelphia, the original iron channel and timber superstructure was built by the Edge Moor Bridge Works for the Pennsylvania Railroad—and designed for a live load of horse and carriage.

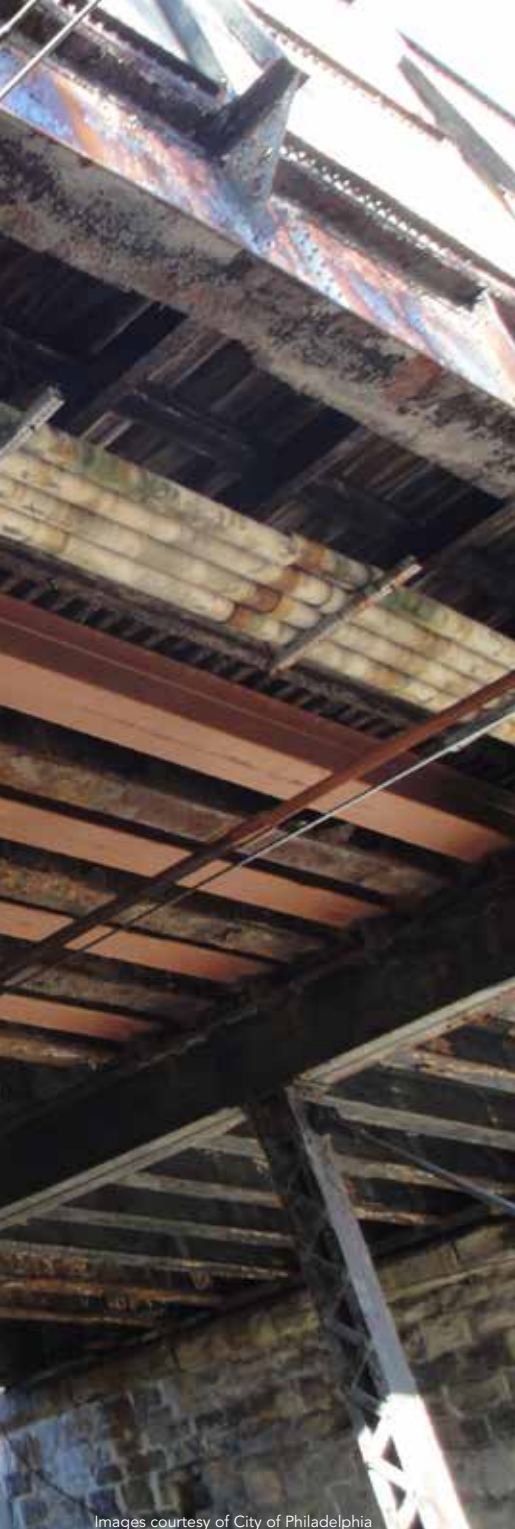
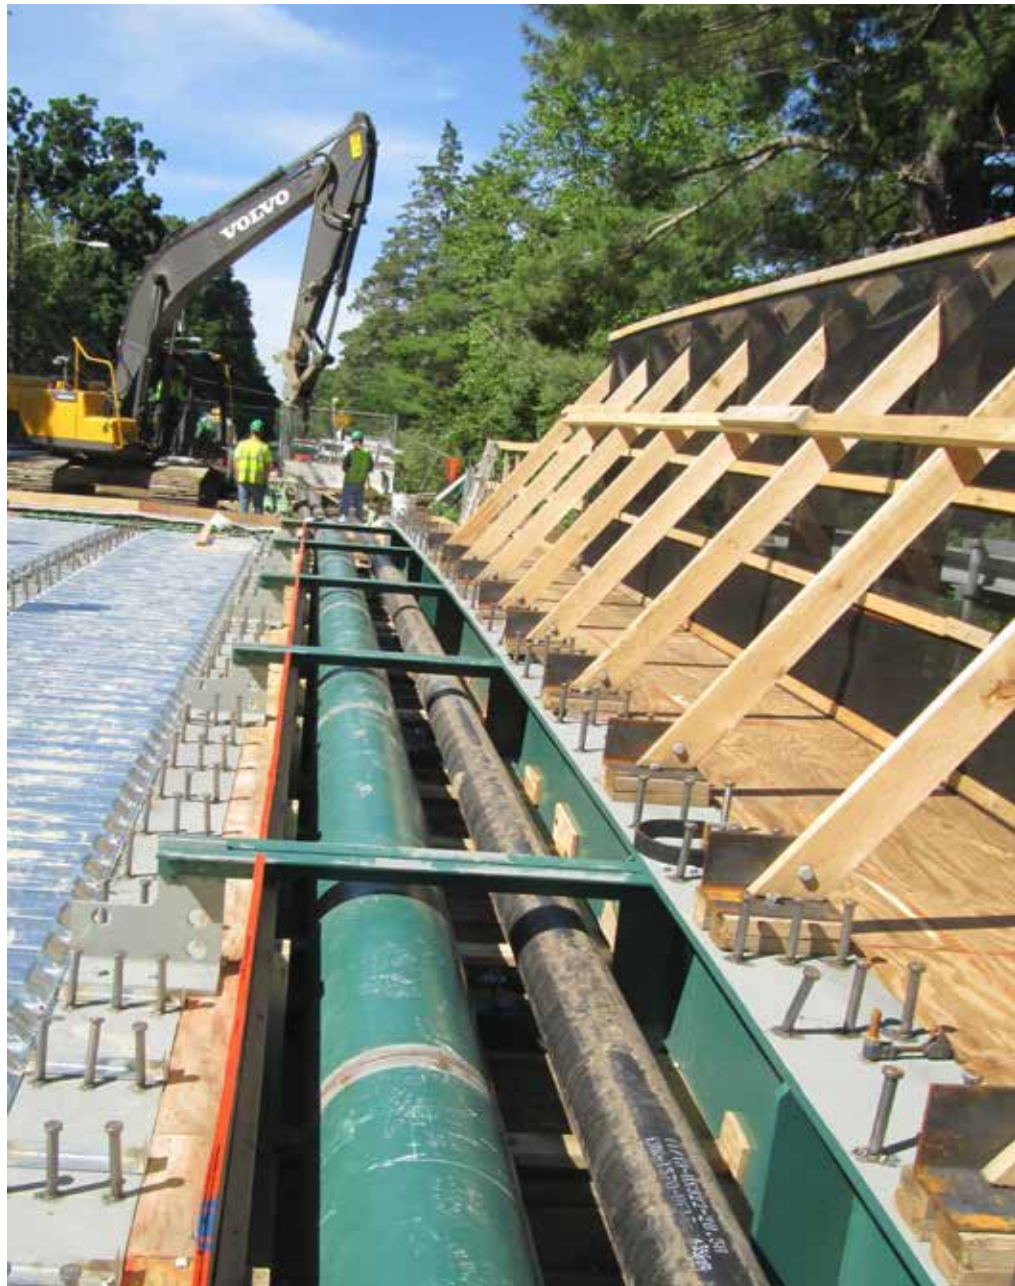
- ◀ “Buddy beams” were installed to strengthen the weakened center-span stringers.
- ▼ Installation of the sidewalk utility bay.

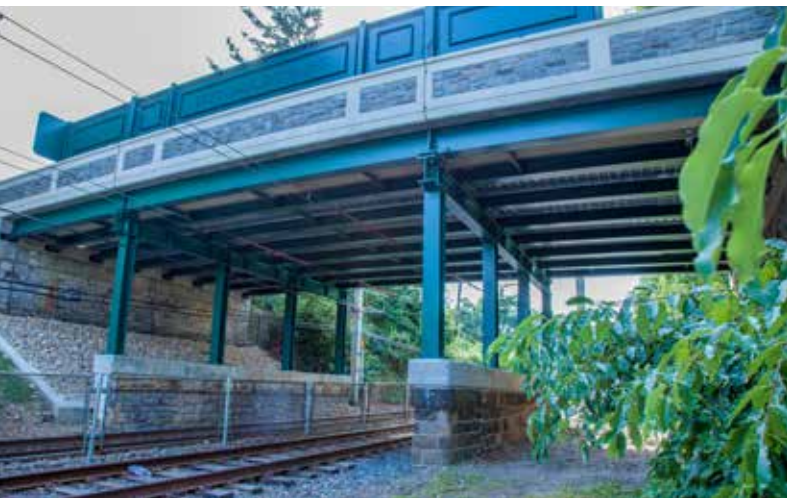
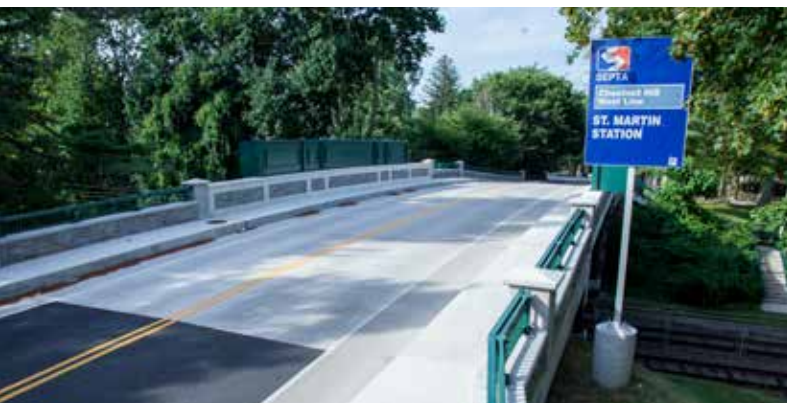
- ▲ The completed bridge, from below.
- ▶ Construction bracing.
- ▼ The completed bridge, at street level.

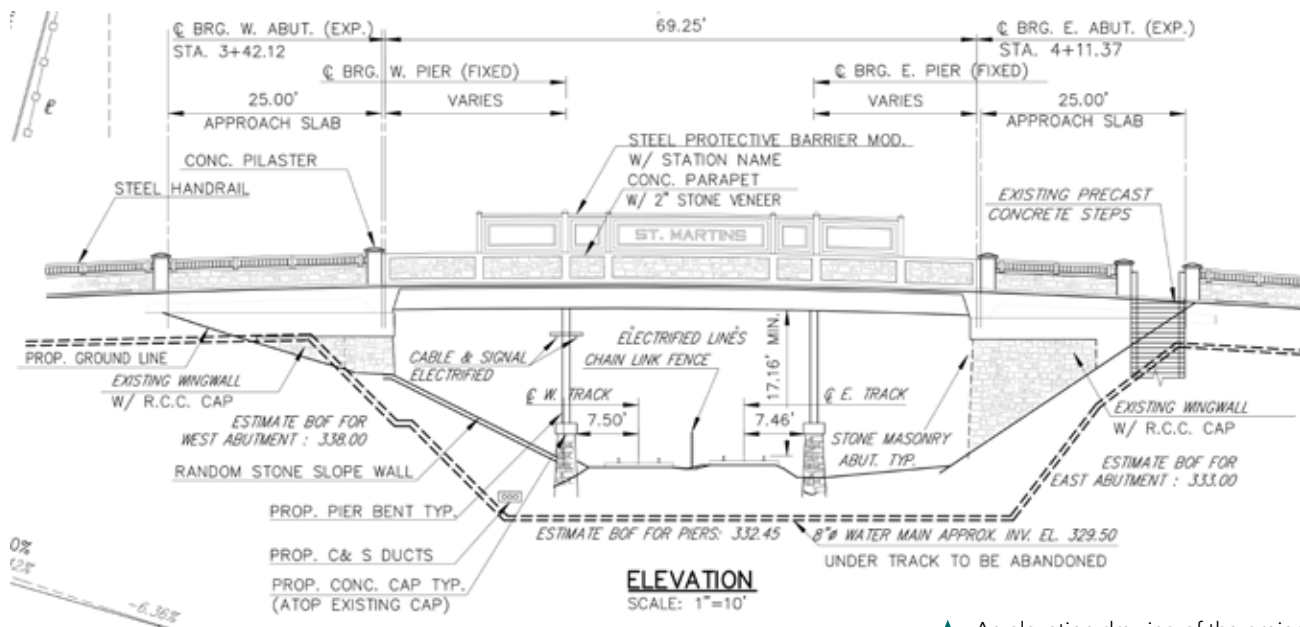
▲ An elevation drawing of the project.

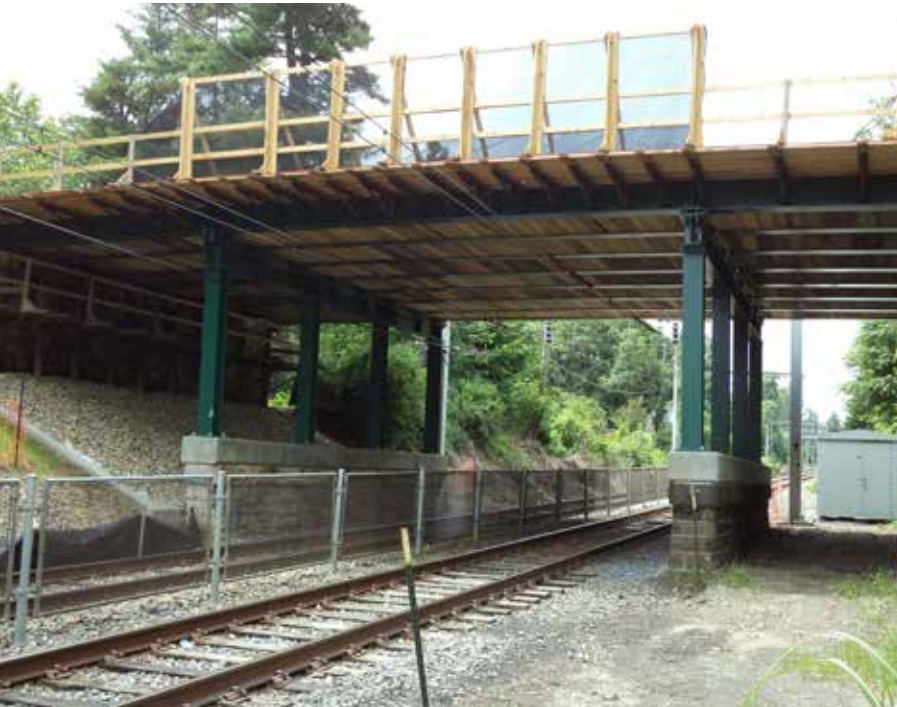
▲ The design scheme mimicked the existing configuration of very shallow, closely spaced stringers.
