IMPACT DAMAGE REPAIRS ON THE JOHNSON RIVER BRIDGE Bridge No. 518

Travis Arndt, P.E.
Alaska Department of Transportation and Public Facilities

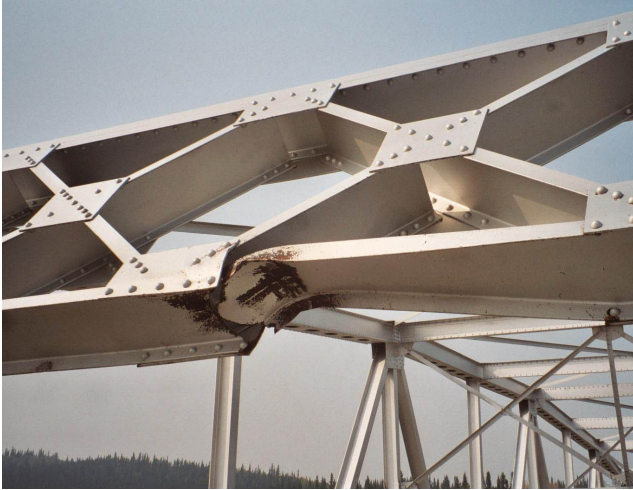
Figure 2: Severed Lower Chord in Span 4 Far End Portal

As the vehicle entered each truss span, the impact severed the lower portal members, see Figures 2 and 3.

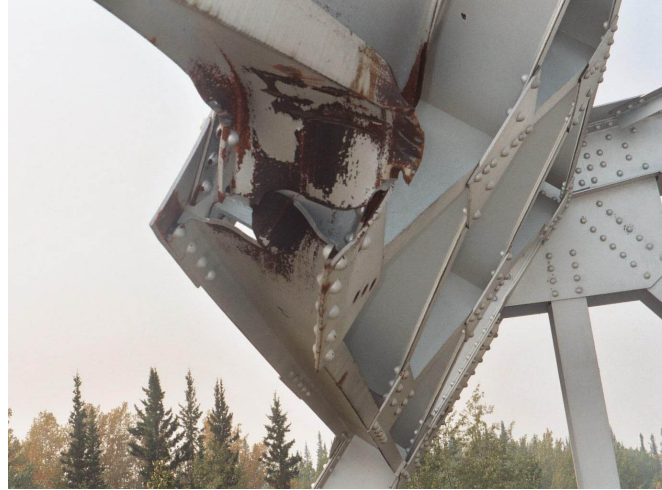
Figure 3: Severed Lower Chord in Span 5 Far End Portal

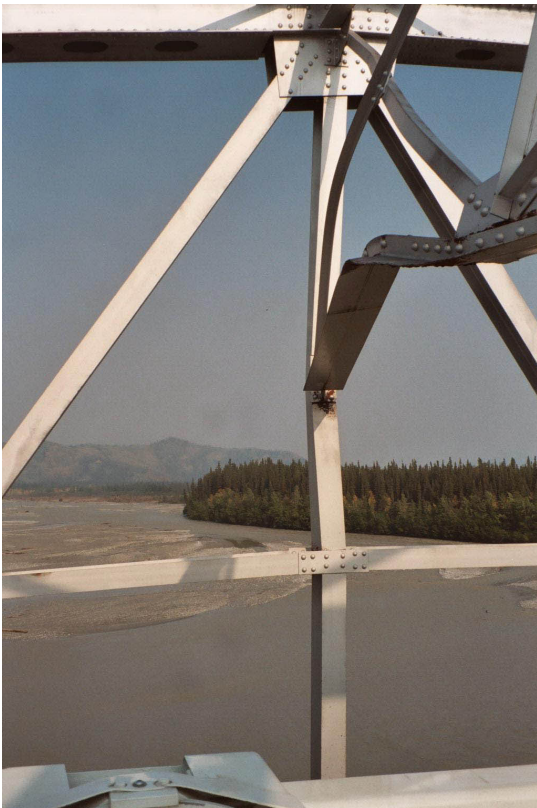
Figure 4: Damaged Sway Bracing

As the vehicle moved through the spans, it impacted the sway bracing between the trusses. This impact bent and twisted the sway bracing, as well as, the truss members to which they were connected. The impact severed a number of connection angles attaching the bracing to the trusses. Large deflections over small distances produced extensive yielding of several truss members. The resulting damage can be seen in Figures 4-8.

Once the truss members have been straightened, the sway bracing members will be removed and replaced in their entirety. The sway bracing members will be galvanized prior to erection to minimize field painting.

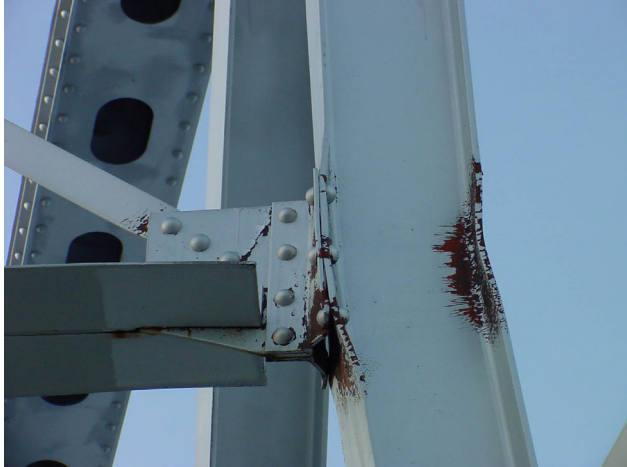
Figure 5: Connection of Sway Bracing to Truss

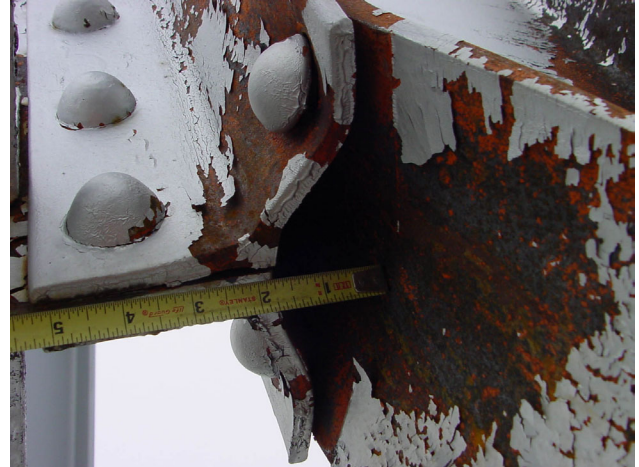
Figure 6: Deformed Connection Angles

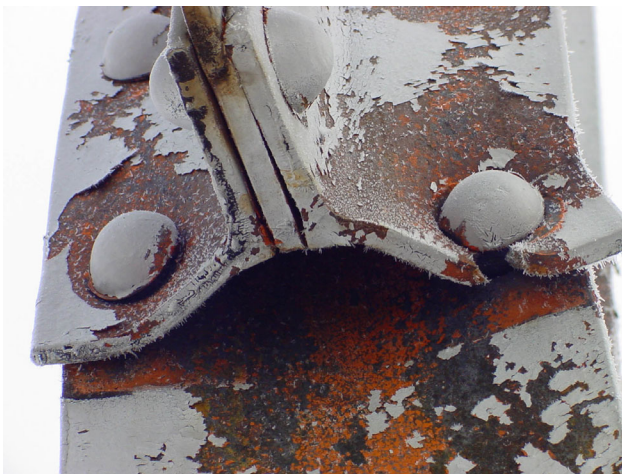
Figure 7: Torn Connection Angle

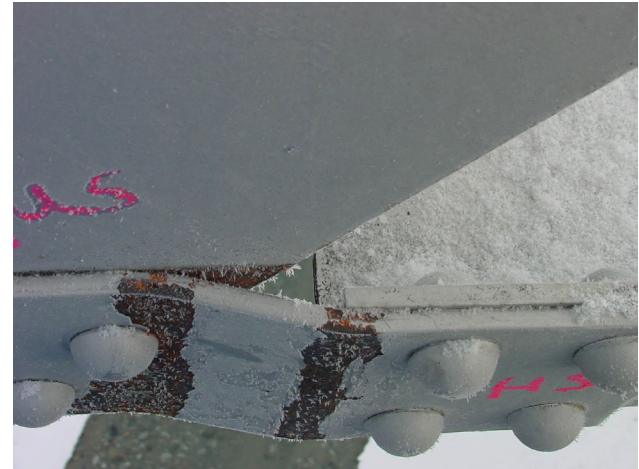
Figure 8: Buckled Connection Plates

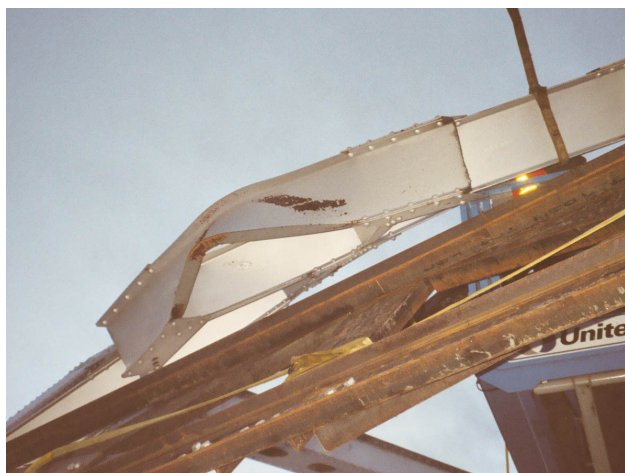
Figure 9: Damaged Span 4 Near End Portal In Place

As the vehicle exited each span, it pushed the portals upward and outward. These portals were plastically deformed approximately 40 inches from their original position. Looking at Figure 9, the top edge of the damaged portal should be aligned with the back edge of the temporary portal. The impact was so severe that many rivets were sheared. Several connections had only one or two out of a dozen rivets still intact.

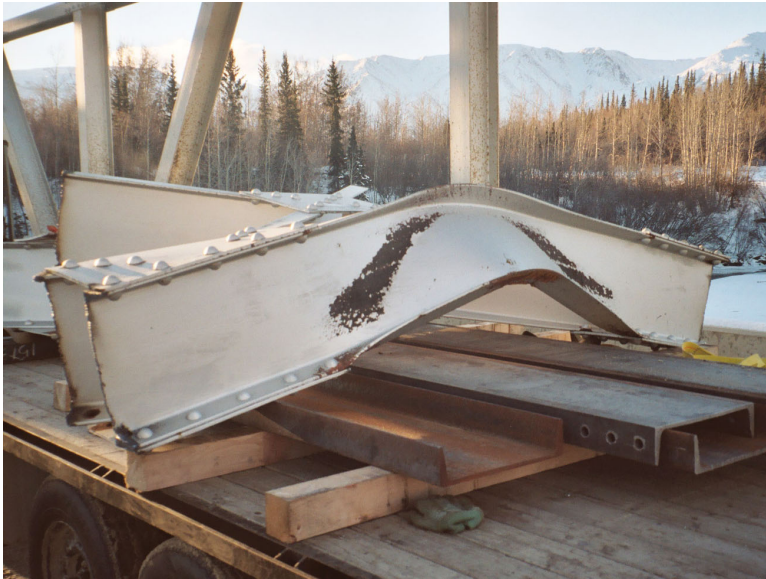
Figure 10: Damaged Span 4 Near End Portal Removed

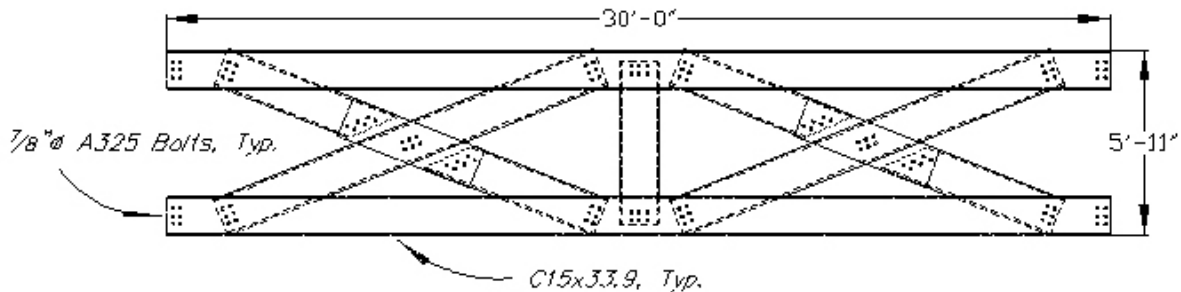
Figure 12: Temporary Portal

In order to speed onsite repairs, maintenance personnel prefabricated the replacement members and temporary portals at the Fairbanks Maintenance Shop. The temporary portals were also completely assembled, such that once trucked onsite, they could be immediately installed as one piece, see Figure 12.

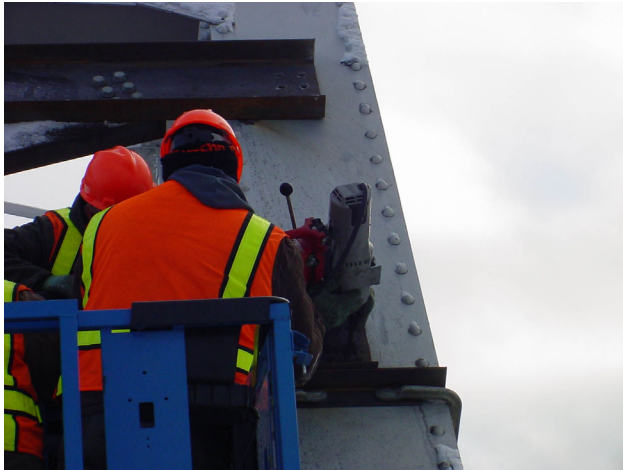
Figure 14: Drilling to Attach Temporary Portal to Truss

With the traffic restricted, the repair process began. The first step was to install the temporary portals. For the temporary portals to lie flat against the trusses, several rivet heads were removed. Small angle sections were C-clamped to the trusses to help align the temporary portals. The temporary portal were lifted and set into place against the angles. Using the holes drilled in the ends of the temporary portals as guides, a magnetic drill was used to drill through the truss members, see Figure 14. A325 bolts were inserted and tensioned to fasten the temporary portals to the trusses.

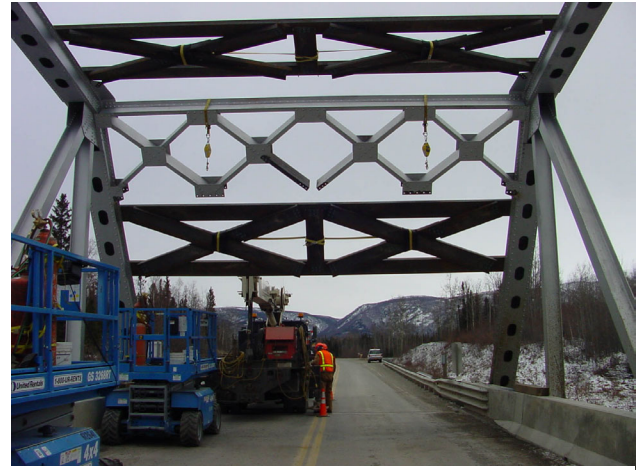
Figure 15: Damaged Section Removed

Removal of the damaged members began once the temporary portals were installed, Figure 15.

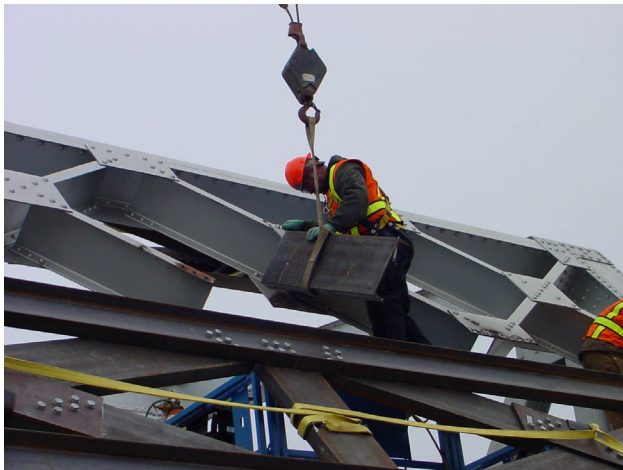
Figure 16: Installing New Member

Rivets were used in the original assembly. In order to salvage as many of the connection plates as possible, the connections themselves were disassembled. The rivets were removed by first cutting off one of the heads and gouging out the rivet body with a torch. The rivets could then be driven out with a hammer and punch. Since care was taken, the connection plates could generally be reused once they were reflattened. With all the damaged members removed, new sections were lifted into place, aligned and bolted, see Figures 16 and 17.

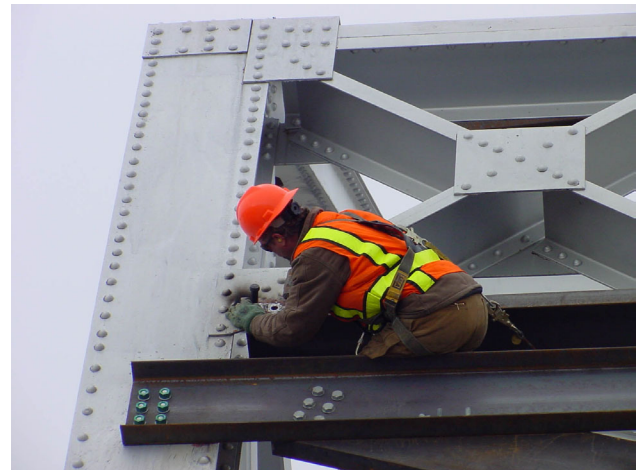
Figure 17: Aligning Bolt Holes

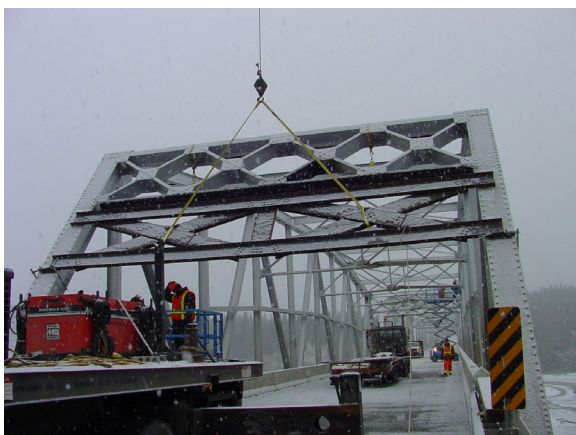
Figure 18: Rigging to Remove a Temporary Portal

Once the new sections were erected and secured, the original transverse load path was reestablished. With the repair of the portal completed, the temporary portals could be removed. They were unbolted, lifted off the trusses and moved to the next portal, see Figures 18-20.

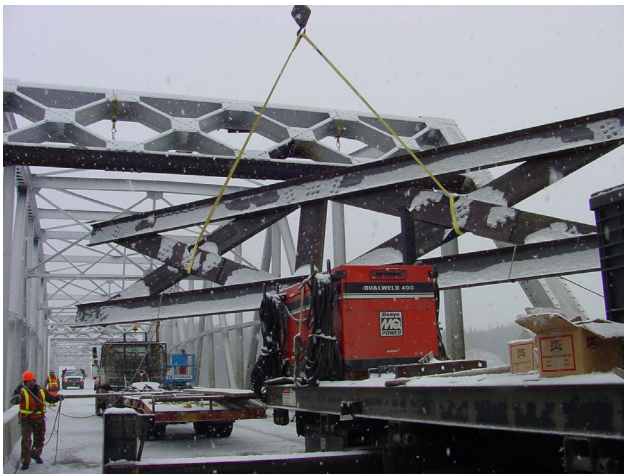
Figure 19: Removing a Temporary Portal

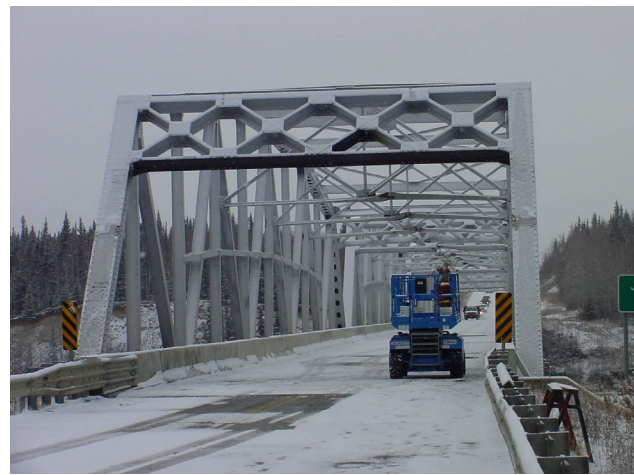
Figure 20: Completed Portal Repair

Bolted cover plates were installed where the temporary portals were attached to the trusses. This leaves the holes in the trusses accessible for future repairs. The temporary portals will be stored nearby as well to more easily allow for future repairs. Finally the portals will be entirely repainted as part of Phase II.

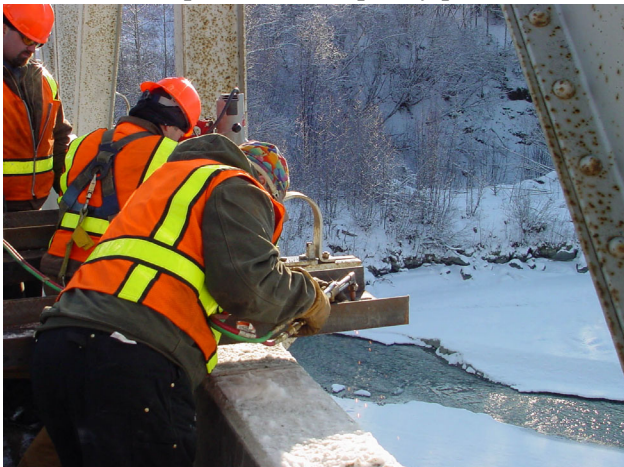
The attachment of the temporary portals went smoothly for the two portals with severed members, but where the portals that were pushed up and outward, the installation ran into problems. The damage was more severe than just deflecting the end portal, as noted by the inspectors. The portals had been pushed to a point where the truss members had deflected and rotated as well. As the vehicle pushed the portal outward, the force pulled the two truss members nearly 2 inches closer together at the top, which also rotated them about their long axis. The resulting rotation caused an inch differential deflection between the outside and inside faces of the members. The hole pattern in the temporary portals was not capable of accommodating such movement. One possible solution was to disassemble the damaged portals without the use of the temporary portals. This solution was discounted due to the known wind conditions and lack of any transverse load path with the end portal completely removed. A second possible solution involved bolting the temporary portals as drilled and trimming the replacement members to fit the new configuration. This solution was discounted due to the change in truss geometry, future implications for vehicle clearance and the unknowns surrounding if the other replacement members could be erected and bolted into this new configuration. A third solution involved slotting the holes in the temporary portals. The end distances and spacing of the holes was reviewed and would allow for slotting. In this case the bolts could not be tightened, however the shear capacity of the bolts would provide adequate resistance. The trusses would be able to move outwards once the damaged sections were removed, but the bolts would bear should significant transverse loads arise. Since the truss members could move outwards, the already fabricated members could be used. This solution was clearly the best option, so work began to modify the temporary portals. The bolt holes in the temporary portals were slotted onsite to accommodate the required movement, see Figures 21-22. With a method to accommodate the needed movement completed, the temporary portals were erected and repairs continued.

Figure 21: Slotting Holes in Temporary Portals

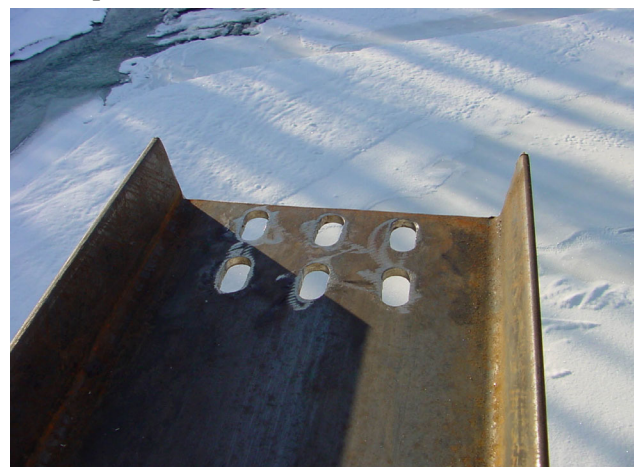
Figure 22: Finished Slots in Temporary Portals

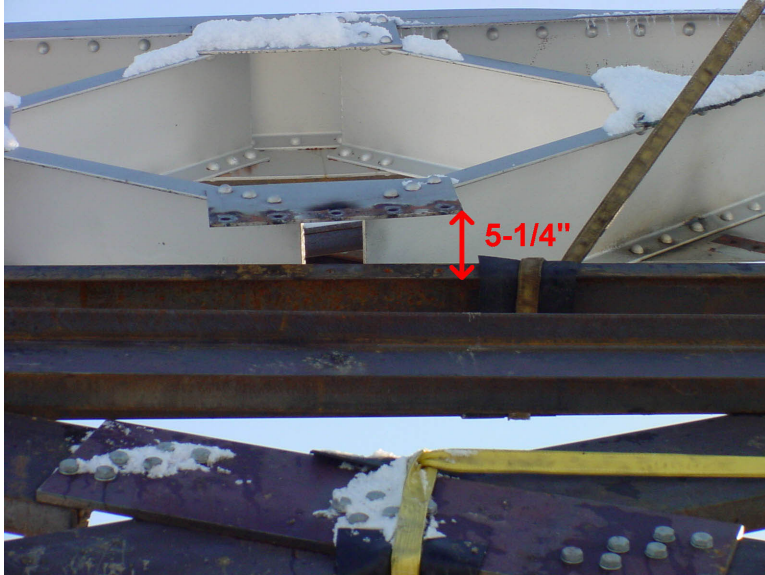
Additional repair work was required with the severely deflected portals. The repair plan assumed that once the damage sections were removed the outward deflection would be minimized as the portals loosened. Unfortunately with the damaged sections removed, the remainder did not relax into its original position. The portal maintained an outward deflection. This deflection can be see in Figure 23, the connection plate should be in contact with the new lower portal member.

Figure 23: Remaining Outward Deflection

Additional damaged members were removed, however the 5-1/4" separation did not close. Multiple thread rods were inserted through the holes in the connection plates and new lower portal member. An attempt to pull the portal into place with the thread rod failed. With the temporary portals in place there was a definite transverse load path established; thus the decision was made to fully disassemble the end portal. Work began carefully disassembling each member and connection plate. Once the portal was completely disassembled, each member and connection plate was checked for straightness, twist, and flatness. The connection plates that connected the portal to the truss were found to have a slight bend. This 3-degree bend was enough to produce the measured offsets. Several

additional members were discarded based on these checks. With the additional disassembly and rejected members, additional channel sections as well as many more nuts, bolts, and washers had to be ordered. Since channel sections were used, tapered or wedge washers were also required. The original tapered washers order was more than the local suppliers had in stock. Now we were in need of the additional tapered washers immediately. The additional tapered washers were shipped airfreight in order to receive them in a timely fashion. Once the new sections arrived, they were fabricated to replace the other damaged sections. With the entire portal removed, the truss members nearly returned to their original positions, however some of the deflection remained. New connection plates were match marked and custom drilled to account for this slight difference. Erection of the portal members progressed smoothly.
