EFFECTS OF INCONSISTENT DETAILING IN HORIZON- TALLY CURVED STEEL I- GIRDER BRIDGES

EFFECTS OF INCONSISTENT DETAILING IN HORIZONTALLY CURVED STEEL I-GIRDER BRIDGES

Brandon W. Chavel and Christopher J. Earls, Ph.D.

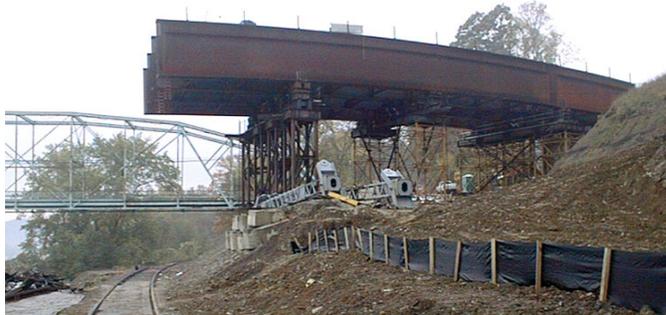
Figure 3. Ford City Veterans Bridge – Completed Steel Erection of Sections 1 and 2

In the field, during erection of this “drop-in” section, some difficulties occurred in placing pins that were part of the field-splices at both end of girder G3-3. Girder misalignments due to unpredicted lateral displacements at the top and bottom of the girder web led to difficulties in closing these field splices. Once girder G2-3 was placed next to G3-3, cross-frame connection

misalignments, measuring approximately 1.5 inch (38mm), were observed. At this point in the construction, significant additional forces had to be applied to the structure in order to solve these girder and cross-frame misalignment problems. These same types of girder and cross-frame misalignment problems occurred when the fascia girders, G1 and G4, of section 3 were placed.

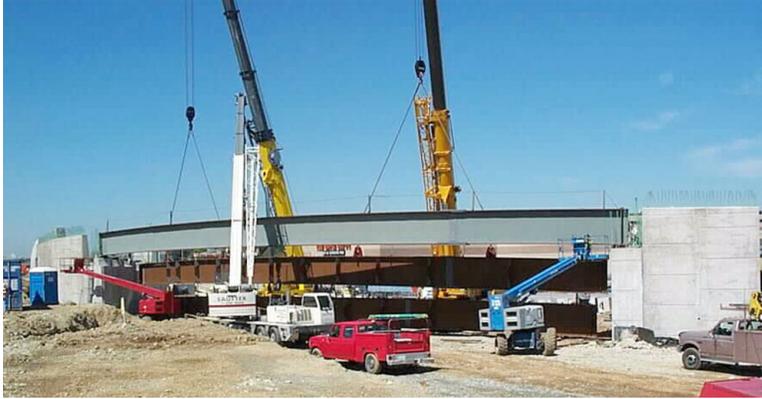
Figure 6. SR 8002 Ramp A-1 - Holding Crane Attached to G1 and Lifting Cranes Erecting G2

The boom truck was then used to erect cross-frames at the abutments and at four intermediate locations. At this time, the intended erection sequence guidelines stated that all of the cranes could be released. However, in the field it was realized that the girders would become unstable if this were attempted. Therefore, the holding crane had to be kept in place; remaining attached to girder G1. In fact, the holding crane was kept in place throughout the erection of the first four girders due to the relative instability in the sub-assembly as construction progressed. This instability in the field

was shown to be consistent with the results from the analytical study of the erection sequence (Chavel and Earls 2004). This result indicates the need for more robust analysis practice when evaluating alternate erection strategies for a given bridge system.

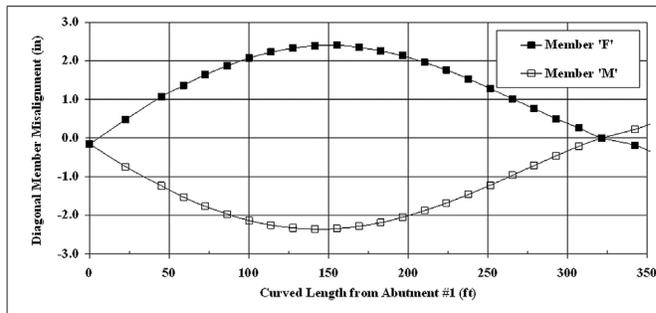
Figure 12. Ford City Veterans Bridge Cross-frame member misalignment for girders detailed per Method #1, and cross-frames detailed per Method #2

The difference in diagonal cross-frame member length resulting from inconsistent detailing varies along the curved length of the bridge, since the girder out-of-plane rotation and vertical deflection vary in a similar fashion. As shown in figure 12, the connection misalignment resulting from inconsistent detailing of the Ford City Veterans Bridge varies along the curved length of the steel superstructure, with the maximum misalignment occurring near the mid-span of the curved section. At the mid-span of the curved section, diagonal member ‘F’ is 2.4in (61mm) too long, and diagonal member ‘M’ is 2.4in (61mm) too short (cross-frame member designation, ‘M’ or ‘F’, is the same for Ford City Veterans Bridge as used in the cross-section of SR 8002 Ramp A-1, as shown in figure 10). The connection misalignment, along the length of the curve, resulting from the inconsistent detailing of S.R. 8002 Ramp A-1 is shown in figure 13. As with the Ford City Veterans Bridge, the maximum misalignment occurs at the mid-span of the horizontal curve, but in this case it is only approximately 0.21in (5.4mm).

As shown in figures 12 and 13, there is a significant difference between the cross-frame misalignments associated with inconsistent detailing of each structure. In the case of the Ford City Veterans Bridge, the girders have a web depth of 14ft (4.275m), and the curved span length is 322ft (98m). Due to the size of the girders and span length, the steel dead load causes significant girder vertical displacement, 12.4in (314mm) at G1; as well as significant differential vertical displacement between girders, 3.5in (90mm) (see figure 12). In regard to SR 8002 Ramp A-1, the girders have a web depth of only 5.67ft (1.7m) and an average span length of 150ft (45.7m), therefore the steel dead load is not very large and hence the vertical displacements due to steel dead load are not very large (see figure 13). Furthermore, the maximum differential vertical deflection between adjacent girders is only 0.4in (10mm).

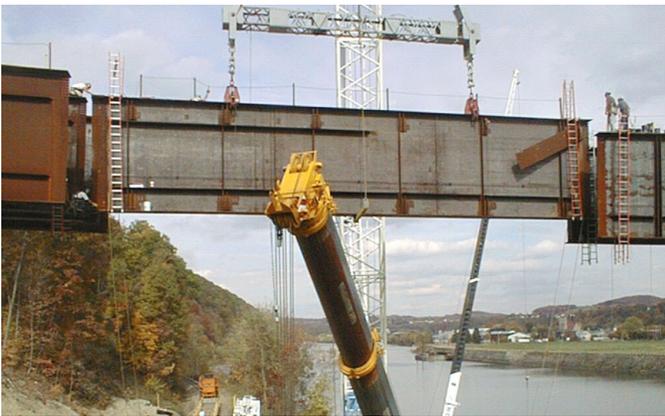
Figure 14. Ford City Veterans Bridge – Erection of Girder G3-3

As discussed previously, in the case of the Ford City Veterans Bridge, an error occurred in the detailing process, and the cross-frames were incorrectly detailed fit girder webs made to be plumb under the application of concrete deck load only (a situation that is impossible to obtain due to the presence of steel dead load). For this detailing case, the diagonal cross-frame member misalignment is +/- 1.25in (32mm) at the mid-span of the curved section, instead of +/- 2.4in (61mm) due to detailing the cross-frames for steel dead load (the condition that would have occurred in the field were it not for the fortuitous mistake mentioned above). Nonetheless, the actual inconsistent detailing in the structure led to significant difficulties during construction where cross-frame misalignments of 1.5in (38mm) were observed in the field, as compared to 1.25in (32mm) misfits predicted via the finite element model.

In addition to the cross-frame connection fit-up problems, misalignments developed at the girder field-splice locations due to unanticipated lateral and torsional displacements resulting from the inconsistent detailing. Unanticipated lateral displacements effected the completion of field-splice #2 of the Ford City Veterans Bridge, with the erection of girder G3 section 3 (G3-3), which was a drop-in section between previously erected girders in section 2 and 4. Figure 14 shows the erection of girder G3-3, with field-splice #2 on the left side of the photo. Based on field observations, the completion of this field-splice was complicated due to unanticipated lateral displacements at the end of previously erected girder G3 section 2 (G3-2, refer to figure 2). Similar complications with the field-splices also developed during the erection of girder G2 section 3 (G2-3). The analytical investigation of the erection sequence, using a *consistently detailed* finite element model, showed that there should have been no significant displacements at the end of girder G3-2 at field-splice #2 (3). Therefore, the field-splice connection misalignments observed in the field can be directly attributed to the inconsistent detailing that occurred in the Ford City Veterans Bridge.

Very large additional external forces had to be applied to the superstructure components in order to bring the cross-frames and girders into alignment. Forces were applied with the available cranes and jacking devices at the construction site. One 200 ton capacity crane, equipped with a 200ft boom and 88kip counterweight, and three 4-wheel-type cranes were available at the job site. However, a significant amount of additional construction time was required to bring the components of the curved section into alignment. For example, according to field records, field-splice #2 for girder G2 was not fully completed until six days after girder section G2-3 was erected. Since very large external forces were applied to the girders and cross-frames to affect fit-up, stresses were induced in the structure that could not have been accounted for by the bridge designer.

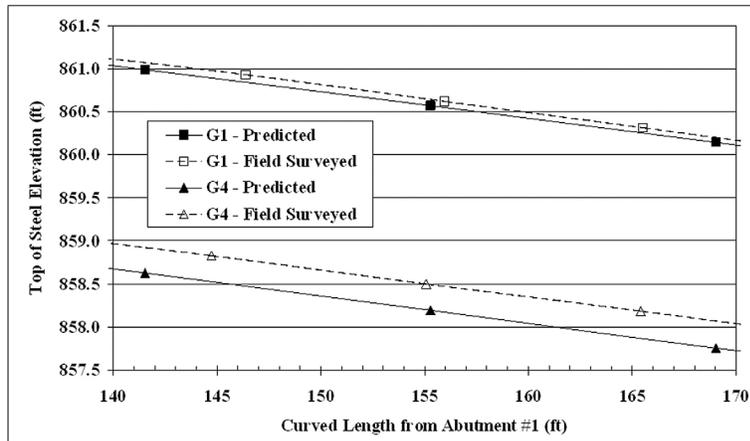
Figure 15. Field-Surveyed and Predicted Steel Elevations Near Span 1 Mid-span Prior to Deck Placement

Additionally, it was observed in the field that the top flanges of the girders in the curved section were not at the predicted top of steel elevations, as shown in the bridge design drawings, upon completion of the steel erection. Near the mid-span of the curved section (curved length from abutment #1 is approximately 157ft (48m)), the field surveyed elevation is approximately 4in (100mm) higher than the predicted elevation using the finite element model, as shown in Figure 15 (the analytical results closely match the elevations called out in the design drawings). This discrepancy in top of steel elevations had to be made up by reducing the haunches at particular locations along the girders so as to achieve the required top-of-deck elevations called out in the contract documents. Consuming haunch depth to make deck elevations is obviously not a desirable outcome since haunch depths are counted on to ensure proper clearances for under deck systems passing

between the steel superstructure and the pier caps. In addition, proper haunch depths are needed for desired functionality of pot bearings within the bridge system.
