US 84 MISSISSIPPI RIVER BRIDGE – TRUSS PIN AND LINK REPLACEMENT

SUMMARY

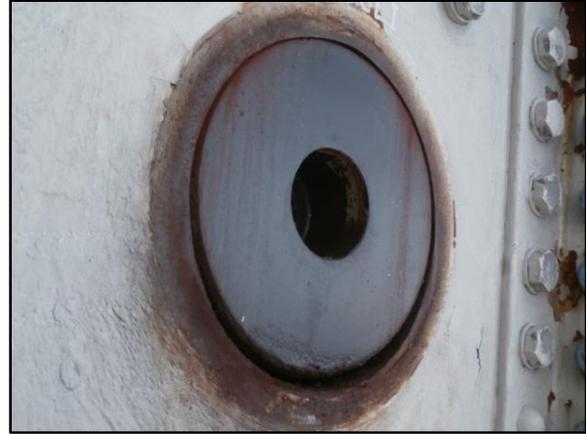
Figure 5 – U29 Lower Pin Downstream Truss Inside Face

In 1995, MDOT observed the tie rod that holds and restrains the pin from lateral movement was fractured and cover plates missing on the lower pin at U29 downstream truss. The weld that prevents the lower pin from rotating about the gusset was broken and the pin had rotated 2¾" from its installed position. The lower pin was also flush with the inside face exterior gusset on one side and extended 1" on the outside face exterior gusset (Figure 5 & 6).

MDOT contracted with HNTB which advised the outside ½" gusset supported the hanger and if the pin continued to move past the outside gusset, there would be an adverse effect to the factor of safety for the bridge, potentially resulting in closure of the bridge.

In 1996, MDOT awarded a contract to temporarily remove the load off the pin and link via temporary restraints and push the lower pin back into place. Beneath one lane of traffic, HNTB proposed a vertical jacking assembly that would bypass the load on the link and pins via 4 post-tensioning bars (Figure 7).

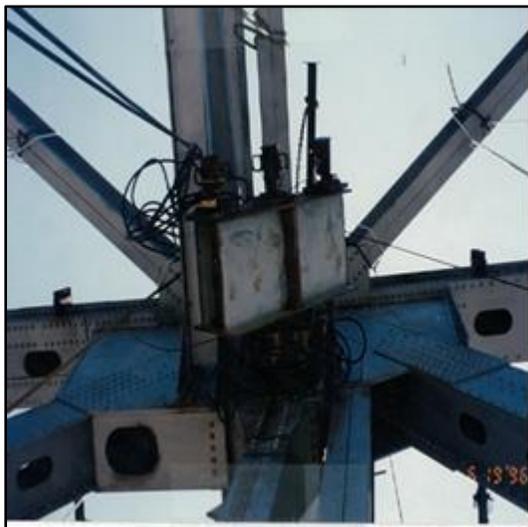
Figure 8 – Horizontal Jacks

Prior to installing the vertical jacking assembly, the contractor attempted to reset the pin without removing the vertical load. The first attempt the contractor applied 675 kips of horizontal load in which his post-tensioning system failed resulting in post-tensioning bars passing traffic and into the river. The second attempt (Figure 8) the contractor redesigned the horizontal jacks and increased the horizontal load to 884 kips. The third attempt the contractor redesigned the horizontal jacks and increased the load to 1,325 kips, at which point no movement in the lower pin was recorded.

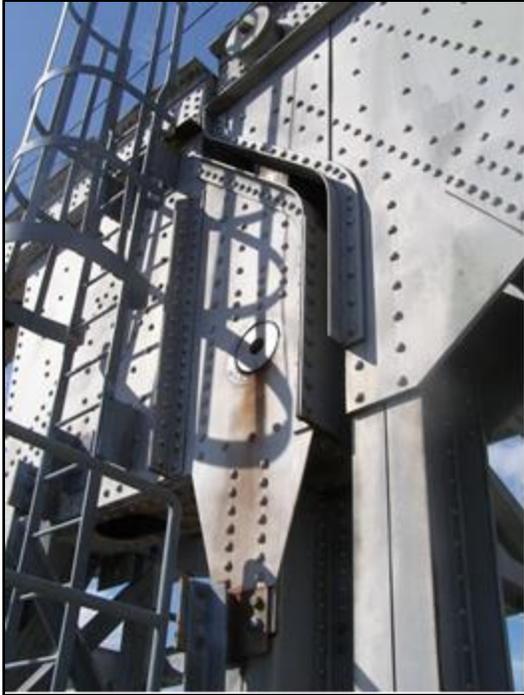
Figure 9 – U49 Lower Pin

The in-depth inspection also revealed the lower pin tie rod on U49 upstream truss had fractured, the cover plates missing, the pin was flush with the exterior gusset, and there was roughly 1/2" gap between the bottom of the lower pin (Figure 9).

Option 4 – MDOT and DOTD unanimously agreed replacing the upper and lower pins and the link at U29 downstream truss and U49 upstream truss was the preferred option. This option had the highest probability of being successful with risk that could be mitigated through the design of HNTB’s temporary restraints.

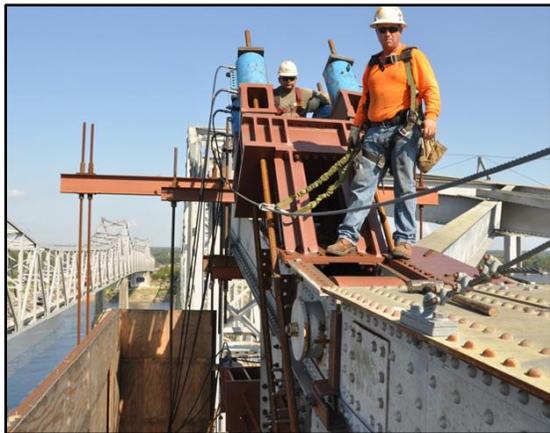
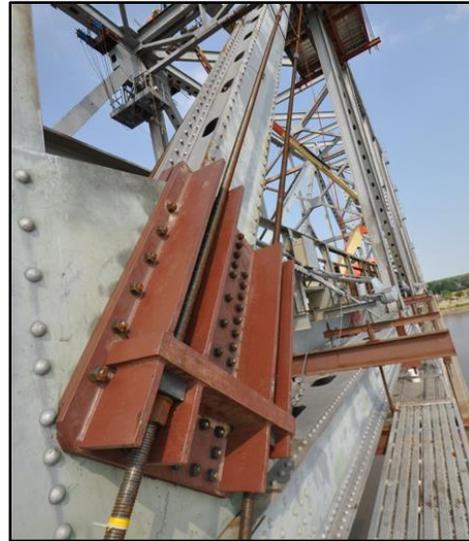
Prior to tensioning U49 diagonal restraint, upper and lower shims were installed. The upper shims would transfer any horizontal force in the diagonal restraint. The lower shims would not be required until Step 2 but were chosen to be installed during Step 1 (Figure 25 and 26). During the stressing of the diagonal bypass, the lower shim shifted transversely by 1/4". As the diagonal restraints became fully engaged, it became clear that one of the post-tensioning bars was conflicting with the truss lateral bracing, potentially causing the shift at the lower shims. The portion of truss lateral bracing that was in conflict was cut further allowing the diagonal post-tensioning bars to adjust; however, because the upper bypass was engaged, the horizontal

Once the existing pin was removed and the new one installed, it was observed that the inboard and outboard lower gusset had walked out by 1/2". Fortunately the new lower pin was made longer and the pin bore directly on the gussets; however, the pin extension beyond the gusset was minimal. Although the gussets did not appear to walk when engaging the diagonal restraints, the existing pins may have been restraining them, and once removed, the gussets were free to walk.

Step 1 – Tension Diagonal Bypass (Figure 23 and 24). L48 – U49 diagonal bypass was tensioned to remove the load in the existing truss diagonal member, link and pin. Stressing operation were conducted in increments and member stresses observed to ensure the bypass was functioning as anticipated. U49 existing link change in force was monitored and U49 diagonal bypass was tensioned to 10% over the anticipated force, resulting in the change in force in the link to be within 1% of the anticipated load (Table 1). Although the entire load would not be released until the pins were removed, it was preferred to minimize the load in the existing link to avoid the pins from binding and prevent sudden movement resulting from pin removal.

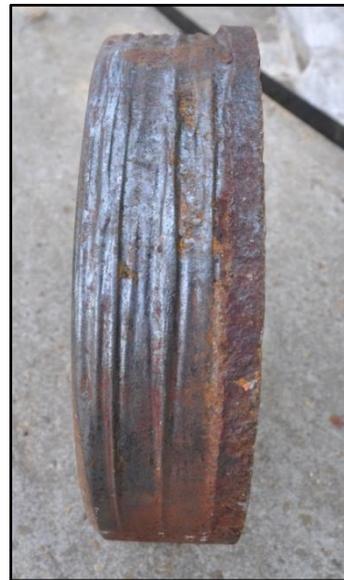
Figure 36 – U49 Lower Pin Drop Cut

The contractor attempted to push out U49 lower pin with hydraulics jacks after the upper pin was cut, but after applying 1,000 kips, minimal to no movement was observed. Ultimately, both faces of all pins required cutting and after the lower pins were removed, it became clear from the observed amount of grooving, the pins would not been able to be pushed out (Figure 36).

Because of the difficulty the previous contractor had with trying to reset the pins in 1997, the contractor elected to cut the pin with a diamond tipped wire saw. After cutting U49 upper pin, minimal change in force was observed in the link, and U49 and U29 splice plates saw about 1 ksi and 7.5 ksi of stress respectively (Table 2). It was speculated the higher stress in U29 was attributed to the misalignment of the truss. No movement was observed in either joint during removal of the pins.
