**REHABILITATION
OF COLLISION
DAMAGED BEAMS
USING HEAT
STRAIGHTENING
FOR I-66 OVER
ROUTE 29**

Ali Hedayati, PE

REHABILITATION OF COLLISION DAMAGED BEAMS USING HEAT STRAIGHTENING FOR I-66 OVER ROUTE 29

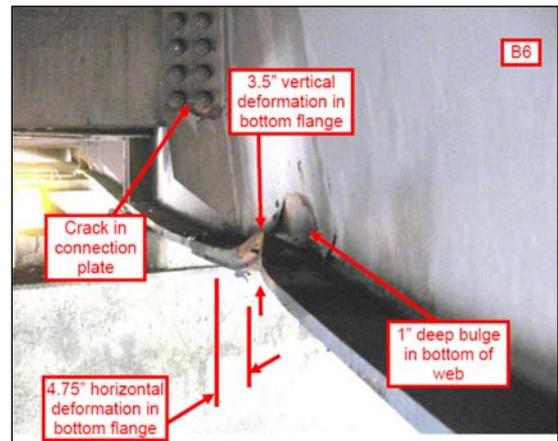
As shown in Figures 5 and 6, damage to the bottom flanges included vertical deformation up to 3 1/2" and horizontal deformation up to 4 3/4".

Figure 5: I-66 EB, Span 2 Beam #6, Bottom Flange Collision Damage

- Step 1:** Remove damaged welds between cover plate and bottom flange where applicable. Heat straighten bulged web and deformed bottom flange (and cover plate) to original position. Bottom flange and cover plate are clamped together during the operation. Grind smooth the gouges and cuts along edges of bottom flange and cover plate.

- **Step 2:** Re-weld the cover plate to the bottom flange along damaged area where applicable.

- **Step 3:** Add splice plates to top and bottom of bottom flange a minimum 2' beyond damaged area to increase/restore moment capacity of the beam. Install additional transverse stiffeners to the web within the damaged area to increase shear capacity of the beam.

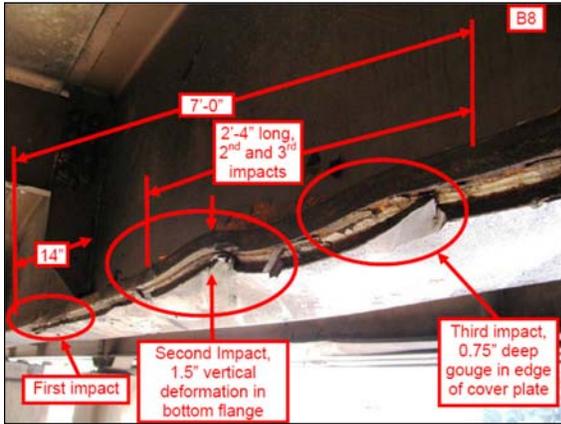
Most of the impact areas had gouges or tears at the edge of the bottom flanges and out of plane bulging of the webs up to 2 5/8", as shown in Figures 6 and 7.

Figure 6: I-66 EB, Span 2 Beam #8, Collision Damage at Three Locations

The results of the load rating analysis showed that damaged EBL Span 2 Beams #5 through #10 had a load rating factor of less than 1.0 for an HS-20 (INV) Design Load. The lowest load rating factor of 0.62 for Beam #8 corresponds with a rating of 22 TONS, which is 39% less than the VDOT-required rating of 36 TONS. Figure 17 shows load rating factors for damaged/deformed beams.

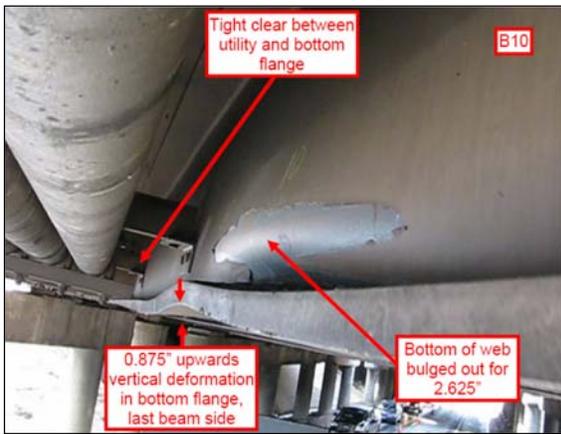
Figure 7: I-66 EB, Span 2 Beam #10, Bulge in Beam Web

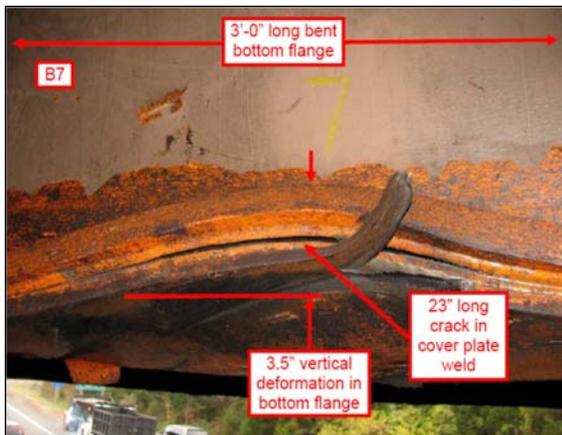
Figure 8: I-66 EB, Span 2 Beam #7, Crack in Cover Plate Weld

Some of the welds between bottom flanges and cover plates were damaged cracked and have separated, as shown in Figure 8.

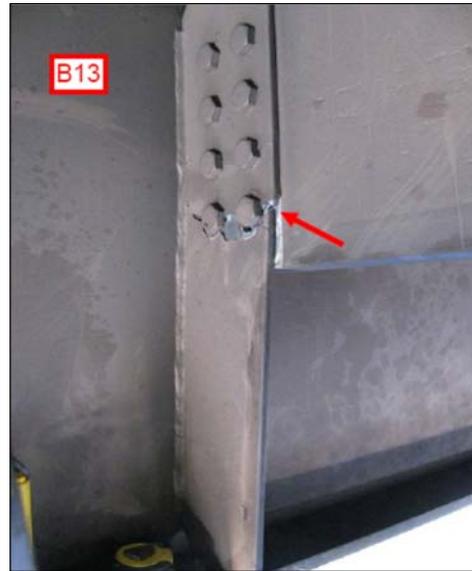
Several connection plates were cracked through existing bolt hole locations and buckling as shown in Figures 9 and 10.

Figure 9: I-66 WB, Span 2 Beam #13, Cracked Connection Plate

After completion of beam straightening and beam repair, damaged diaphragm connection plates at 17 locations were removed and replaced.

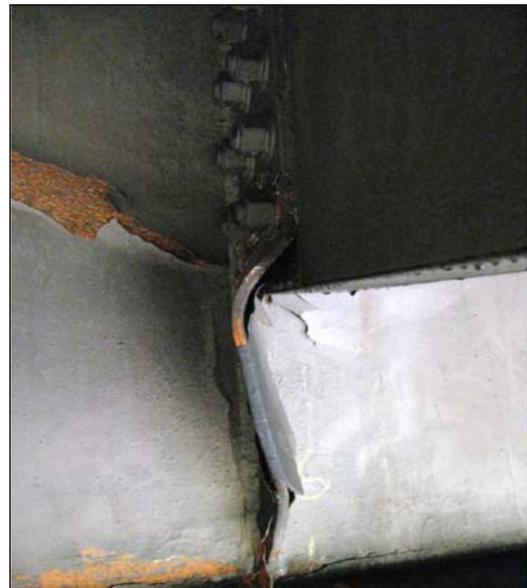
Figure 10: I-66 EB, Span 2 Beam #6, Buckled Connection Plate

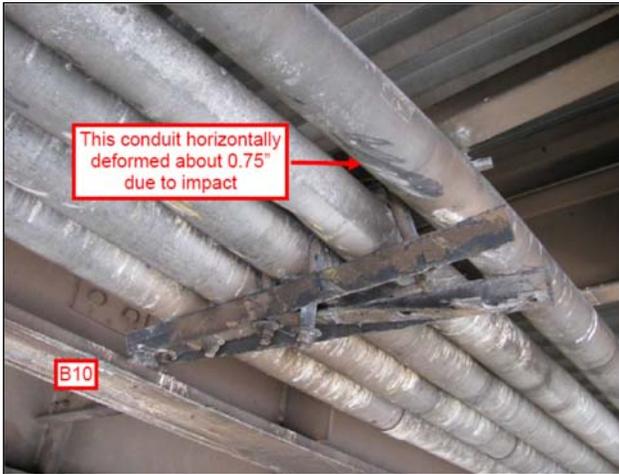
Some utility support hangers that had a vertical clearance similar to the adjacent beams were also damaged, as shown in Figure 11.

Figure 11: I-66 EB, Span 2, Damaged Utility Hanger

All damaged utility hangers and connections were replaced.

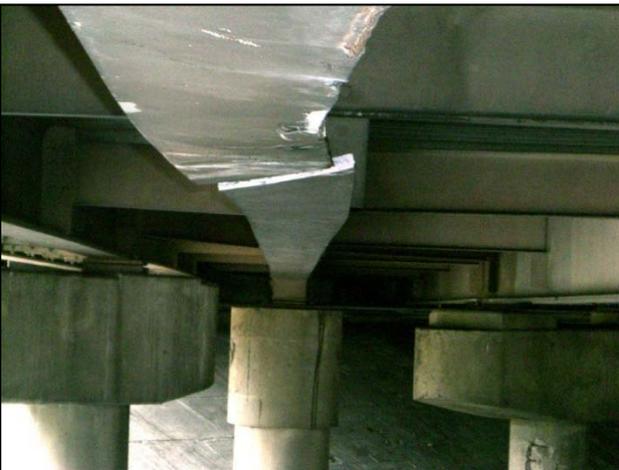
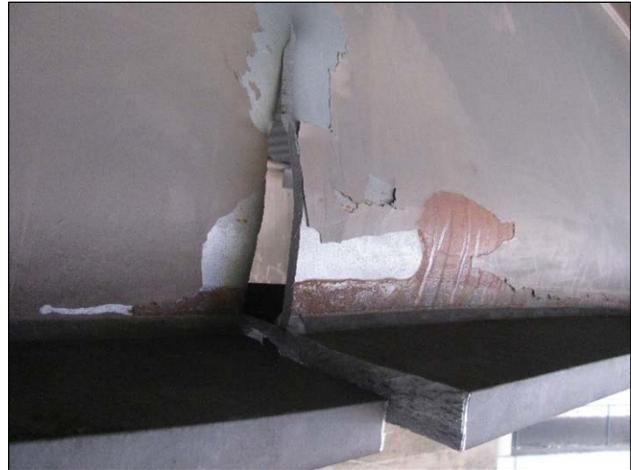
During a follow-up visual inspection in December 2010, a truck again struck the bridge. The impact split the bottom flange and half the web of Beam 22 in Span 2 of the EB Bridge as shown in Figures 12 and 13. The right lane and shoulder of EB I-66 were immediately closed to traffic, and all traffic lanes shifted to the left until beam repairs were completed.

Figure 12: I-66 EB, Span 2 Beam #22, Collision Damage (Split Beam)

Figure 13: I-66 EB, Span 2 Beam #22, Collision Damage (Split Beam)

Partial beam replacement. Damage to the I-66 EB Span 2, Beam #22, which included a split bottom flange and web, was too severe to be repaired. A portion of the beam from the damaged area to the beam end was removed, and a new section spliced in its place. A carrier beam was used to give temporary support for the bridge deck during the partial beam replacement. Carrier beam details are shown in Figures 18, 19, and 20.

The partial beam replacement was 25'-long from a few feet beyond the damage, to the beam end at Pier 2, and included the bottom flange and the web up to 2" below the top flange. The new beam was spliced to the existing beam, with a full penetration groove weld along the top of the web, and bolted splice plates connecting the side of the web and bottom flange.

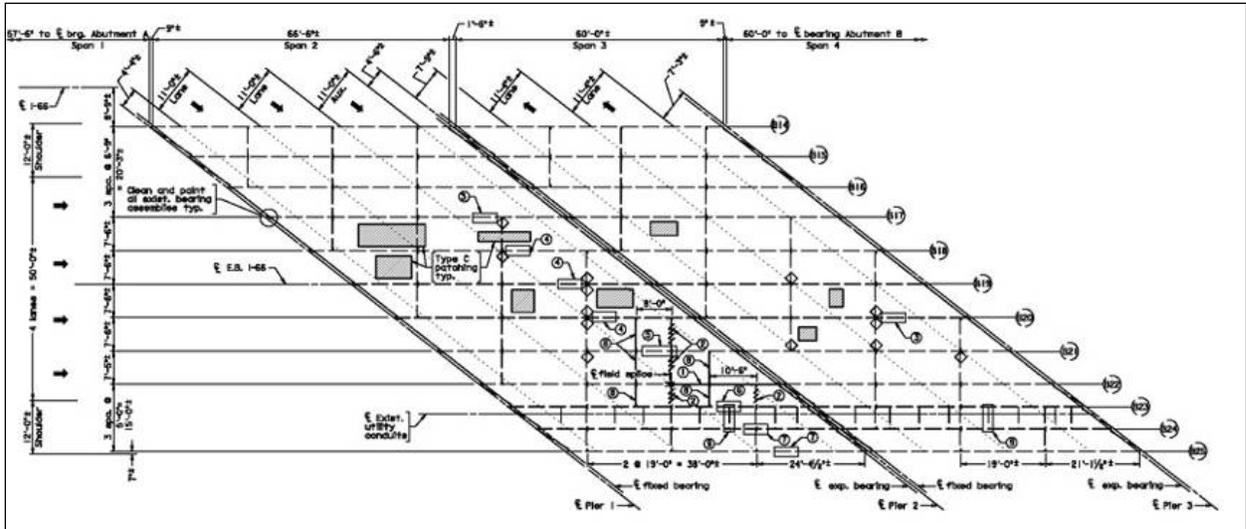
Figure 14: I-66 EB, Spans 2 and 3, Collision Damage Location Plan
