# **NONDESTRUCTIVE TESTING AND MATERIALS ANALYSIS OF THE PA / NJ TURNPIKE CONNECTOR BRIDGE**

# NONDESTRUCTIVE TESTING AND MATERIALS ANALYSIS OF THE PA / NJ TURNPIKE CONNECTOR BRIDGE

## Introduction

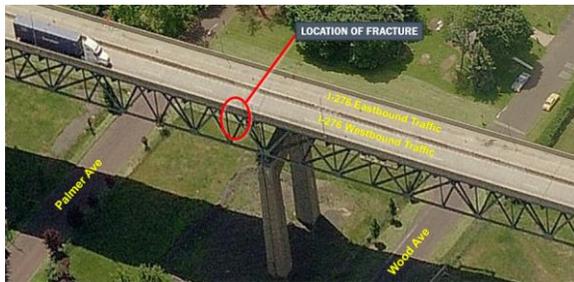
Figure 1 Aerial View of Fractured Chord Location

The I-276 Delaware River Bridge (DRB) is a 6,571-ft., 31-span bridge joining the Pennsylvania and New Jersey Turnpike's across the Delaware River. A complete fracture was discovered in the top chord tension member of a 4-span continuous deck truss unit on the Pennsylvania approach on January 20, 2017, resulting in an immediate closure of the bridge. This paper focuses on the nondestructive testing and materials sampling and analysis that was conducted in parallel to ascertain whether other possible fracture initiation sites were present or whether substandard materials contributed to the fracture. An aerial view and section locating the fracture are provided in Figures 1 and 2.

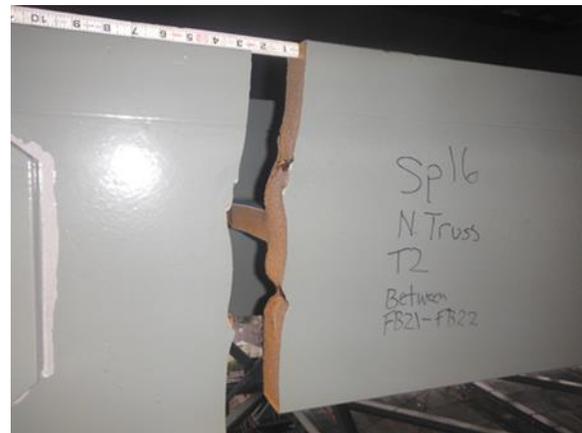
Figure 3 Fractured Chord

Within the first day of the closure, photographs of the fracture site and small samples removed from the fractured surface led various parties to believe that the fracture emanated from a plug weld, or some attempt to fill a mis-drilled hole with weld metal. A photo of the fractured chord taken the first night is provided in Figure 3. Visual observation of the fracture surface provided the telltale signs of holes filled incompletely with weld metal. Fracture was hypothesized to have originated from these holes. The fracture surface is jagged and clearly originates at the two filled holes.

Review of the shop drawings confirmed there were to be no holes at this location. These holes are well outside the limits of the gusset plate connection, the extreme limit of which can be seen at the left side of the photo. Given that this fracture came from what was later confirmed as a hole filled with weld the concern immediately became “if this hole exists, and was filled, is this a systemic problem or a single occurrence?” It is not possible to answer this question other than through nondestructive testing (NDT). Thus, a decision was made that a testing program would be initiated. The initial question was what would be tested, and how quickly?

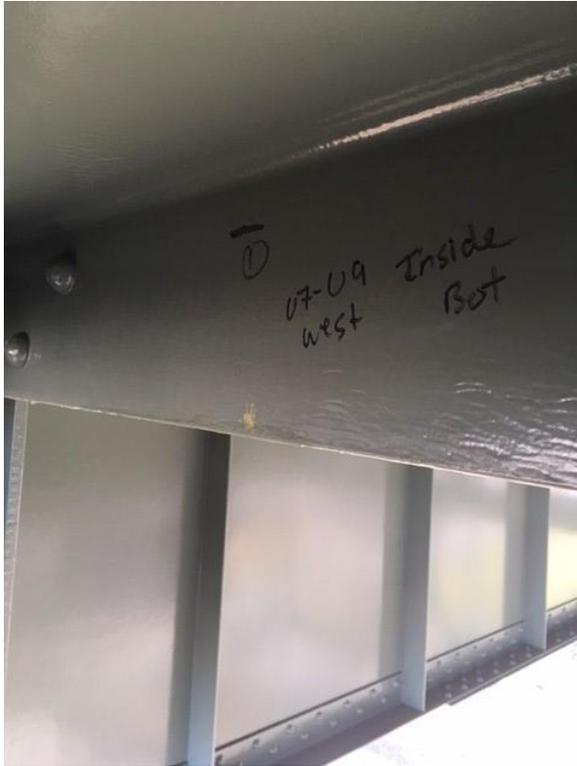
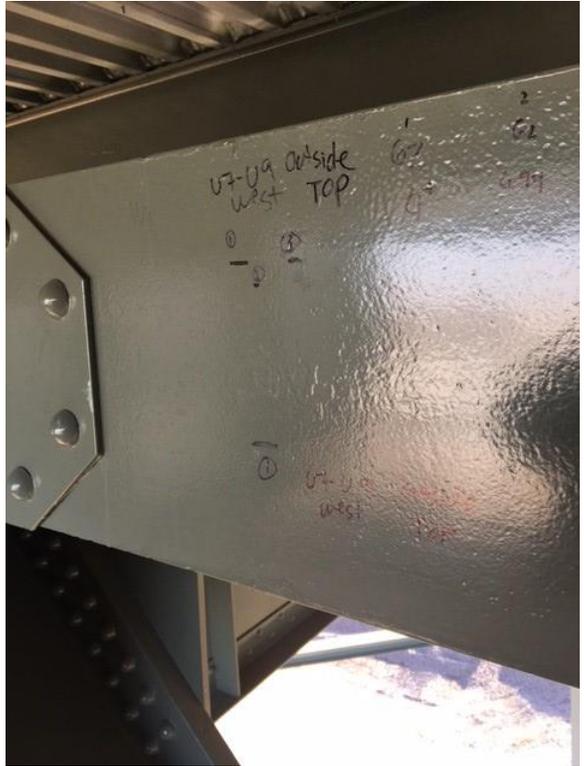
**Figure 8 Indications at U7-U9 Marked for Further Examination**

**PA 3-span, north truss, U7-U9** - A finding at U7-U9 on the North truss of the PA 3-span deck truss was noted on February 4<sup>th</sup>, early in the Phase I work. Testing with a 70-degree shear wave on the same day was inconclusive. Further testing with a 60-degree shear wave was completed on February 6<sup>th</sup> and confirmed the presence of indications on the inner and outer flanges both above and below the web. These ranged from “recordable”, meaning these must simply be noted, to “rejectable” if these were present in a weld. There is no UT rating system in AWS D1.5 for base metal, it relates only to acceptance of welds, so the significance of these findings in a rolled shape is difficult to characterize. On February 8<sup>th</sup> and then again on February 10<sup>th</sup> an attempt was made to etch the indications to determine if weld metal or some other surface indication could be detected. These attempts also revealed no apparent welds. Prior to etching on the 8<sup>th</sup>, a second UT Technician confirmed the location of the indications so the indications were confirmed by two separate technicians using the 90-degree compression wave and a single technician using the shear wave. The markings on the inside of the flange below the web are shown on Figure 7. All indications transferred to the outside flange face are shown on

the right. Since each of the indications was roughly in line with the rivet pattern it was suspected these might be filled holes.

After paint removal and etching there was no visual evidence to suggest a plug weld was present yet there were multiple indications. It was decided to core two of the indications. The Class A inside-top and Class B outside-bottom indications were removed using an annular cutter. The core being taken from the outside bottom is shown in Figure 8. The core was taken with a 3-in. outer diameter cutter. The intent of taking the cores was to

The RT testing also revealed no sign of internal defects. Both cores were tested in the through-thickness direction as they were removed from the flange as well as 90 degrees, i.e. along the axis of the member, as seen in the sectional view. In both cases the test was unable to locate any defects in either core. At this point there was no evidence as to what was found by multiple technicians. Even though these two cores were apparently clean of any defects that could be detected by RT, other indications remained in the member. It was decided in lieu of trying to further characterize these remaining findings that a cover plate retrofit of this area would be provided.

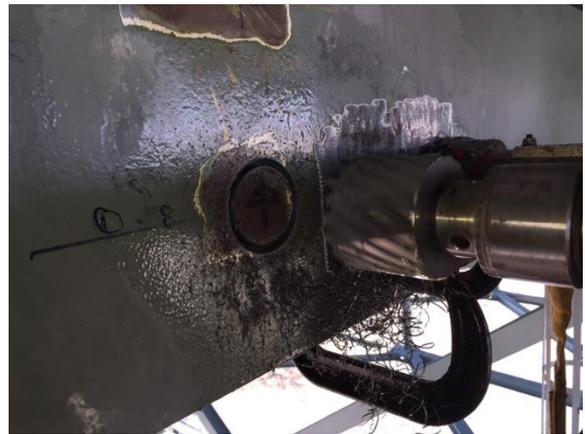
**Figure 7 Coring of Indication at U7-U9**

examine them destructively by sectioning to determine what was present inside. It had the added benefit of removing the indications.

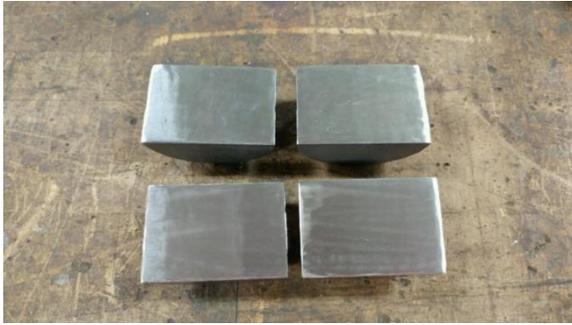
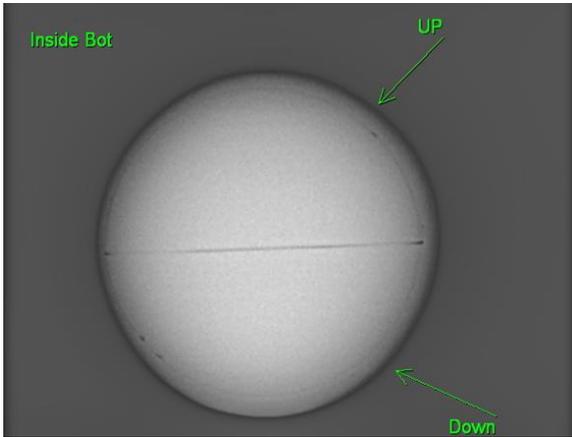
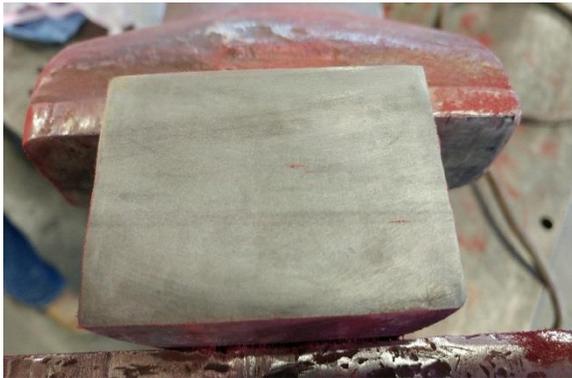
**Figure 9 Section, Radiograph and MT Testing of Core U7-U9**

Once the cores were removed they were sent to the laboratories of Purdue University who polished and sectioned them (see Figure 9). No evidence of a plug weld was found. The material was solid base metal with no evidence of internal defects. With no evidence of what caused the indications the cores were sent to High Steel who subjected them to examination using digital radiography. Those results are shown in Figure 9 as well.

The cores were returned to Purdue University. A decision was made to not further section them since what caused the UT reflection was of such a small size that it could not be detected using the RT testing. Testing with magnetic particle (MT) testing revealed very small internal discontinuities on the sectioned face (bottom photo of Figure 9). It is hypothesized that these, or similar, are responsible for the UT test result. These are of no consequence and illustrate the judgment that must go along with UT testing when assessing the significance of a finding.

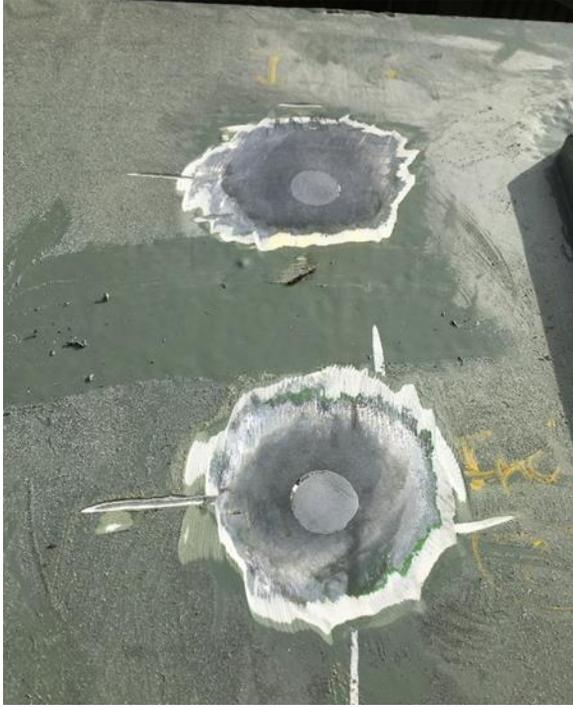
**Figure 10 Mechanically Filled Holes at L6-L8**

**PA 4-span, north truss, L6-L8** - A finding consistent with a plug weld (a large defect) was detected by UT testing using the 90-degree compression wave technique. These were at the same gage line as where existing rivets were so it was suspected that these might also be plugged holes. After paint removal and acid etching it was apparent that they were in fact filled holes but not with weld metal (see Figure 10). The suspicion was that these were rivets placed in a mis-drilled hole and the heads were chipped off and ground. It was decided to core these anyway even though they were obviously not plug welds to see what had been done at these locations. For the mechanically plugged holes shown, it was determined once a 3-in. core was taken and sectioned that the two holes were apparently mis-drilled holes that were tapped, filled with a bolt, with the head and stick through ground flush and then painted. These are of no concern with respect to fracture or fatigue since they are mechanical in nature.

Further examination of the L6-L8 connection also revealed additional mis-drilled holes that had additional holes drilled next to them and then were subsequently riveted. These were apparent on the inside face the I-shaped chord member but not from the outside face. A sketch of the general location of the mis-drilled holes was transferred using a marker to the outside face of the member. The two offset holes correspond to the inner line of rivets at the fill plates. Again, with no real understanding of what the fill material was at these locations, a core was taken. It was found that these holes were filled with a paste or putty-like substance. It was somewhat magnetic but not as magnetic as the steel itself. Chemical testing of the compound was inconclusive but it is not a weld and this material is of no concern with respect to fracture.

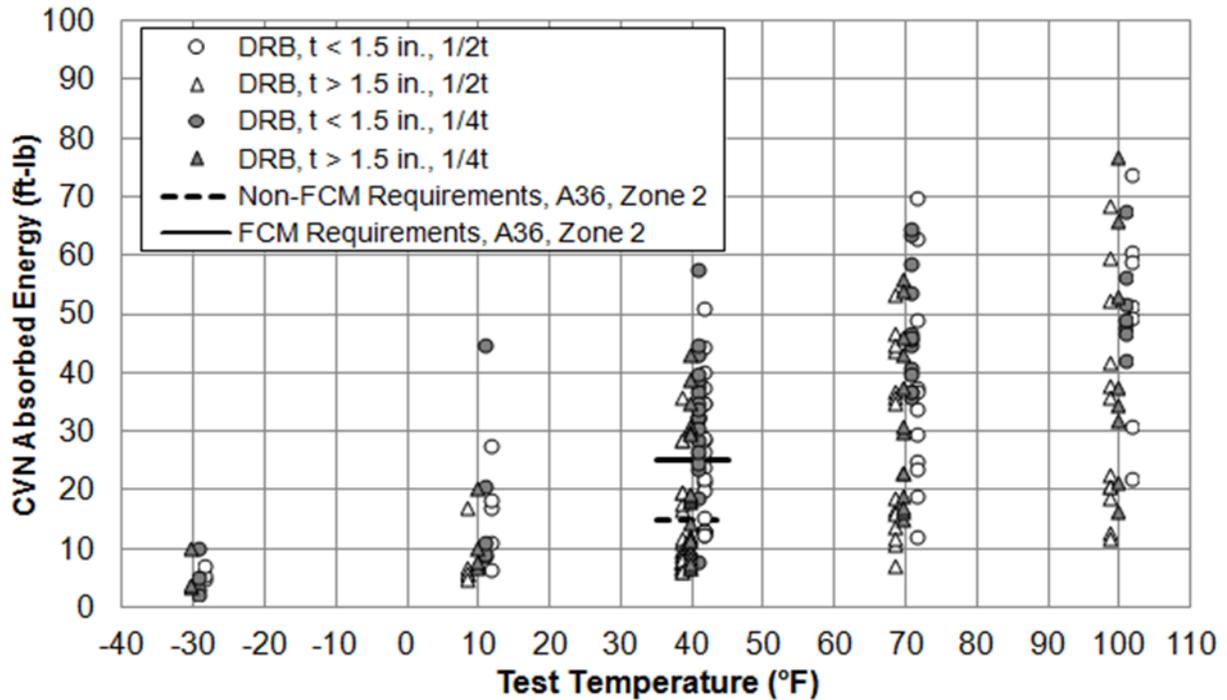
**Figure 12 Delaware River Bridge CVN Test Results**

The results of the Charpy V-Notch (CVN) impact tests for Man-Ten material samples from rolled shapes are presented in as a scatter plot of impact energy vs. test temperature in Figure 12. It is important to note that the CVN impact tests are not a direct measure of fracture toughness. However, fracture toughness can be inferred from CVN test data using known correlations. Nevertheless, the term impact toughness is commonly used when discussing CVN impact energy data.

The data points are grouped by specimens taken from (1) the quarter-thickness of plates less than 1.5 in. thick, (2) the quarter-thickness of plates greater than 1.5 in. thick, (3) the mid-thickness of plates less than 1.5 in. thick, and (4) the mid-thickness of plates greater than 1.5 in. thick. The points are slightly offset from actual test temperatures (10, 40, or 70 °F) for clarity. Also plotted are the Zone 2 CVN impact toughness requirements for fracture-critical members (FCMs) and non-FCMs per the current AASHTO LRFD Specifications. There are no requirements given for ASTM A242 or A440 steel, and as such, the values for ASTM A709 Grade 36 steel are plotted for a simple comparison to modern steel toughness.

It should be noted that the modern impact toughness requirements were plotted only to highlight the differences between modern and historic steels. There were no impact toughness requirements during the era of the bridge's construction. Additionally, modern CVN requirements as per the AASHTO/AWS specifications are based on the requirements for welded construction. Historically, lower CVN requirements were enforced for mechanically-fastened structures (such as the bridge in question) due to their reduced propensity for initial flaws and lack of high residual stresses introduced by welding. Separate CVN requirements for mechanically-fastened structures were removed from the AASHTO specifications in 2009, as most modern structures contain both welded and mechanically-fastened connections and having a single toughness requirement simplifies material ordering and tracking. Further, modern steels regularly exceed the required impact toughness for welded structures and hence the need to differentiate between the two requirements was effectively unnecessary. As such, the DRB steel, intended for a riveted structure, should not be expected to meet the modern-day requirements intended for welded structures.

Past studies have revealed that the fracture toughness of heavy shapes (flange thicknesses > 1.5 in.) can be significantly lower than that of normal shapes (flange thickness < 1.5 in.), due to the large thicknesses of the flanges and the existence of a core in the mid-thickness of these sections resembling a cast steel with coarse grain structure. This observation was confirmed by the test results.

For specimens from plates less than 1.5 in. thickness, there appears to be some dependence of the CVN absorbed energy on the location of the sample through the thickness, with generally higher results for quarter-thickness than mid-thickness samples. For specimens from plates greater than 1.5 in. thickness, this distinction is not present, with the absorbed energies approximately the same regardless of where the sample was taken through the thickness. This observation suggests that the extent of steel worked by rolling processes extends a fixed depth into the thickness rather than a percentage of the thickness. As such, for specimens from plates of 1.5 in. thickness or less, the quarter-thickness samples are within the worked region and the mid-thickness samples are not. For specimens from plates greater than 1.5 in. thick, the quarter-thickness and mid-thickness

samples both fall within the non-worked core,  
where the steel exhibits less toughness.

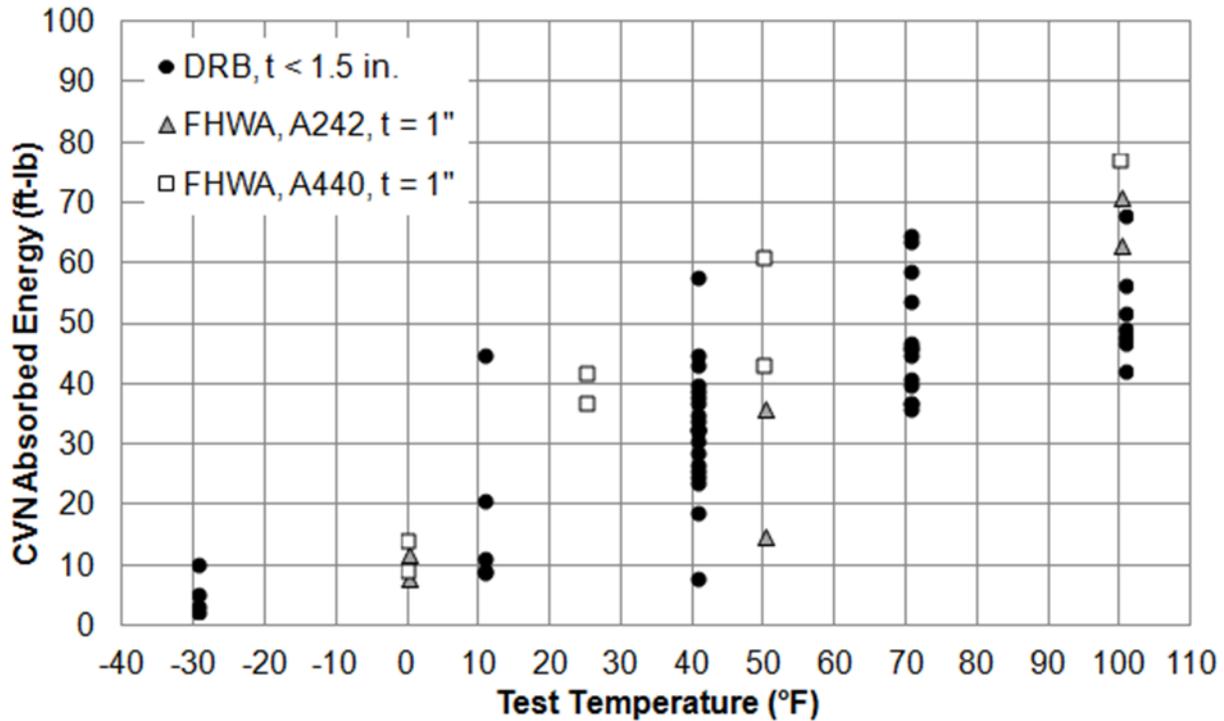
**Figure 13 Comparison of Delaware River Bridge Man-Ten CVN Values to Historical Data**

To further assess the findings, a comparison was made to toughness data compiled in 1974 by the FHWA in a study on the fracture toughness of bridge steels. As part of that study, CVN impact tests and direct dynamic fracture toughness tests were completed, and data was tabulated for ASTM A242 and ASTM A440 specimens from plates of 1 in. and 2 in. thickness. These sizes and material grades correspond well with the DRB test specimens, and were used for comparison.

Comparisons of CVN impact test data from the DRB and FHWA studies are presented in Figure 13. The data points from the two studies correlated well, which indicated that the DRB steel CVN toughness was typical for ASTM A242 and A440 steel of that era.
