# **DELAWARE RIVER TURNPIKE BRIDGE FRACTURE REPAIR**

# DELAWARE RIVER TURNPIKE BRIDGE FRACTURE REPAIR

On January 20, 2017, a full-depth fracture was discovered in the top chord of the north deck truss between Panel Points U20-U19', adjacent to Pier 15 on the Pennsylvania side of the bridge. The bridge owners were immediately alerted and the bridge was closed to traffic. Over the course of next 49 days, the cause of the fracture was evaluated, temporary supports were installed, the fractured member was repaired, and the bridge members were restored to their original dead load stresses. This paper discusses the compressed time frame effort to repair a major deck truss fracture, which has never been attempted.

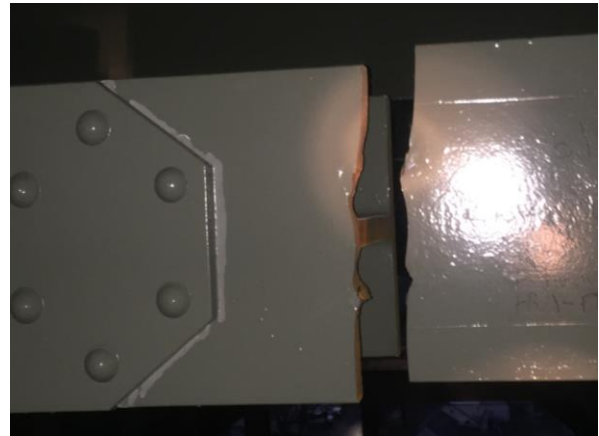
**Figure 1:** Fractured Truss Chord

The fracture was noted on the in-service bridge on the afternoon of Friday, January 20<sup>th</sup>. A primary member in the top chord of the north truss had fractured completely through the cross section of the member leaving an approximate 2" gap between the fracture surfaces. Surprisingly, the bridge showed no change in function and stability. In fact, the surface corrosion on the fracture surface suggested that the fracture had occurred days or weeks prior to being identified. As the member had been recently painted, the difference was readily noticeable. The brittle nature of the fracture with no apparent ductile behavior in the base metal suggested that the fracture

was immediate and energetic, a conclusion substantiated by the fact that the recently painted connection adjacent to the fracture cracked and ejected the paint at the connection interface, as seen below in Figure 1.

The fracture noted above would later be identified as a brittle fracture through the entire section emanating from two mis-drilled rivet holes in the near side flange that had been filled with weld metal. This can be seen in Figure 1 above, thereby creating a stress riser condition in the manganese steel of the member. These welds were traced back to a repair made in the original fabrication of the member in the shop. The forensics of the cause of this failure are discussed by others participating in this session of the Symposium.

The first step to the repair effort for the bridge was to stabilize the member. At this point, the bridge had successfully survived the fracture and carried live load, possibly for several days to weeks prior to its discovery. However, there was no way to immediately determine the actual demands placed on the still functioning members of the truss, and whether they were near failure. Given the potential for loss of collateral and public safety, combined with a weather forecast of high winds, the decision was made to immediately splice the two fractured ends back together with an ad-hoc bolted connection fabricated from available plates and bolts. Prior to any repair work, coupons were cut from the fractured ends for later testing.

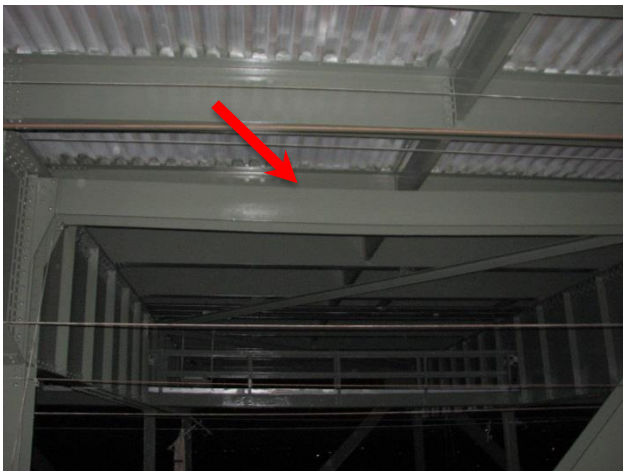
**Figure 2:** Installed Emergency Splice

After initially surveying the damage, it was noted that failed paint could be traced back to either end of the fractured member at the plate laps. The member adjacent to the fractured member also appeared to be bowed near the point of buckling, and the adjacent floorbeam was visibly deformed. Review of the structure later would reveal that the four span continuous north truss plane had survived the fracture by effectively becoming two, two span continuous truss frames with a plastic hinge over the center bearing at the middle pier (Pier 15). A schematic of this effect is shown below in Figure 4. The adjacent top chord members, which were lightly loaded contraflexure members that were nominally sized W14x87, had now become heavily loaded compression members. The adjacent W14 on the eastern side of the fracture had also absorbed the majority of the energy of the fracture and had visibly buckled along its weak axis. There was concern that this member had survived relying on post yielding strength and that it had little, if any, reserve capacity remaining to support the structure. A photo of this member is shown below with a red arrow pointing to the bow.

As can be seen above, the small truss member was under duress and exhibited signs of post-yield behavior. Later work would show that the bow would not elastically relieve from the member,

The bowed member adjacent to the fractured member also did not return to normal geometry and retained its bow, albeit somewhat lessened. This validated the belief that the member had in fact experienced post-yield force effect and almost buckled. The decision was made to fully reinforce

this member with bolted cover plates to double its original capacity and effectively neglect the contribution of the yielded base metal.

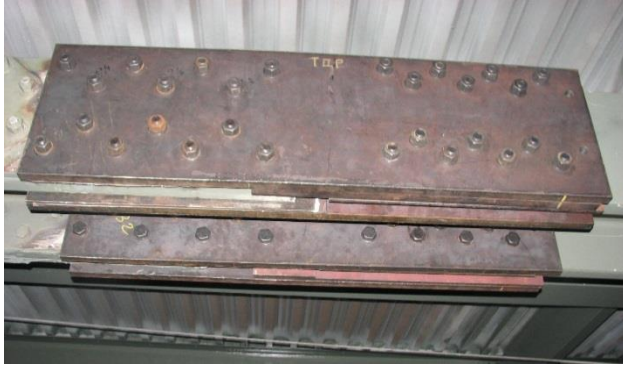
**Figure 3: Installed Emergency Splice**

Limited room for the connection made installing the splice difficult, and the misalignment of the two ends required careful shimming to align the splice plates. Forcing of the two ends back into alignment was not permitted. Work to install the splice progressed on 24 hour shifts through the weekend to beat the forecast high wind event, with the splice work being completed just as the wind speeds began impacting the ratings for the manlifts used to access the splice. A photo of the completed splice is noted below:

Plates were drilled in the field on the ground and hoisted up. Shimming of the plates with various thickness fills became something of a puzzle to attain adequate fitment. With the space and time available, the decision was made to design the bolted connection using the ultimate capacity of the bolts without the usual factors of safety granted by load and resistance factors, which were omitted.

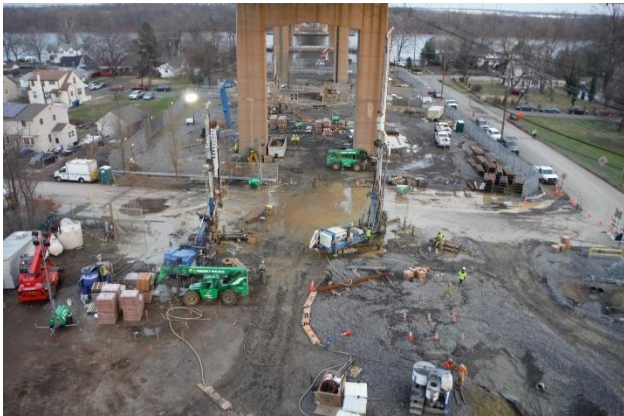
**Figure 5:** Micropile Installation

After notice to proceed was given, a specialty contractor, Moretrench, was able to provide three micropile installation rigs which worked around the clock to install the micropiles. The effort to concurrently drill in such tight confines created large-scale water runoff and muddy conditions that had to be mitigated with free draining gravel fill. The drilling operation can be seen below in Figure 5.

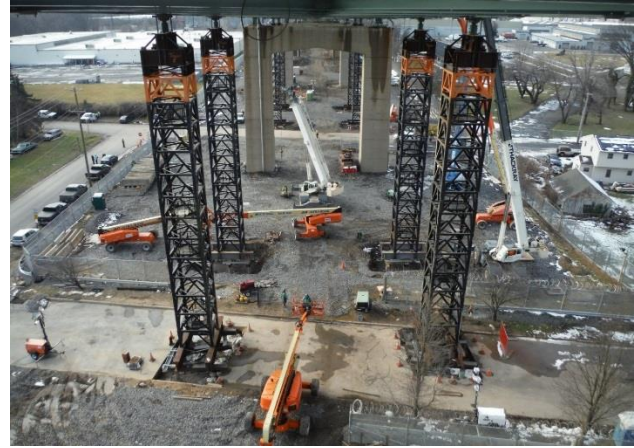
**Figure 6:** Support Tower Installation

Design responsibilities for the towers were divided to speed the work. The design engineer (HNTB) designed the micropile foundations and worked directly with Moretrench to expedite installation and testing. Cornell and Company designed the support grillage across the tops of the piles using steel shapes from their available stocks with HNTB reviewing the designs and shop drawings. A photo of the erected towers can be seen in the below Figure 6.

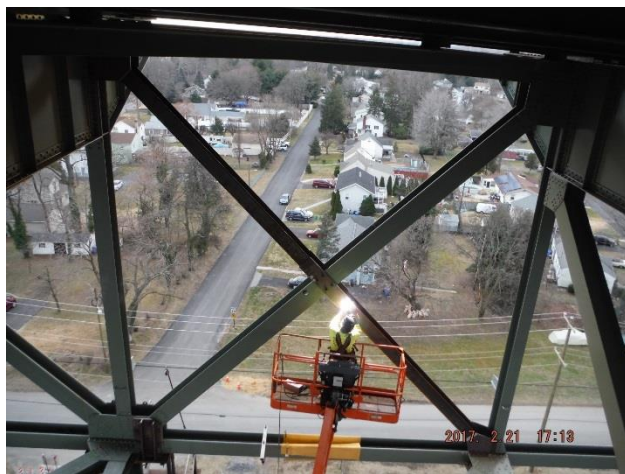
**Figure 7: Cross Brace Installation**

Minimal strengthening of the truss at the jack points was required to resist the force from the jacks, and a temporary cross brace was installed at the jack points as can be seen below in Figure 7. In addition to the cross braces, the gusset plates at the jacking locations were heavily reinforced with stacked plate steel saddles to uniformly distribute the jacking force across the full width of the gusset plate without damaging it.

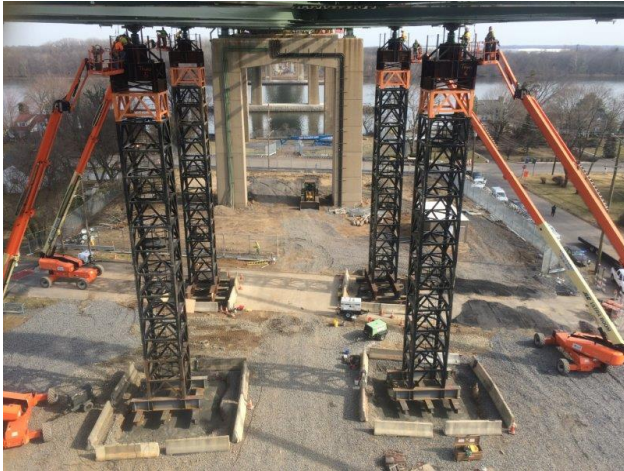
**Figure 8:** Vertical Jacking Day

Vertical jacking of the truss back to its original profile was completed on February 24<sup>th</sup>. The combined approach with the horizontal post tensioning meant that only a fraction of the vertical jack capacity was required and the procedure was distilled into four runs of eight separate incremental jacking pressure increases of 100 psi increments until the target pressures were reached. Throughout the entire jacking procedure, the behavior of the truss was continuously monitored using a suite of strain gauges linked to a central reporting facility in an ad-hoc ‘command center’ located adjacent to the bridge. The sensor suite was installed and maintained by WSP, Inc. In the end, the behavior of bridge showed an elastic response throughout the operation. The vertical jacking was completed in a single day.

Lessons learned from the jacking operation were used to inform our understanding of the bridge and prepare for the next step of the process. Most notably, it was found that the truss responded elastically, but was actually much stiffer than expected. Trusses are traditionally designed with the assumption that the connections between members at gusset plates act as pinned and are free to rotate. In truth, gusset plate connections are incredibly stiff and offer significant restraint against rotation. Therefore, we prepared two models of the structure with both pinned and fixed end conditions considered. After jacking, these models were recalibrated to correspond with the actual encountered stiffness of the truss, which was approximately 30% stiffer than the pinned end condition assumption. This additional stiffness is likely due to the contribution of the deck and secondary members offering unanticipated load paths.

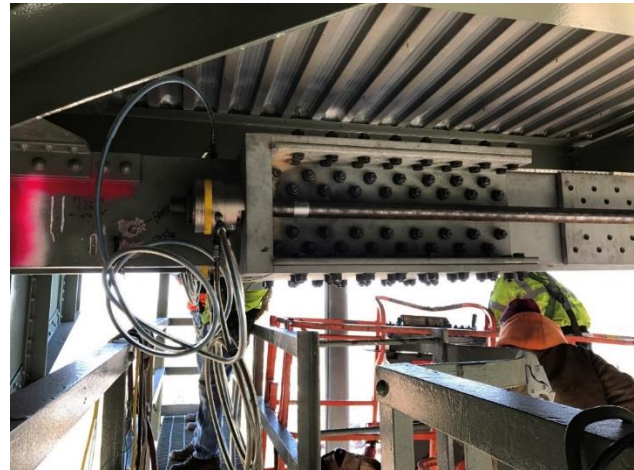
**Figure 9:** Post Tensioning Installation

The limited room available for the post tensioning work meant that traditional jacking equipment would not fit. Instead, compact bolt tensioning hollow jacks sourced from the wind tower industry were used. These jacks are intended to pretension tower foundation bolts and have extremely short stroke capacity. However, their power and compact footprint made them ideal for this application. Custom tension bars were cut and threaded to work with the jacks. The west end of the jacking arrangement can be seen below in Figure 9.

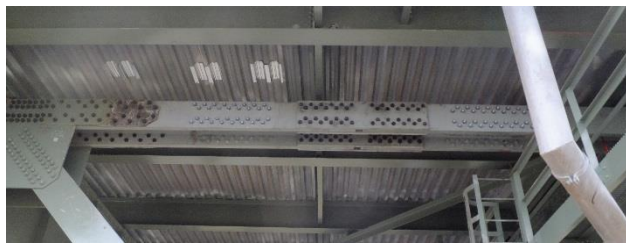
**Figure 10:** Repaired Chord

After completion of the post tension work, the new field splice between the new and the old member sections was field drilled and fully tightened. The vertical jacks were retracted and the truss was permitted to stand on its own for the first time since January. A photo of the repaired member is shown below in Figure 10.

The remaining portions of the fractured truss chord were less than required to install a full capacity permanent splice. The decision was made to replace the chord member on the east side of the fracture with a new member fabricated from modern HPS bridge steel plate. After the vertical jacking was complete, the contractor installed the new member and cut-back the existing member so that a new permanent splice could be installed. Provisions were made for the longitudinal post-tensioning frames to be installed on both the new and existing ends of the member following its design.

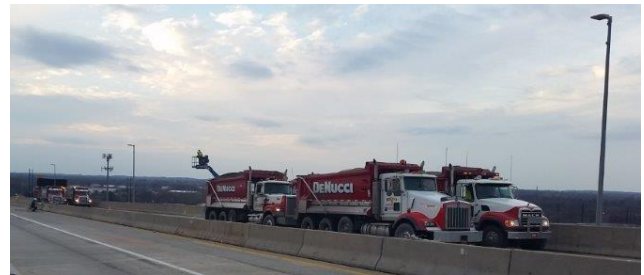
**Figure 11:** Load Test Trucks in Position

After work was completed, the final step was to prove the truss capable of carrying live load and behaving elastically in response. Various loading configurations were considered following load testing guidelines outlined in the AASHTO Manual for Bridge Evaluation. However, at the end, and given the severity of the damage to the bridge, the decision was made to load the bridge with eight fully loaded (approximately 90 kips each) triple axle dump trucks explicitly placed in gangs of four to effect maximum negative moment flexure in the repaired beam. The belief was that while this loading configuration is highly extreme and incredibly unlikely in the normal service of the bridge, it offered a high level of confidence in the event of success. A photo of the trucks in the loaded position is shown below in Figure 11.

The load testing confirmed that the bridge behaved elastically and predictably. For surety sake, a parallel load test was performed on the nigh-identical four span unit truss mirrored on the east side of the main span. The compared results between the two spans indicated that the damaged and restored four span unit behaved similarly to the undamaged sister four span unit, this validating the results. The bridge was then reopened to traffic on March 9<sup>th</sup>.
