# DELAWARE RIVER BRIDGE FRACTURE: REPAIR STRATEGY AND MONITORING BY DIGITAL IMAGE CORRELATION

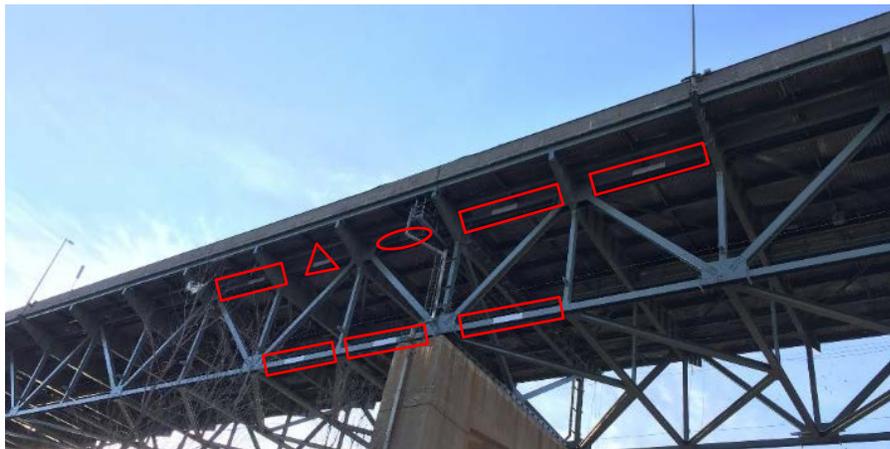
The fracture occurred in U19'-20' (where U indicates upper chord and the numbering refers to the nodes identified in Figure 2), a W14 x 314 rolled section with a design force of 1851 kips, in the upper chord of the North truss of the four-span continuous approach above the fixed bearing (Figures 1 and 2). The load redistributed to the surrounding members, notably the neighboring upper chord U18'-19', a W14 x 87 rolled section with design tension force of 364 kips and compressive force of 251 kips, which buckled about its weak axis. The fracture also caused the deformation of adjacent verticals and sway bracing. Further, both the North and South trusses vertically deflected (the North more than the South). The bridge was repaired by 1) vertically jacking the structure from towers to restore the vertical position of the trusses, followed by 2) post-tensioning and

- Fractured Member (U19'-20)
- △ Buckled Member with DIC Pattern (U18'-19')
- Other Members Monitored via DIC

**Figure 1 Photograph of the North truss of the Delaware River Bridge, highlighting the fractured and buckled members, as well as the members monitored by DIC.**

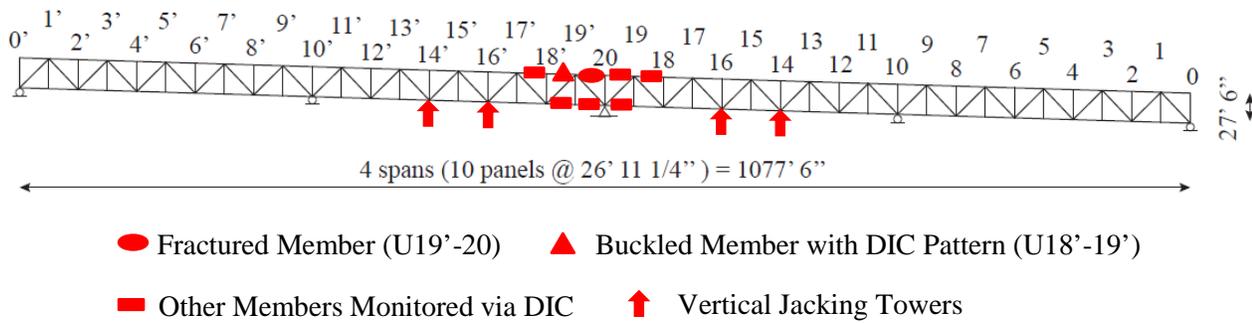
**Figure 2 Elevation of the North truss, indicating node numbers and locations for jacking towers. The fractured and buckled members, as well as the members monitored by DIC, are highlighted.**

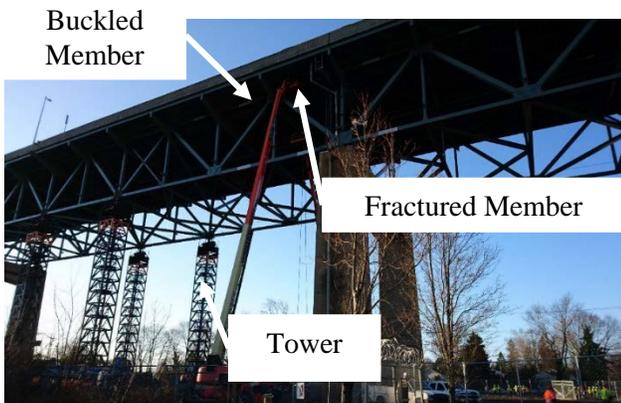
**Figure 3 Photograph of vertical jacking towers.**

The aim of the vertical jacking was to restore the vertical position of the trusses. The temporary splice was first removed. The jacking was performed from eight 80-ft high temporary towers that were erected for this purpose. Four towers were located under the South truss (located under nodes 14', 16', 16' and 14') and four were located under the North truss at symmetric locations (Figures 2 and 3). The pressure in the jacks under the trusses at nodes 16' and 16' were gradually increased in four phases: 25%, 50%, 75% and 100% of the repair design pressure. The other jacks remained in contact during this process. The entire procedure was completed on February 24, 2017.

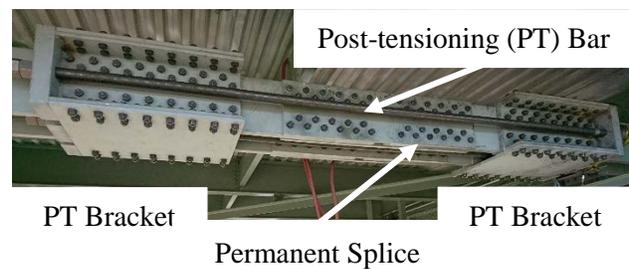
**Figure 4 Photograph of post-tensioning system.**

Post-tensioning was then performed with the aim of restoring the original dead load force in the fractured member. First, the steel surrounding the fractured region was removed and replaced. Post-tensioning bars and brackets were installed (Figure 4). The bars were tensioned on March 3, 2017 in two phases: 90% and 100% of the post-tensioning design force of 1500 kips. A permanent splice was then installed on March 4, 2017 (Figure 4). Additional steel channel sections were added to reinforce the buckled member, U18'-19' with the aim of compensating for the Bauschinger effect (Figure 5). On March 5, the post-tensioning was released and the post-tensioning system was demobilized.

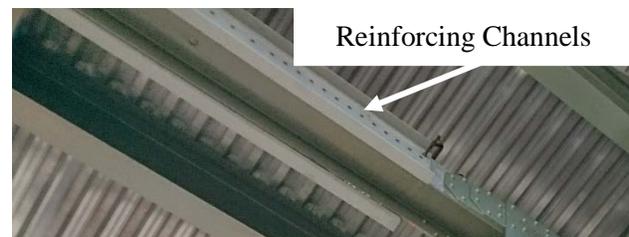
**Figure 5 Photograph of reinforcing channels (during installation).**
