# **STRUCTURAL BEHAVIOR AND FATIGUE REHABILITATION OF THE I-64 STEEL DELTA FRAMES OVER KERRS CREEK AND MAURY RIVER IN VIRGINIA**

The twin delta frame bridges carrying I-64 over the Maury River within the Virginia Department of Transportation's (VDOT) Staunton District have experienced fatigue cracking problems that caused structural deterioration and a deficiency in the bridges' inventory ratings. Analytical investigation by researchers at Virginia Polytechnic Institute and State University (Virginia Tech) showed that the bridges could be retrofitted to achieve essentially infinite fatigue life. A fatigue retrofit approach, recommended by VA Tech, has been implemented and a 3-D finite element computer model was developed to examine the stress levels within the structures and its global stability through the retrofit process. In addition, the bridges' structural behavior was monitored through a structural health monitoring program aimed at correlating the actual response with that of the analytical model. The paper discusses the comprehensive structural retrofit program designed to control the fatigue cracks to attain infinite fatigue life. Currently, the bridge rehabilitation has

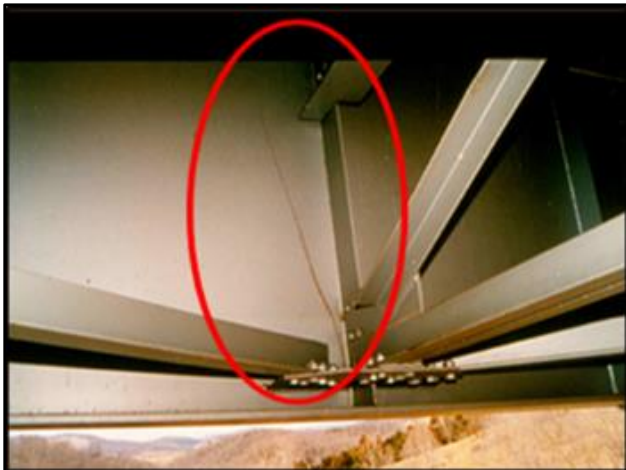
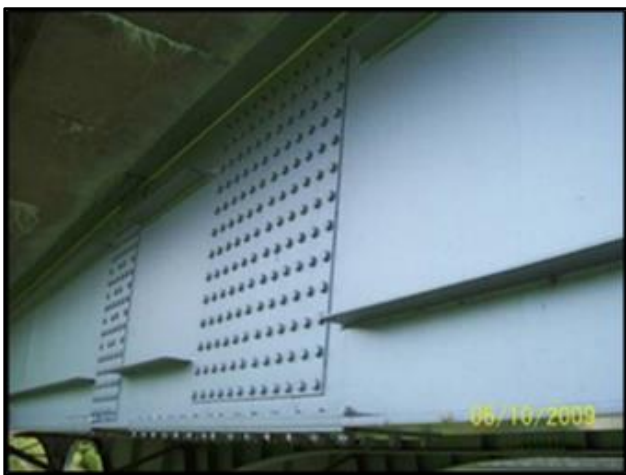
**Figure 5: 1991 Web Crack and Bolted Retrofit**

In 1991, a large crack was discovered in the EBB south fascia girder web, near the bottom flange, at the cross-frame K-brace and lower lateral bracing connections in the vicinity of Pier (2). The crack was immediately repaired using a bolted web splice connection (Figure 5).

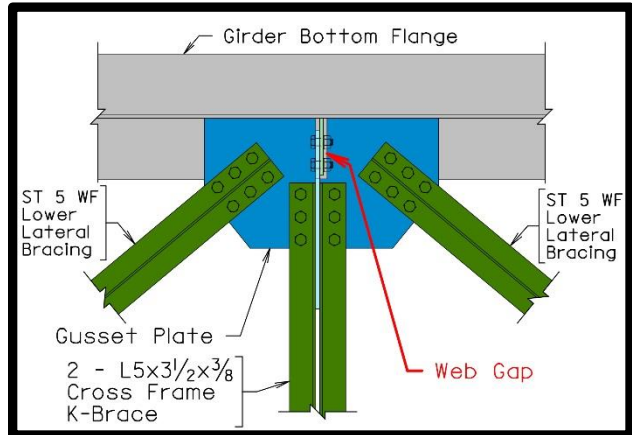
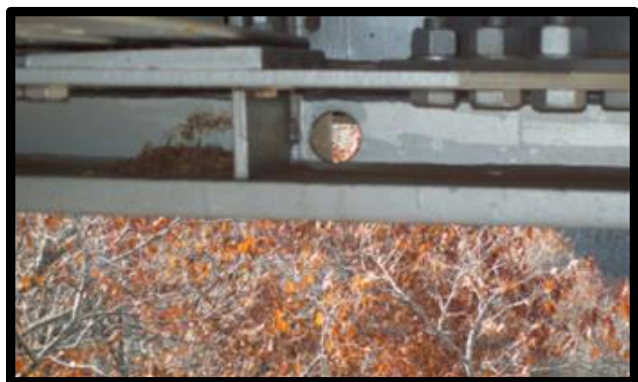
**Figure 6: Crack at Web Gap Between Connection Plate of Cross-Frame K-Brace and Gusset Plate Connecting Lateral Lower Bracing**

Later the same year, three additional cracks were discovered in the interior girder of the WBB bridge. The cracks occurred in the web gap between the connection plates for the cross-frame K-brace and the gusset plate connecting the lower lateral bracing (Figure 6).

In 1994, researchers at Virginia Polytechnic Institute and State University (Virginia Tech) classified the cracks as fatigue cracks produced by repetitive out-of-plane bending (distortion-induced fatigue) acting on the girder webs and caused by the horizontal component of the forces generated in the cross frames. Later, the cracks were reclassified as constraint-induced fractures based on the 2004 American Association of State Highway and Transportation Officials (AASHTO) guidelines on the separation between transverse welds in the gusset plate cutout around the transverse connector plate.

In order to eliminate the potential for additional cracks, a decrease in the restraint at the connection

between the girder web and the vertical/lateral bracing systems was introduced by VDOT. This was achieved by partially disconnecting the lower lateral bracing members (by the removal of all but one or two bolts) from the bracing connections while leaving the lower cross frame and the lateral bracing connections at the haunch “knuckles” areas connected to provide global lateral stability for the structures.

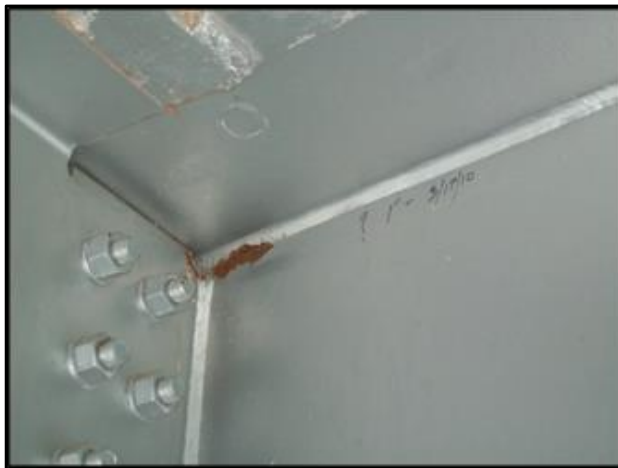
**Figure 7: 2009 Cracks at Floorbeams and Delta Girders**

In 2009, a new pattern of cracks appeared at the cross frame floorbeam connections to the delta girder web near the girder top flange. The cracks were discovered along the total length of the bridge. Studies at Virginia Tech suggested that the cracks resulted from local-distortion/constraint-induced fatigue conditions (Figure 7).

Consequently, the bridge required another round of retrofitting that focused on improving the fatigue response of the structures. Virginia Tech proposed that the bridge could attain infinite fatigue life by: a) introducing bi-directional composite behavior between the deck and the floorbeams by removing the existing deck, installing shear connectors at the top flange of the transverse floorbeams and reconstructing a new, 2-way composite deck and; b) modifying the fatigue-prone connection details to attain a higher (essentially infinite) fatigue capacity.

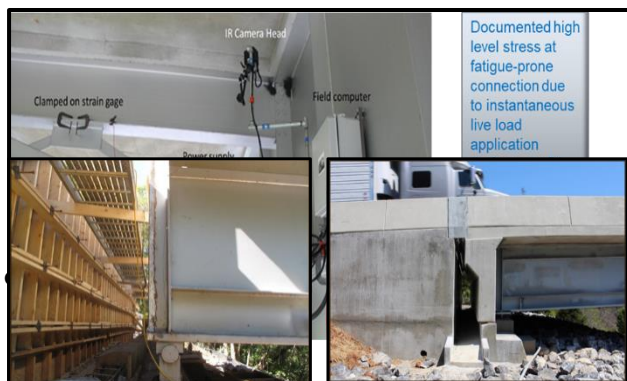
**Figure 20: Newly Virginia Alternate Abutment**

the bridge seats. The originally designed superstructure continuity delivered an 845' jointless deck system over the piers but required large-movement compression seals at the abutment backwalls. These original seals failed repeatedly and caused embankment erosion and abutment undermining. The project restoration incorporated the modification of the existing stub abutment into a Virginia Abutment producing a truly jointless bridge design (Figure 20).

Meanwhile, the VDOT Staunton District Bridge Section directed WRA to extend the jointless deck superstructure and introduce a Virginia Abutment configuration to locate the expansion joint beyond
