# Single Coat Inorganic Zinc Protection for Steel Bridges

**NEED  
FOR  
SPEED**

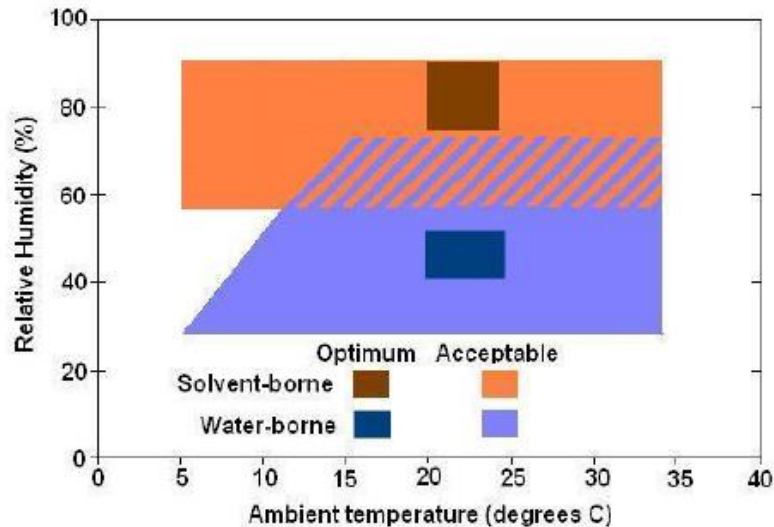
Figure 1. Optimum and Acceptable Curing Conditions for Solvent-Based and Water-Based SIOZ (Francis, 2013b).

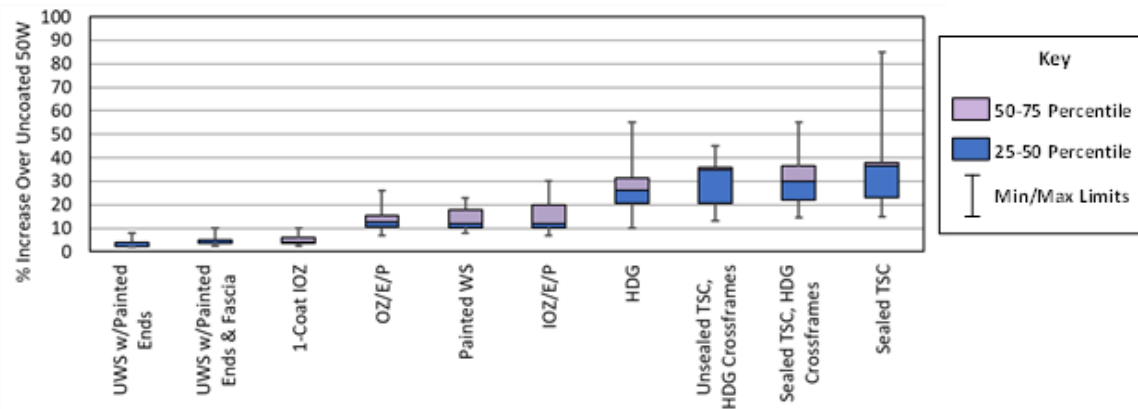
Figure 2. Relative Costs of Steel Corrosion Protection Systems (adapted from Carlson, 2020).

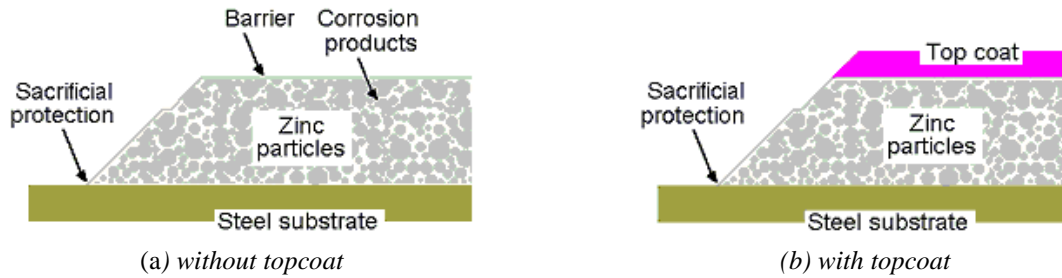
Figure 3. Protection mechanisms in a zinc-rich coating (Francis 2013c).

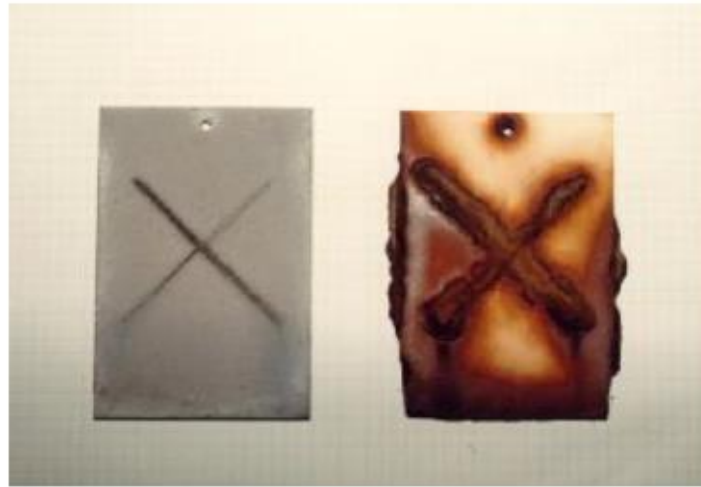
Figure 4. SIOZ without a top coat (left) and IOZ top coated with epoxy and urethane (right) after 8 years of atmospheric exposure in marine environment (Calle 2019).

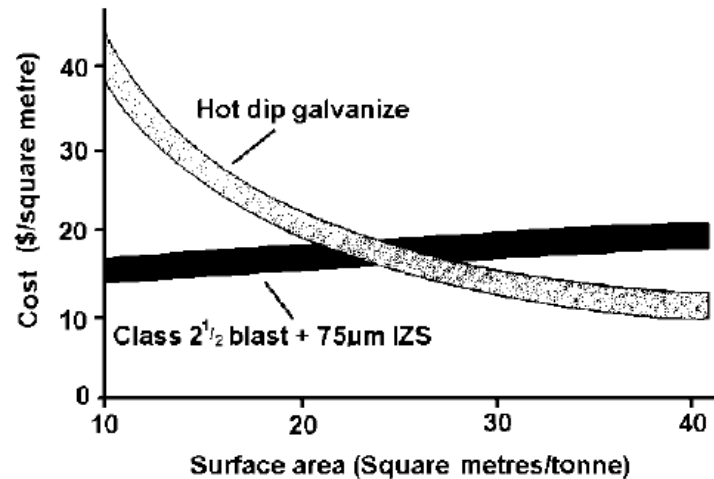
Figure 7. Cost Comparison of Galvanizing and SIOZ based on Surface Area (Francis 2013b).

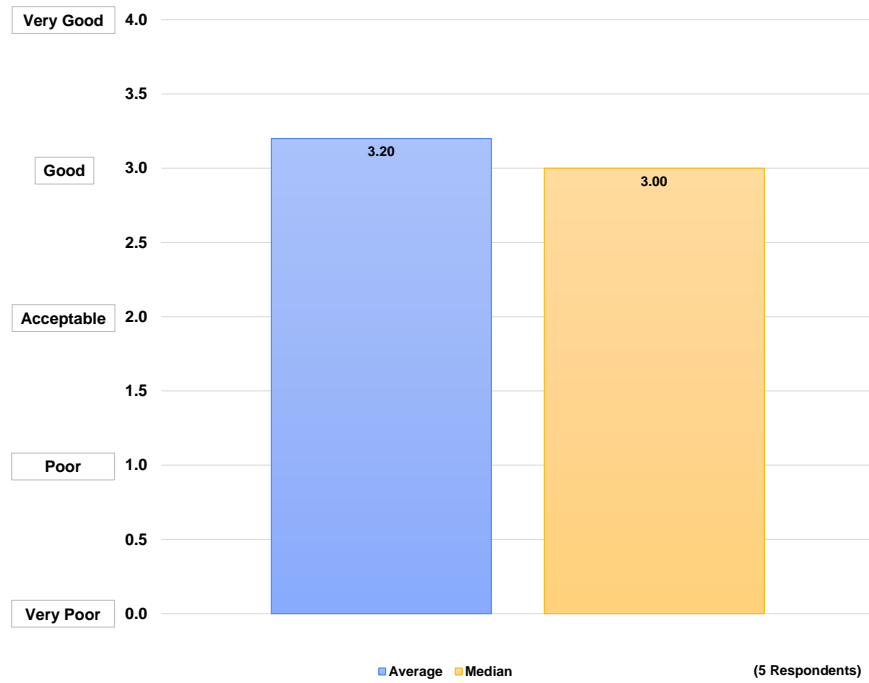
Figure 9. Survey results for State experience with SIOZ performance (Carlson, 2020).

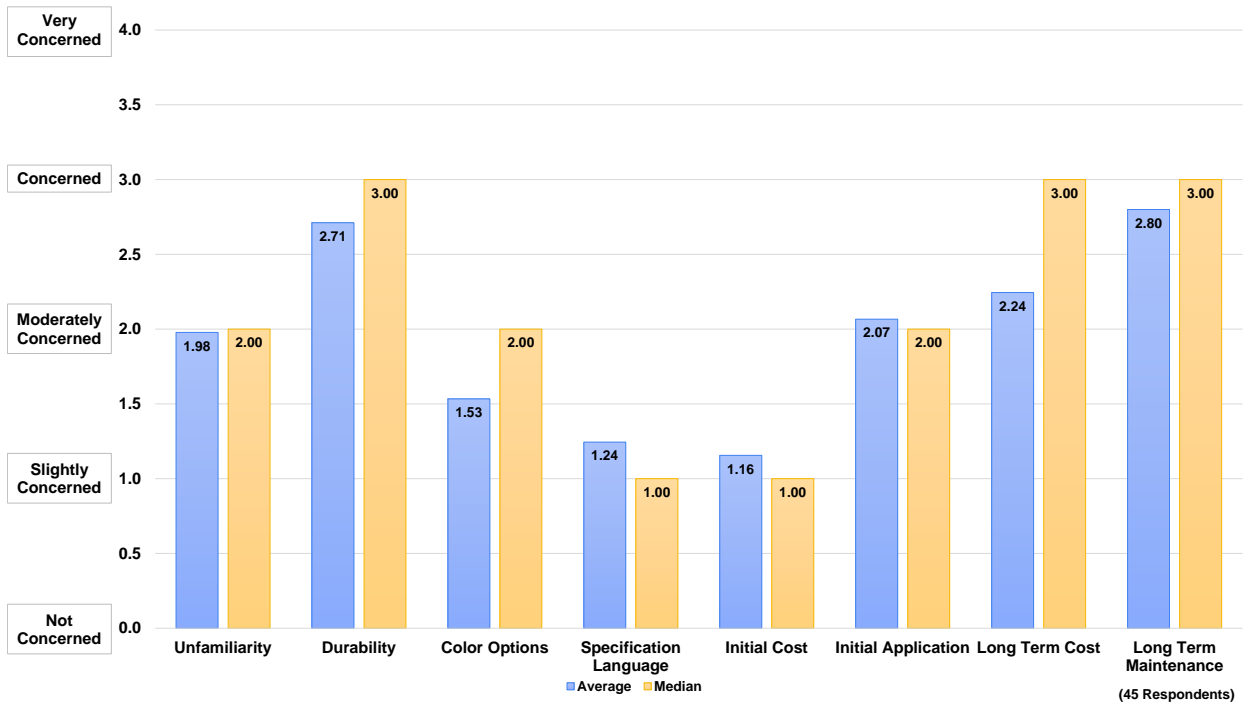
Figure 10. Survey results for State concerns with using SIOZ (Carlson, 2020).

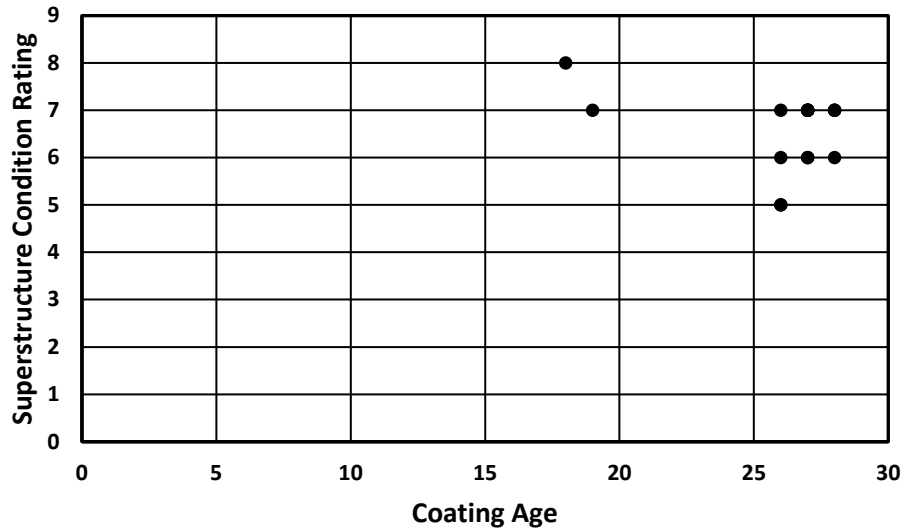
Figure 11. Superstructure condition rating versus SIOZ coating age.

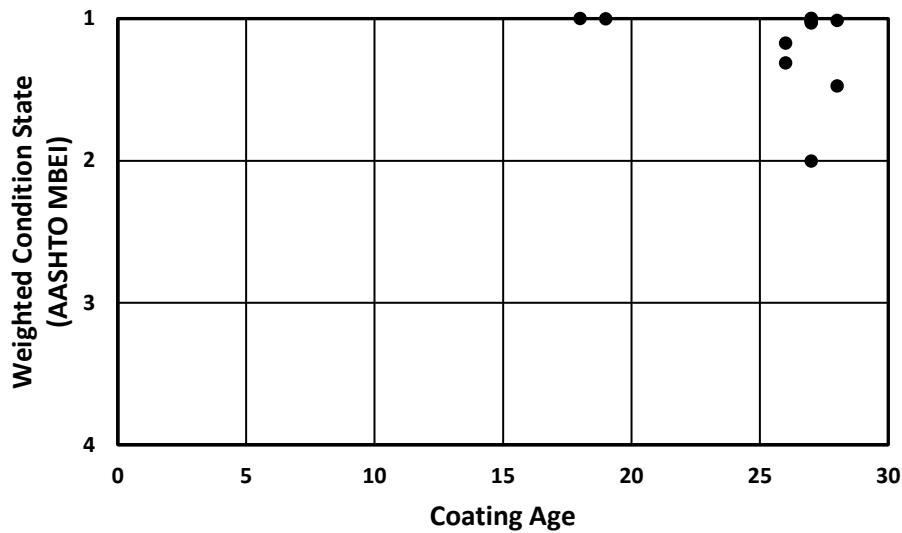
Figure 12. Weighted condition state versus SIOZ coating age.

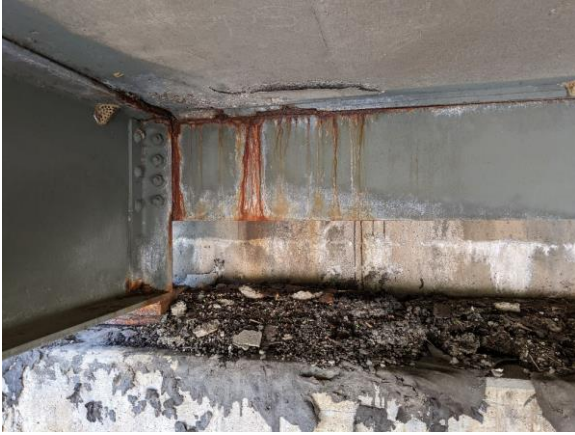
*(a) efflorescence and corrosion of end diaphragm, connection plate, girder, and bearing plate*

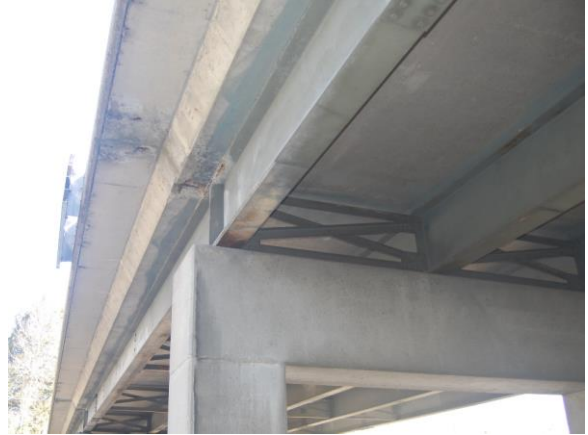
*(b) deck overhang deterioration allowing unintended drainage onto the fascia girder resulting in coating failure and corrosion*

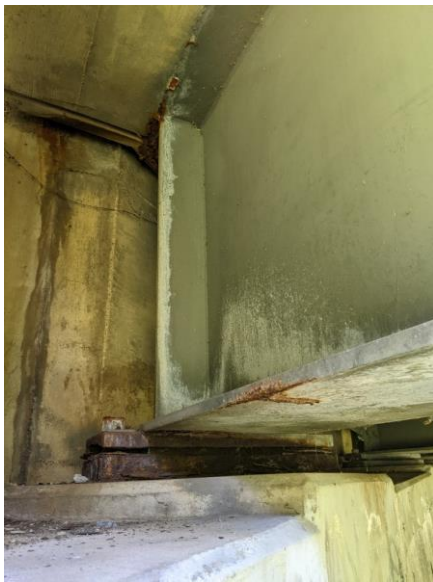
*(c) efflorescence and corrosion of girder, bearing stiffener, and bearing plates*

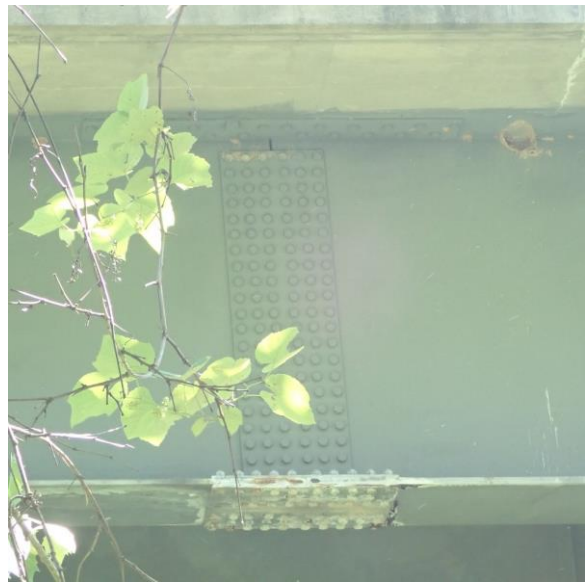
*(d) bottom flange splice coating deterioration and steel corrosion caused by the same deck joint failure from (c)*

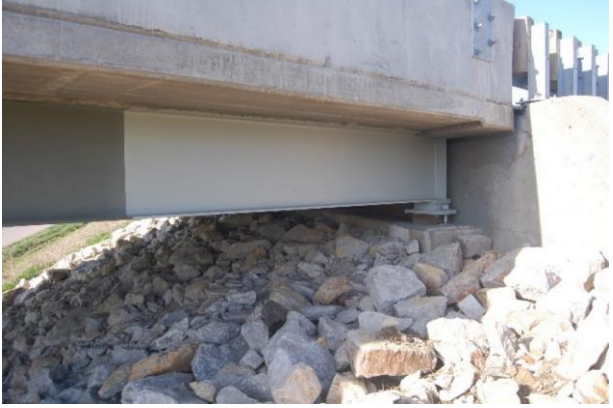
(a) girder end at an abutment

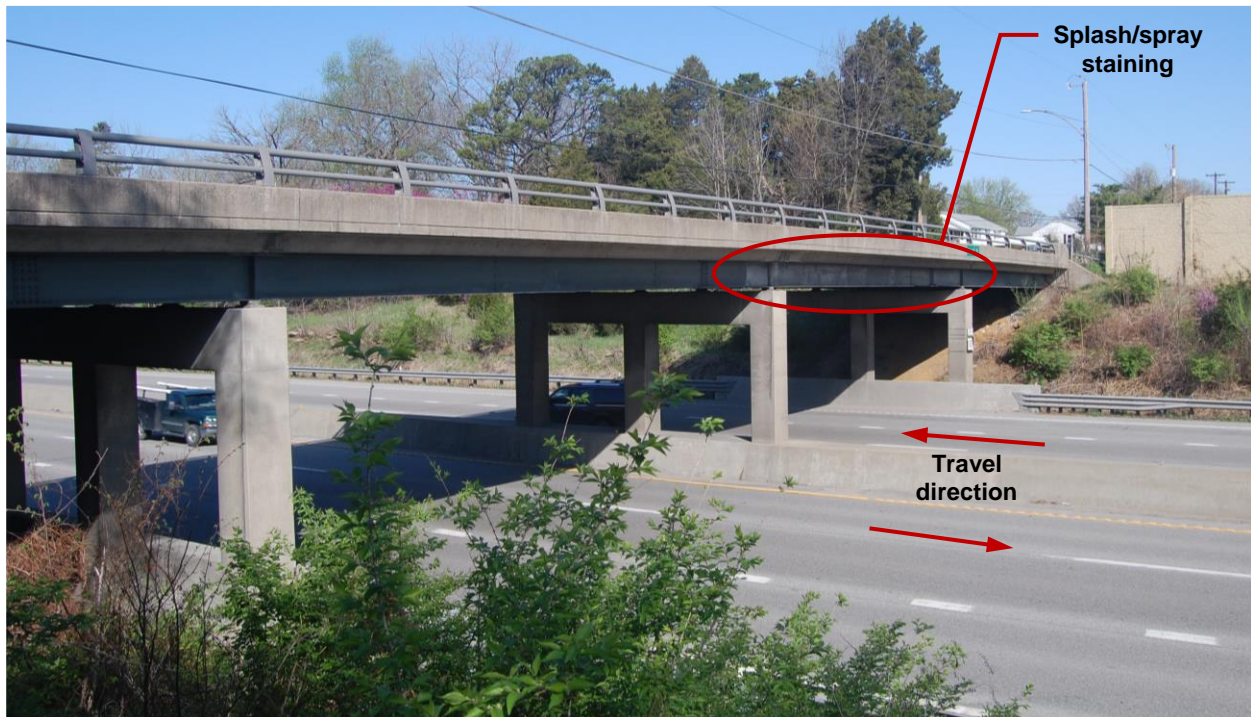
Figure 15. Roadway splash/spray zone.

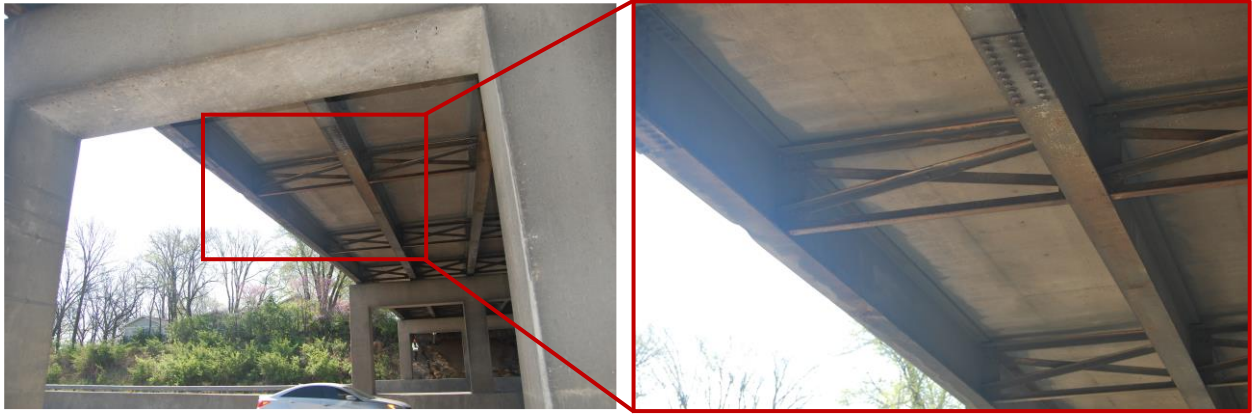
Figure 16. Underside view of the bridge from Figure 15 with coating deterioration in regions over the roadway.

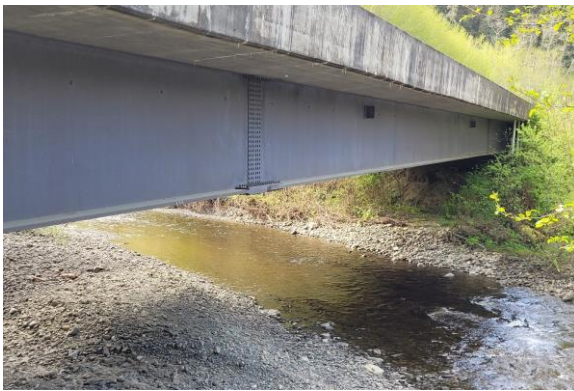
In regions away from the aggressive micro-environments discussed in the preceding sections, the SIOZ coatings generally performed well and were in good condition. Besides some of the application and construction related problems presented in subsequent sections, there were no atmospheric corrosion problems observed. Examples of good performance are shown in Figure 17.

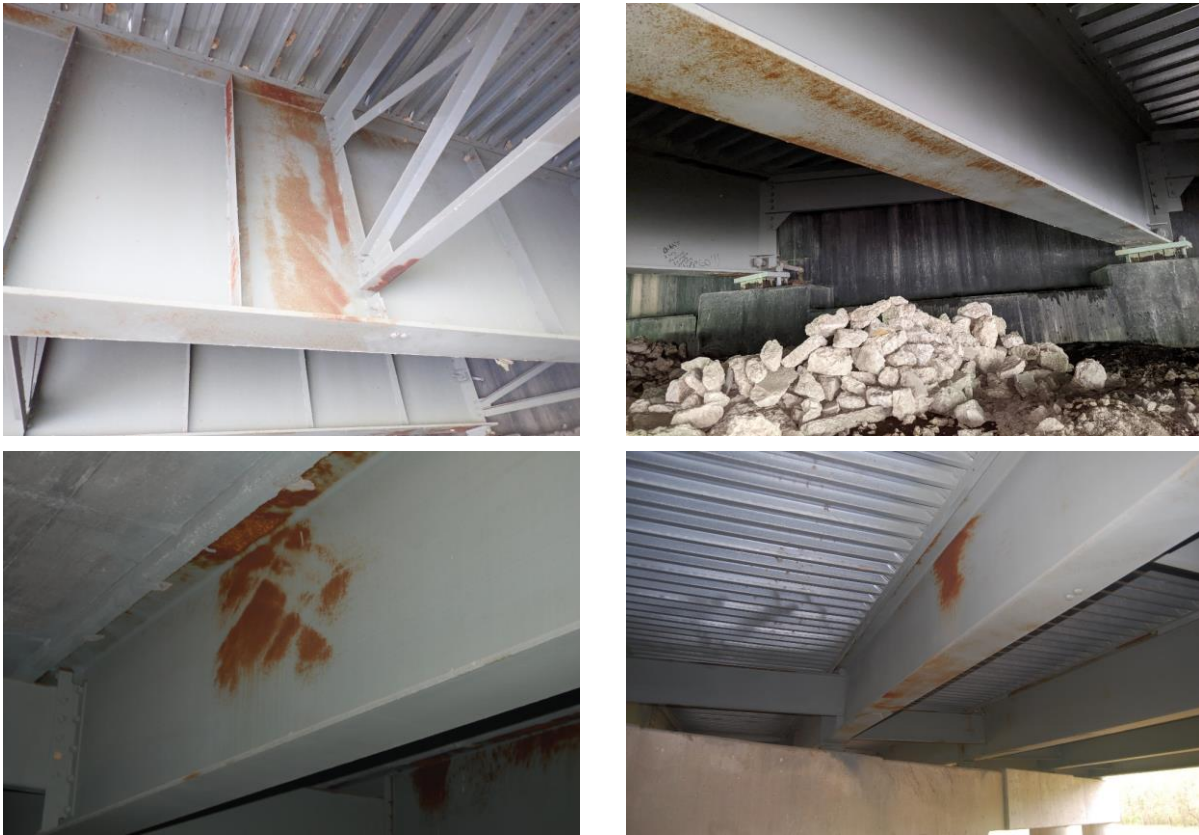
*Figure 18. Examples of surfaces with low DFT.*

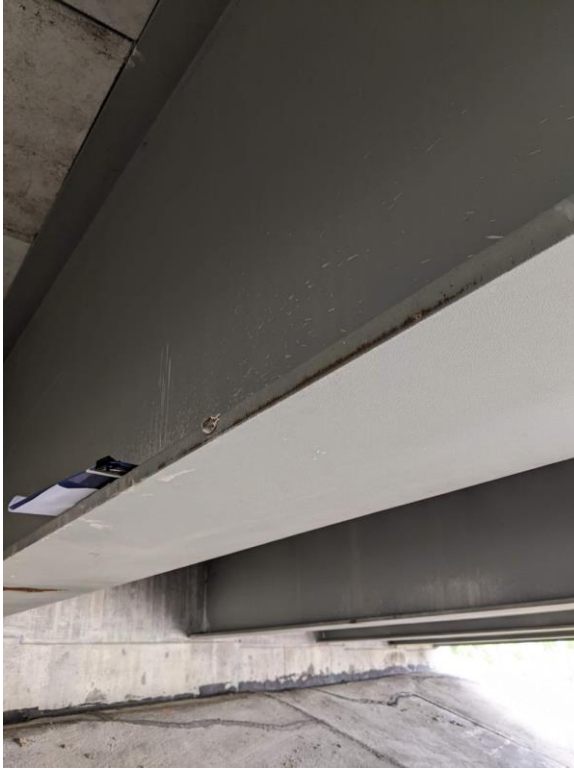
A related observation to low DFT was that specific surfaces were more susceptible to having low or nonexistent DFT. These surfaces included edges and bottom surfaces (see Figure 19). As discussed in Chapter 1, edge failure is common for most coatings due to their tendency to shrink around edges during curing. The low DFT observed on bottom surfaces was likely due to access limitations in the shop or field during application (i.e., harder to reach and spray bottom surfaces).

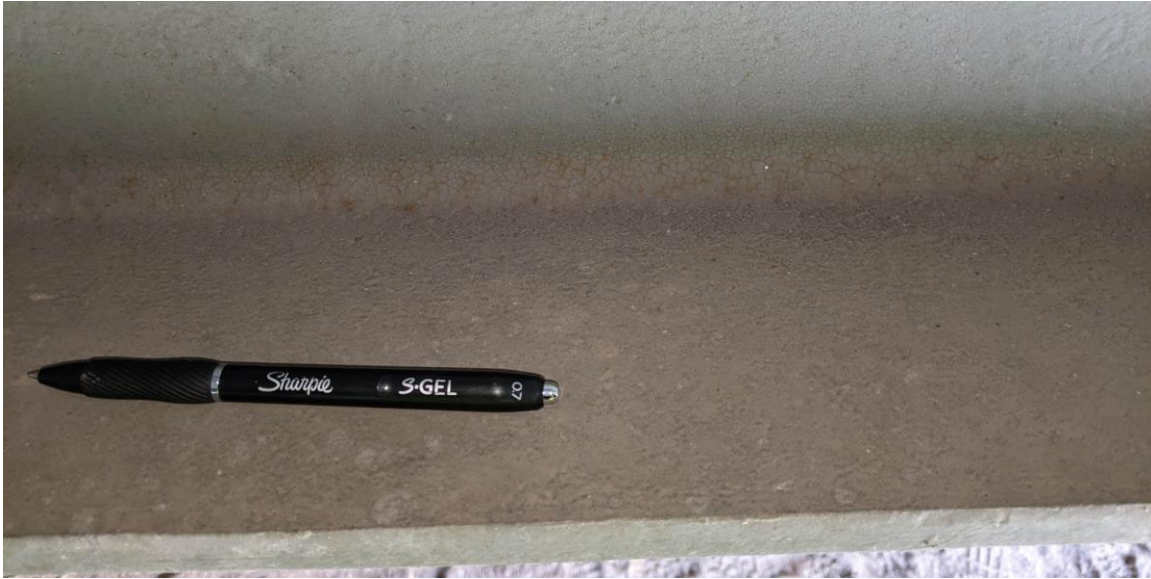
*(a) at bottom flange*

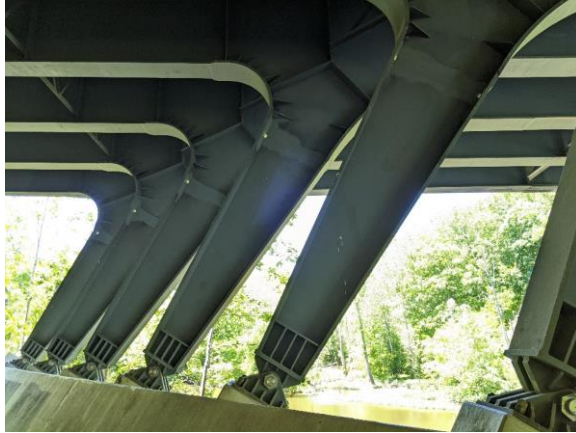
(a) typical condition

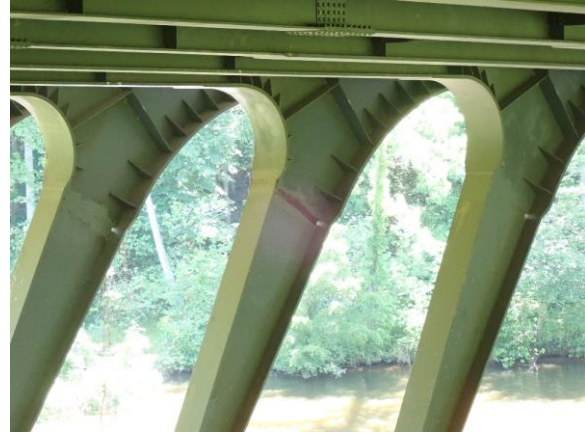
(b) location of corrosion

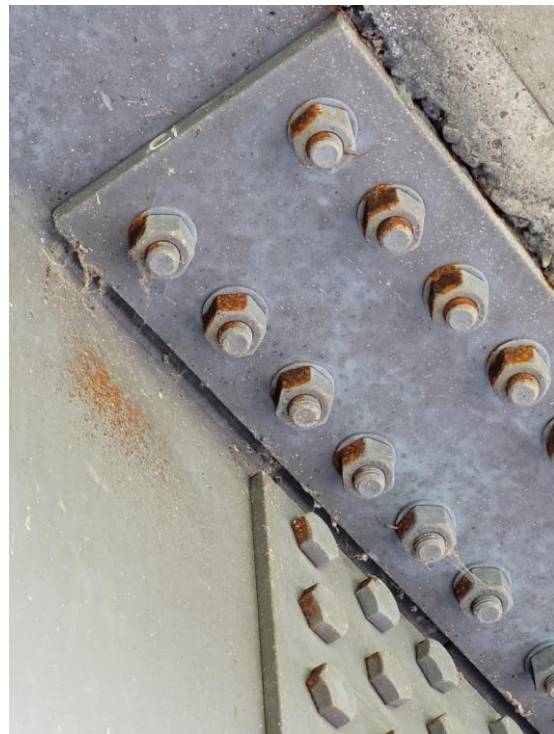
(b) surfaces of a bolted splice that were missed during field coating application

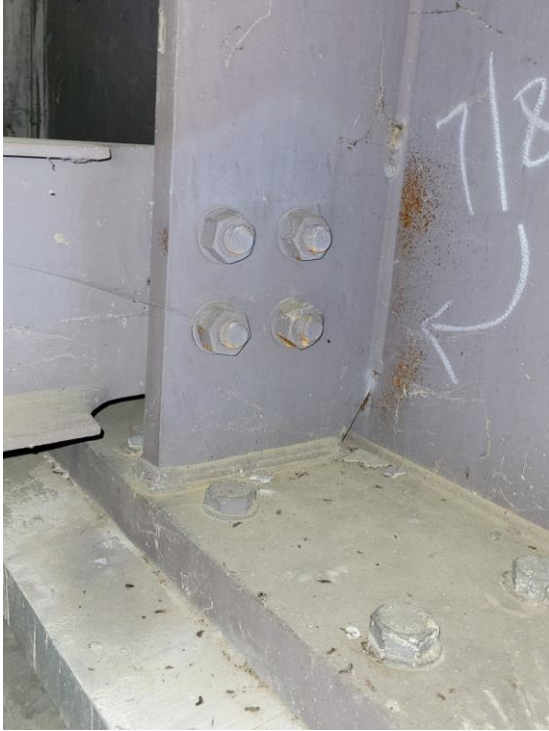
(a) insufficient coating and missed surfaces of a field coated bolted connection

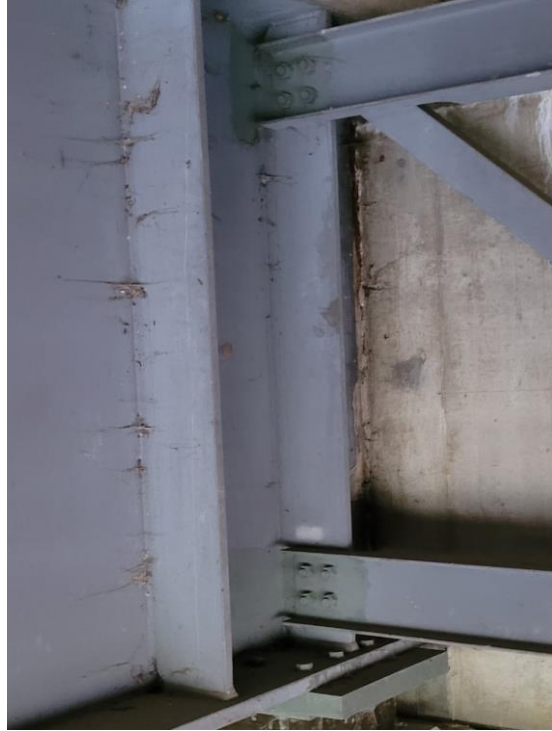
(b) properly field coated bolted connection

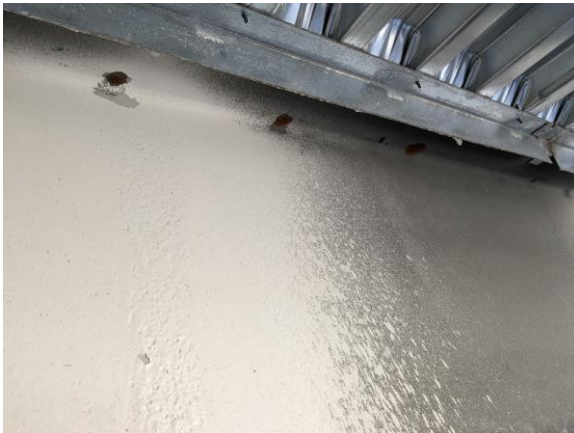
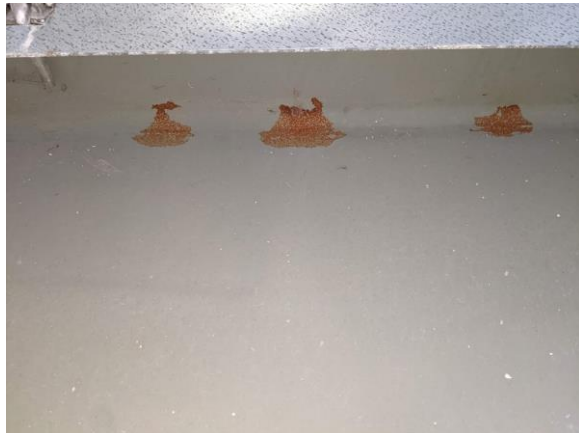
Figure 24. Examples of coating damage attributed to construction practices.

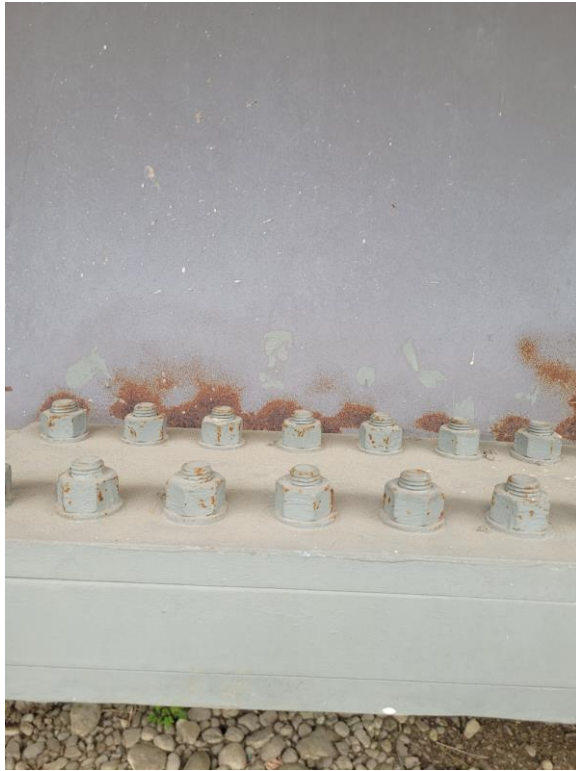
*(a) SIOZ coated fasteners*

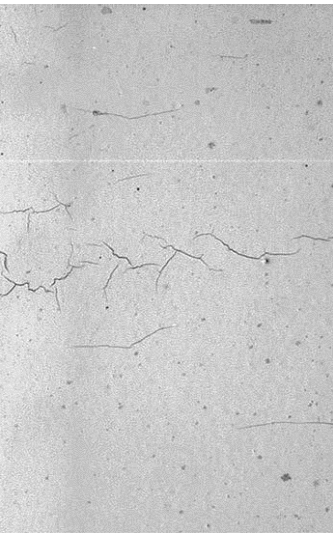
<p><i>Cracking:</i> That phenomenon manifested in paint films by a break extending through to the surface painted.</p>	<p>ASTM D661</p>

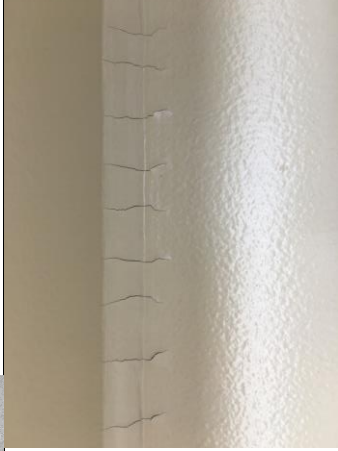
<p><i>Blistering:</i> Dome-shaped projections or blisters in the dry paint film through local loss of adhesion and lifting of the film from the underlying surface.</p>	<p>ASTM D714</p>

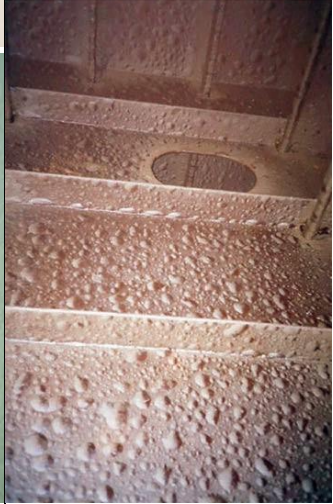
**Table 2. Coating Condition**

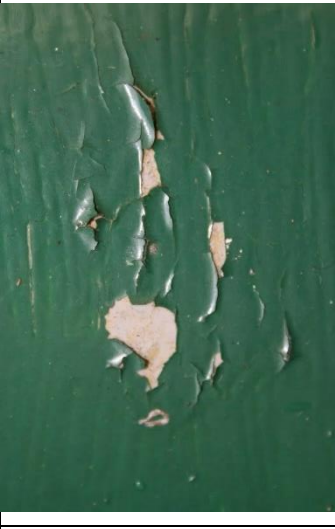
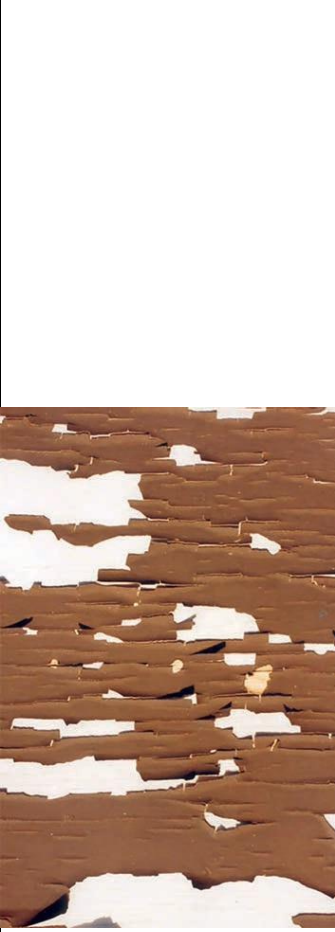
<p><b>Chalking:</b> The formation on a pigmented coating of a friable powder evolved from the film itself at or just beneath the surface.</p>	<p>ASTM D4214</p>

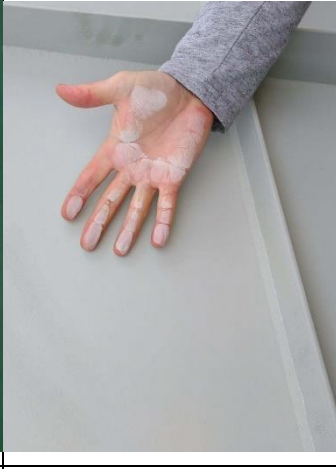
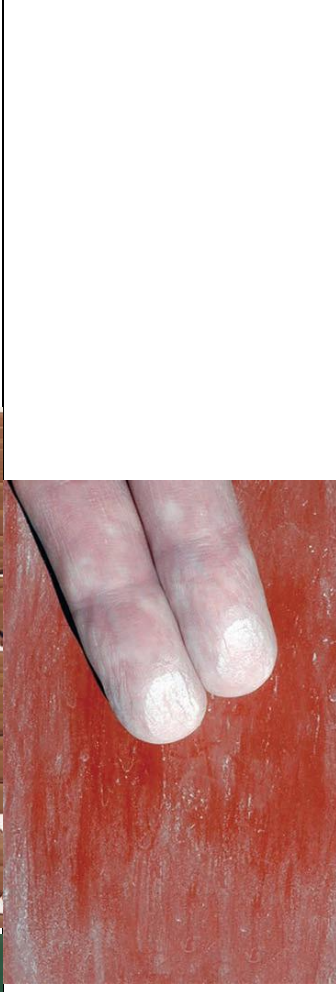
<p><b>Bubbling:</b> Trapped air or solvent due to improper drying, entrainment during mixing, or high ambient temperature during application. May be intact or broken (leaving a crater). Should not be confused with blistering.</p>	<p>-</p>

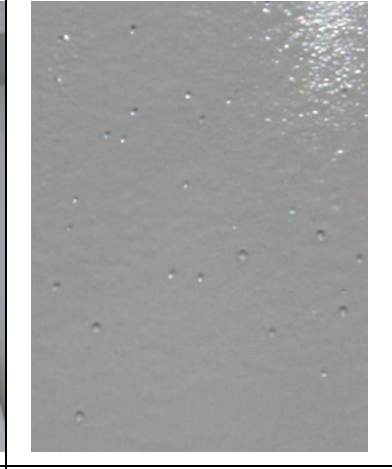
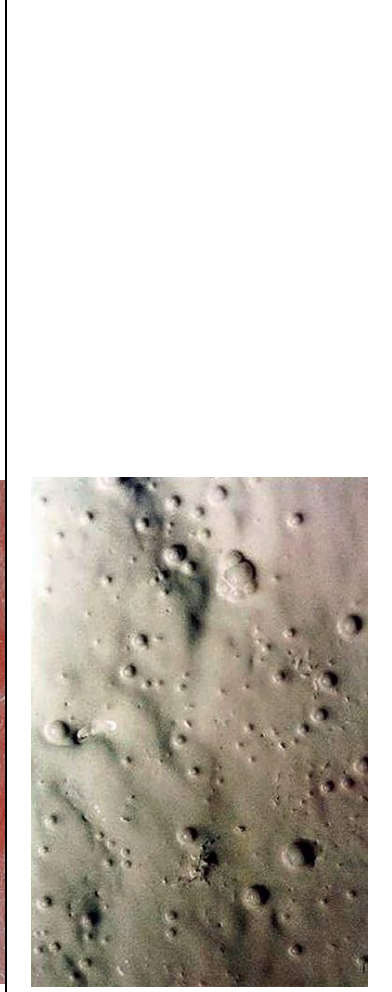
**Table 2. Coating Condition**

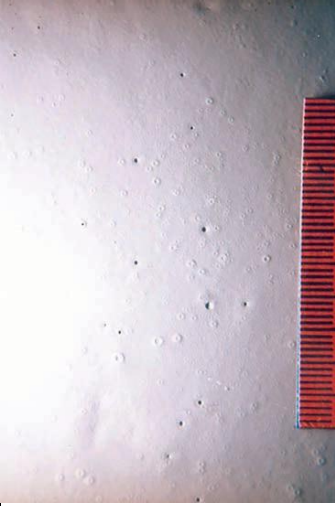
<p><i>Runs:</i> Downward movement of a coat due to accumulation of excessive coating quantities.</p>	-

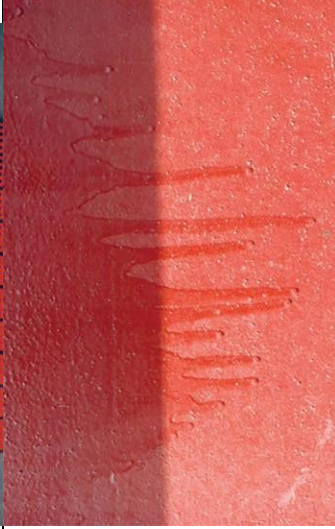
<p><i>Undercutting:</i> Visual corrosion beneath a paint film, often called creep. Corrosion travels beneath the paint film and lifts the paint from the substrate.</p>	-

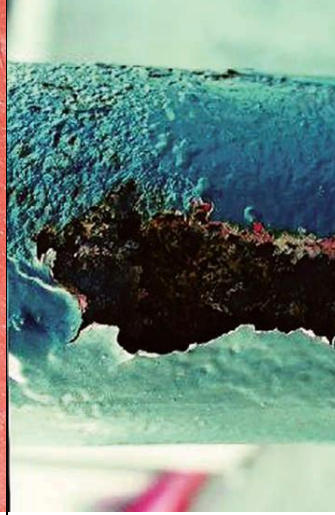
**Table 2. Coating Condition**

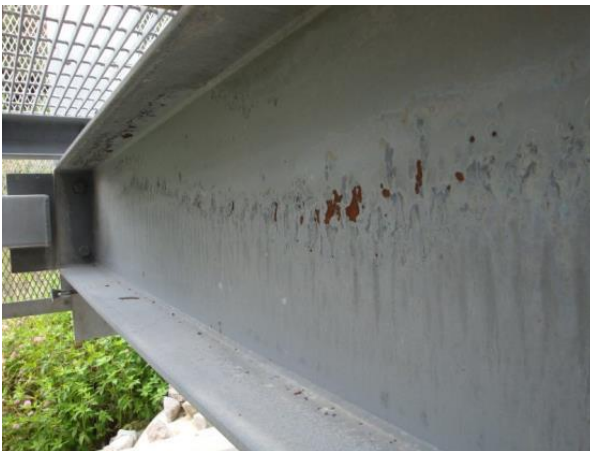
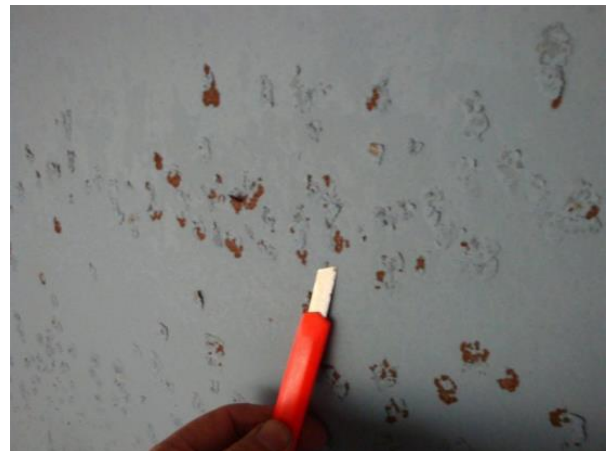
Figure B33. Photo. Example overall view of coating and substrate steel deterioration.
