Comparison of Structural Performance of Multi-Story Buildings Under Extreme Events

**COMPARISON OF STRUCTURAL PERFORMANCE
OF MULTI- STORY BUILDINGS UNDER EXTREME EVENTS**

Project Number 9809-000

October 5, 2004

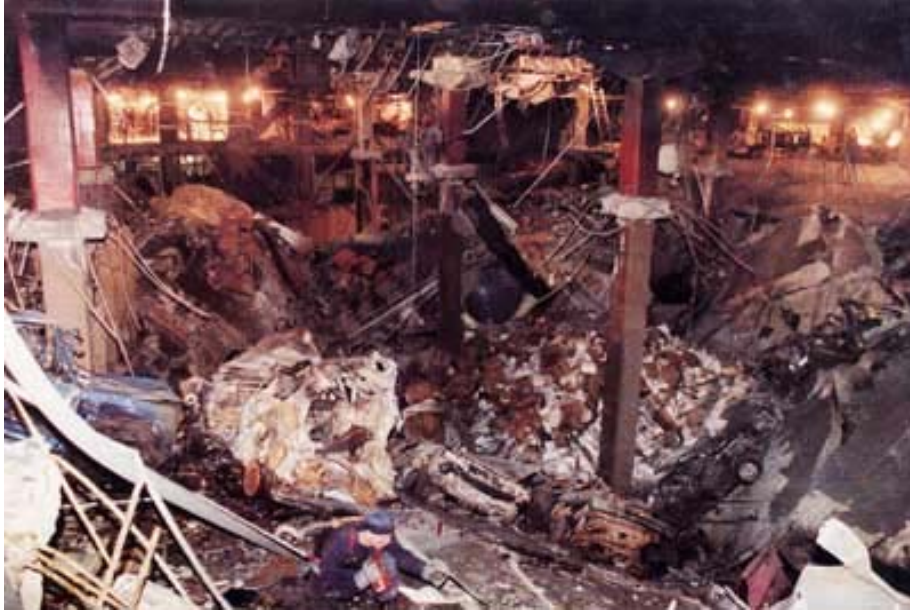
Elastic buckling strength of longer slender columns is an inverse quadratic function of their unbraced length, but shorter and stockier columns are governed by inelastic buckling that is relatively less sensitive to changes in member length. Under the assumed idealization that the blast damage increased the column unbraced length from about 15 ft to 60 ft, such a quadrupling of the column length is estimated to have effectively reduced the column strength of the affected members to approximately 33-67% of their pre-existing condition, with an assumption of initially stocky column slenderness ratios of 20-30. The overall structure remained standing through alternative load paths, which likely included whatever degree of lateral support was provided by the debris piles and remaining fire-protective concrete column encasement.

Figure 1. Destruction of Floor Slab Bracing and Weakened Lower Columns in WTC 1 after February 1993 Explosion (from Bureau of ATF 1993 explosives incident report)

Supplemental bracing of the blast-damaged columns became the first repair priority in the repair effort. Steel hollow structural sections (HSS) were connected horizontally and diagonally as temporary replacement for the failed floor slabs on an emergency basis in five days, after which the many other repairs and clean up could then safely proceed.

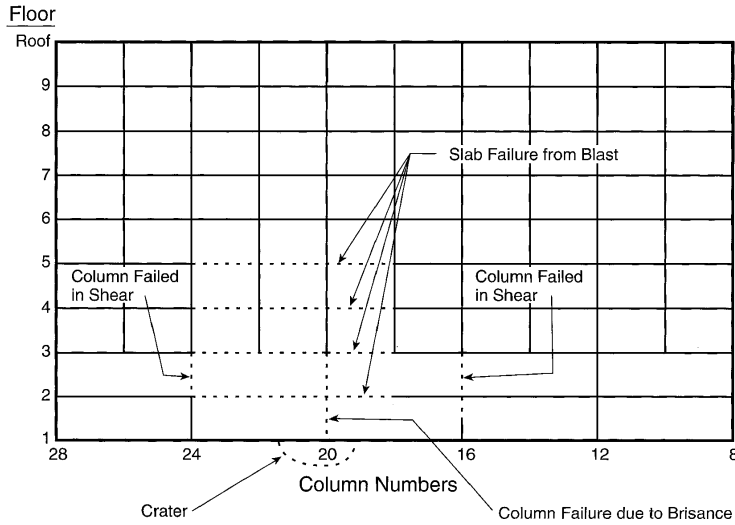
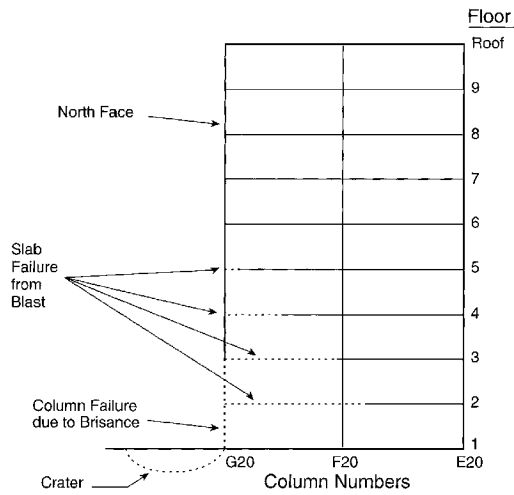
A bomb, estimated to be about 4,000 lbs TNT equivalent, was detonated on April 19, 1995. It immediately failed parts of three of the building's columns stacks and four levels of floor bays on the north face, as shown in Figure 3. The detonation occurred about 16 ft from column G20, and caused a crater approximately 28 ft in diameter and 6.8 ft in depth. The initial blast damage area in the Murrah Federal Building can be estimated to have totaled about 11,200 ft² of floor area. Approximately three seconds after this blast detonation, a progressive collapse ensued that brought down almost the entire northern half of the 9-story building, as shown in Figure 4. The term progressive collapse, as used herein, is generally defined as one which the failure is significantly disproportionate to the initial triggering event. The ratio of the final collapsed floor area to that originally damaged by the blast is roughly four, which would qualify the Murrah Federal Building collapse to be considered a progressive, or disproportionate, collapse.

Once the three columns on lines G16, G20, and G24 were initially damaged by the blast at the second level to effectively sever their vertical gravity load paths, the rest of the northern half of the frame was unable to redistribute these loads to the remaining members, and progressive collapse ensued. Simply put, given the initial blast damage and member failures, particularly the critical loss of the lower column G20, the remaining

a) Initial Blast Damage, North Elevation at Column Line G

b) Elevation Section of Blast Failures

Figure 3. Immediate Blast Damage to Murrah Federal Building

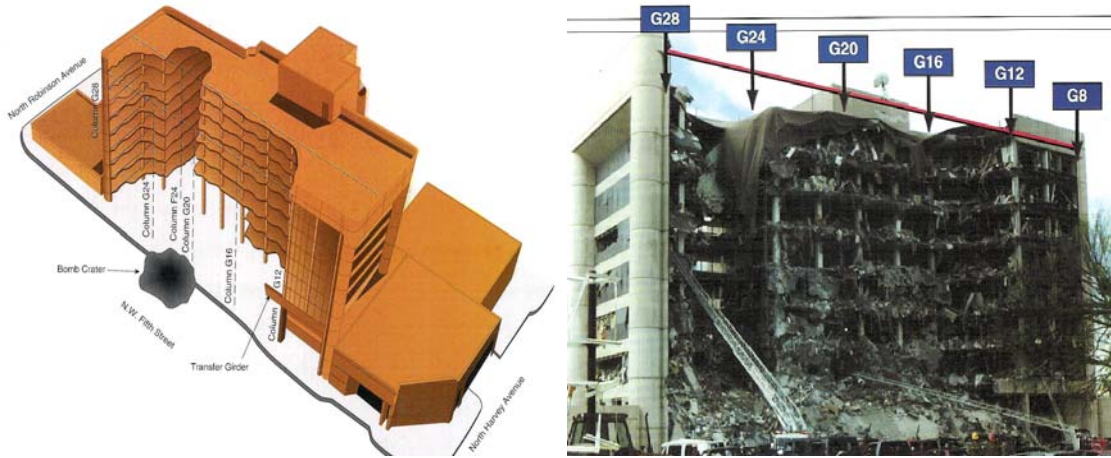
FEMA 277 attributes the causes of this progressive collapse to several factors. One factor was the lack of continuity reinforcement in the transfer girders and floor slabs, which was not required by code for a concrete Ordinary Moment Frame. A second factor was the ordinary detailing provisions for the concrete columns did not provide for the redundancy and ductility necessary for additional column demands, which would have been present with spiral and shear reinforcement. The absence of these features contributed to the original blast damage in the columns, and subsequently did not allow for a beneficial secondary bending mechanism to develop in the floor spans between the surviving columns. This led to the final catastrophic failure. FEMA 277 concludes and recommends that seismic detailing, as required for a concrete Special Moment Frame, would have mitigated much of the primary and secondary structural damage for this type of explosion. The American Concrete Institute (ACI) has since introduced reinforcing detailing requirements for structural integrity, currently contained in Section 7.13 of ACI 318-02. These requirements are general prescriptive criteria intended to provide some nominal continuity of reinforced concrete joists, beams and two-way slabs for cases of limited unexpected structural damage, such as failure of one support.

Figure 4. Progressive Collapse of North Side of Building

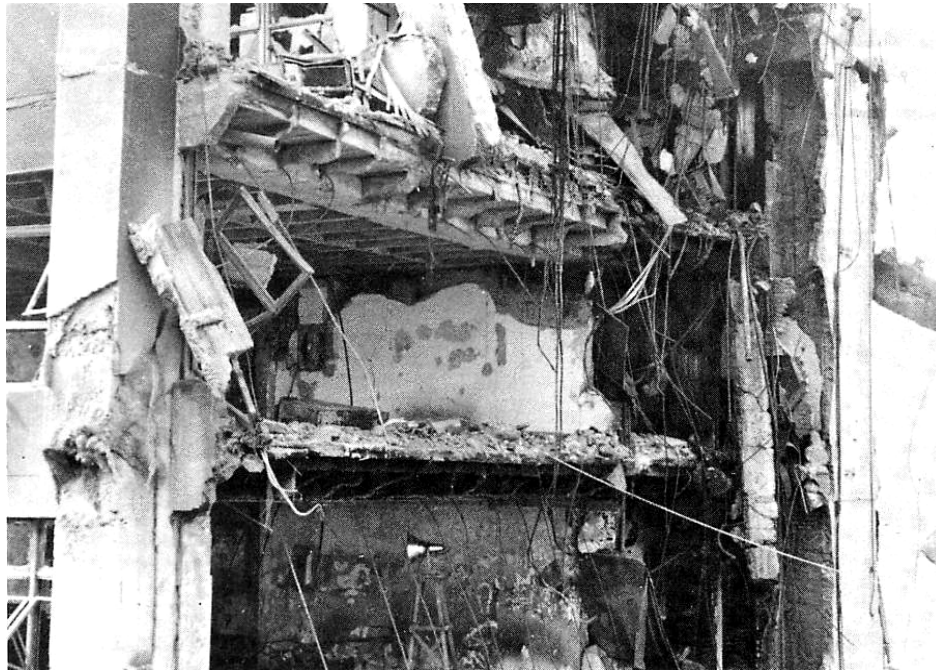
Figure 7. CESP 2 Core Collapse in Sao Paulo, Brazil

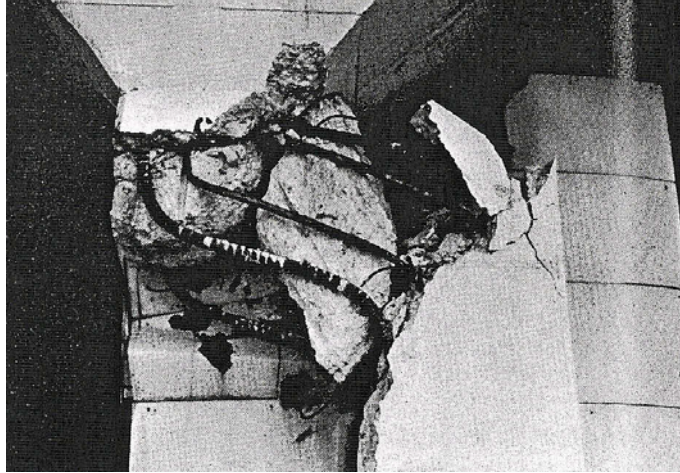
6th floor. The roof collapse began after about 12 hours of fire exposure, and was concentrated in the 30 percent of the roof slab above the estimated point of origin of the fire. Subsequent to this, most of the remaining freestanding columns on the sixth floor toppled over. Almost no fire damage was experienced below the 6th floor. The collapse and damage were attributed to the large horizontal expansion of the 7-in.-thick, conventional concrete roof slab that was supported by 16-in. square tie-reinforced concrete columns. There were no expansion joints in the floors or roof. Lateral roof displacements of almost 2 ft occurred in one corner. Figure 8 shows the extent of the sixth floor horizontal deformation and damage to the concrete columns due to this roof thermal expansion. These failures appear to be similar to the column failures that have often occurred during earthquakes.

Figure 8. Large Lateral Deformations and Failure of Columns at Sixth Floor of Military Personnel Records Center

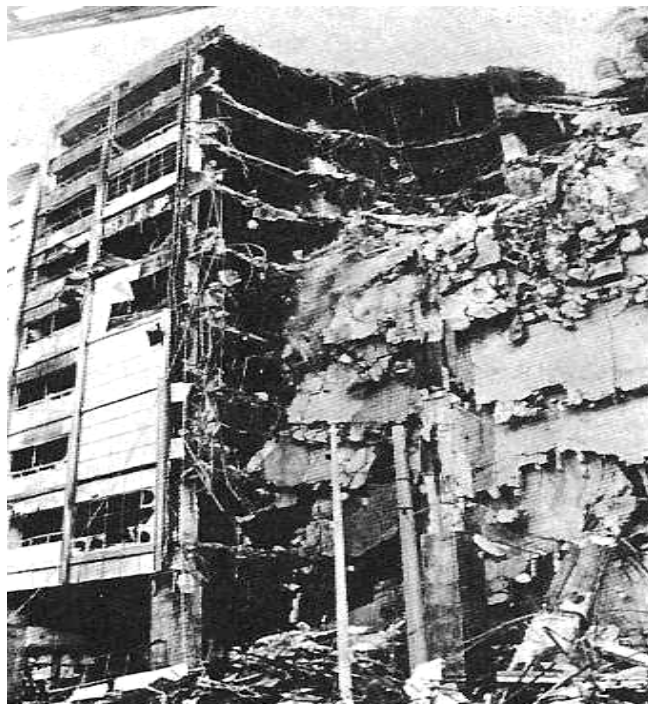
Two large department store fires occurred in Athens, Greece in 1980 (Papaioanna, 1986). These fires began at 3 AM on Dec. 19, 1980, with arson being suspected as the cause. The Katrantzos Sport Department Store was an 8-story reinforced concrete building. Its fire started at the 7th floor and rapidly spread throughout the building, due to lack of vertical or horizontal compartmentalization and the absence of sprinklers. Evidence collected indicated that the fire temperatures reached 1000°C over the 2-3 hour fire duration, and the firefighters concentrated on containing the fire spread to the adjacent buildings. Upon later inspection, it was discovered that a major part of the 5-8th floors had collapsed. Various other floor and column failures throughout the Katrantzos Building were also observed (see Figure 9). The cause of these failures was considered to be restraint of the differential thermal expansion of the structure that overloaded specific elements or connections.

Figure 9. Katrantzos Building in Athens, Greece After 1980 Fire

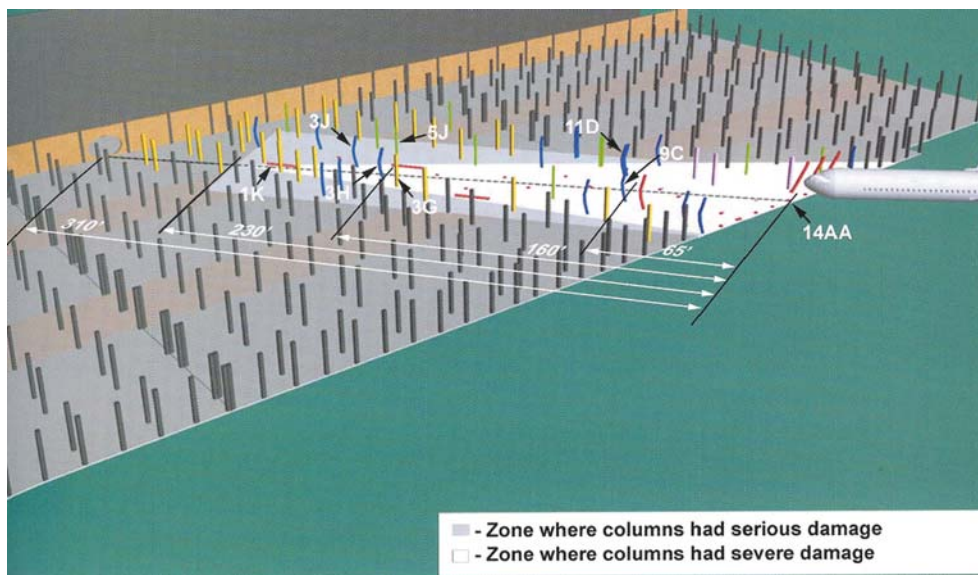
Figure 11. First Story Impact Damage in the Pentagon

The impact damage documented in ASCE-SEI (2003) to the Pentagon's first floor is summarized in Table 1 and shown in Figure 11. It illustrates the depth of the jet's penetration and resulting extent of column damage to the building's outer ring. About 50 reinforced concrete columns were destroyed, or significantly impaired, with the jet piercing through a 120 ft width of the nominally 13-in.-thick perimeter exterior wall, and its parts or debris exiting through an approximately 6-ft-diameter hole punched out in the AE drive wall between Rings B and C, as shown in Figure 12. In the process, a corridor of major damage measuring approximately 90 ft to 45 ft in width, 250 ft in length, and 25 ft in height (1-2 stories) along the impact trajectory was mapped.

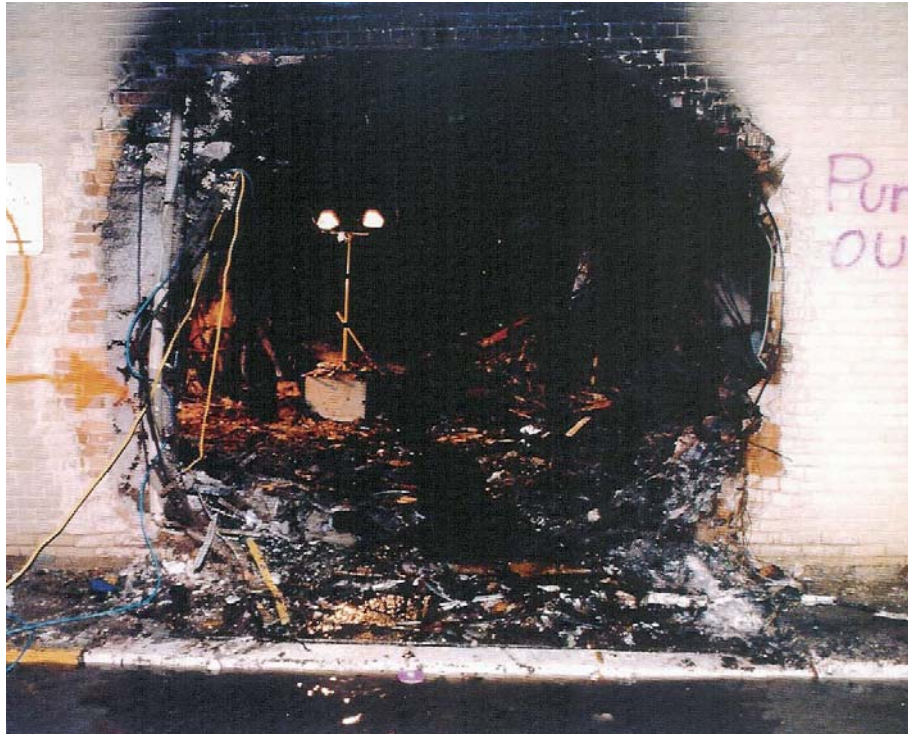
Figure 12. Impact Exit Hole at AE Drive Wall in Pentagon

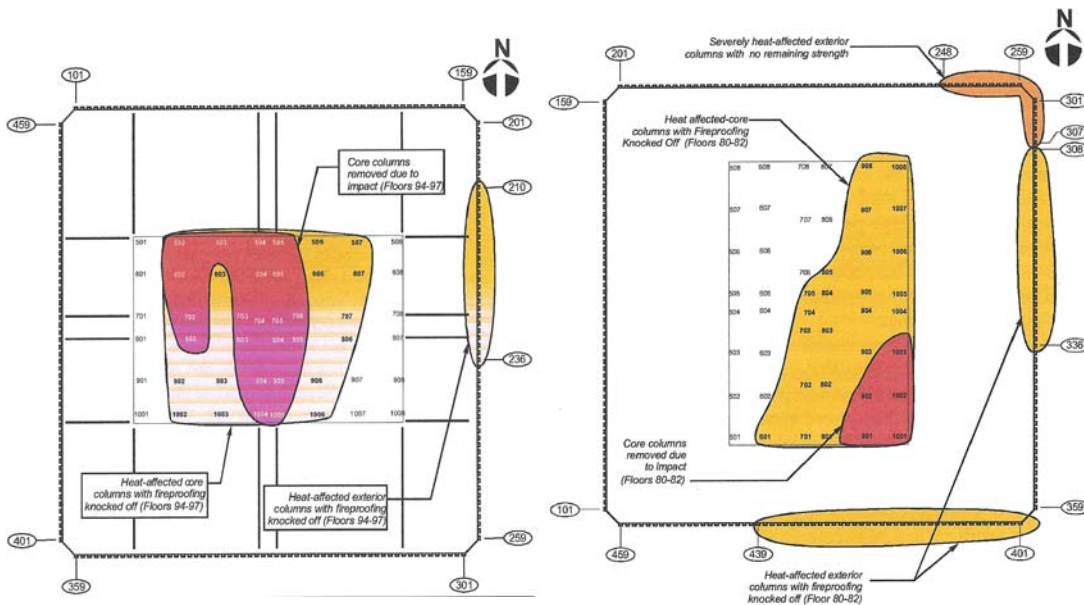
Figure 13. Expected Impact Damage to Columns of WTC Towers 1 and 2

One simple measure of estimated impact damage is the spatial volume enveloping the most seriously damaged areas. This volume is calculated from the approximated length, width, and height distances. Using the average spatial volume of the damage paths given in Table 1, it can be seen that the initial damage patterns are roughly equivalent (within 10 percent) in each of the three targeted buildings at about 500,000 ft³. Essentially, the lower depth of impact damage to the Pentagon relative to the WTC is offset by its longer depth of penetration. Also, a count of the impact damaged column lines in Table 1 is about the same (a total of 50) between the Pentagon and WTC 1, without consideration of the steel columns that only lost spray-applied fire protection material from the impacts. The total number of seriously damaged column lines in WTC 2 was slightly lower (about 35) but their asymmetry (see Figure 13) was a factor in the secondary collapse.

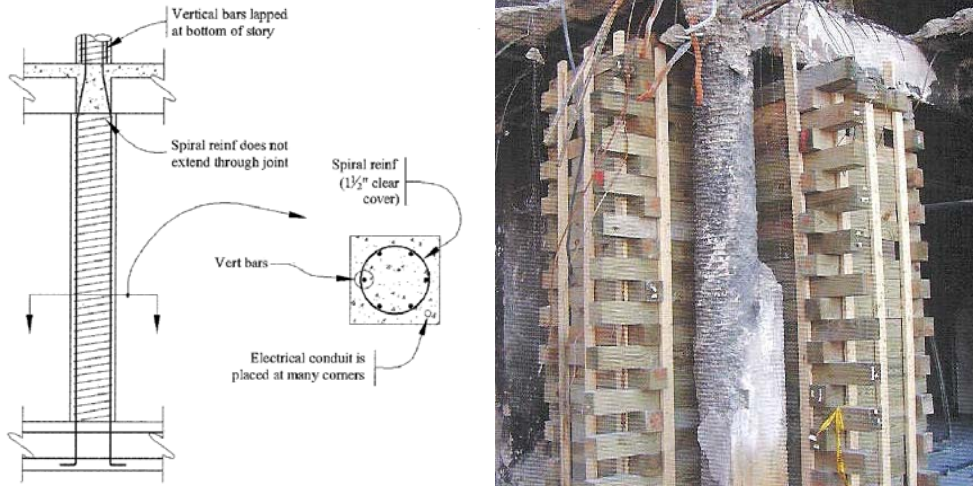
FEMA 403 clearly raises concerns about the impact resistance of spray-applied fire protection material for steel framing. ASCE-SEI (2003) is silent on the parallel danger that prior destruction or spalling of concrete cover over steel reinforcement brings in the event of a fire, not to mention the loss of section effects on reduction of the compressive strength capabilities of the concrete member. The importance of maintaining adequate fire protection and fire resistance for reinforced concrete construction under extreme conditions appears to have not been as widely acknowledged as it has been for structural steel framing. Harder and stronger materials, such as concrete, will usually offer more durable fire protection to the structural framing for typical service conditions. However, under high impact and blast exposures, it is probable that all normal fire protection, such as conventional concrete cover, spray-applied materials, and gypsum

Figure 15. Original Detail and Post-impact Condition of Pentagon Column
