**VIRGINIA POLYTECHNIC INSTITUTE
AND STATE UNIVERSITY**

**EVALUATION OF THE EFFECT OF BOAT-SHAPED WELDS AND
PNEUMATIC POWER ACTUATED FASTENERS
ON THE SEISMIC BEHAVIOR OF MOMENT FRAMES**

December 2015

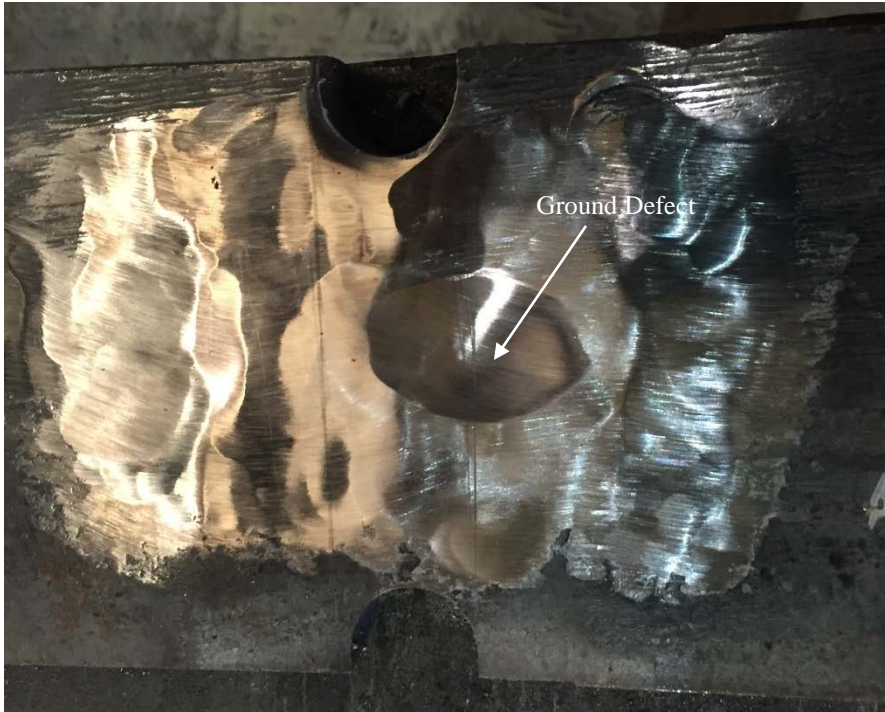
Figure 2.9 – Ground out defect in BSWR specimen.

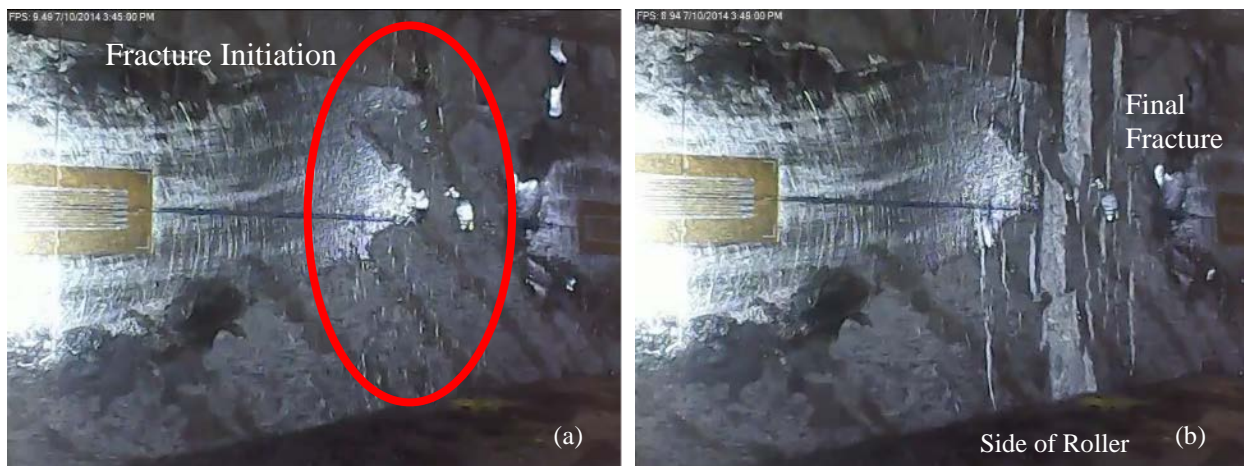
Fracture initiation was observed to occur in many locations across the face of the bare specimens as shown in Figure 3.4a. The cycle associated with fracture initiation was determined visually using six high definition cameras. Upon further bend cycles, the fractures propagated and linked up until one fracture line reached a critical length and the fracture propagated through the rest of the specimen in a sudden and brittle fashion as shown in Figure 3.4b.

Figure 3.4– Fracture initiation at multiple locations at the bottom of Specimen W24-B2-T59-R025 on cycle 3, complete fracture at the bottom side of the specimen at cycle 5.

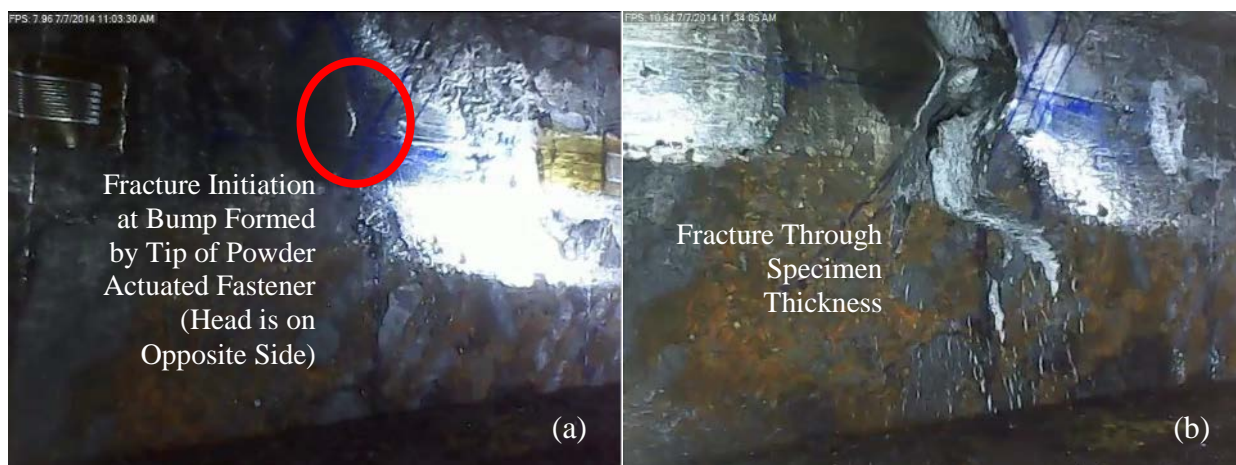
The behavior of the powder actuated fastener bend specimens was sensitive to specimen thickness. When the PAF were installed in 0.59 in. thick specimens in the top side of the specimen, the tip of the fastener was close to the surface of the bottom side of the specimen. An observable bump formed on the bottom side as shown in Figure 3.5(a). See Section 2.5 for a definition of the top side and bottom side of a specimen. During cyclic bend testing, fracture initiated at the bump on the back side of the specimen. The fracture propagated relatively slowly compared to other artifacts, and then final fracture through the thickness of the specimen occurred at the location of the PAF tip. The local effect due to the PAF tip was likely the reason that fracture initiated at an average of 2.3 cycles as compared to 8.3 cycles for bare steel specimens. Even though the fracture formed earlier than some other artifact types, the slow fracture propagation led to an average cycle at full fracture of 9.0 as compared to 13.3 average cycles to failure for the bare steel specimens. Although fractures also formed on the top side of the specimen around the head of the PAF, the final fracture occurred when the bottom side of the specimen was in tension.

Figure 3.5 – Fracture initiation on Specimen W24-PAF1-T59-R000 at the bottom of the PAF at cycle 3, cycle 18

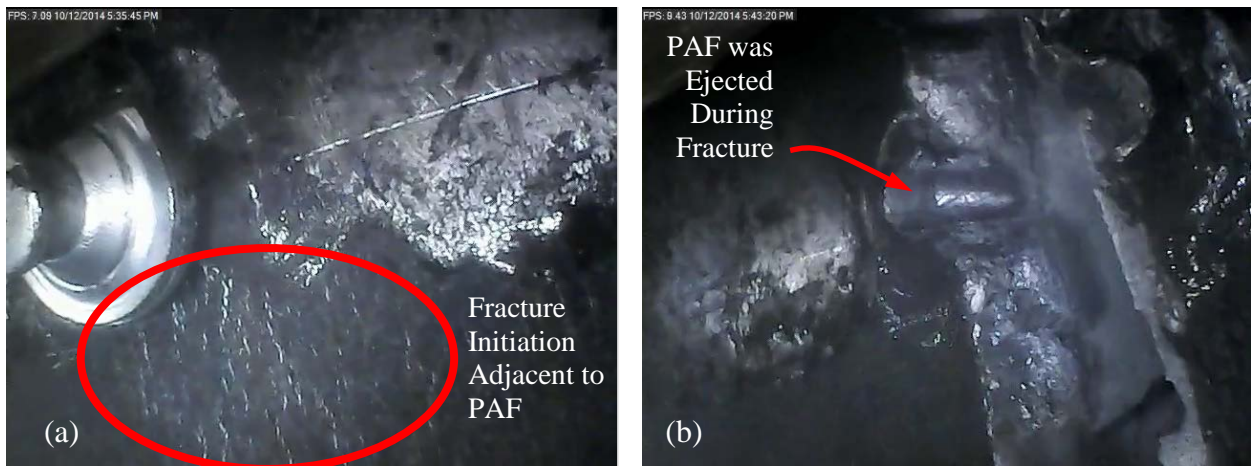
Thicker specimens with 0.94 in. thickness behaved differently than thinner specimens. Multiple cracks formed in the areas adjacent to the PAF as shown in Figure 3.6. Fracture propagation was observed to happen on the top side around the PAF head until final fracture occurred through the PAF location as shown in Figure 3.6b. For the 0.94 in. thick specimens, the tip of the PAF was more in the center of the specimen closer to the neutral axis. In the absence of local effects described above for thinner specimens, fracture initiation occurred in a similar cycle as the bare specimen. The average cycle at fracture initiation was 2.7 as compared to 2.3 for bare steel specimens. Since 0.94 in. thick specimens with puddle welds had the same average cycle at fracture initiation as PAF, it is likely that the difference in fracture initiation cycle between PAF and bare specimens was due to variability in the material. The cycle at final fracture was 3.7 on average for PAF compared to 4.0 for bare steel specimens. This implies that for the 0.94 in. thick specimens, PAF had little effect on the cycle number when fracture initiated or the cycle when fracture propagated through the specimen.

Figure 3.6 – Fracture initiation on Specimen W36-PAF1-T94-R000 at the top of the PAF at cycle 4, complete fracture occurred at the top side of the specimen near the PAF at the beginning of cycle 6.

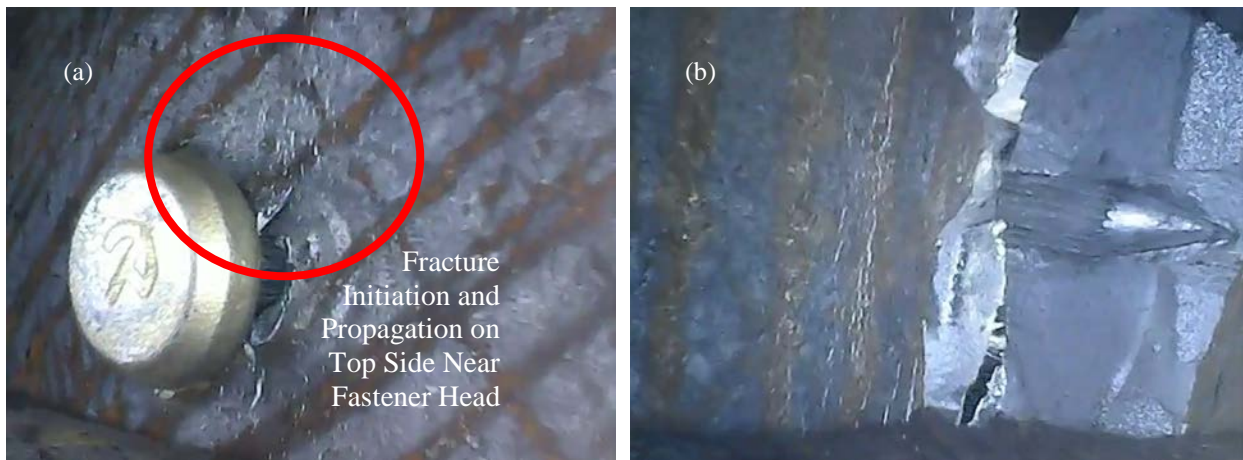
Similar to powder actuated fasteners, the effect of the 5/8" PnAF artifacts on the fracture behavior was sensitive to specimen thickness. For all three of the 0.59 in. specimens, fracture was observed to initiate on the top side of the specimen (side with the head of the fastener) near the fastener head as shown in Figure 3.7a. Fracture initiation for all three specimens occurred while the top side with the fastener head was in tension and the bottom side was in compression. The average cycle when fracture initiation occurred was 2.7 compared to 8.3 for the bare steel specimens and 2.3 for the powder actuated fastener specimens. The average cycle at full fracture was 6.3 compared to 13.3 for bare steel specimens and 9 for the powder actuated specimens. For two of the specimens, full fracture occurred on the bottom side when the bottom side was in tension and for one specimen full fracture occurred on the top side when the top side was in tension. Even though the 5/8" PnAF's did slightly better in their fracture initiation cycle, the fracture propagated much faster than in the PAF specimens leading to a final fracture cycle that was much lower. This may have been due to the fact that the fracture initiated on the top of the specimen around the fastener head where the steel was discontinuous due to the fastener shaft rather than on the back side where the continuity of the steel remained intact.

Figure 3.7– (a) Multiple fracture initiation and fracture propagation on Specimen W24-PnAF062.5-T59-R100 at the top and side of the fastener head at cycle 3 while in tension, and (b) complete fracture occurred on Specimen W24-PnAF062.5-T59-R100 at the bottom side of the specimen at cycle 4 while in tension.

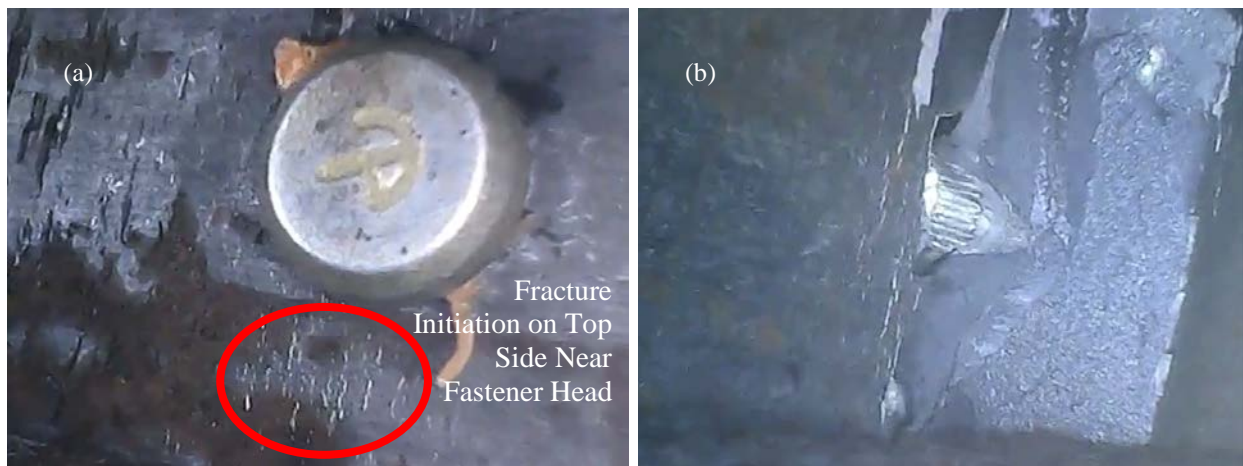
In all three of the 0.94 in. thick specimens, fractures also initiated around the fastener head as shown in Figure 3.8a. Fractures initiated and propagated when the top side (side with the fastener head) was in tension. For all three specimens, final fracture through the thickness of the specimen occurred when the fastener head side was in compression (see Figure 3.13b). With an average fracture initiation cycle of 2.3 and average final fracture cycle of 3.3, which are similar to the values for bare steel specimens, however the average final fracture cycle is slightly lower. These are promising results given that the bare steel specimen represents the best case scenario when evaluating defects in the protected zone.

Figure 3.8– (a) Multiple fracture initiation on Specimen W36-PnAF062.5-T94-R025 at the bottom of the fastener head at cycle 2 while in tension, and (b) complete fracture occurred on Specimen W36-PnAF062.5-T94-R025 at the bottom side of the specimen at cycle 2 while in tension.

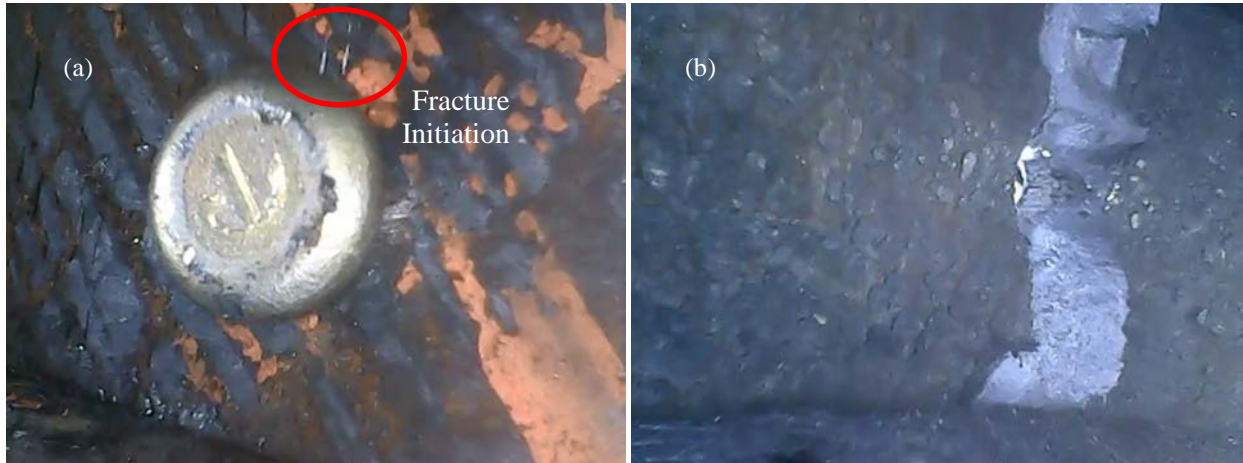
The number of cycles to fracture initiation and propagation for the 3/4” PnAF was also sensitive to specimen thickness although not as sensitive as for the 5/8” PnAF’s. For all three of the 0.59” specimens, fracture was observed to initiate on the top side of the specimen (side with the head of the fastener) near the fastener head as shown in Figure 3.9a. Fracture initiation for all three 0.59” specimens occurred when the top side of the specimen was in tension. Final fracture as seen in Figure 3.9b occurred for all three specimens on the bottom side when the bottom side of the specimen was in tension and the top side was in compression. The average cycle when

Figure 3.9 – a) Fracture initiation on Specimen W24-PnAF075-T59-R000 on the top side of the specimen near the fastener head at cycle 4 while in tension, and b) Bottom of the specimen showing complete fracture at cycle 9 while in tension.

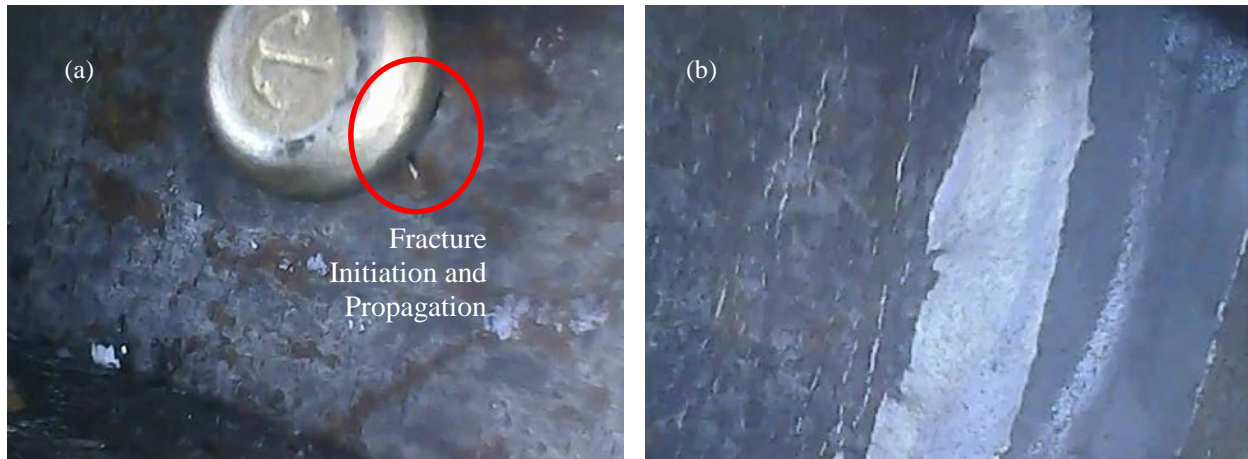
For the 0.94” thick specimens, fracture was observed to always initiate near the fastener head on the top side of the specimen as shown in Figure 3.10a. Fracture initiation for all of the 0.94” specimens occurred when the top side of the specimen was in tension. For two of the 0.94” thick specimens, final fracture occurred on the bottom side of the specimen when the bottom side was in tension and for one of the 0.94” thick specimens, final fracture occurred on the top side of the specimen when the top side was in tension. The average cycle when fracture initiation occurred was 2 as compared to 2.3 for the bare steel specimens and 2.7 for the powder actuated fastener specimens. The average cycle at full fracture was 3 as compared to 4 for the bare steel specimens and 3.7 for the powder actuated fastener specimens. So in the case of the 3/4” PnAF artifacts, none performed as well as the control in the cyclic tests.

Figure 3.10 – a) Fracture initiation and propagation on Specimen W36-PnAF075-T94-R000 under the fastener head on the top side of the specimen while in tension at cycle 2, and b) complete fracture on back side of specimen while in tension at cycle 5.

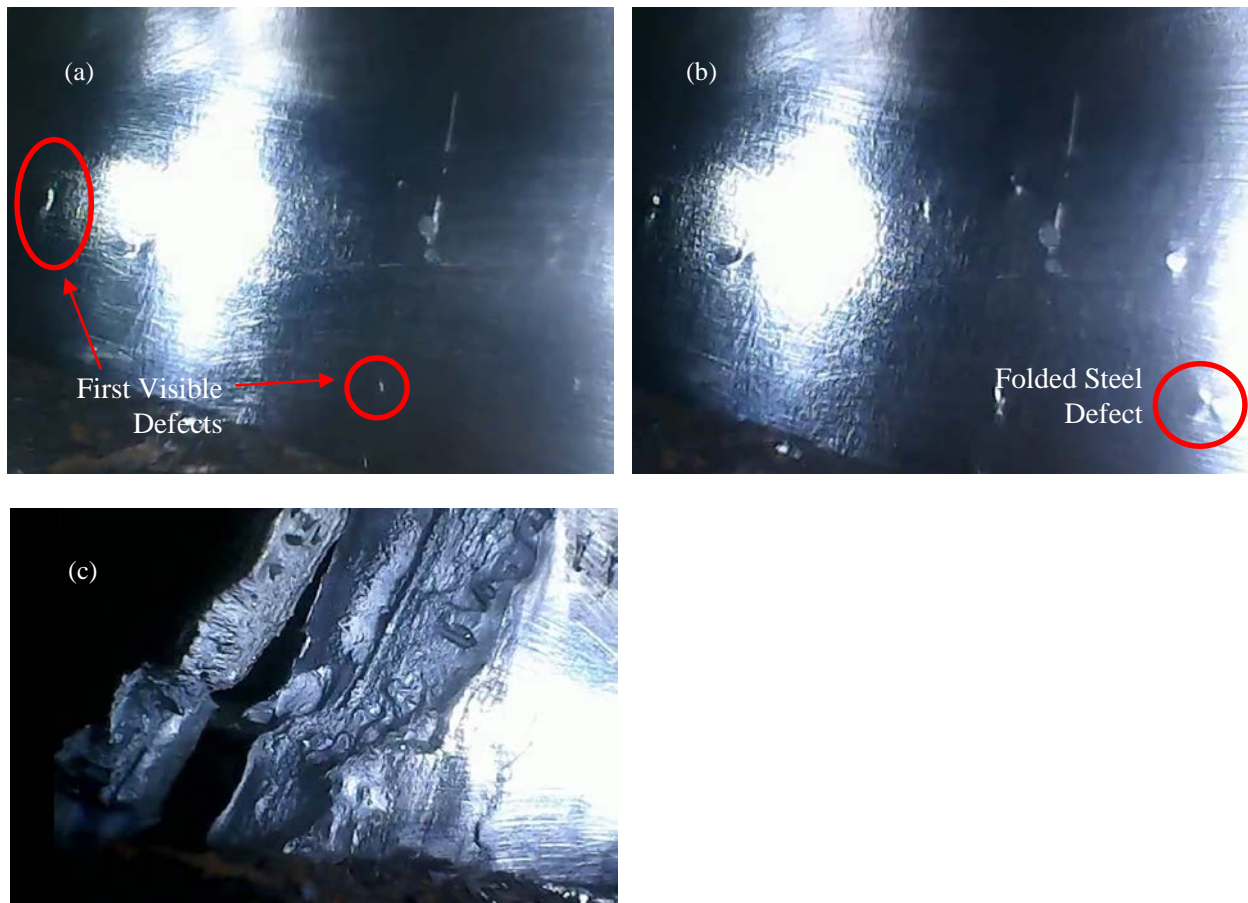
The first visible defect and fracture initiation cycle didn't seem to be effected by specimen thickness however the final fracture cycle was. For the 0.59" specimens, fracture was observed to always initiate and propagate on the top side of the specimen (side with the weld repair) as shown in Figure 3.11a and b. The first visible defect and fracture initiation always occurred when the top of the specimen was in tension. The final fracture for two of the 0.59" thick specimens occurred on the bottom side of the specimen when the bottom side was in tension. For the third 0.59"

Figure 3.11 – a) First visible defects on specimen W24-BSW-T59-R000 during first cycle on top side of specimen in tension, b) Folded steel defect on specimen during cycle 2 on top side of specimen in tension, and c) final fracture through top side of specimen in tension during cycle 13.

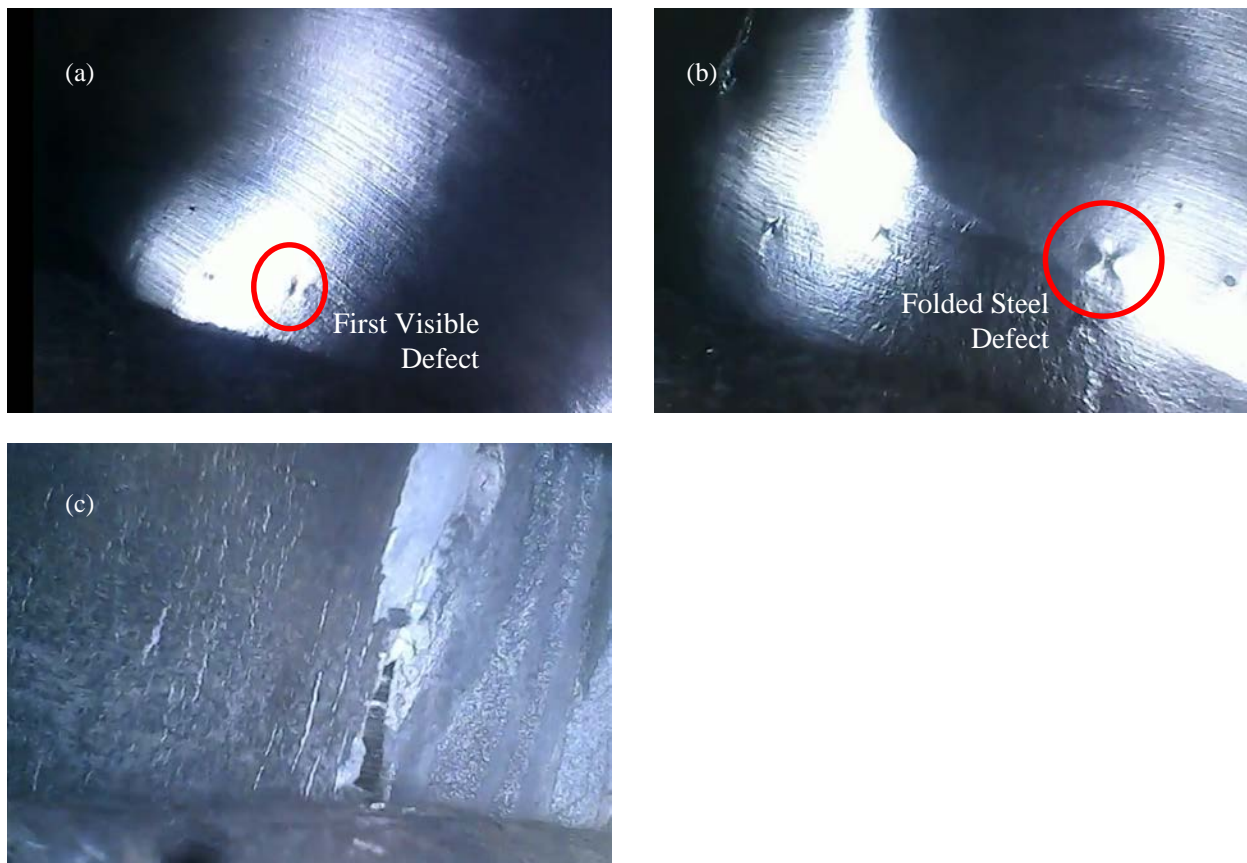
Figure 3.12 – a) First visible defect on specimen W36-BSW-T94-R000 on top side of specimen in tension in the first cycle, b) folded steel defect on top side of specimen in tension in the second cycle, and c) final fracture through bottom side of specimen in tension in cycle 4.

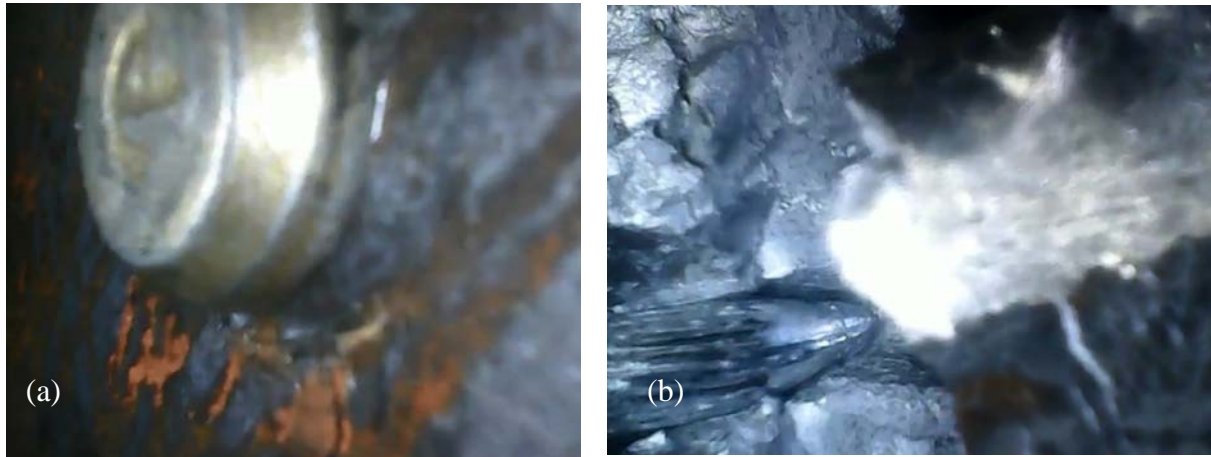
Figure A.1 – (a) Multiple fracture initiation on Specimen W24-PnAF062.5-T59-R000 next to the fastener head while the top side of the specimen was in tension and (b) complete fracture occurred through the top side of the specimen while the top side was in tension.

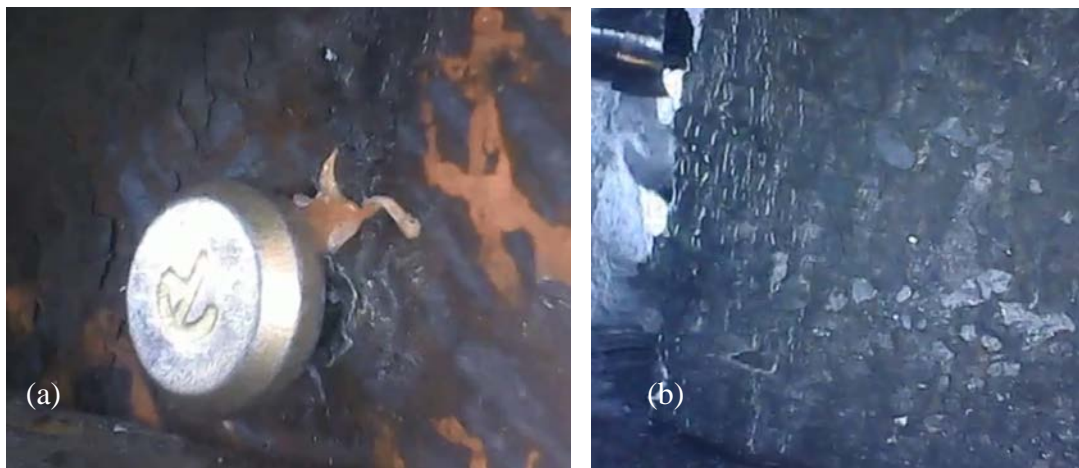
Figure A.2 – (a) Fracture initiation and propagation directly below the fastener head in specimen W24-PnAF062.5-T59-R025 during cycle 2 while the top of the specimen was in tension and (b) Full fracture through the bottom of the specimen during cycle 2 when the bottom was in tension.

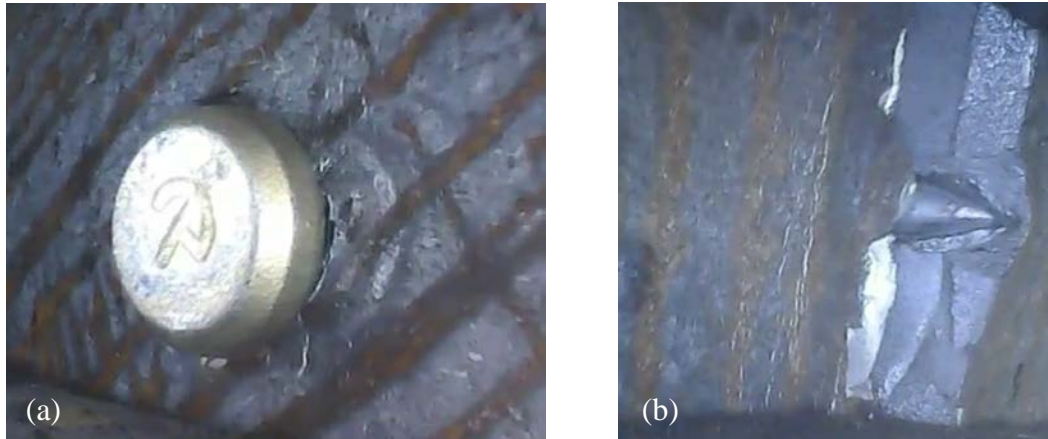
Figure A.1 – (a) Fracture initiation on Specimen W24-PnAF062.5-T59-R100 directly under the fastener head during cycle 3 when the top of the specimen was in tension and (b) full fracture through the back side of the specimen while the back side was in tension.

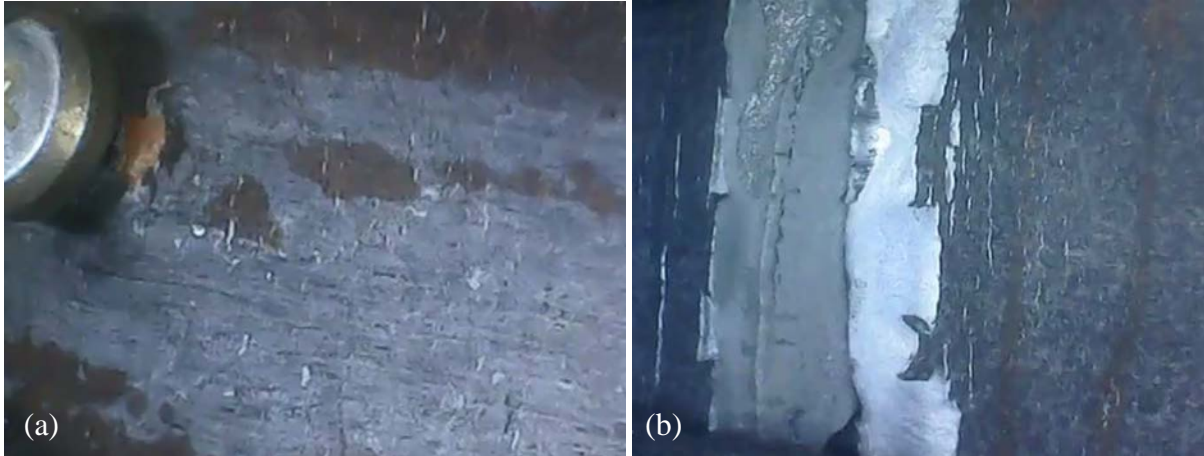
Figure A.2 – (a) Minor fracture initiation on Specimen W36-PnAF062.5-T94-R000 on the top of the specimen near the head of the fastener and (b) complete fracture occurred at cycle 5 through the bottom side of the specimen.

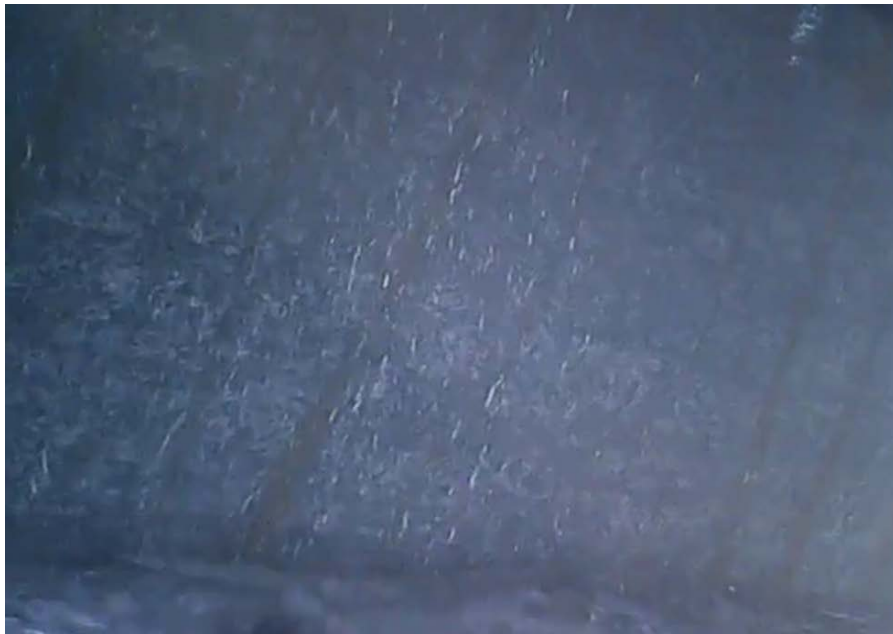
Figure A.3 – Minor fracture initiation on bottom side of specimen W36-PnAF062.5-T94-R000 during cycle 3 when bottom side was in tension.

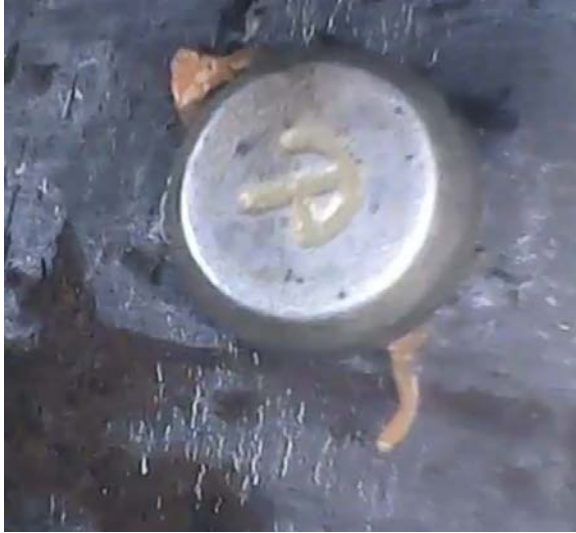
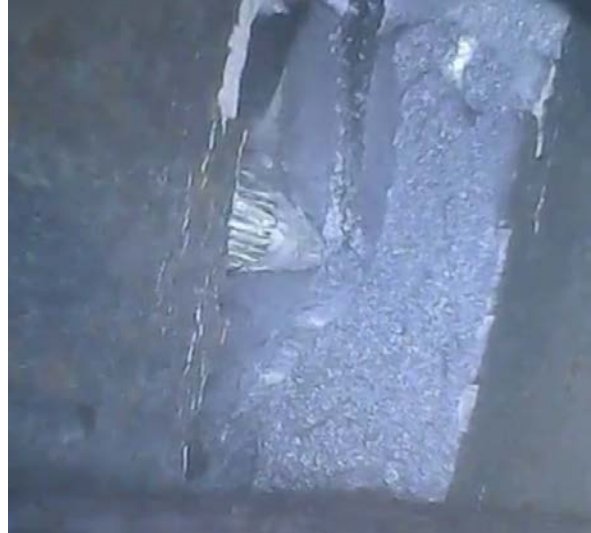
Figure A.4 – a) Multiple fracture initiation on Specimen W36-PnAF062.5-T94-R025 around the fastener head during cycle 2 when the top side of the specimen was in tension and b) full fracture through the bottom side of the specimen when the bottom side was in tension during cycle 2.

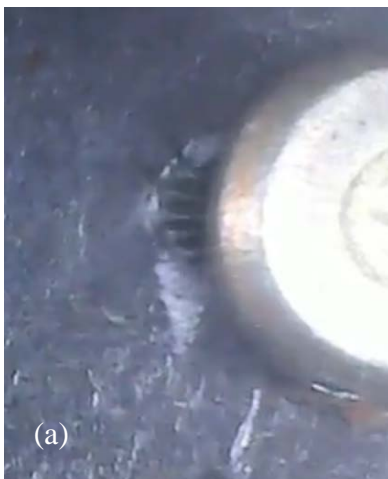
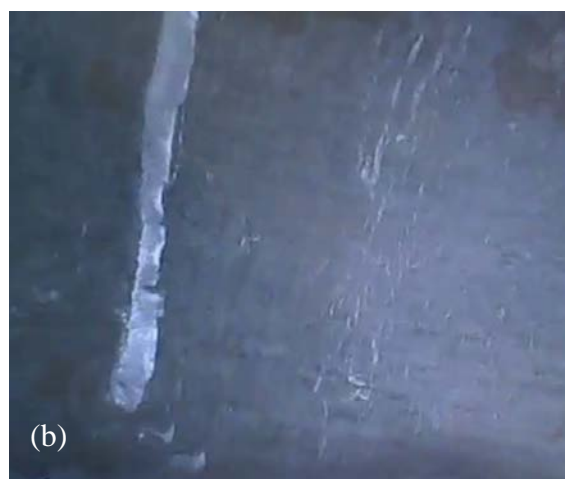
Figure A.5 – (a) Fracture initiation and propagation directly under the fastener head in specimen W36-PnAF062.5-T94-R100 during cycle 2 on the top side of the specimen while the top side was in tension and (b) complete fracture through the bottom of the plate during cycle 3 when the bottom was in tension.

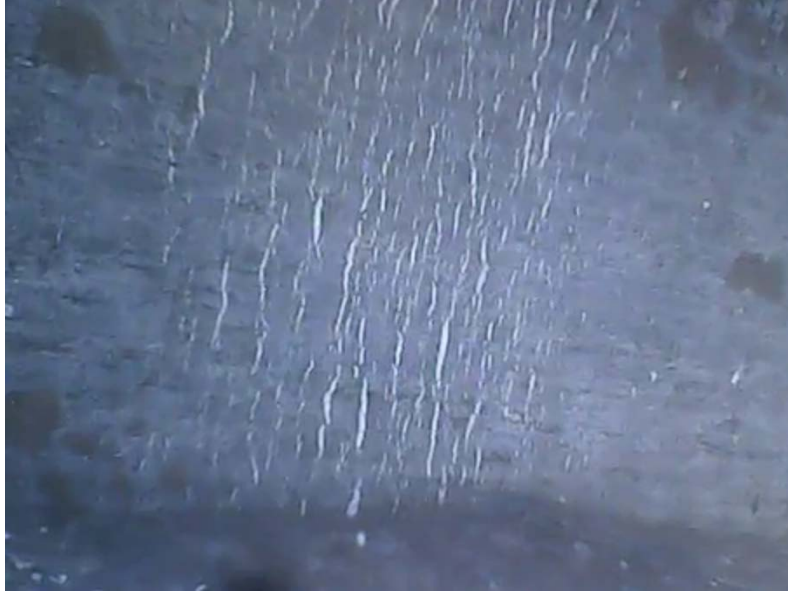
Figure A.8 – Fracture initiation on bottom side of specimen during cycle 2 when bottom side was in tension.

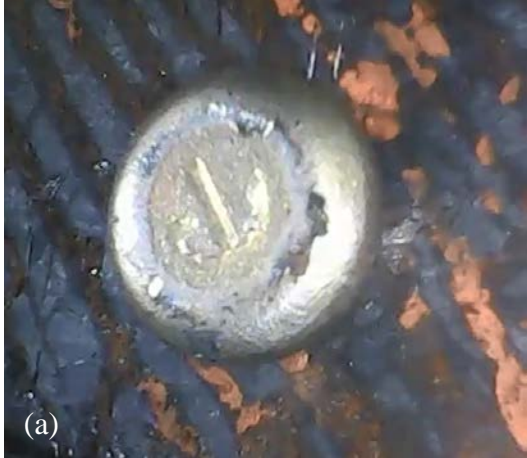
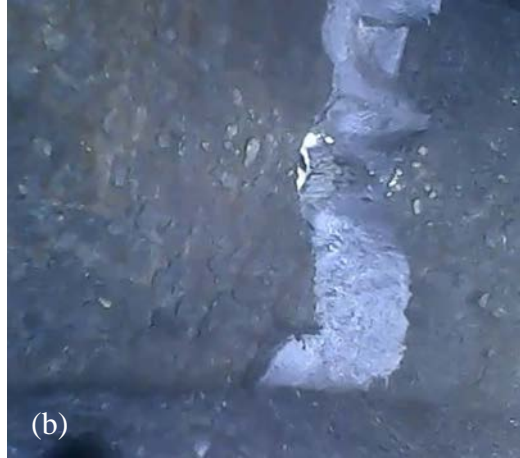
Figure A.9 – (a) Fracture initiation on Specimen W24-PnAF075-T59-R000 at the top of the fastener head during cycle 4 on the top side of the specimen when the top side was in tension and (b) full fracture through the bottom side of the specimen in cycle 9 when the bottom side was in tension.

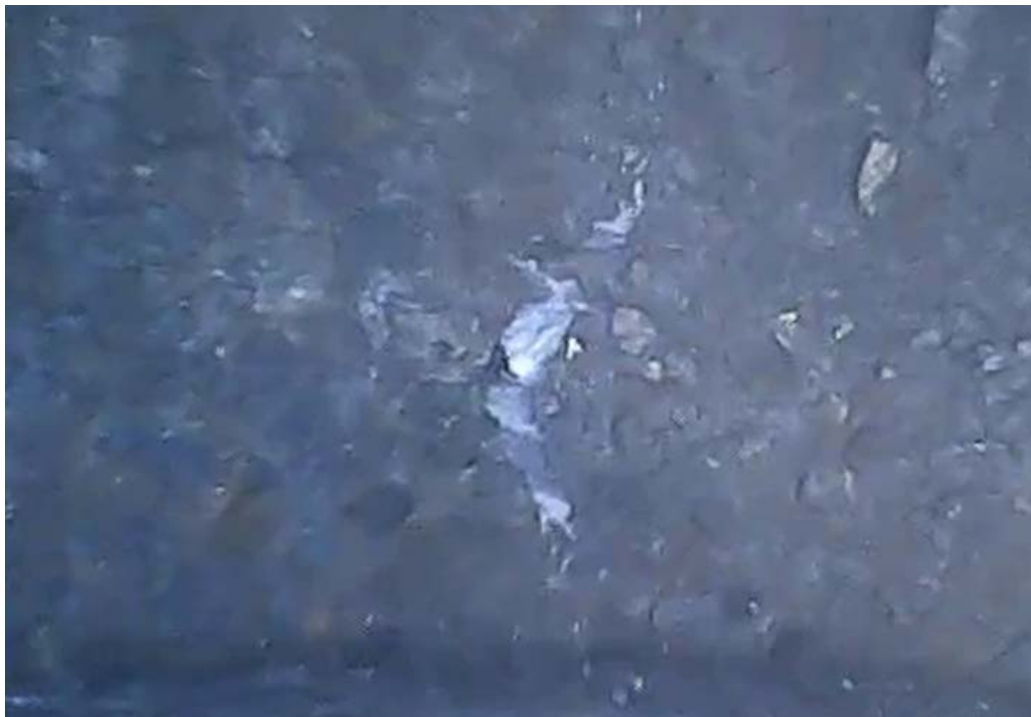
Figure A.10 –Fracture initiation and propagation through bottom of specimen during cycle 6 when the bottom side was in tension.

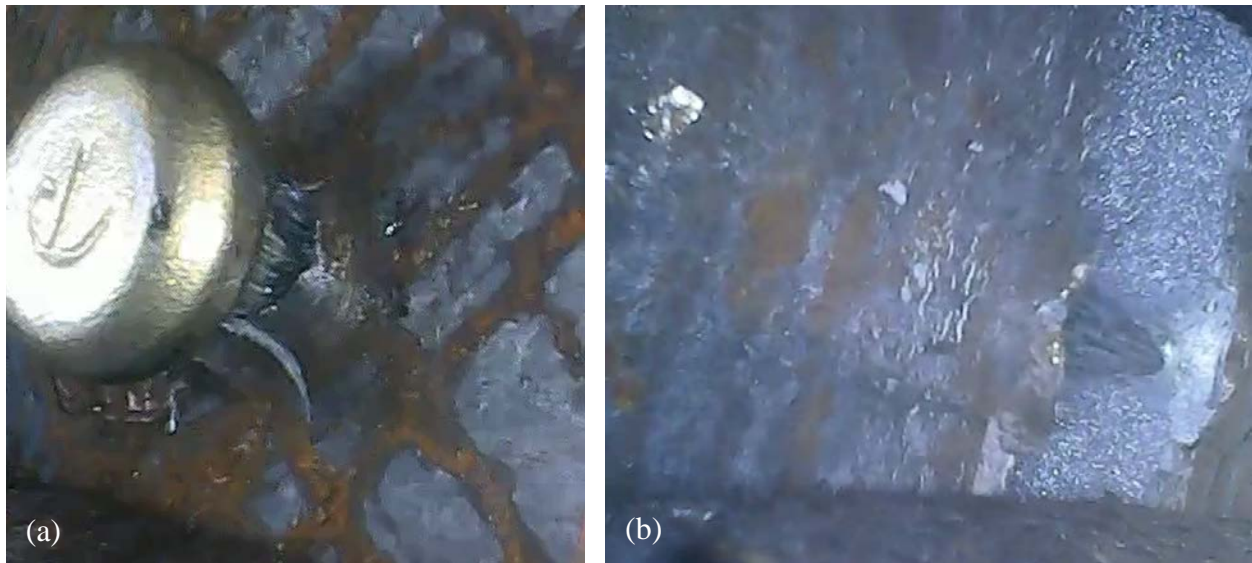
Figure A.11 – (a) Fracture initiation and propagation on specimen W24-PnAF075-T59-R025 right next to the shaft of the fastener during cycle 2 when the top of the specimen was in tension and b) full fracture through the bottom of the specimen during cycle 2 when the bottom of the specimen was in tension.

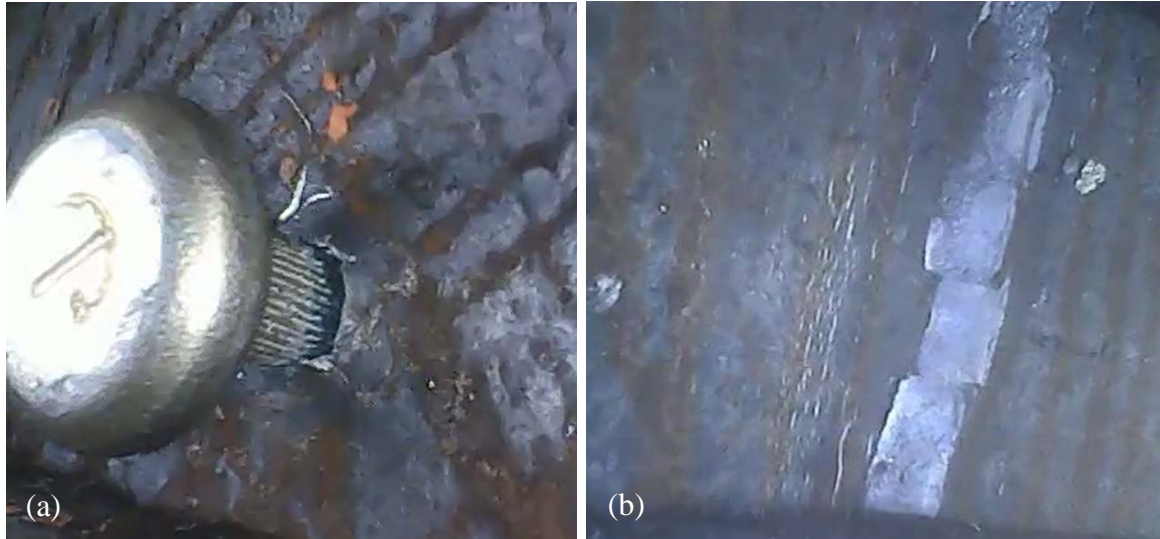
Figure A.62 – (a) Fracture initiation on the top side of the fastener shaft during cycle 2 on the top side of the specimen when the top side was in tension and (b) full fracture through the bottom side of the specimen during cycle 4 when the bottom side was in tension.

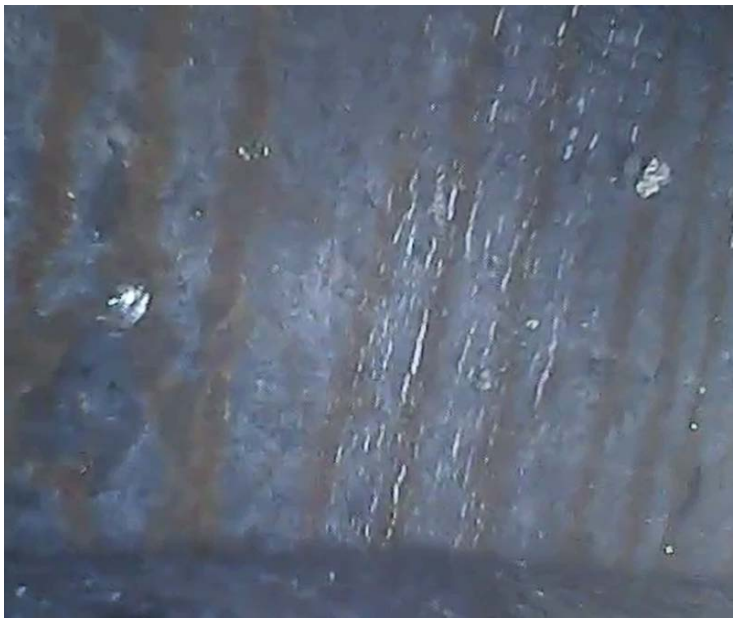
Figure A.13– Fracture initiation on the bottom side of the plate during cycle 3 when the bottom side of the plate was in tension.

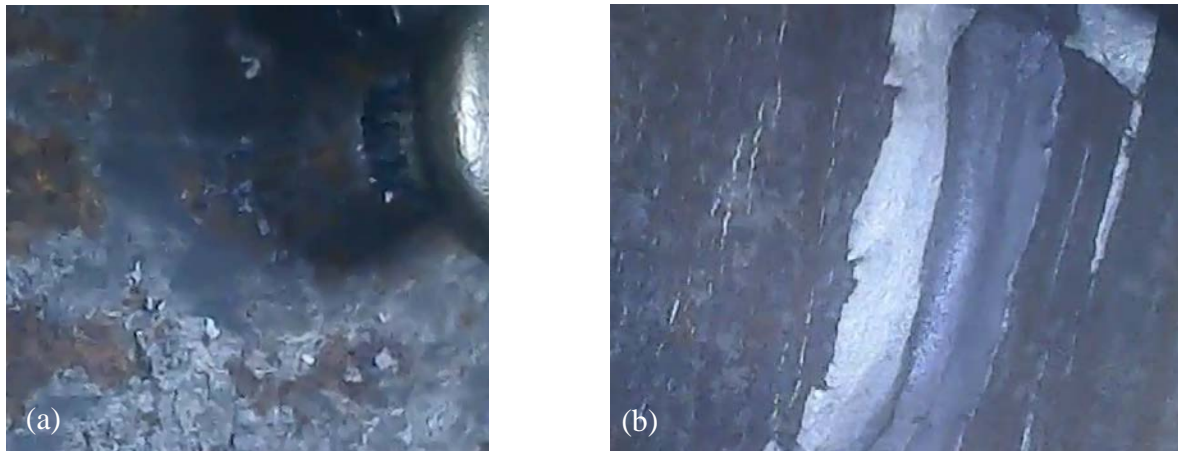
Figure A.14 – (a) Fracture initiation at the very top of the picture by the fastener shaft for specimen W36-PnAF075-T94-R000 occurring at cycle 2 on the top side of the specimen when the top side was in tension and (b) full fracture through the bottom of the specimen during cycle 5 when the bottom side was in tension.

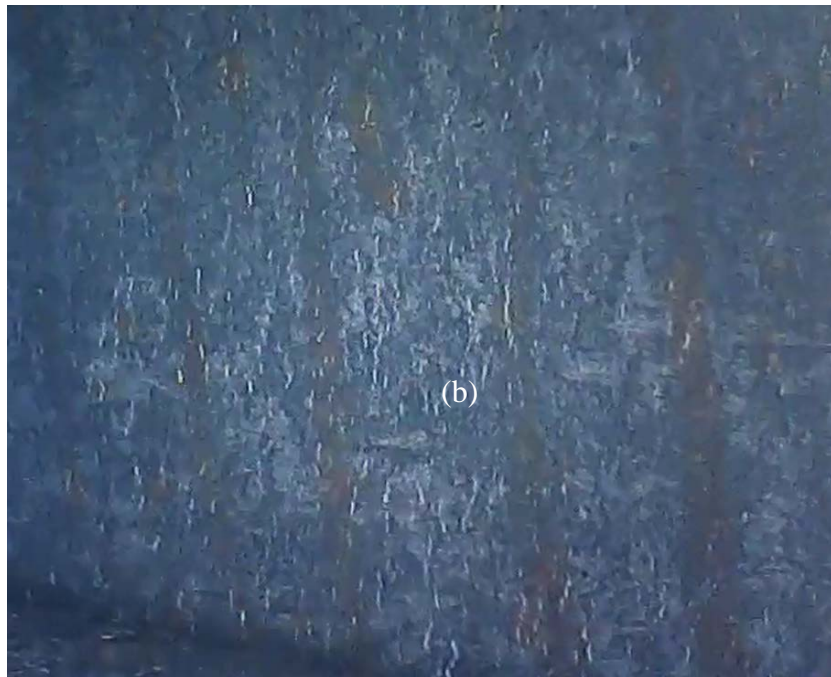
Figure A.15 – Fracture initiation on the bottom side of the plate when the bottom side was in tension during cycle 3.

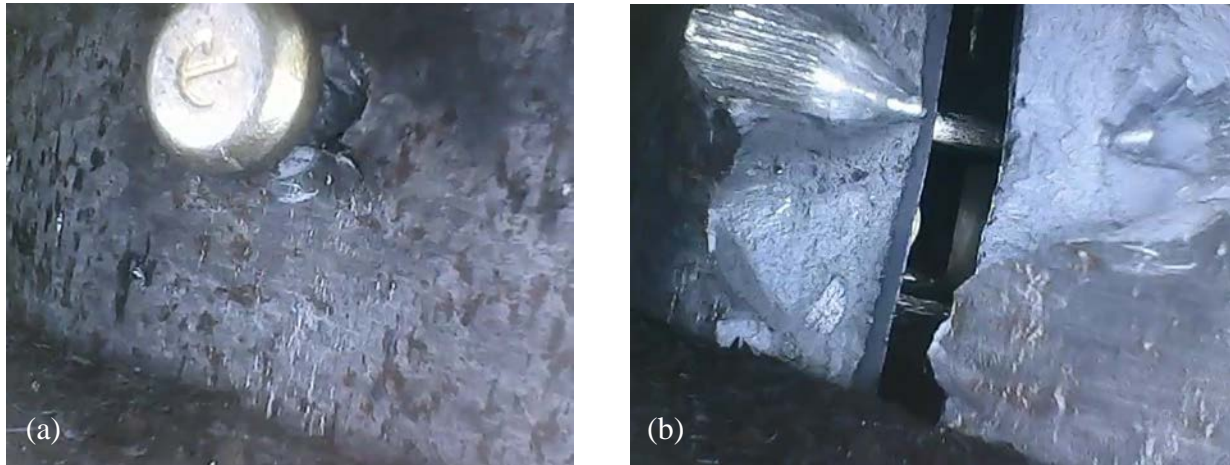
Figure A.16 – (a) Fracture initiation and propagation on specimen W36-PnAF075-T94-R025 around the fastener shaft during cycle 2 when the top side of the specimen was in tension and (b) full fracture through specimen during cycle 2 when the top side of the specimen was in tension.

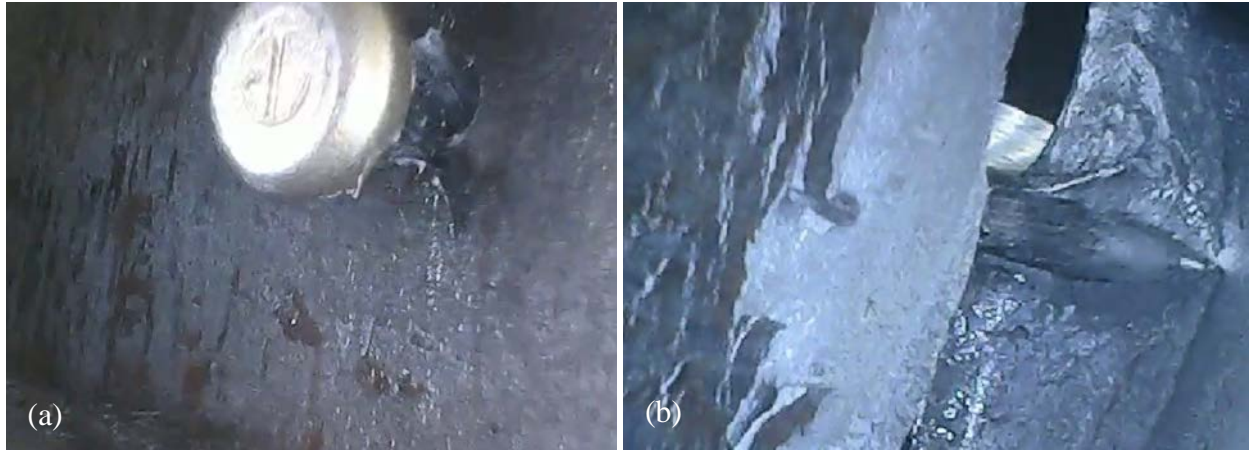
Figure A.7 – (a) Fracture initiation and propagation during cycle 2 for specimen W36-PnAF075-T94-R100 on the top side of the specimen around the fastener shaft when the top side was in tension and (b) full fracture through the bottom side of the specimen during cycle 2 when the bottom side was in tension.

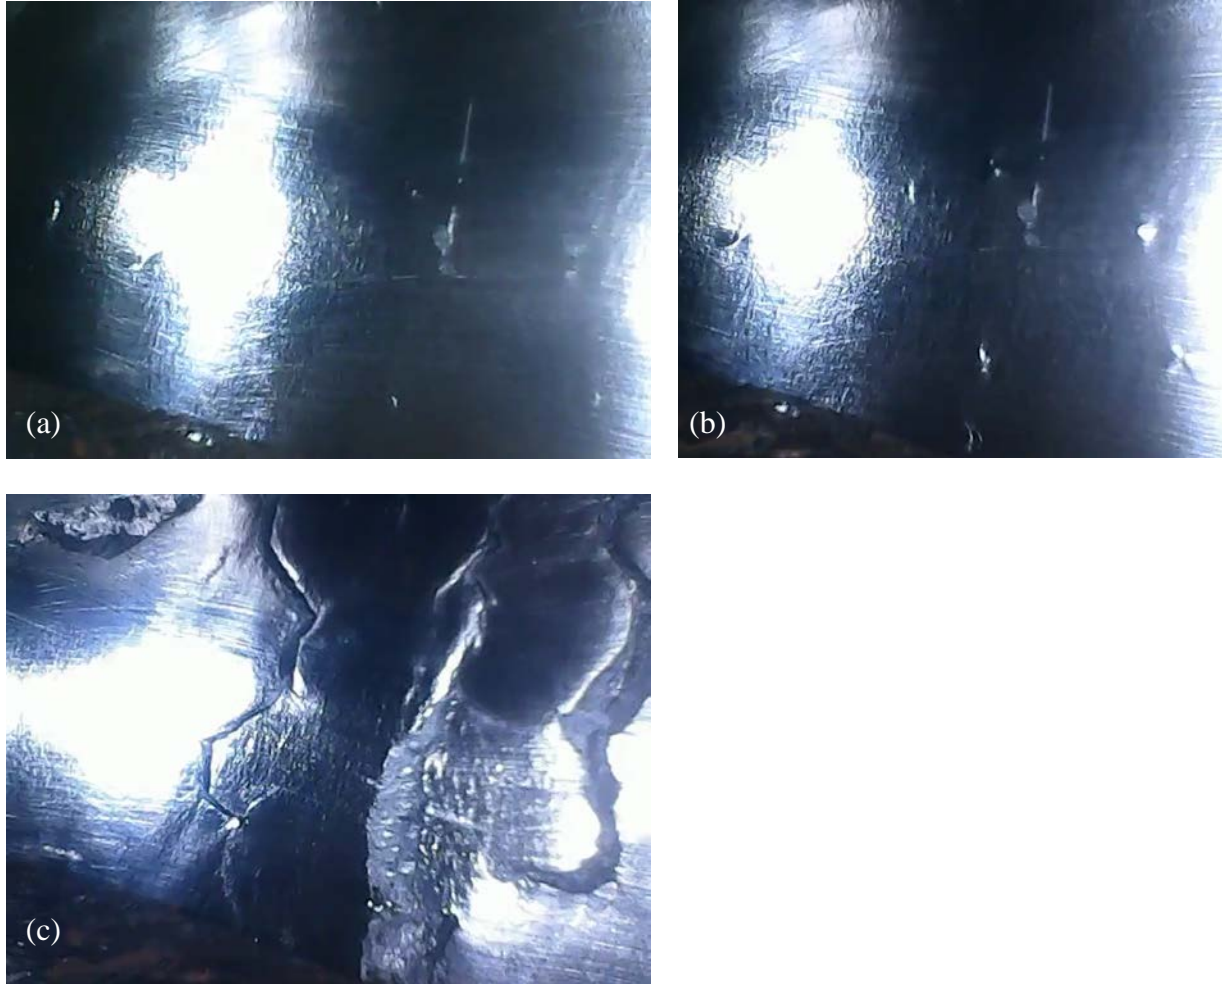
Figure A.8 – (a) Shows first visible defects in specimen W24-BSW-T59-R000 on the surface of the BSWR during cycle 1 when the BSWR is in tension, (b) first folded steel defect can be seen in the bottom right corner after forming during cycle two, and (c) final fracture through top of specimen when the top side was in tension.

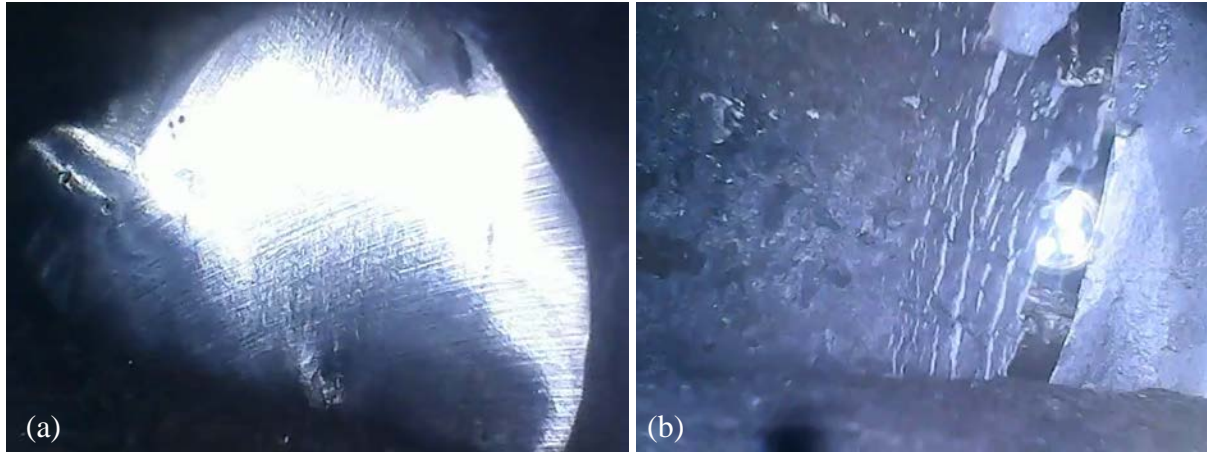
Specimen W24-BSW-T59-R025

Figure A.19 – (a) First visible defects starting to form on surface of the weld on the top side of specimen W24-BSW-T59-R025 during cycle 2 when the top side was in tension and (b) full fracture through bottom of specimen during cycle 2 when bottom side was in tension.
