**VIRGINIA POLYTECHNIC INSTITUTE
AND STATE UNIVERSITY**

**EVALUATION OF THE EFFECT OF BOAT-SHAPED WELDS AND
PNEUMATIC POWER ACTUATED FASTENERS
ON THE SEISMIC BEHAVIOR OF MOMENT FRAMES**

December 2015

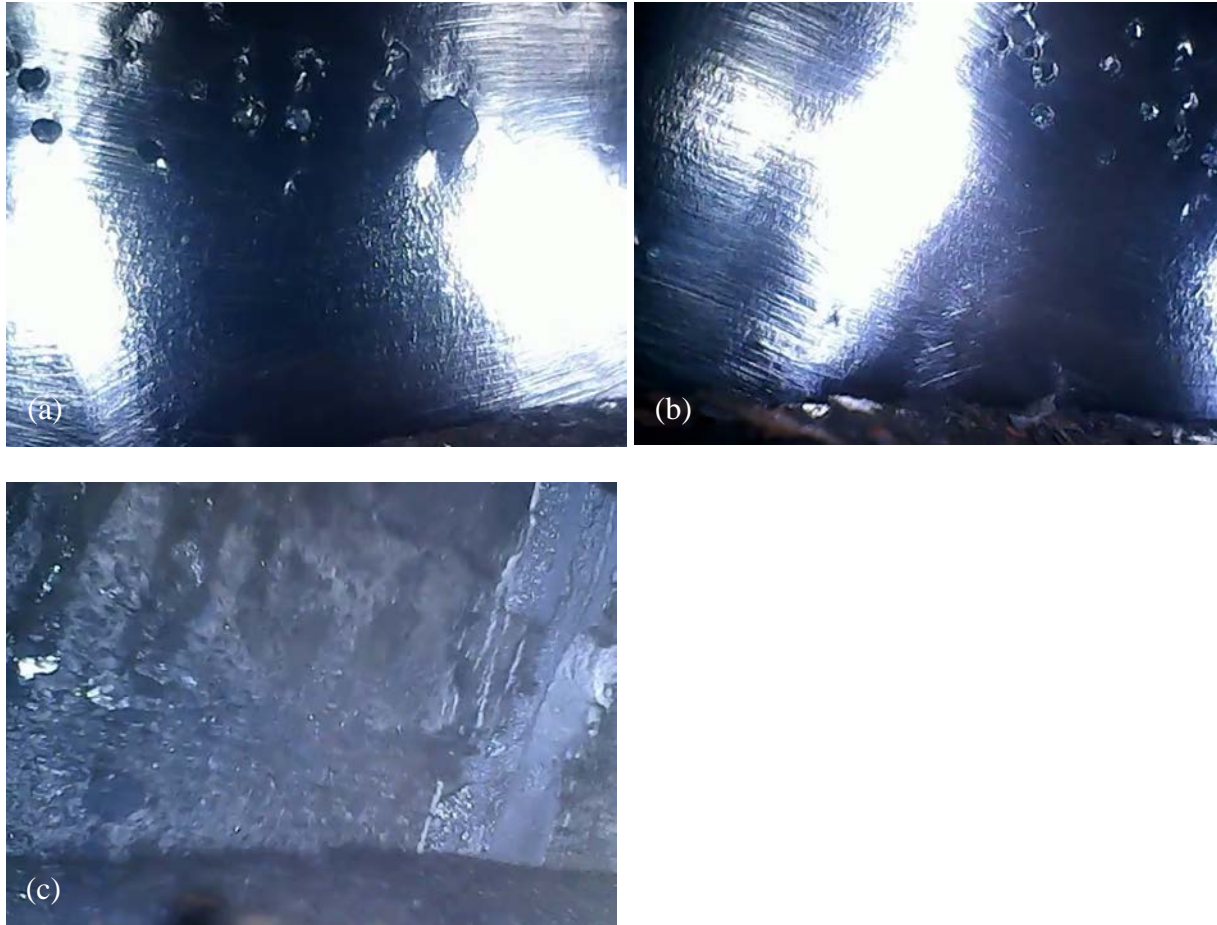
Figure A.90 – (a) First visible defects can be seen around the voids in specimen W24-BSW-T59-R100 during cycle 1, (b) the first folded steel defect can be seen at the bottom of the area with the glare during cycle 2, and (c) full fracture through the bottom of the specimen occurred during cycle 3 when the bottom of the specimen was in tension.

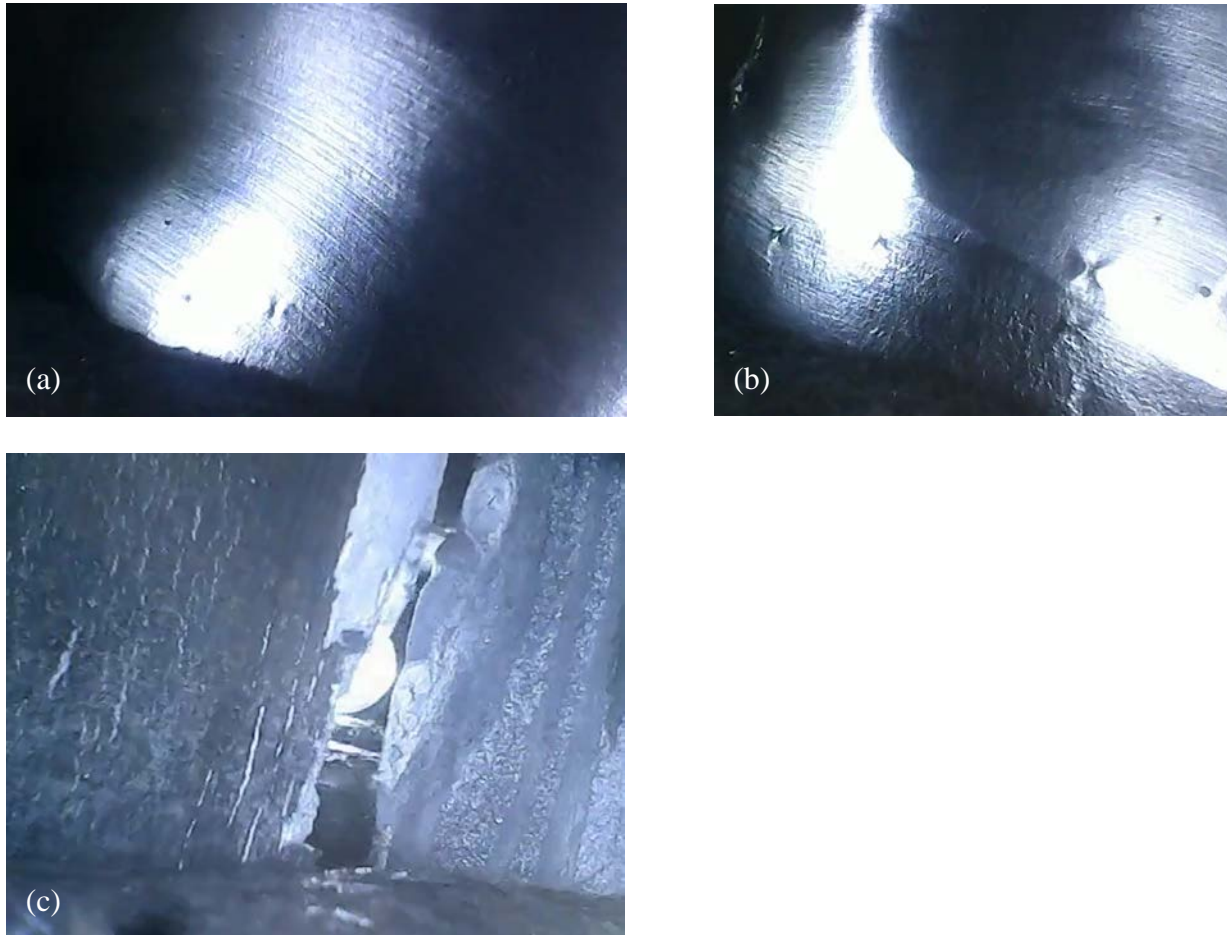
Figure A.21 – (a) First visible defects can be seen on weld surface on specimen W36-BSW-T94-R000 during cycle 1, (b) a very clear folded steel defect can be seen in the bottom right of the picture during cycle 2, and (c) full fracture through the bottom side of the specimen in cycle 4 when the bottom side was in tension

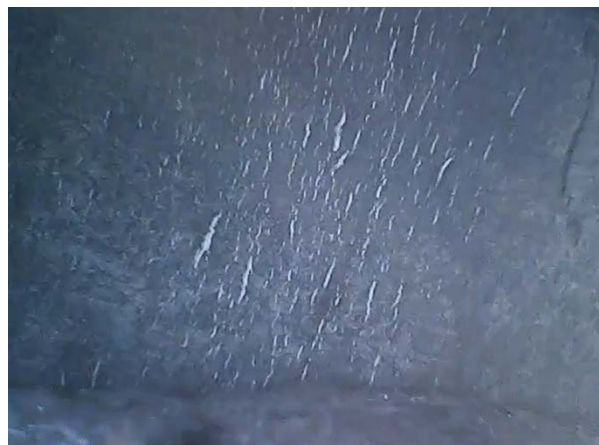
Figure A.22 – Fracture initiation on bottom side of specimen during cycle 3 when the bottom side was in tension

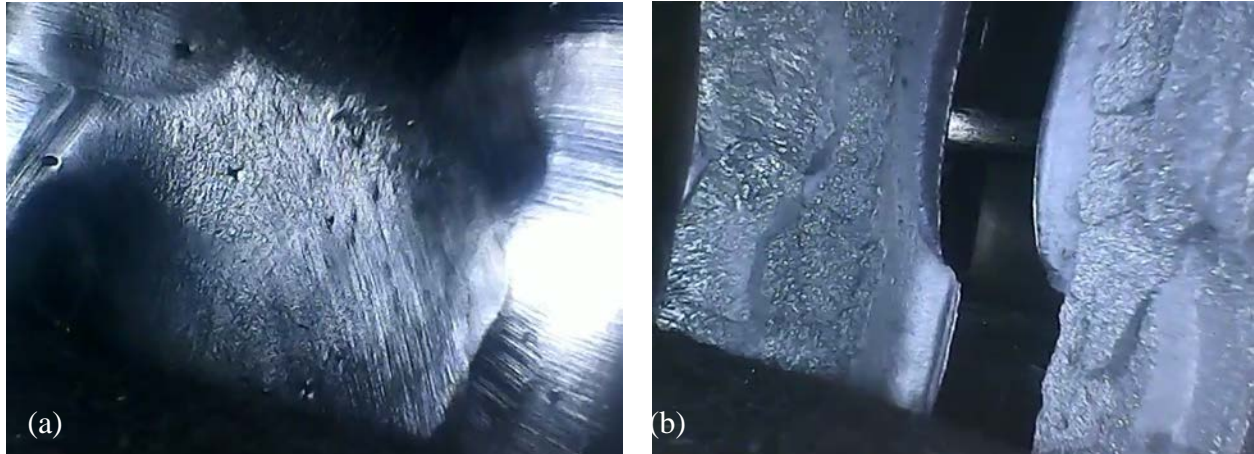
Figure A.23 – (a) First visible defects during cycle 1 on the surface of the BSWR in specimen W36-BSW-T94-R025 and (b) final fracture through the top side of the specimen during cycle 2 when the top side was in tension.

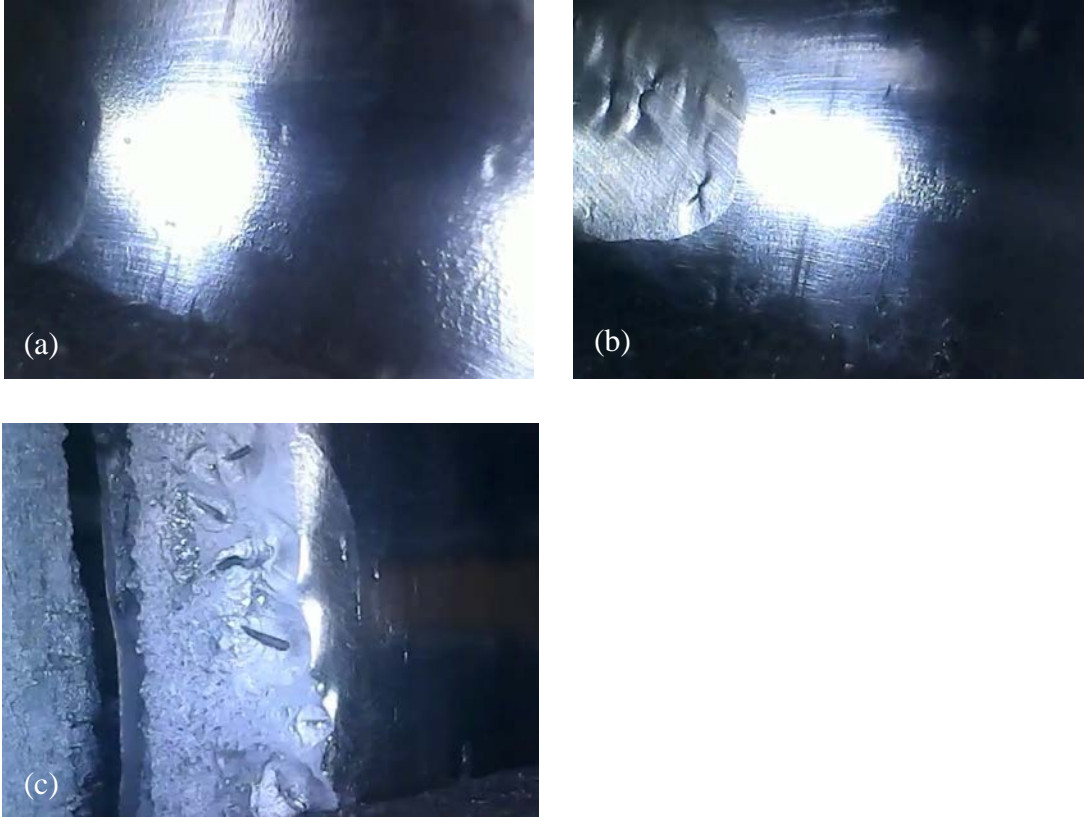
Figure A.24 – (a) Small visible defects on surface of weld on specimen W36-BSW-T94-R100 during cycle 1, (b) multiple folded steel defects forming in cycle 2 in the area where a void was ground out, and (c) final fracture through top of specimen during cycle 2 when top side was in tension.
