Failure Analysis of a Column k-Area Fracture

By John M. Barsom and J. V. Pellegrino, Jr.

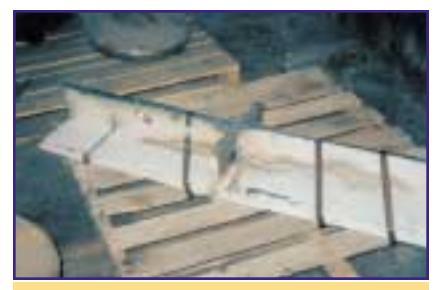
Three deep column moment connections with a Reduced Beam Section (RBS) were tested at the University of California San Diego to investigate the behavior of RBS welded moment connections (Gilton et al., 1999). One of the specimens, DC-3, had a W27×194 column, and a beam of A572 Grade 50 steel with a 5/8" thick doubler plate and 1.0" thick continuity plates. The design of specimen DC-3 is shown in Figure 1. The specimen was subjected to simulated seismic loads recommended by the SAC Joint Venture. At the peak of the second positive 4% drift cycle, specimen DC-3 developed an 8"-long crack along the k-area region of the column at the beam bottom flange level, Figure 2. The crack extended to 33" during the third positive 4% drift cycle.

A section of the column containing the crack in the k-area region was removed from specimen DC-3, Figure 2, to conduct a failure analysis of the fracture. Figure 3 is a close up of the k-area fracture at the weld access hole. It also shows the fracture of the continuity plate, which initiated at the weld access hole and propagated in a brittle manner to the free edge. Figure 4 is a close up of the fracture at the weld access hole along the weld joining the doubler plate to the column web. Also shown is the bottom end of the doubler plate, which extended 3" below the continuity plate.

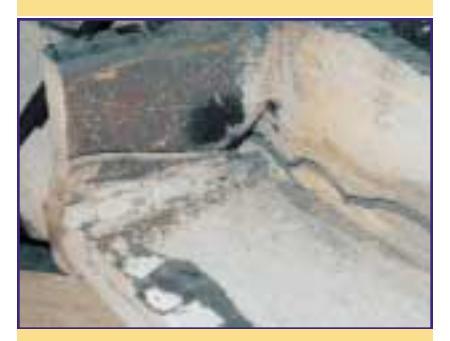
At the instant of fracture the bottom continuity plate on the panel zone side without a doubler plate had yielded completely, Figure 3. The bottom continuity plate on the doubler plate side also yielded but to a lesser extent, Figure 4.

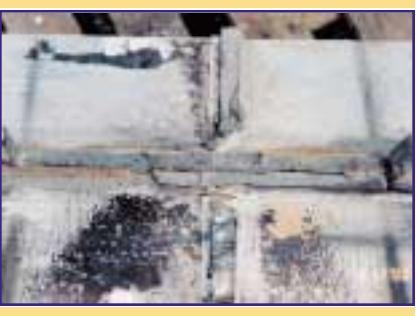
The section containing the k-area crack was opened to expose the fracture surfaces, Figure 5. The chevron markings on the fracture surfaces suggested two possible initiation sites. One fracture originated from a large weld discontinuity in the weld joining the continuity plate in the column web side to the column flange, Figure 6. This crack would have fractured the continuity plate first followed by the fracture of the column web and the doubler plate weld.

Extensive yielding was observed on the column flange both above and below the bottom beam flange but only on the doubler plate side of the panel zone, Figure 5. The size of the plastically deformed area was larger below than above the bottom flange. Also, yielding extended more along the edge of the column flange than along the column flange-to-web intersection, Figure 5. Negligible yielding of the column flange on the panel zone side without a doubler plate had developed at the time of the fracture, Figure 5.

The plastic deformation pattern of the column flange, Figure 5, both above and below the beam bottom flange and on both sides of the panel zone was consistent with out-of-plane bending of the column flange welded to the beam bottom flange. The larger magnitude of plastic deformation below the beam bottom flange represents the superposition of out-ofplane bending of the column flange and the bending of the beam.

the weld joining them. As the out-ofplane displacements and the beam deflection increased, the stress reached the tensile strength of the column web causing its fracture. The fracture propagated 8" along the k-area to the edge of the deformed region that was driving the crack, Figure 5. The next positive excursion extended the preexisting crack to 33" (Gilton et al., 1999).

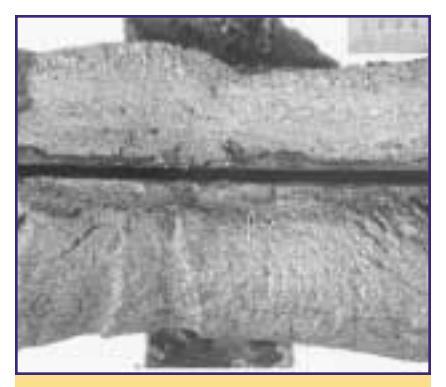
Figure 7.

The other fracture origin, Figure 7, was embedded within the column web in the vicinity of the fusion line between the doubler plate groove weld and the column web. This fracture would have severed the column web first followed by fracture of the doubler plate groove weld then the fracture of the continuity plate. Examination of the recorded strains during loading and the deformation pattern on the cracked section that was removed from the connection indicated that the 8" k-area crack occurred first, followed by the continuity plate fracture during the folpositive load cycle. lowing Therefore, the primary fracture was embedded within the column web.

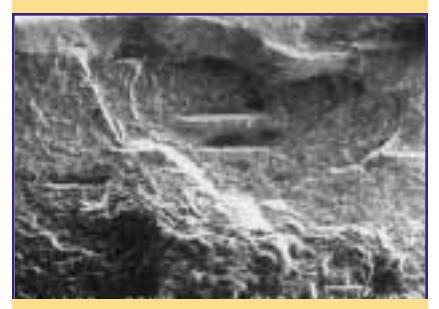
Figure 8.

Examination of the fracture surface under a light microscope and a scanning-electron microscope indicated the presence of 0.07 to 0.10" long planar inclusions (laminations) at the primary fracture origin, Figure 8, and at other locations away from the fracture origin. The sample shown in Figure 8 was tilted at a small angle to expose the laminations. The planes of these laminations were parallel to the web surfaces and perpendicular to the fracture plane. Therefore, these planes of discontinuities were parallel to the direction of stresses and strains that caused the fracture. Consequently, their contribution to the fracture process would have been negligible (Barsom and Rolfe, 1999).

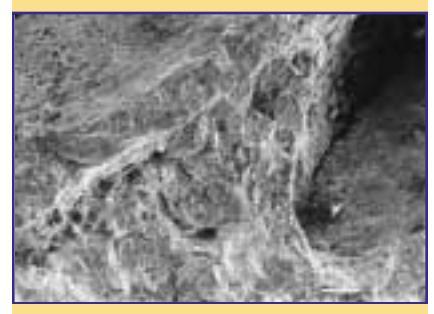
Scanning-electron fractography of the fracture origin showed that the material between the two laminations at the fracture origin fractured by ductile shear then the fracture extended in a brittle cleavage mode, Figure 9. Also shown are a multitude of voids on the surface of the lamination where inclusions resided.

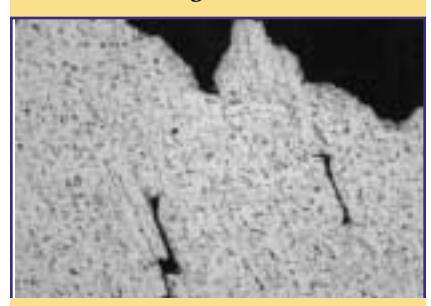
Metallographic examination of a transverse cross section through the fracture origin revealed the presence of laminations immediately below the fracture origin, Figure 10. These laminations contained inclusions, Figure 11, which were identified by energy-dispersive x-ray spectroscopy to be manganese silicates, Figure 12.

Figures 10 and 11 show that the ends of the laminations had extended a short distance out of plane to align themselves perpendicular to the direction of the applied stresses and strains. A high magnification scanning-electron fractograph, Figure 13, shows this extension was by formation and coalescence of ductile microvoids around inclusions and along grain boundaries. This observation demonstrates that, in the vicinity of the fracture, the steel was subjected to stress levels that approached the tensile strength prior to fracture.
