Two fire-damaged brick buildings in Brookline, MA, were re-purposed and rebuilt from the inside out with structural steel.

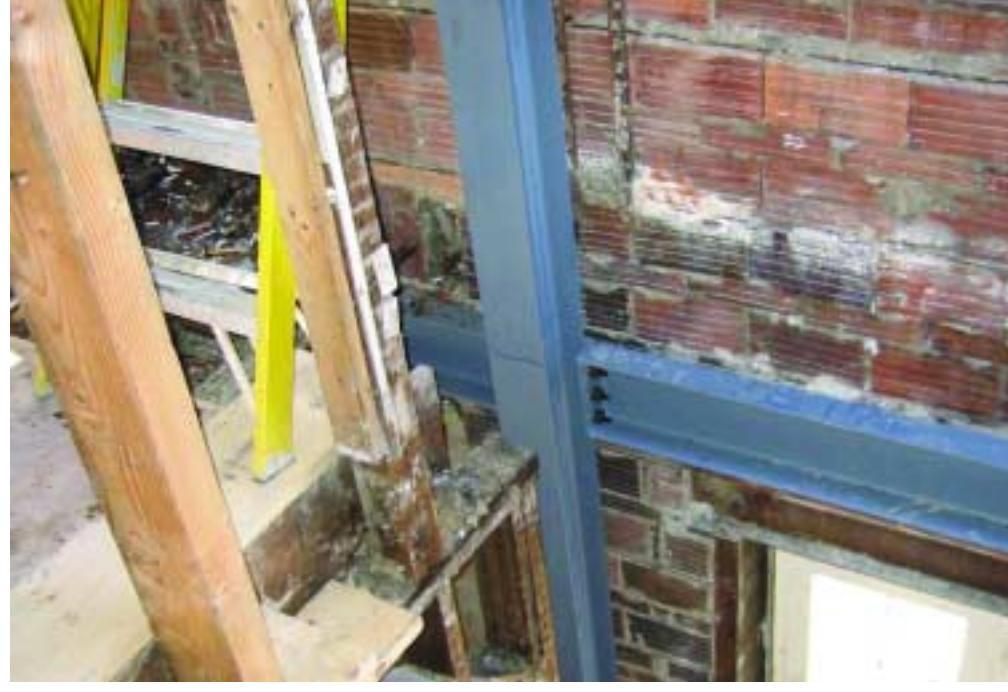
Steel framing was inserted into the existing structure prior to the demolition of the existing wood framing.

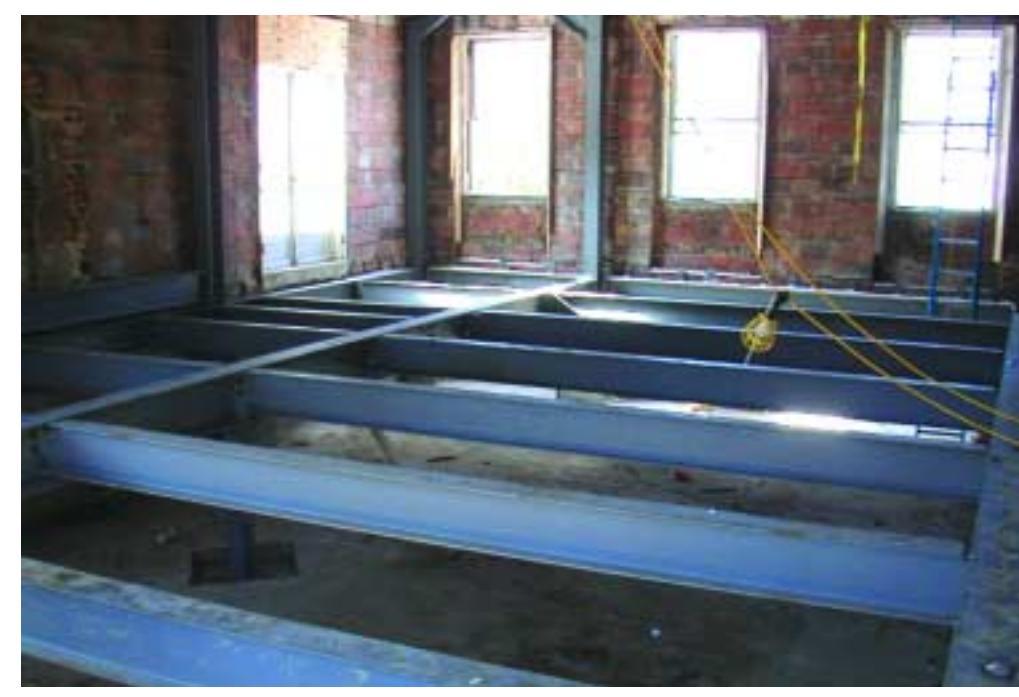
Steel floor framing for the new gymnasium before installation of the non-composite metal deck and concrete floor.

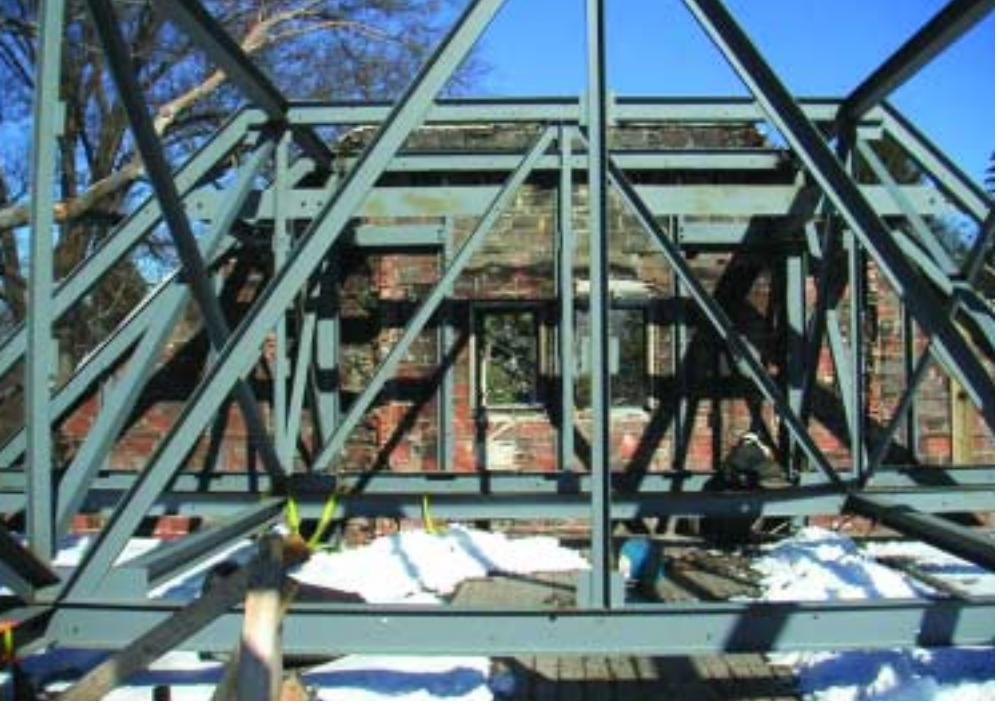
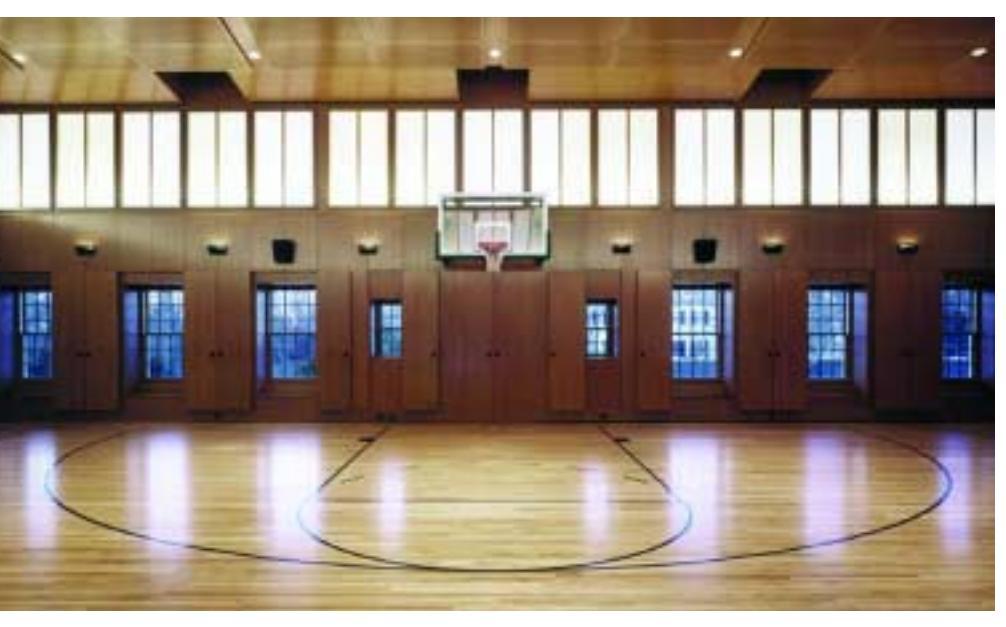
New roof trusses (*above*) made of C8s and L3×3s created the column-free interior spaces required for the gymnasium (*below*).

Steel roof trusses framed the roof and tied the new steel columns at the roof. Double C8×11.5 channels were the main members, and double $L3\times3\times^{1/4}$ angles were auxiliary members. This created a column-free space for the gymnasium. Wood 2×10 rafters spanned between trusses at the top and bottom chord elevation. Plywood ³/₄" thick provided a diaphragm to transfer the loads to moment frames attached to the exterior walls.
