Sorry, Charley!

By Joseph C. Kosinski, P.E.

The Lighthouse Resort in Fort Myers Beach, FL was “high and dry” in Hurricane Charley’s aftermath—thanks to a renovation and hurricane-rated structural steel retrofit.

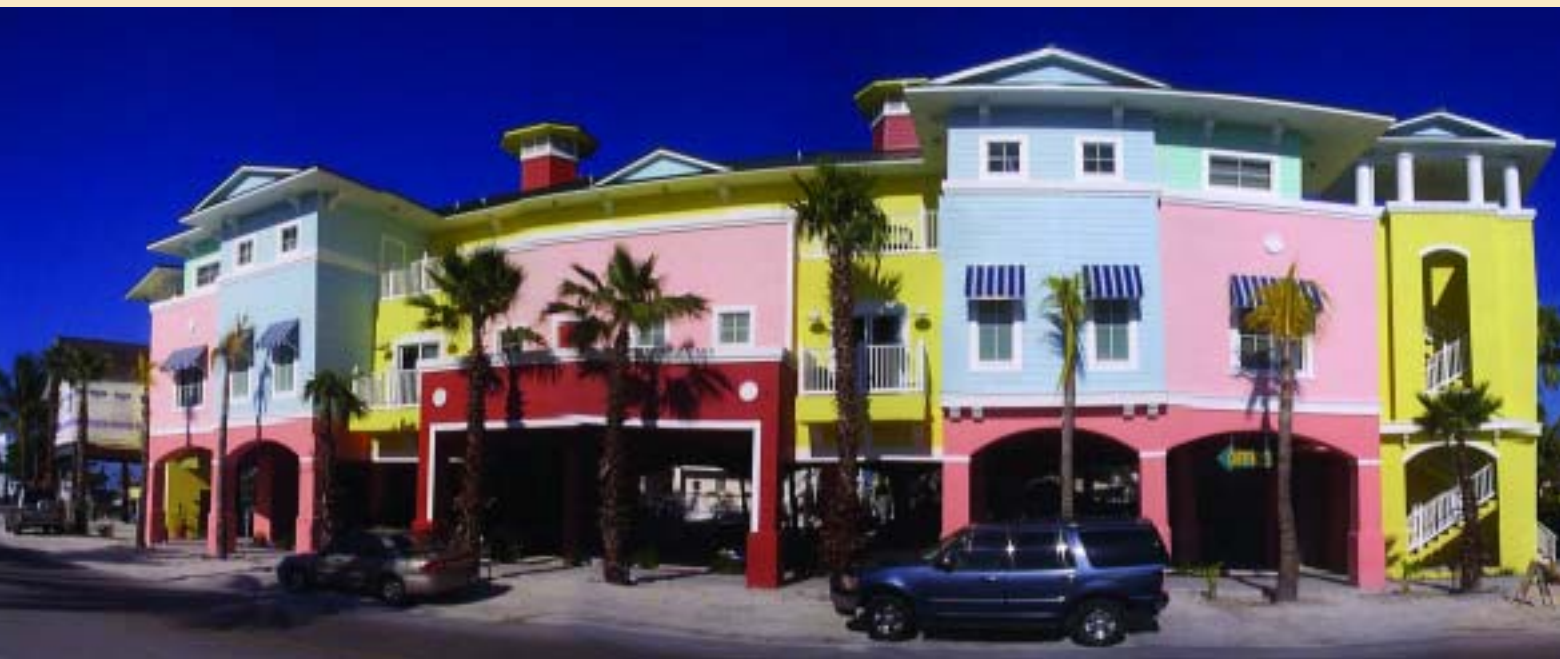
When Hurricane Charley struck southwest Florida in August of 2004, Fort Myers Beach was directly adjacent to the eye of the storm. Wind gusts exceeded the required 130 mph wind code, and the island was covered by 3' to 4' of rushing water. Despite extreme wind forces and the rushing storm surge, the newly renovated Lighthouse Resort cottages sustained no damage. ★

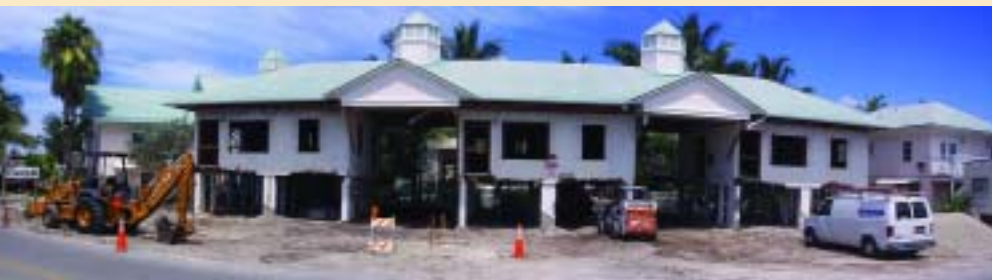
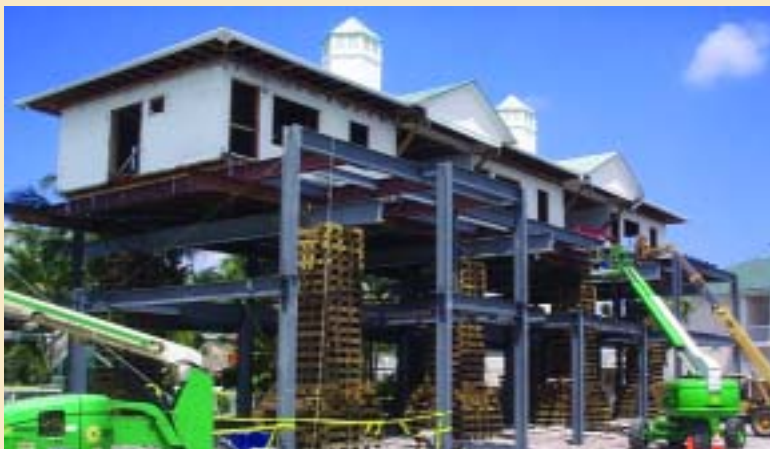
The first floor of the original cottages was demolished (*above*) before raising the remaining structure and inserting a new two-level steel frame underneath (*below*).

The lower level of each unit was opened up to allow the insertion of three heavy steel support beams installed beneath the second floor bearing wall locations. The 18"-deep "carry beams" served as the main support for the second levels while the cottages were being hoisted up. The carry beams were oversized to allow flexibility for placement of the hydraulic jacks, minimize deflection of the carry beams, and increase connection requirements for the beams onto the structural steel frames. The beams also

When the carry beams were correctly positioned below the second floor, hydraulic jacks were inserted at selected locations along the length of each lift beam. Galvanized, light gauge steel hurricane straps were installed to secure the wood floor joists to each steel lift beam. Additional hurricane straps were attached to each stud within the bearing walls, top and bottom, to anchor the studs to the floor joists. Each roof truss hurricane tie-down was reinforced and upgraded to the new 2001 *Florida Building Code*. This approach provided a continuous load-resisting path from the existing cottage roof and walls to the new structural steel frame below, and down to the new anchoring foundations.

After that, the first floor-bearing walls were demolished. The cottages were then gradually and uniformly hoisted to the third level. Heavy-duty timber blocking was installed to provide a backup support for the carry beams in the event of loss of hydraulic pressure in the jacks.

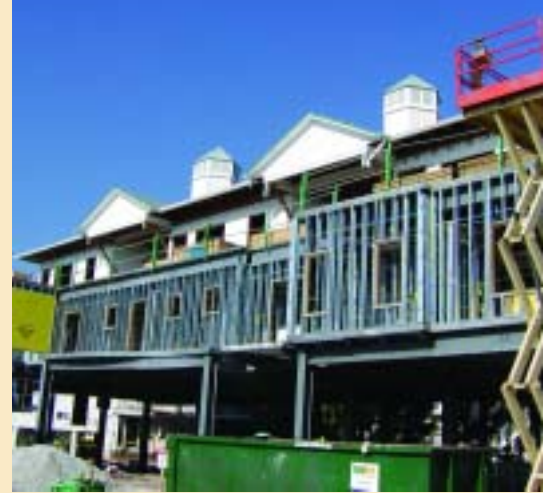
The second floor of the original cottages became the third floor after the renovation. All new infill construction used light gauge steel. "Hurricane clips" and straps were added to all existing wood framing.
