NEW CROTON DAM SPILLWAY BRIDGE

WILLIAM E. NYMAN, P.E., Hardesty & Hanover, LLP, New York, NY

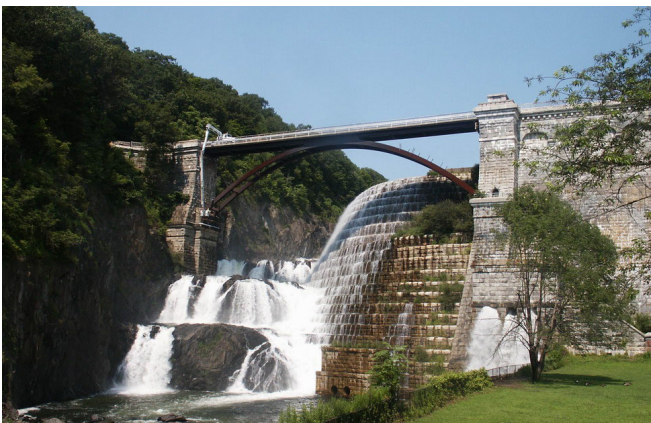
Figure 4: Open Spandrel Arch Bridge completed in 1975

By the 1970's, the 1905 superstructure had deteriorated due to the constant exposure to the spillway spray and lack of maintenance at this relatively inaccessible site. The superstructure was replaced with a new weathering steel open spandrel arch in 1974-75. Papers describing the 1970's bridge replacement along with

discussions with the designers and the resident engineer for the bridge construction gave some insight into problems experienced during construction. Apparently, the new bridge was erected with the arch ribs inboard of the old bridge and the old bridge was used as a working platform. During construction, spray over the spillway caused difficult working conditions and water accumulation in the box arch rib sections prior to welding. The nontraditional detailing exacerbated construction problems in the already difficult site conditions. This bridge is shown in Figure 4.

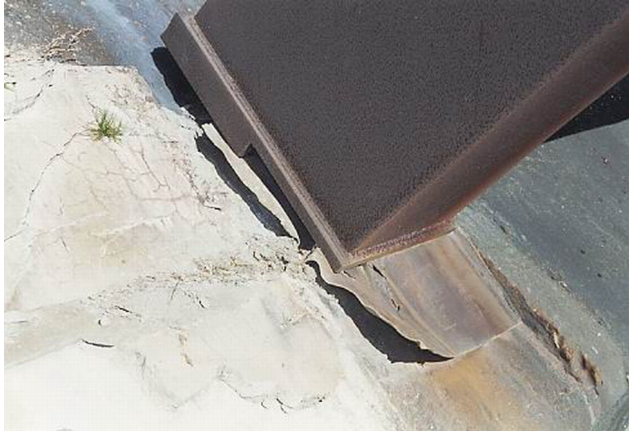
Figure 5: Arch Base displacements of the 1975 bridge were up to 14 inches

substantial arch base movements continued a trend measured in the previous inspection cycles. Figure 5 shows a displaced arch base. The box arch ribs remained in the elastic range and bearing plates showed no signs of distress due to the arch base displacements.

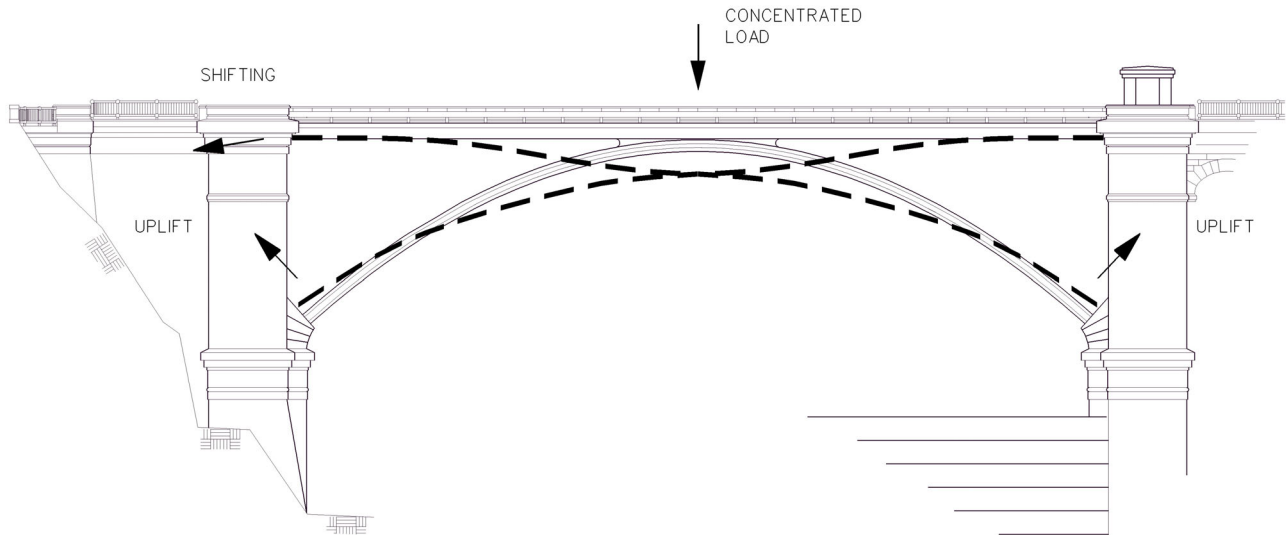
Figure 6: Existing Bridge Behavior

Due to uncertainty in the degree of fixity at the arch base, two conditions were analyzed in the load ratings, first a fixed arch and second a two hinged arch. Although the arch was not physically anchored to the skewbacks, it would act fixed if sufficient thrust existed to keep the thrust line in the center third of the rib. In this condition, the base plate would not uplift. Arch type bridges perform efficiently under uniform load. Since this particular arch was only loaded with a point load at the center, there was a significant bending moment in the arch under dead load alone. The thrust line did not follow the rib and in fact fell outside the member. The arch base movements may have been attributed to the self-correcting of the arch base to reduce eccentricity of the thrust (See Figure 6). This condition may have combined with repetitive live loading and environmental factors to allow base movement. If a pinned arch is assumed in the analysis, the thrust line was found to pass through the hinged support.
