## The Cardington Fire Tests

**T**his paper briefly reviews the structural fire engineering methods available to engineers in the United Kingdom and Europe and then gives a description of some full-scale fire tests carried out at Cardington (UK) in an old, very large, airship hangar.

# THE CARDINGTON FIRE TESTS

Gerald Newman, Ian Simms et al  
Steel Construction Institute, Ascot, UK

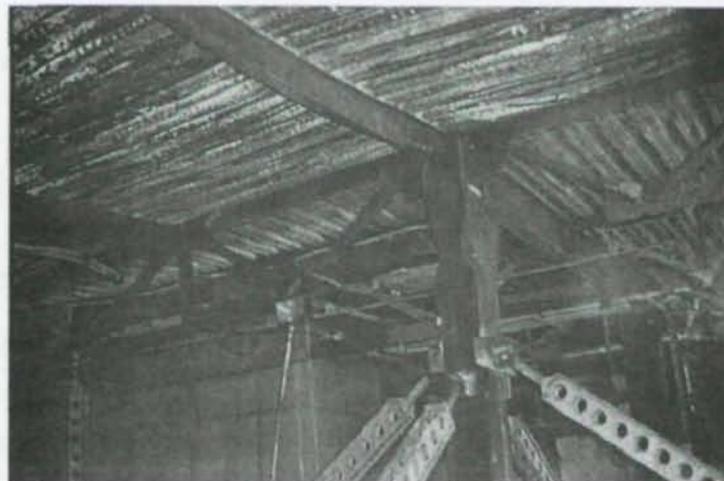
Figure 1 *Deformed structure at Broadgate*

In 1990 a fire developed in a partly completed 14 storey office block on the Broadgate development in London<sup>(3)</sup>. Fire temperatures were estimated to be over 1000°C. Following the fire structural elements covering an area of approximately 40 x 20m were replaced, but importantly no structural failure occurred and the integrity of the floor slab was maintained during the fire (Figure 1). The direct fire loss was in excess of £25M, of which less than £2M was attributed to the structural frame and floor damage, the other costs resulted from smoke damage.

The design of the Cardington tests was influenced by the Broadgate fire. Following this fire it could be seen that some of the elements had lost their load carrying capacity during the fire. However, the structure performed well with no signs of collapse. It was clear that the composite floor had a major influence on the overall stability of the structure, acting as a diaphragm or membrane distributing loads from weakening members.

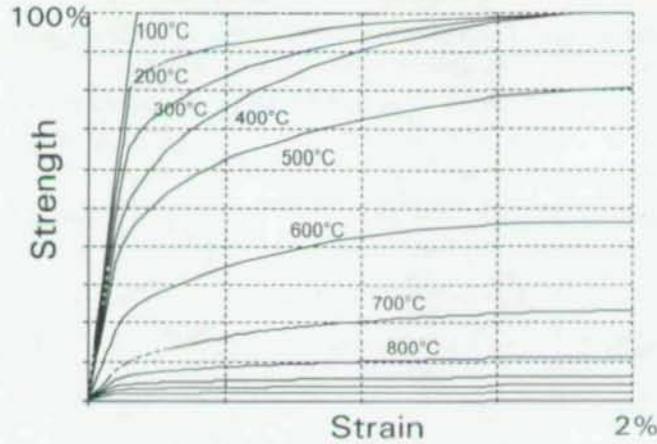
Figure 2 Elevated temperature stress strain curves for steel

All materials lose strength and stiffness at high temperatures. The commonly used grades of structural steel and concrete lose about half their strength at 600°C. The elevated temperature stress-strain curves for structural steel are presented in Figure 2.

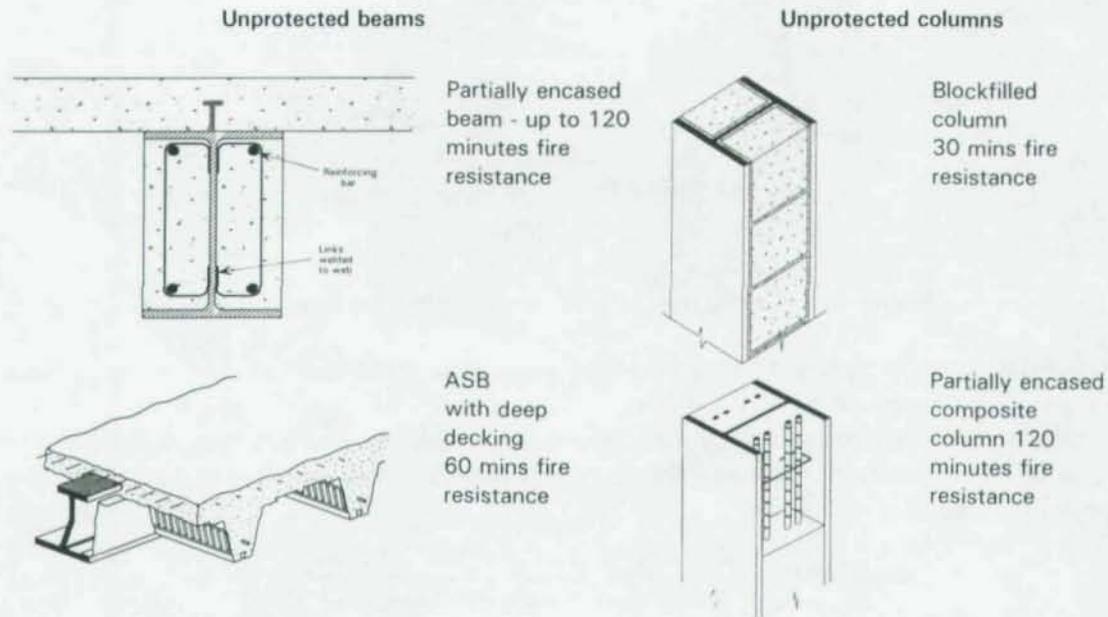
Figure 3 Types of unprotected steel beams and columns

In UK and Europe the use of unprotected steel for fire resistance resistances up to 60 minutes (and sometimes 90) is common<sup>(6)</sup>. Some types of unprotected beams and columns are illustrated in Figure 3. Exposed flange temperature in all cases will be in excess of 750°C.

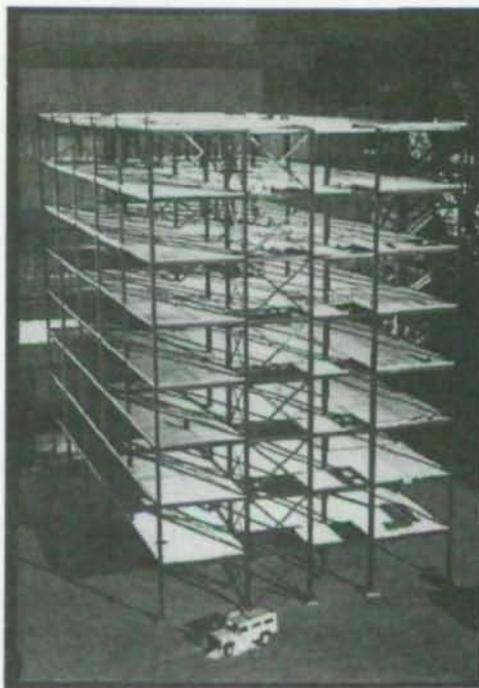
Figure 4 *The test building under construction*

The Cardington fire tests were conducted in an eight story office building designed to be a typical example of the type of braced structure and load levels which are commonly found in the UK. On plan the building covered an area of 21m x 45m with an overall height of 33m. There were 5 equally spaced bays along the length of the building and three bays 6m, 9m and 6m across the width. The frame had three braced cores, one central 9m x 2.5m lift core and two 4m x 4.5m stairwells at either end of the structure. The building under construction is shown in Figure 4. The beams were designed as simply-supported acting compositely with the floor slab. The composite flooring system consisted of steel decking with grade 35 concrete and A142 mesh. The depth of the slab was 130mm. To comply with UK building regulations this type of building would normally have 90 minutes fire resistance. Fin plates were used for the beam to beam connections and flexible end plates for the beam-to column connections. The structure was loading using sandbags distributed over each floor to simulate typical office loading.

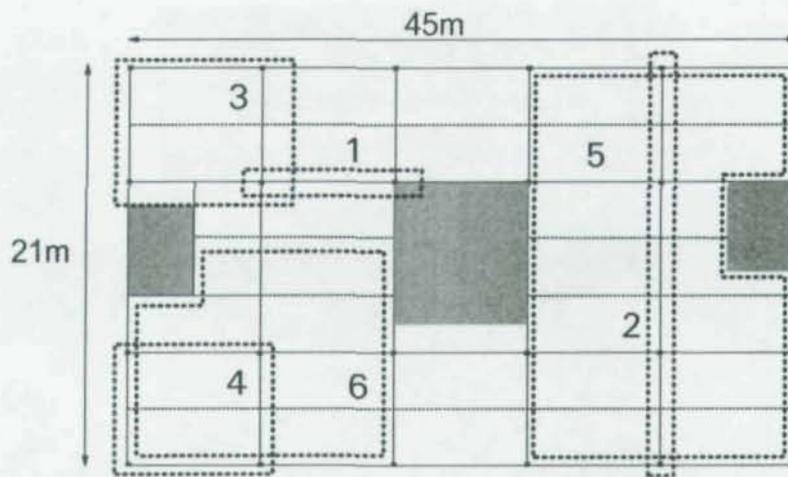
Figure 5 Test locations

| 1. Restrained beam test (ECSC) | 2. Plane frame test (ECSC) |
| 3. Corner test (ECSC) | 4. Corner test (BRE) |
| 5. Large compartment (BRE) | 6. Simulated office (ECSC) |

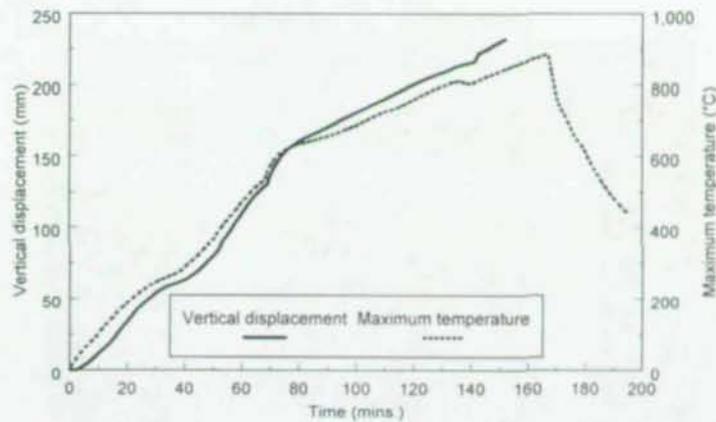
Figure 6 Maximum displacement and temperature

The restrained beam test was carried out on the seventh floor of the building used a purpose built gas fired furnace which heated the beam over the middle 8.0m of its 9.0m span. This permitted the connections to remain as close as possible to ambient temperature. Although, previous research has shown that it is not necessary to fire protect the voids between the beam and the steel decking, the voids were filled in this case in order to reduce the thermal gradient and simplify the computer modelling. The heated steel beam and the surrounding structure were extensively instrumented using strain gauges, position sensors, inclinometers and thermocouples. The maximum displacement and temperature of the beam are shown in Figure 6.

The test was terminated because of instrument failure. At the end of the test the maximum displacement was approximately 250mm and the bottom flange was at a temperature of about 900°C. The beam showed no sign of 'runaway' and was clearly being supported by the floor slab.

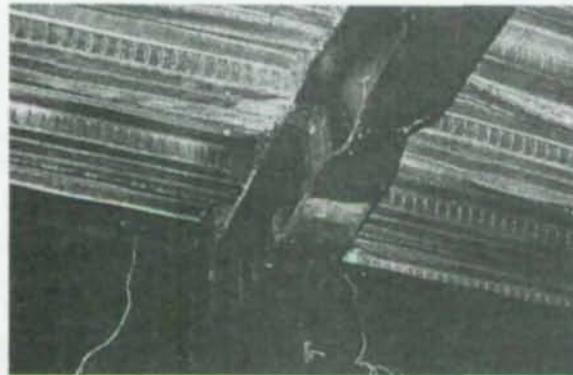
Figure 7 Restrained beam after test

Local buckling occurred in the bottom flange of the beam at both ends (Figure 7). In addition to this the bottom flange had also distorted as it expanded against the web of the column section.

Thermal contraction of the beam during cooling caused the end-plate connection at both ends of the beam to fracture in the region adjacent to the edge of the heated affected zone of the weld on one side of the connection. Although the end plate has become completely detached down one side this had relieved the induced tensile strains, with the plate on the other side of the beam web maintaining the shear capacity of the connection.

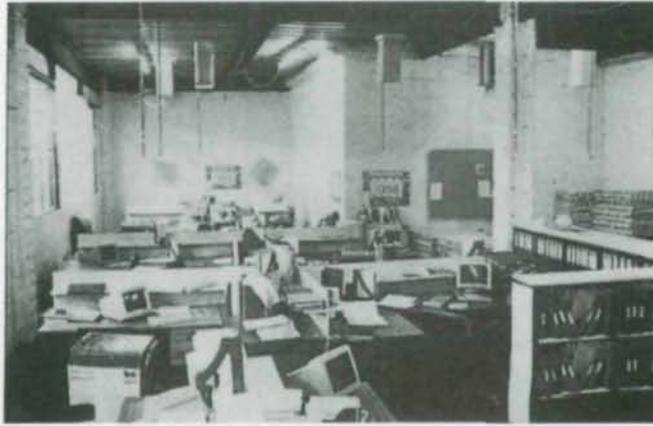
**Figure 8** *Internal view of the compartment*

A compartment 18m wide and up to 10m deep with a floor area of 135m<sup>2</sup> was constructed using concrete blockwork. A gap, later filled with ceramic fibre, of approximately 250mm was left between the top of the blockwork and underside of the structure to allow the heated structure to deform freely. The design of the compartment was such that it represented an open plan office and contained a series of work stations consisting of modern day furnishings, computers and filing systems (Figure 8).

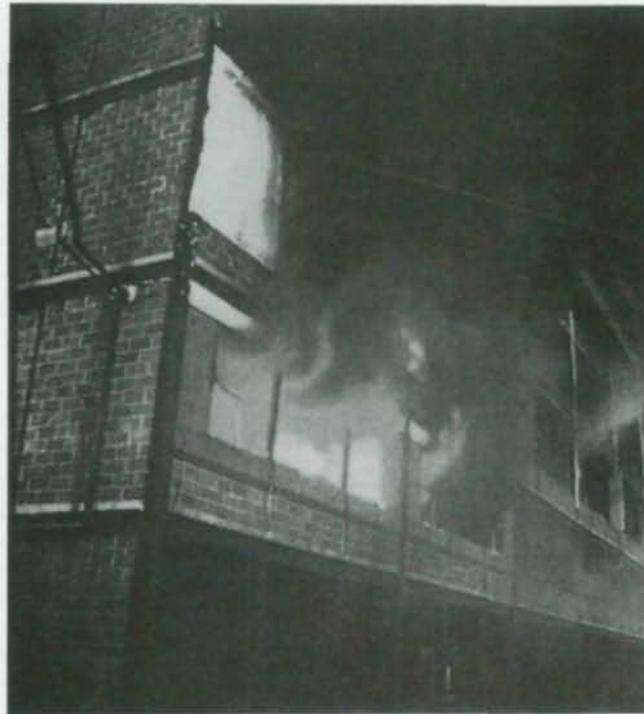
**Figure 9** *Test 6 at the height of the fire*

Within 10 minutes of ignition, local atmosphere temperatures had attained in excess of  $900^{\circ}\text{C}$ . The recorded maximum atmosphere and unprotected steel temperatures were  $1213^{\circ}\text{C}$  and  $1150^{\circ}\text{C}$  respectively. At the height of the fire (Figure 9), the calculated heat release rate was 58MW. A maximum vertical displacement of 640mm was recorded after 62 minutes (Figure 10)

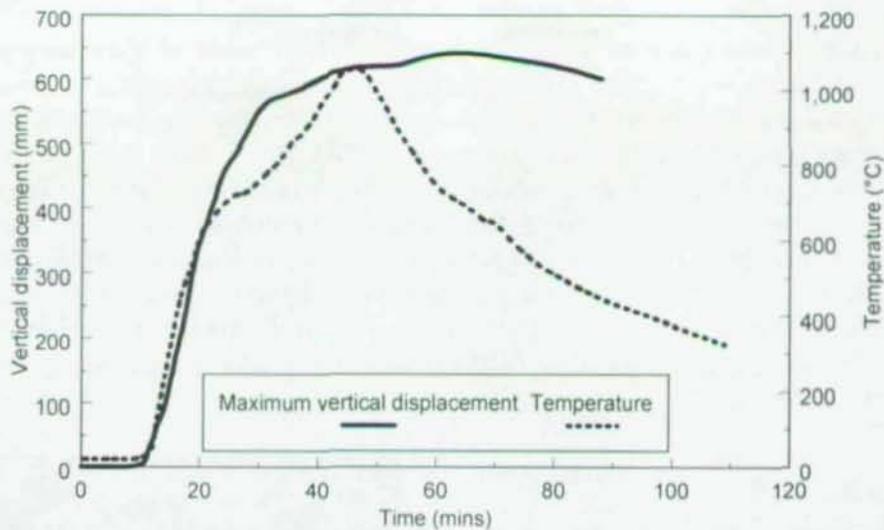
Figure 10 Maximum displacement and temperature of 9m secondary beam

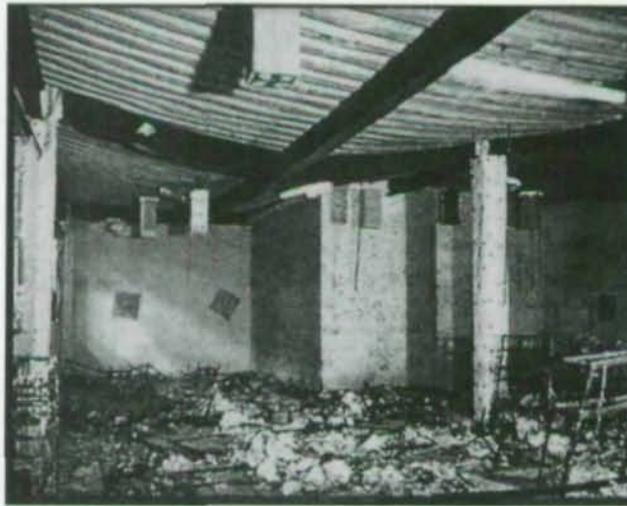
Figure 11 Structural damage resulting from Test 6

All the combustible material in the compartment was completely burnt including the contents of the filing cabinets. From the temperatures measured by protected indicative specimens suspended from the floor slab, the fire severity was found to be equivalent to 74 minutes in the standard fire resistance test. The structure showed no signs of failure (Figure 11).

In the test some of the connections suffered partial failure on cooling. The main cause is quite well understood. Beams are subject to various stresses during the heating. These include those caused by thermal restraint and negative bending. In some cases some form of compressive instability occurred which caused the beams to shorten. On cooling the connections were then subject to tensile forces which caused various forms of failure. This is discussed later.

The failures included the shearing of bolts and the shearing of end plates in heat affected zones. However, no beams collapsed. This was largely due to the shear path provided by the composite slab and the residual strength of the damaged connection.

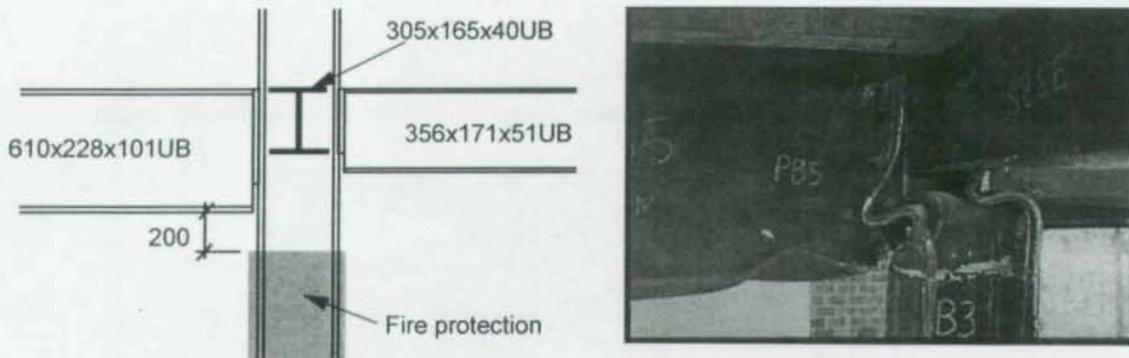
Figure 12 Extent of column fire protection and column deformation in Test 2

In Test 2, the heated columns were fire protected over most of their length, with the passive protection being stopped 200mm below the deepest connecting beam (Figure 12). During the test, the exposed part of the steel column failed in compression when it reached a steel temperature of approximately 670°C. The shape of the squashed column was governed by the induced imperfection caused by the bottom flange of the connected beams (which were of different depth) bearing onto the column flange, as the curvature of the beams increased (Figure 13). Although this behaviour did not result in overall structural failure, the local compression deformation of the column did cause damage to the floors above the fire compartment. It was decided to protect the columns over their full length (including the connections) in all the remaining tests and therefore to avoid local failure of the columns.

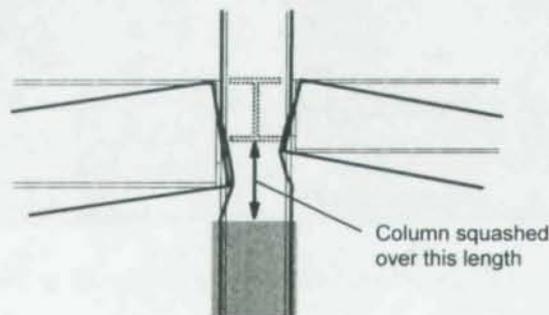
Figure 13 Part of exposed column which squashed during Test 2

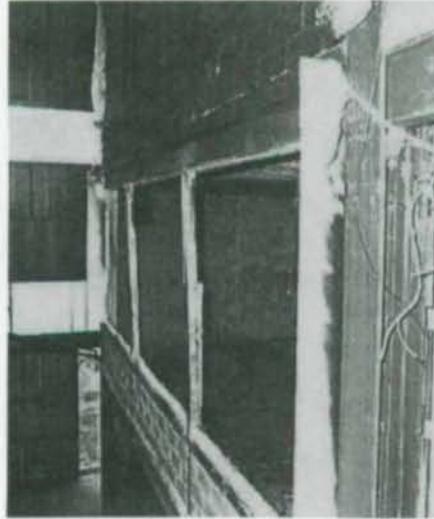
Figure 14 *Windposts following fire*

In Test 3 the perimeter beams were protected. In Test 4, 5 and 6, the perimeter beams were left totally exposed. In the case of the unprotected perimeter beams, the attached windposts acting in tension above the fire compartment were beneficial, resulting in very small vertical displacements of these beams (Figure 14). Therefore, if used, the windposts can be included in the fire design to justify the use of unprotected perimeter beams. In other cases, it is probably necessary to fire protect edge beams.

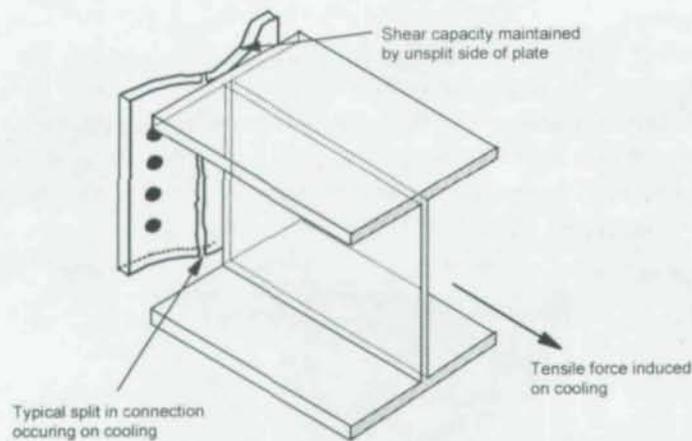
**Figure 15** *Fracture of end-plate during the cooling phase of the fire*

Apart from Test 2, all beam-to-column connections were protected as a consequence of the columns being protected over their full height. During the heating phase of the fire, both the end-plate and fin-plate connections performed adequately (including those in Test 2) with structural integrity being maintained. During the cooling phase many of the end-plate connections fractured down one side of the beam, as shown in Figure 15, and in one instance, the beam web fractured (Figure 16). The fin-plates connections failed by shearing of the bolts. This type of behaviour in the connections was attributed to the high tensile forces induced during the cooling phase of the fire. This was caused by the steel beam cooling down from a plastic state (typically recognised by the presence of local buckling). This tensile strain on cooling was relieved by the plate fracture or bolt shear of the connection.

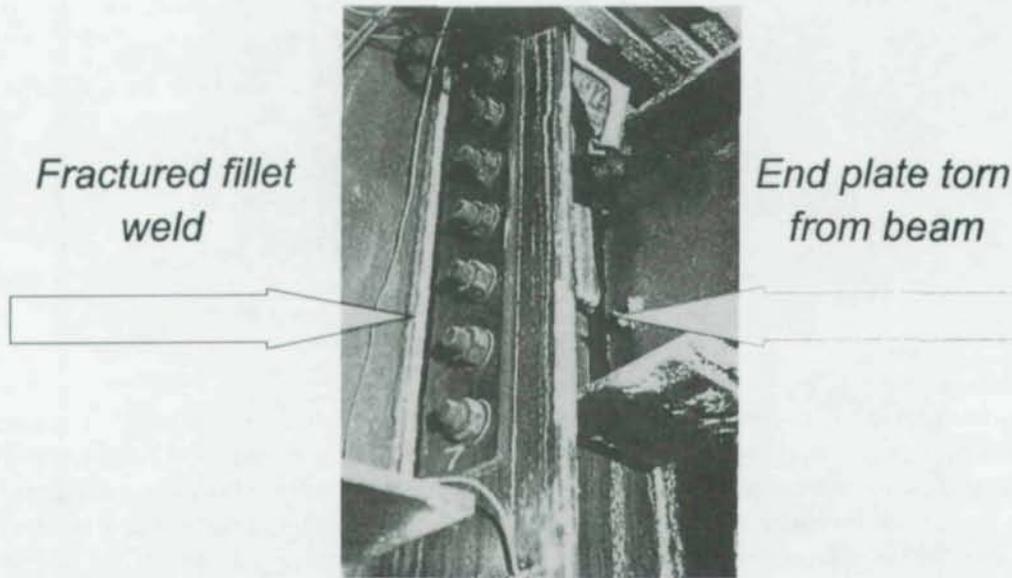
**Figure 16** *Connection detail showing fractures*

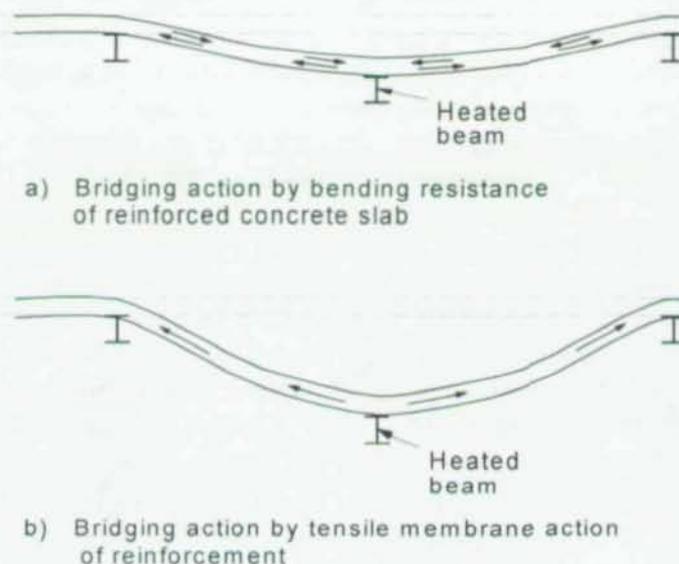
**Figure 17** *Bridging across a heated beam by the slab acting in bending and membrane action*

The bridging/membrane characteristics of the composite slab had a beneficial effect on the structural performance of the unprotected beams during the tests, when the beams had lost a large proportion of their bending resistance. In the first instance the slab bridges across the weakening heated steel members by utilising its full moment capacity. As the displacements increase further, the slab then acts as a tensile membrane through the mesh reinforcement. Both types of behaviour are shown diagrammatically in Figure 17. In the case of tensile membrane action, if the supports have no horizontal restraint (i.e. the slab is at an edge of a building) then a compressive membrane ring will eventually form around the area of slab in the cooler part of the compartment, as shown in Figure 18.

This action only occurs when a local area of the slab is heated and there is sufficient restraining effect around the perimeter of the heated area. It is not clear how large the heated area can be in order that this action is effective in supporting the beams to well beyond their critical temperature. The slab above protected beams is effective in resisting compression.

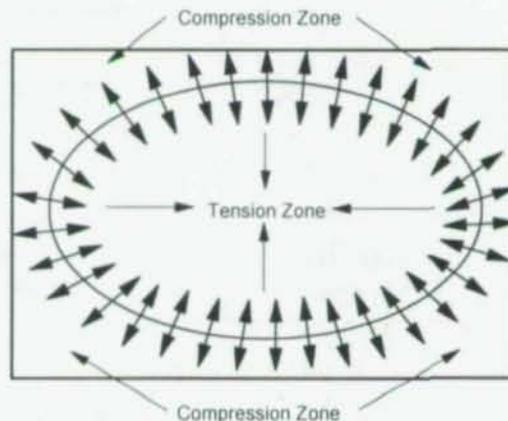
**Figure 18** *Tensile membrane action of slab without horizontal restraint to edges*

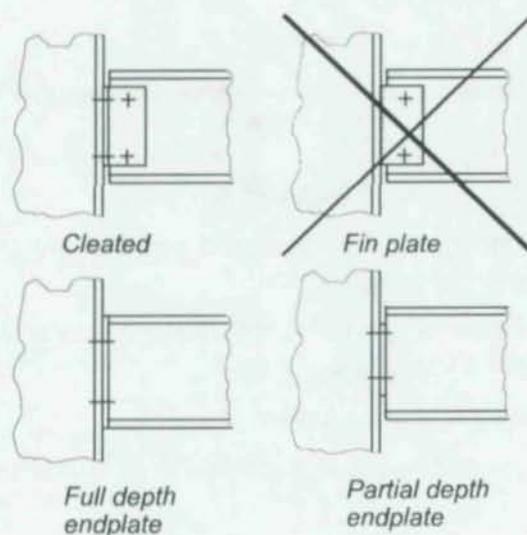
Figure 19 Connection types

Connections should be design to have partial or full depth end plates or double angle cleats connections. These types of connection provide the necessary failure modes to overcome the potential problem of high axial loads and strains which may be developed during the cooling phase of a fire. Fin plate connections are sufficiently ductile and are therefore not recommended. Recommended connection types are shown in Figure 19.

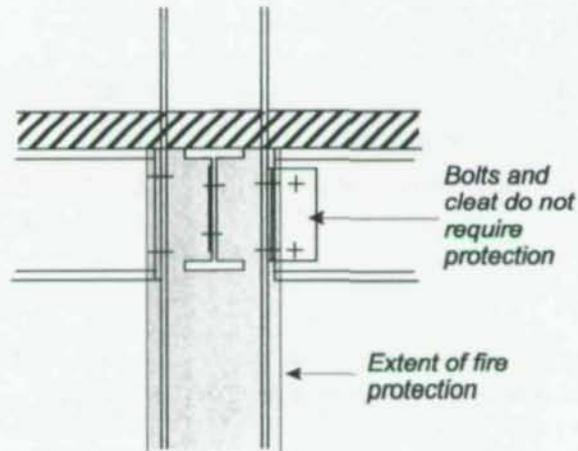
**Figure 20** *Extent of column fire protection (60 minutes)*

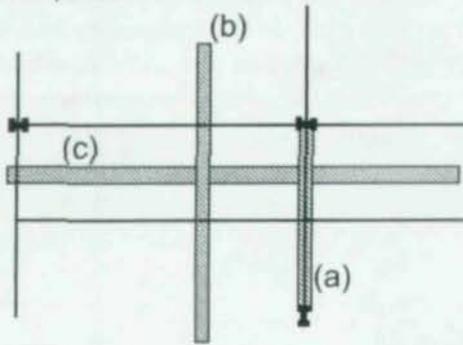
Figure 21 Positions of compartment walls

Walls which divide a floor into more than one fire compartment must be designed to accommodate expected structural movements (Figure 21).

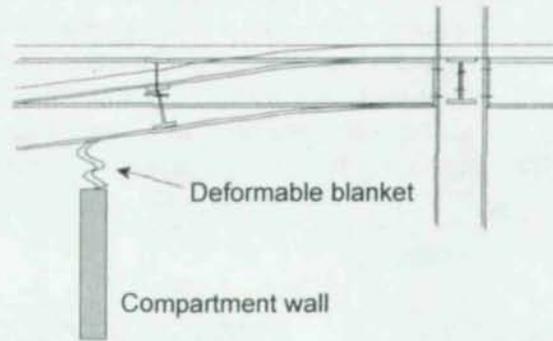
Figure 22 Large deflection of floor slab
