Durability of Steel Bridge Corrosion Protection Systems
Using Environment-Based Accelerated Corrosion Testing

FINAL REPORT

American Institute of Steel Construction (AISC)

April 21, 2022

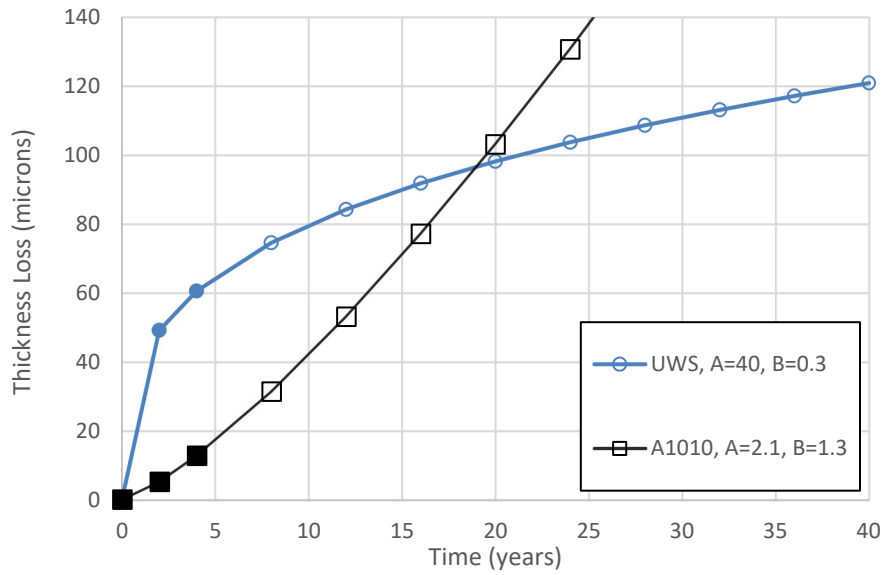
Figure 3-1. Power Law Curve Fits to Fletcher et al. (2003) UWS and A1010 Field Coupons After 4 Years of Exposure

Fletcher et al. (2003) provide useful corrosion data that has been carefully controlled for different materials in different US environments. Figure 3-1 shows the curve obtained by solving for constants A and B in Eqn. 1 that would fit the corrosion data on UWS coupons after 2 and 4 years of exposure at Kure Beach, NC that were reported by Fletcher et al. along with Fletcher et al.'s data for A1010 specimens. The fact that the data at 2 and 4 years is known and that the long-term corrosion behavior is extrapolated is highlighted by the filled data points at 2 and 4 years and the open data points for the remaining time periods.

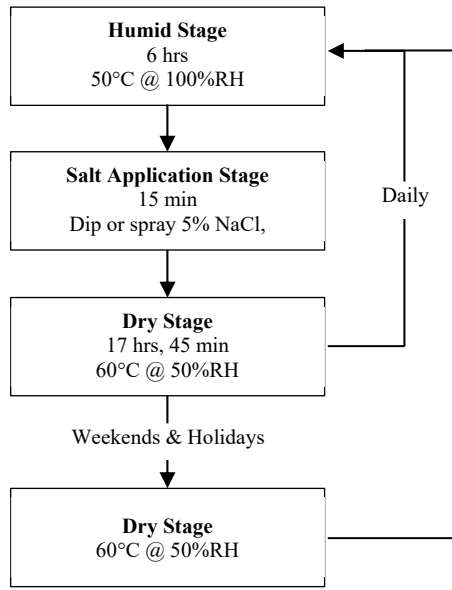
Figure 3-2. J2334 Accelerated Corrosion Test as Modified by Fletcher et al. (2003); “Standard Method” Used for Further Modifications

Figure 3-2 summarizes the modified J2334 test cycle used by Fletcher et al. (2003), which consists of daily cycles of wetting, salt application, and drying achieved by controlled variations in humidity and temperature. This method will be referenced herein as the “standard method”. Fletcher et. al showed that the test gave a good correlation for a variety of bridge steels with the corrosion in severe marine environments. This standard method modified the NaCl concentration of the salt application stage from 0.5% (used in the original SAE J2334) to 5%, which resulted in the formation of akaganeite, while the original SAE J2334 test did not. Akaganeite is known to form in the field conditions where chlorides are present in sufficiently high levels, which can interrupt the formation of more protective corrosion byproducts in UWS and is likely also detrimental to other corrosion protection systems. Further modification of this testing protocol may be necessary to further improve testing such that the corrosion mechanism of accelerated corrosion testing better matches the corrosion mechanism found in the field.

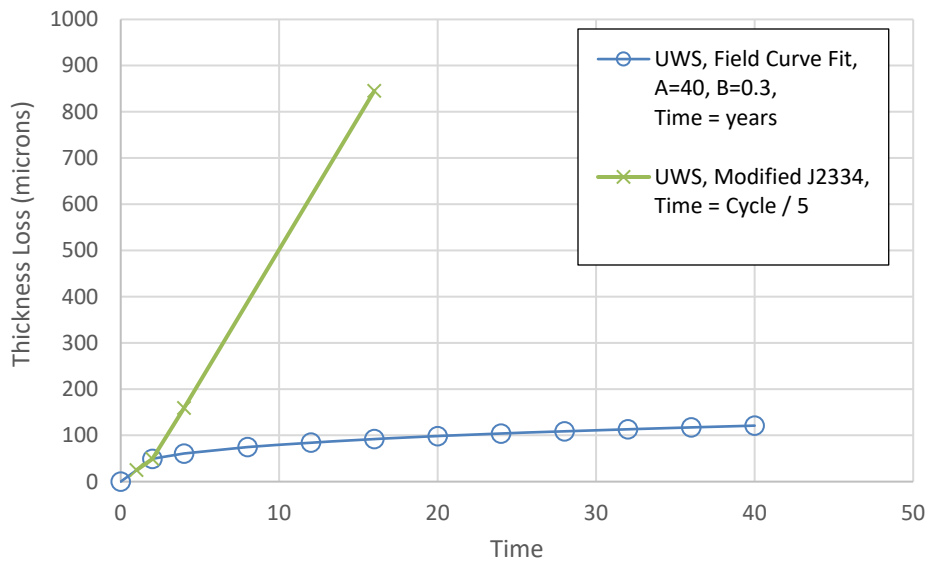
Figure 3-3. Comparison of Trends in Corrosion Rate of Field and Accelerated Corrosion Testing Specimens

Figure 3-3 shows the trends in corrosion rate of UWS both from the field data previously seen in Figure 3-1 and from the data obtained through accelerated corrosion testing by Fletcher et al. (2003). The curve of the corrosion rate obtained through accelerated corrosion testing does not match that of the data obtained in the field, as it never reaches a point of stabilization and over-predicts the amount of corrosion that would actually occur. This shows the need for further modifications to the SAE J2334 testing protocol to be able to make realistic long-term predictions.

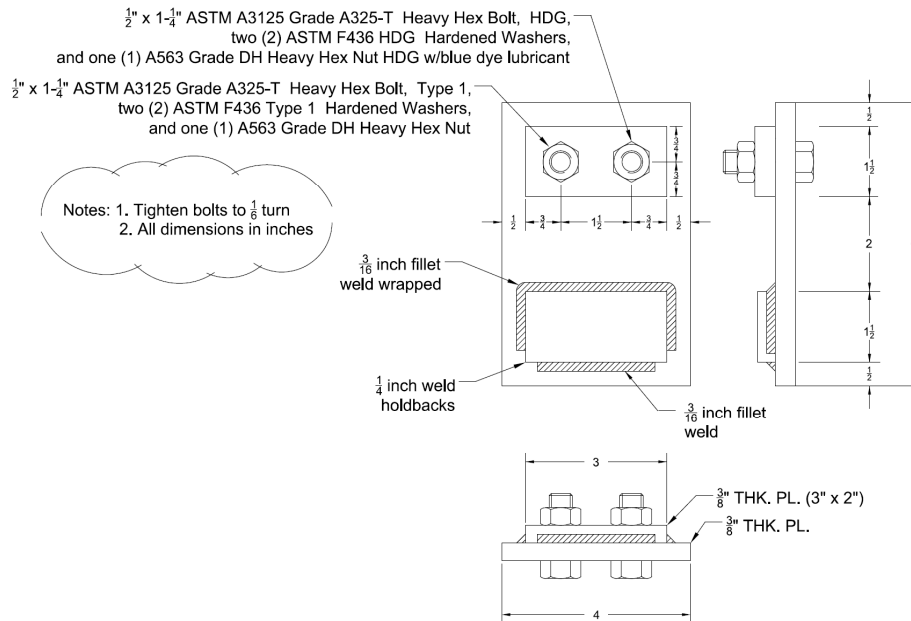
Figure 3-5. AutoCAD Drawing for Plate with Bolted and Welded Features

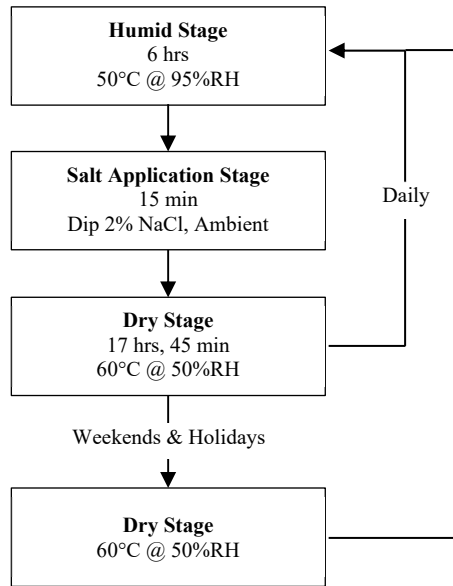
Figure 3-6 Method 1 Accelerated Corrosion Testing Protocol

The first attempted modification of the standard method was the reduction of the NaCl concentration in the salt bath during the salt application stage, as shown in Figure 3-6. A 5% concentration of NaCl is dictated by the standard method. However, since results show that the standard method leads to exponential increase of corrosion rate instead of exponential decrease of corrosion rate as experienced in the field, the first modification reduced that amount to a 2% NaCl concentration to attempt to lessen the rate of corrosion. The required amount of salt to satisfy this concentration was calculated and added to containers of deionized water to create the salt bath that the specimens were submerged into during the daily salt application stage. All other aspects of the daily cycles remained the same as the standard method. See Table B-1 in Appendix B for the mass of salt used in the salt baths for each method.

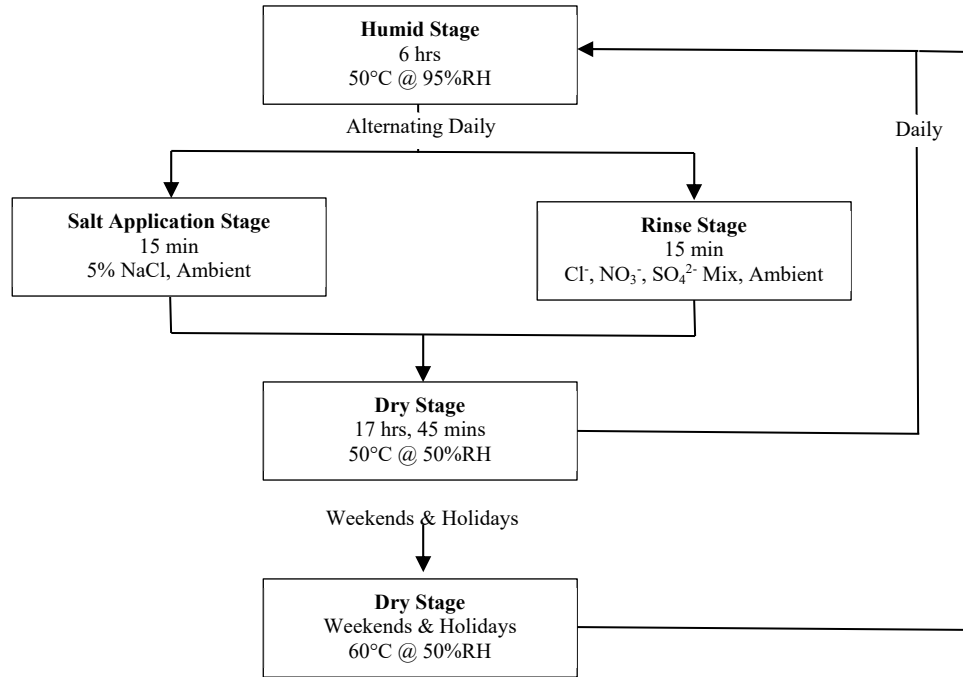
Figure 3-8. Method 3 Accelerated Corrosion Testing Protocol

The third modification to the standard method was adding a rinse cycle to simulate more realistic field conditions, as shown in Figure 3-8. In reality, bridges are not constantly doused with chlorides. During the summer, highway overpasses are typically subject to roadway spray consisting of rainwater and other elements that may be dissolved in the rainwater. This roadway spray could provide a rinsing effect to remove corrosive elements from the steel. This rinsing effect would likely slow down the rate of corrosion.

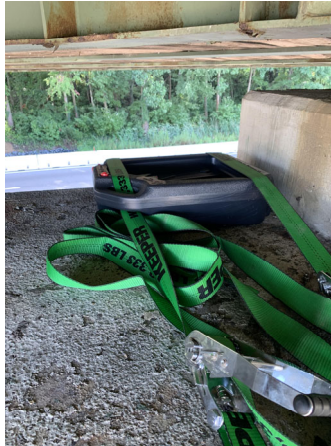
Figure 3-9. Water Collection on the Chapman Rd. Bridge

To properly simulate the road spray rinse water, water was collected from the Chapman Rd. bridge crossing I-95 in Newark, Delaware. A clean oil pan was placed on the pier of the bridge and secured with tiedown straps, as shown in Figure 3-9, and was retrieved after a rainstorm. The water was then analyzed by a pH test, conductivity test, ion chromatography test, and gran titration using the methodology described in “Techniques of Water-Resources Investigations Reports” (USGS 2020). The results of these tests describing the chemistry of the water from the road spray are shown in Table 3-2.

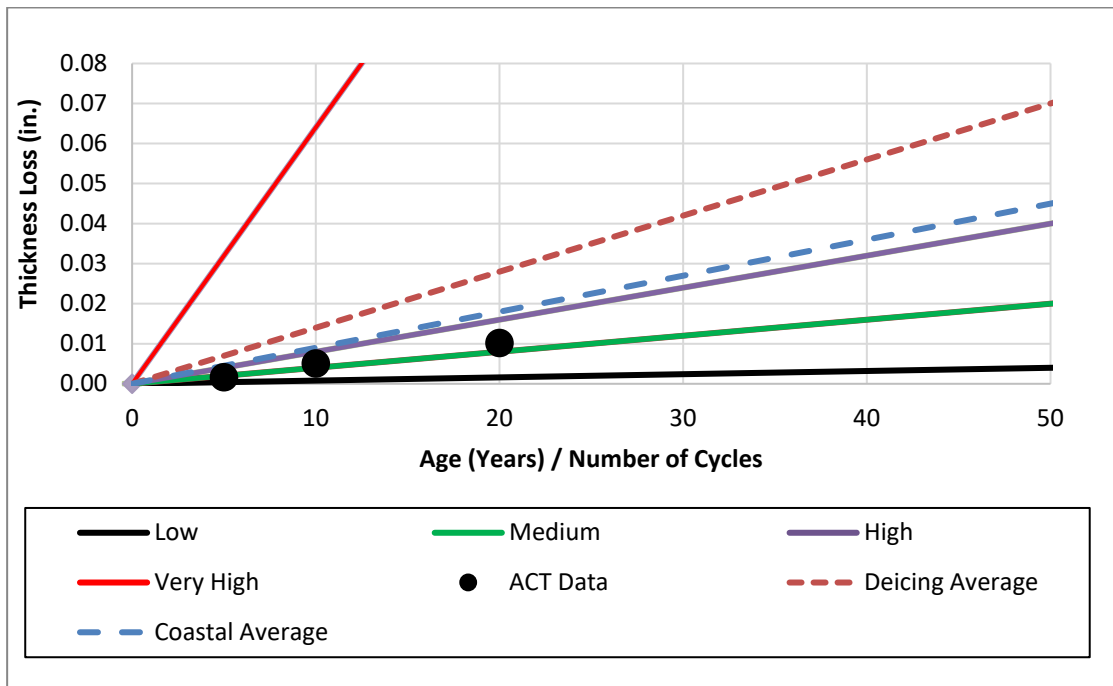
Figure 3-14. Method 5 Weathering Steel Thickness Loss Compared to Albrecht et al. Corrosivity Categories and Field Data

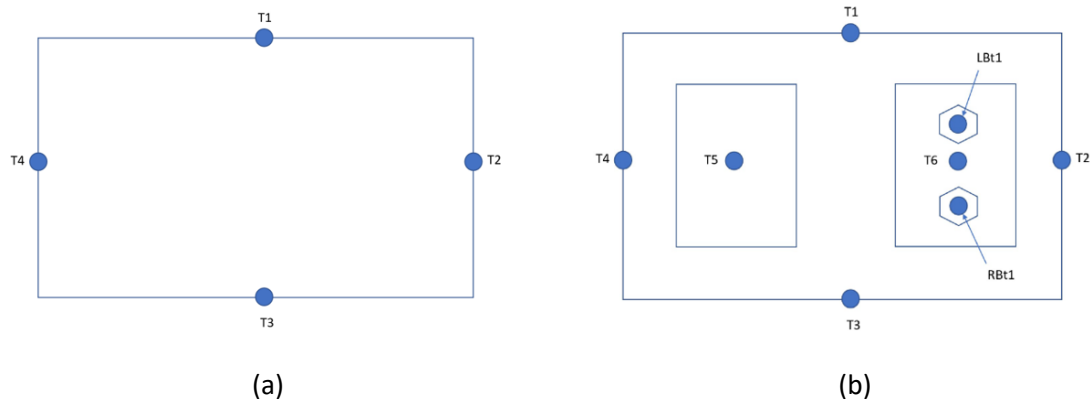
Figure 3-29. (a) Locations of Thickness Measurements for Plate Specimens (b) Locations of Thickness Measurements for Specimens with Bolted and Welded Features

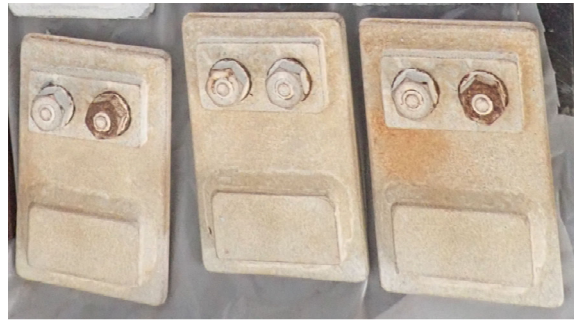
Figure 4-3. Galvanized Plates with Bolted and Welded Features After 80 Cycles of Accelerated Corrosion Testing

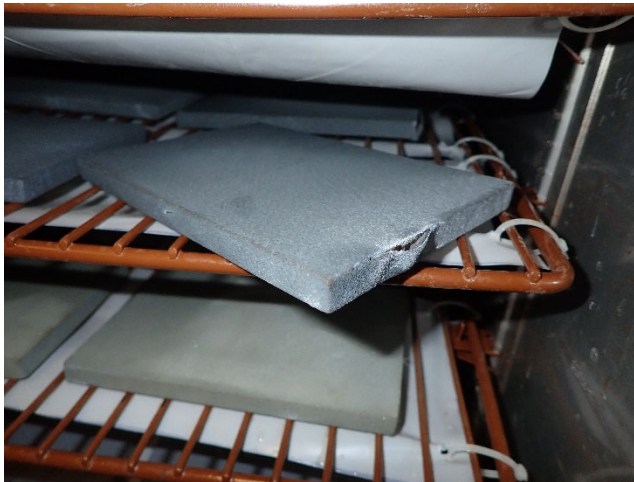
Figure 4-5. Metallized Coating Pulling Away on the Edge After 7 Cycles of Accelerated Corrosion Testing

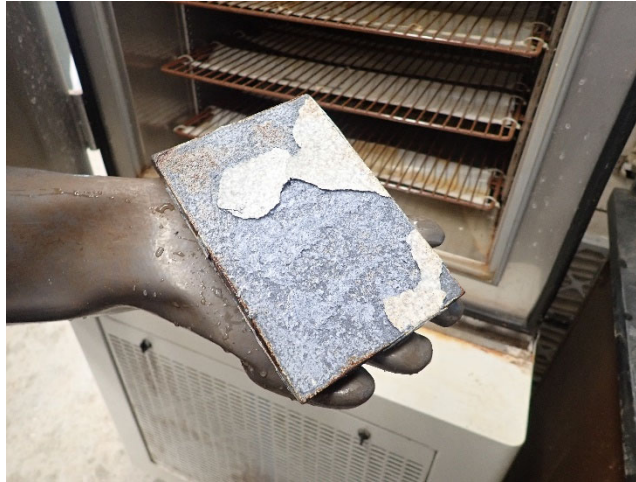
Figure 4-6. Metallized Coating Deterioration on 4” x 6” Face of Specimen After 55 Cycles of Accelerated Corrosion Testing

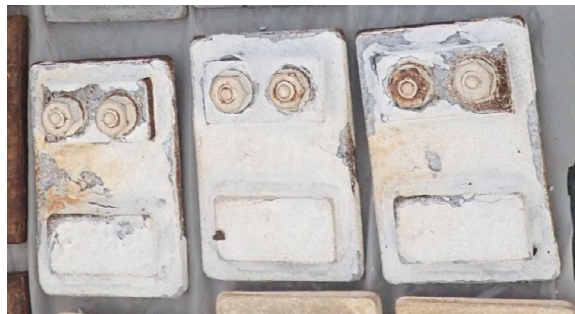
Figure 4-7. Metallized Plates with Bolted and Welded Features After 80 Cycles of Accelerated Corrosion Testing

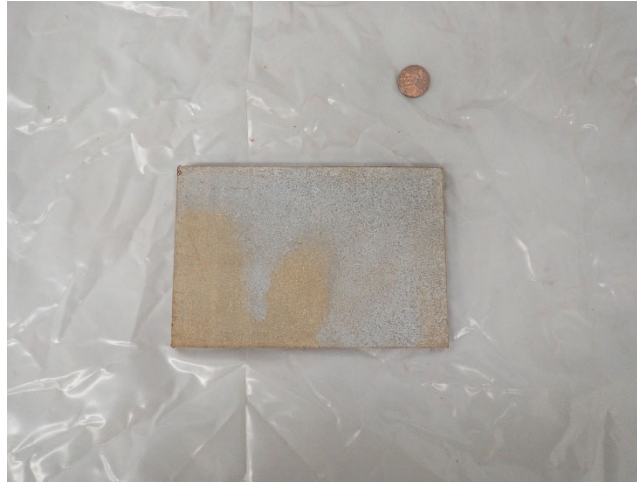
Figure 4-9. 1-Coat IOZ Specimen Discoloration After 80 Cycles of Accelerated Corrosion Testing

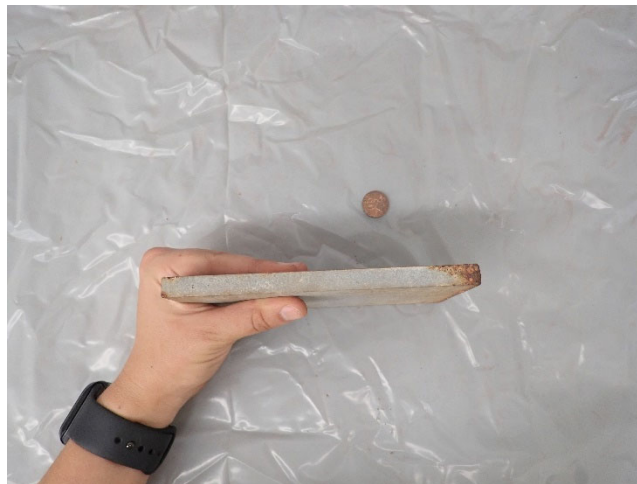
Figure 4-10. 1-Coat IOZ Specimen with Corrosion at the Corner After 80 Cycles of Accelerated Corrosion Testing

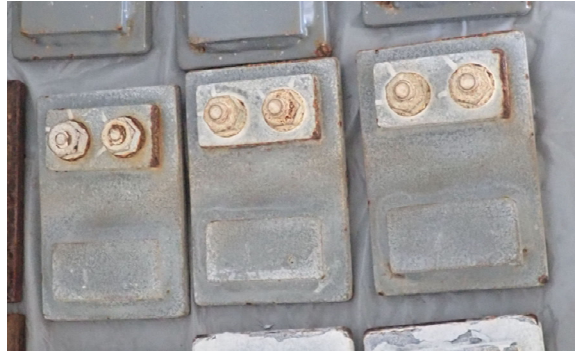
Figure 4-11. 1-Coat IOZ Plates with Bolted and Welded Features After 80 Cycles of Accelerated Corrosion Testing

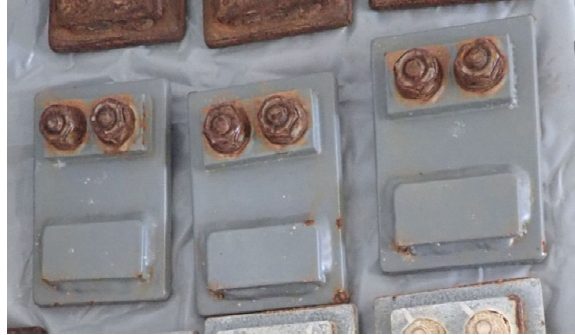
Figure 4-14. 3-Coat OZ Plates with Bolted and Welded Features After 80 Cycles of Accelerated Corrosion Testing

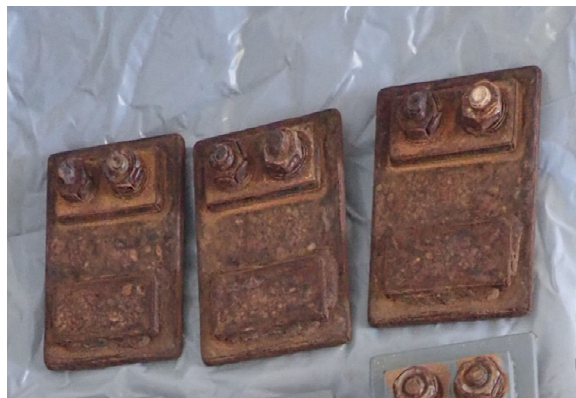
Figure 4-16. UWS Plates with Bolted and Welded Features After 80 Cycles of Accelerated Corrosion Testing

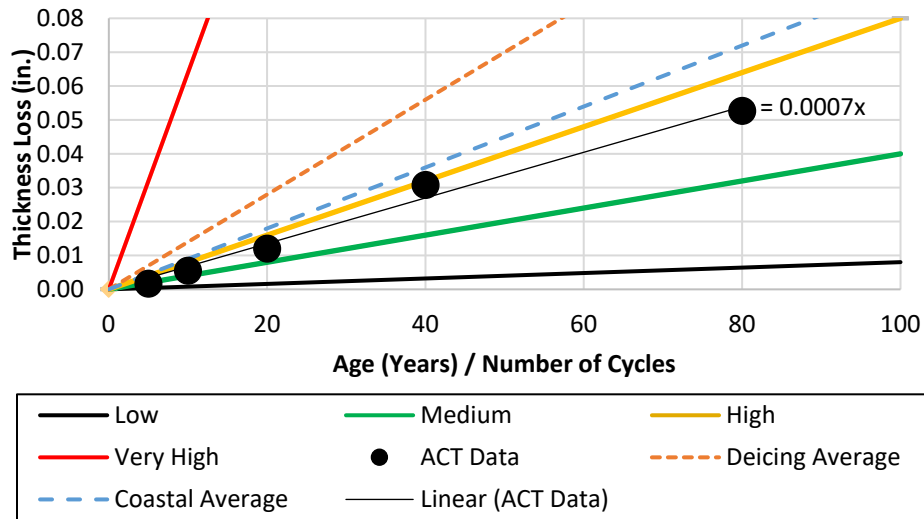
Figure 4-25. UWS Thickness Loss Scaled Such that 1 Cycle = 1 Year
