report submitted to American Institute of Steel Construction

Effects of Slab Post-tensioning on Supporting Steel Beams

March 2007

Bhavna Sharma and Kent A. Harries, Ph.D., F.A.C.I., P.Eng.
University of Pittsburgh
Department of Civil and Environmental Engineering
Pittsburgh PA 15261

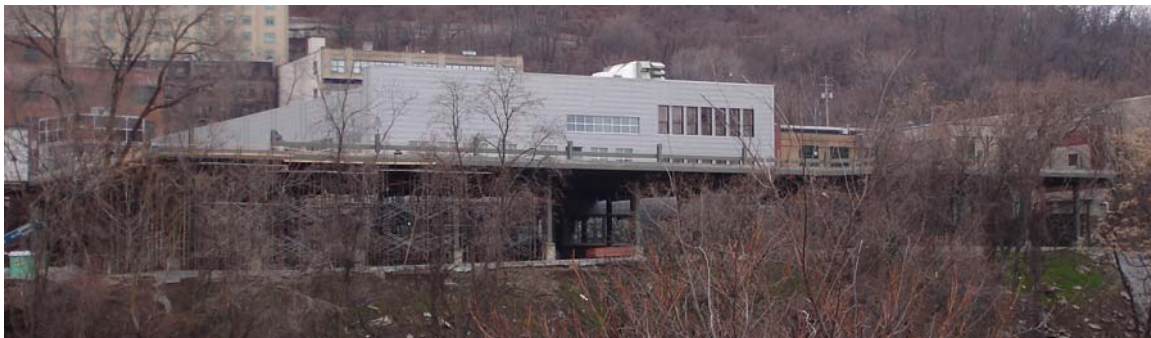
Figure 3.1 450 Melwood Avenue, Pittsburgh PA.

Overall view of 11 bay parking structure looking West from across railway right-of-way.

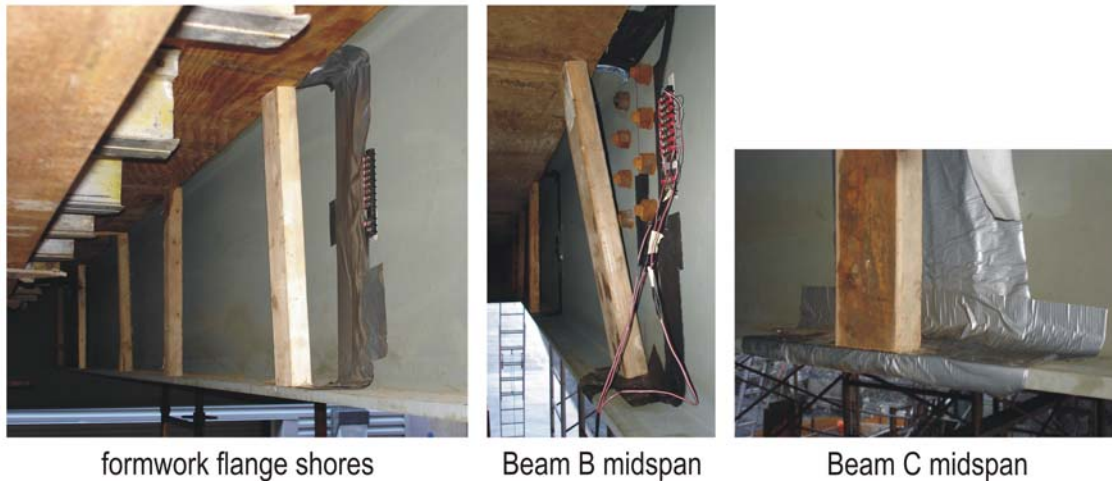
Figure 4.3 Installations of formwork shores near and directly on top of strain gages.

It was not possible to control all field conditions at all times. Following gage installation, the formwork contractor installed flange shores. In many cases, the shores were located very near gage locations. In two cases, shown in Figure 4.3, these shores were placed directly on top of the gages! Section 6.3 addresses the integrity of the strain gages through the test program.

As discussed in Section 4 and shown in Figure 4.3, field conditions resulted in damage to some of the strain gages. The following gages were excluded from the data analysis due to inconsistent and erroneous readings indicating damage: B4, B7, B13, C5, D5, D6, D10 and D14. Additionally gages B1 and C9 returned multiple inconsistent readings although they later appeared to be operational. Other gages were observed to return single erroneous readings; these are attributed to the data acquisition process and the likelihood that one of the screw terminals was inadequately tightened. Inconsistent data has been discarded in every case.

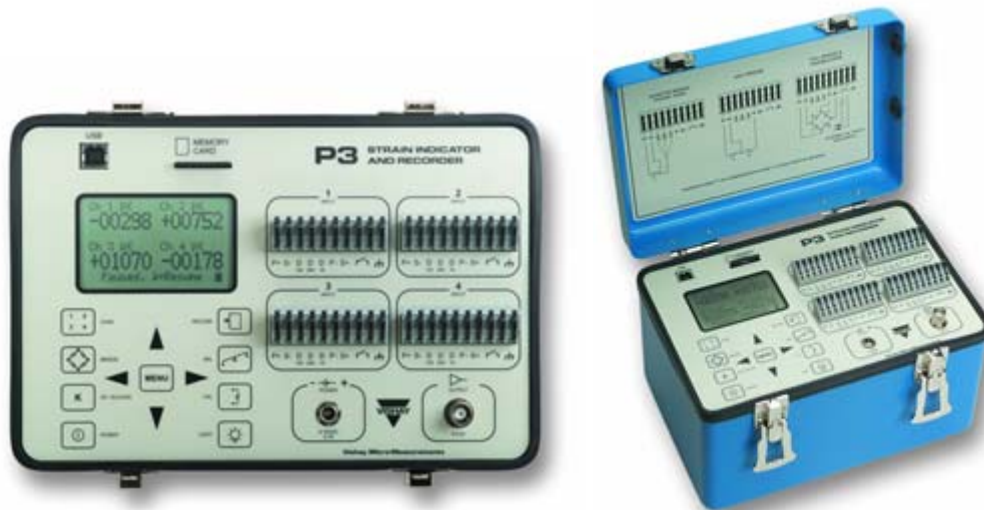
Figure 4.4 Vishay P3 4-channel strain gage indicator (images: Vishay).

All gage data was collected on the same Vishay P3 (S/N 164882) 4-channel strain gage indicator (Figure 4.4). Channels 1 through 3 were connected to the three gages at each beam section and data was manually recorded. In all cases, gages were always recorded by the same channel having balancing and offset functions disabled. In this manner gage readings through time are made consistent and comparable.

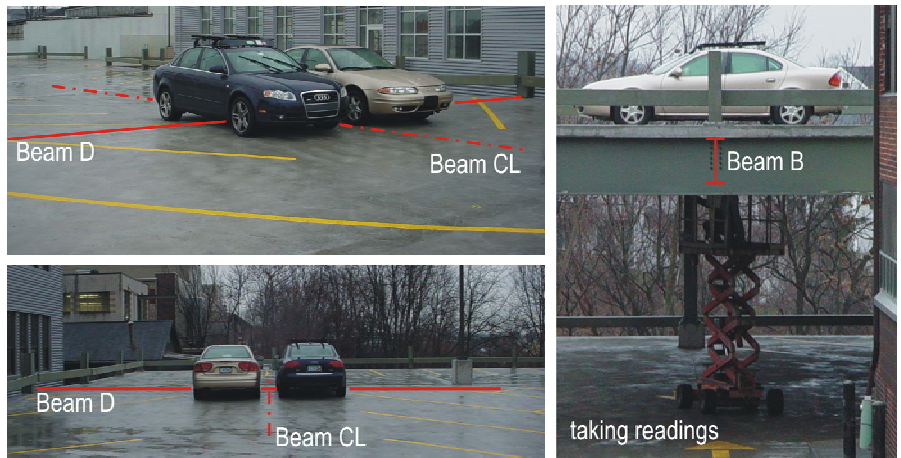
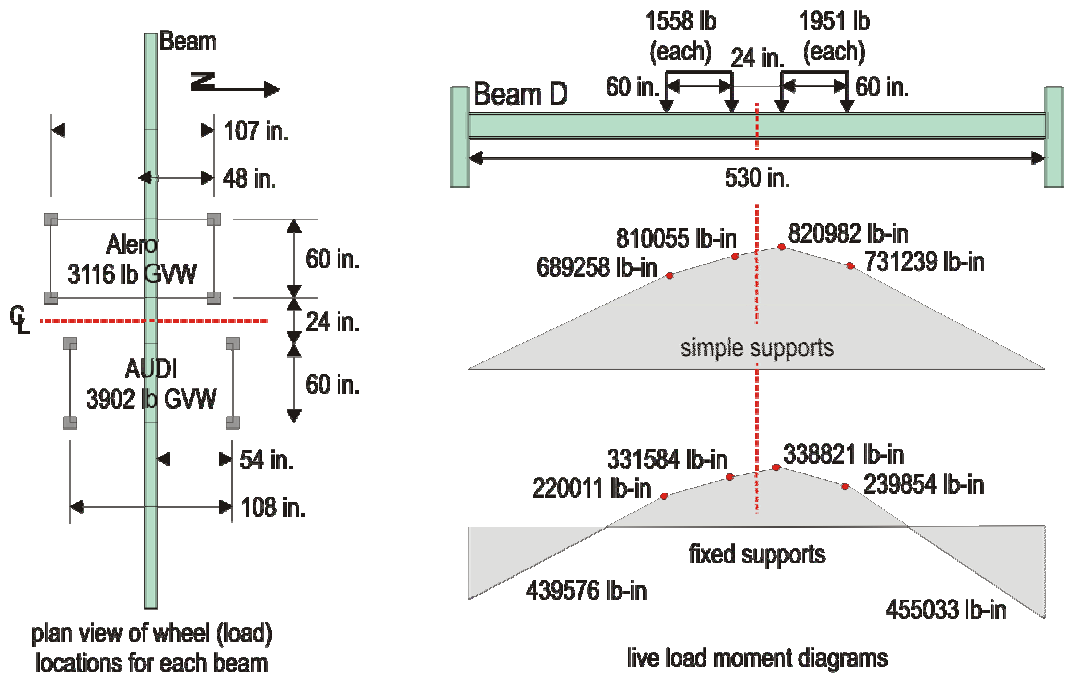
Figure 6.4 Live load test: January 12, 2007.

A second live load test was conducted on all beams January 12, 2007. In this test, An AUDI A4 having specified front and rear GAVW of 1960 lbs and 1942 lbs, respectively, and an Oldsmobile Alero having specified front and rear GAVW of 1714 lbs and 1402 lbs, respectively, were positioned over the center of each beam in turn as shown in Figure 6.4. The strains resulting only from the application of the live load are given in Table 6.1. From the live load strain distribution obtained, the location of the beam neutral axis was determined and the resulting applied moment found in the same manner as indicated in Section 6.2.1. The live load moment resulting from each loading case is shown in Table 6.1. Based on the observed strain behavior and neutral axis locations, all beams are clearly behaving as composite members having ends largely restrained from rotation. This observation is discussed in Section 7.4.

Beam at midspan (gage 9)		
	B	C	D
observed tension flange strain (microstrain)	173 ¹	42	44
apparent neutral axis location, y (inches)	22.2	22.9	26.9
apparent moment (assume $b_{eff} = 105"$) (lb-in)	1	324,000	289,000
apparent moment (assume $b_{eff} = 240"$) (lb-in)	1	351,800	313,700
applied moment (simply supported) (lb-in)	815,500		
applied moment (fixed supports) (lb-in)	335,200

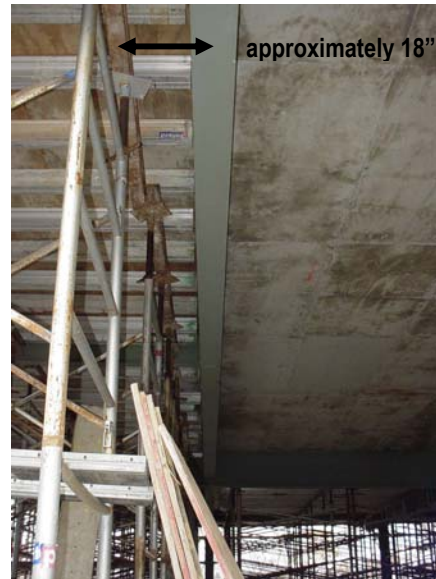
Figure 7.1 Location of form shores at Beam B
(photo taken as shores are being removed and coincides with the photo shown in Figure 5.4).

Between the time that the concrete deck hardens and begins acting compositely with the underlying beams and the time at which the formwork is removed, a limited portion of the deck slab is able to act in a composite manner with the beam. The formwork supports the majority of the slab and is stiffer in resisting gravity loads than the beam, therefore only that portion of the slab tributary to the beam will affect the load carrying capacity of the beam. In this work, this effective width, $b_{eff, form}$ is taken as equal to 36" based on the observed spacing of the formwork as shown in Figure 7.1.

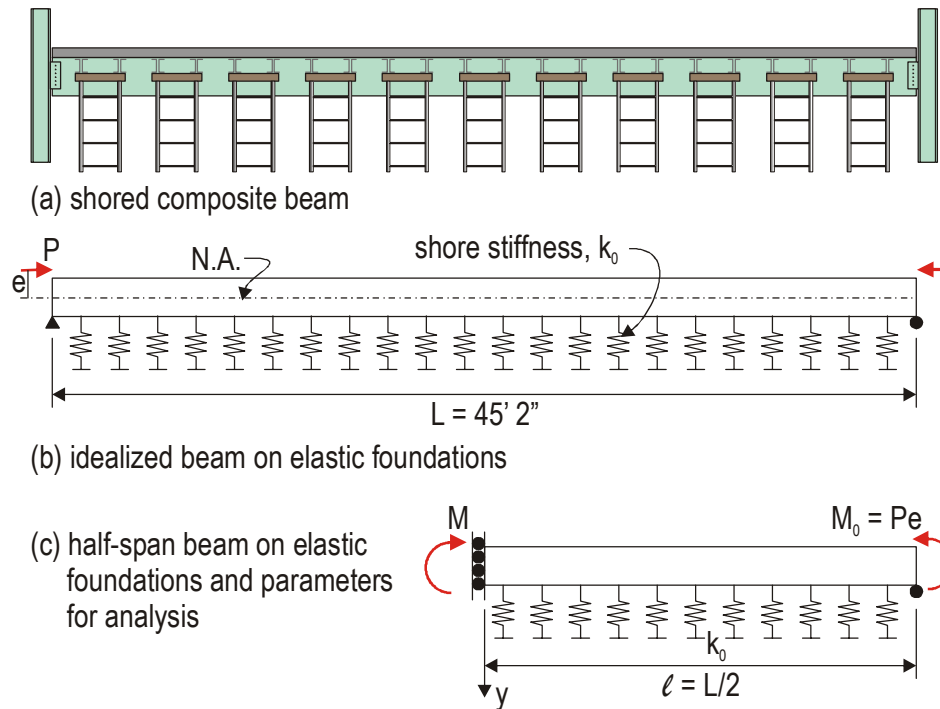
Figure 7.2 Modeling shored beam as beam on elastic foundations.

The assumption promulgated above that the PT operation results in only axial stresses provided the slab remains shored is, admittedly, an idealization. A rigorous analysis of the problem may be made by considering the shored system as a beam on elastic foundations subject to an axial force moments at each end. The elastic foundation, representing the shores, is assigned a stiffness in terms of a unit stress to cause a unit deflection (psi/in, for instance). This stiffness is effectively the axial stiffness of the shoring system as indicated in Figure 7.2. In general, this stiffness will be relatively large since it effects the vertical deflection of the forms when placing the concrete deck. An example of estimating the effective stiffness of the shoring system is provided below:

The shore stiffness has no effect on the axial component of the PT force; thus the axial stress in the system may be calculated as in Section 7.5.1. The effect of the induced moment is determined based on the behavior of a beam on elastic foundations. A standard solution to the problem shown in Figure 7.2(c) is provided in *Roark's Formula's for Stress and Strain* (Young and Budynas 2002) as shown below. It is clear from these calculations that stresses due to the PT induced moment are negligible provided the shores remain engaged.

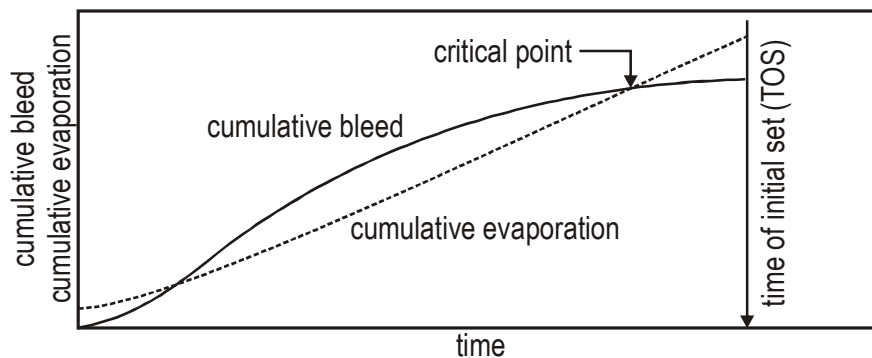
Figure B.2 Cumulative bleed and evaporation as function of time (after Poole 2006).

To predict PSC, the anticipated evaporation rate is compared to the expected rate of bleed water coming to the concrete surface during the time of initial concrete set (TOS). If at any time during the TOS, the cumulative evaporation exceeds the cumulative production of bleed water, the surface becomes dry and PSC may occur. This is shown schematically in Figure B.2. PSC is more critical in high-performance concrete mixes where the inclusion of supplementary cementitious material (specifically silica fume) retards bleed water.
