EXPERIMENTAL RESULTS OF THE AISC FULL-SCALE COLUMN BLAST TEST

Joseph M. Magallanes
Ruben Martinez
John W. Koenig

March 21, 2006

The American Institute of Steel Construction
1 East Wacker Drive., Suite 700
Chicago, IL 60601

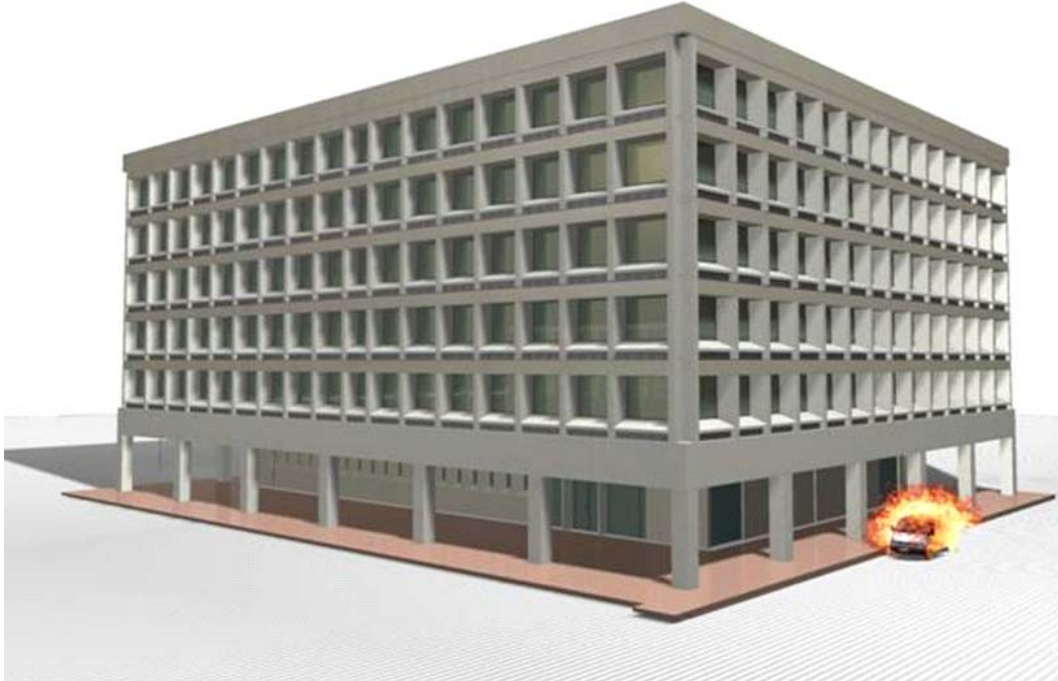
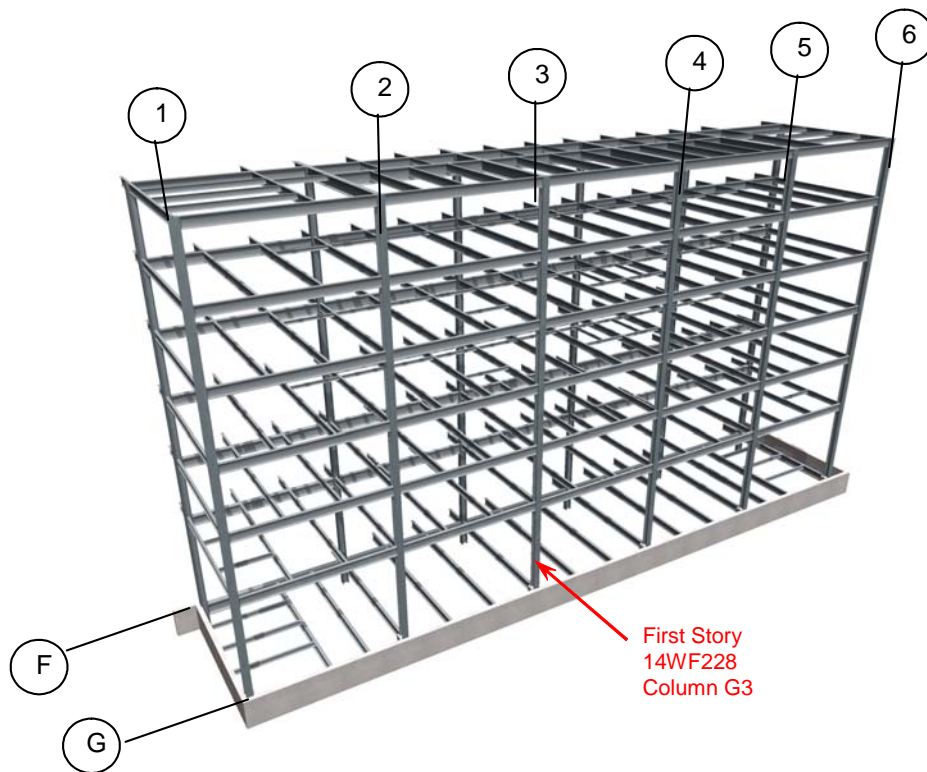
Figure 1-1. Explosive threat of interest to the FEMA/DHS study.

(a) Attack scenario of interest.

(b) Steel framing.

The study focused on a modified version of an existing steel structure subjected to an explosive charge similar to that experienced during the terrorist attack on the Murrah Building in Oklahoma City in 1995. The scenario of interest to the study is illustrated in Figure 1-1. The structure consists of a steel-framed gravity system supporting a steel metal deck with concrete infill and relies on moment-frames as the building's primary lateral force-resisting system (LFRS). Since the structure reflects older LFRS detailing requirements, several building retrofits were considered to upgrade the existing building to conform to current seismic design requirements for areas of high seismicity (e.g., San Francisco, CA). A blast effects analysis of each retrofit scheme was executed to quantify the blast resistant benefits obtained through implementing these various seismic upgrade schemes.

A threat representative of the attack on the Murrah Building was determined by the FEMA/DHS peer review panel to be a 4,000-pound TNT-equivalent charge positioned away from the column at gridline G3 as illustrated in Figure 1-2. This equated to an effective slant standoff of 15'-6" from the center of this column to the center of the explosive source.

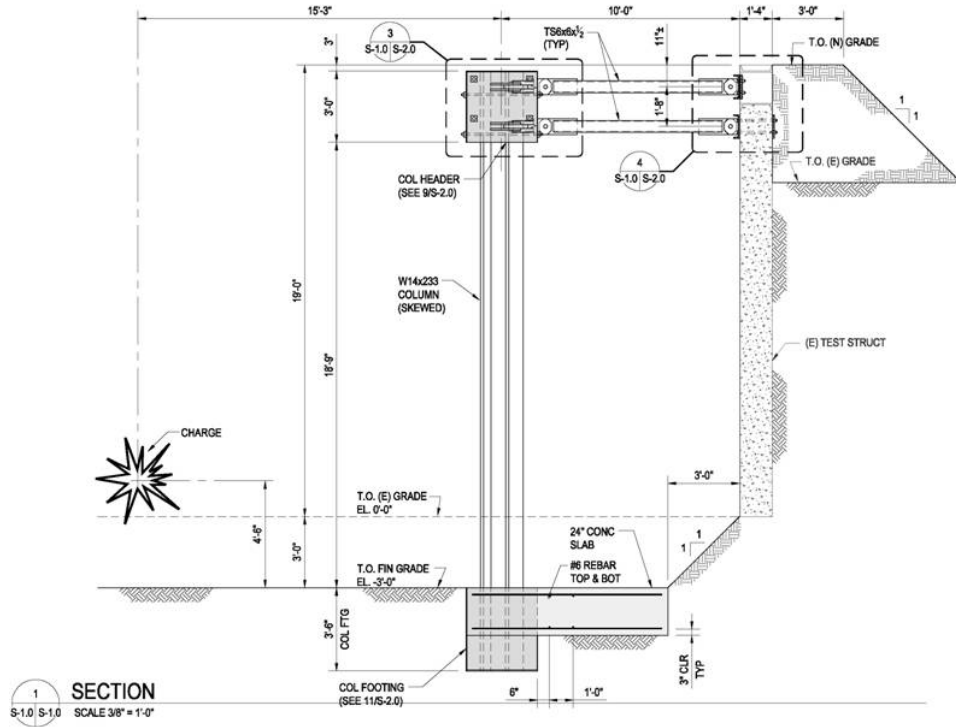
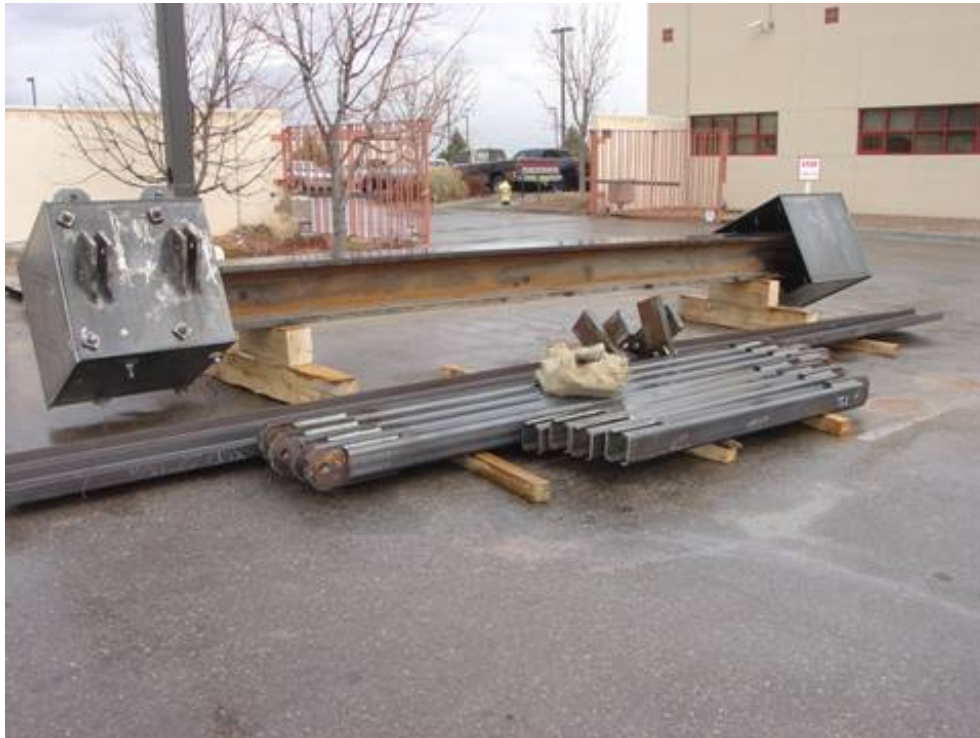
Figure 2-1. The AISC test column specimen.

(a) Structural detail of the test article.

(b) Fabricated column specimen prior to installation.

A test article was designed and structural drawings issued for construction. These are shown in Appendix A, including the shop drawings upon which the specimen was fabricated. A structural elevation of the test article, reproduced from Appendix A, is shown in Figure 2-1a. A photograph of the test article upon delivery to EMRTC is shown in Figure 2-1b.

The test column was an AISC W14x233 standard rolled shape of ASTM A992, Gr.50 structural steel, as this section possesses the most similar cross-section properties to the 14WF228 section used in the FEMA/DHS column study. The cross-section properties of the W14x233 column is shown in Figure 2-2 [3]. The test article had a clear span of 18'-9" measured from the top of the reinforced concrete (RC) base assembly to the bottom of the RC header assembly. Both the base and header reaction assemblies were constructed of a series of ¼" thick steel plates shaped into a box which had the dual purpose of serving as a perimeter where the steel struts could be welded, in addition to serving as forms for the concrete pour. Nelson studs welded to the sides of each steel plate facilitated this connection to the concrete. At each end of the column, these base and header assemblies were connected to the column via full-penetration welds. Photographs of the base and header reaction assemblies are shown in Figure 2-3, prior to filling each with concrete. When filled with concrete, the base and header assemblies provided fixed boundary constraints at each end of the column.

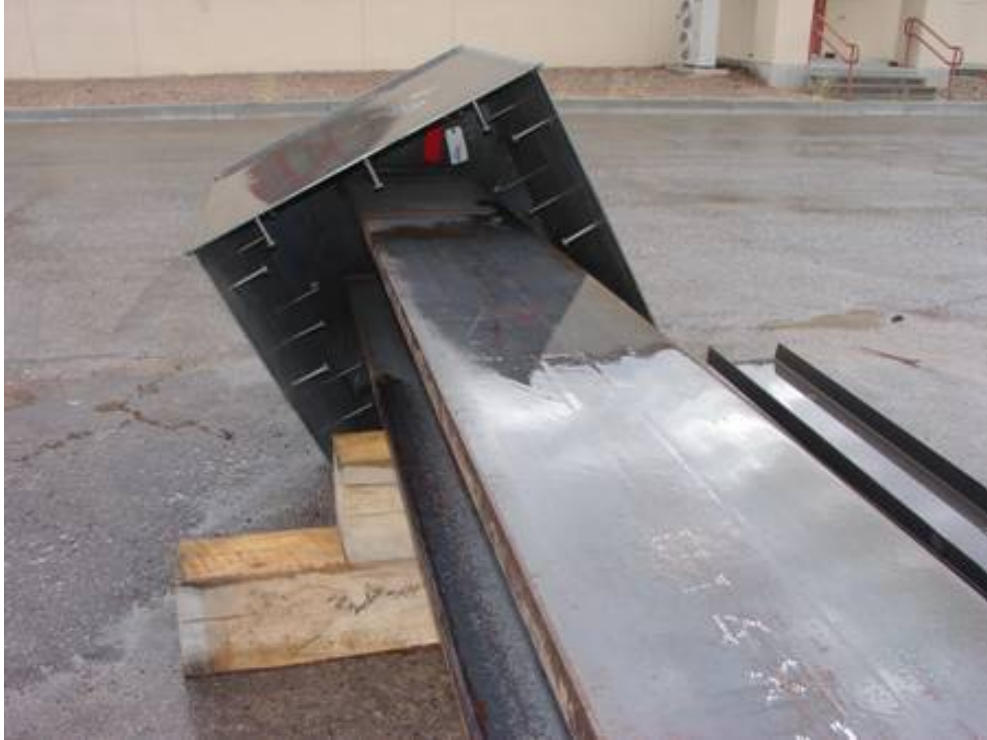
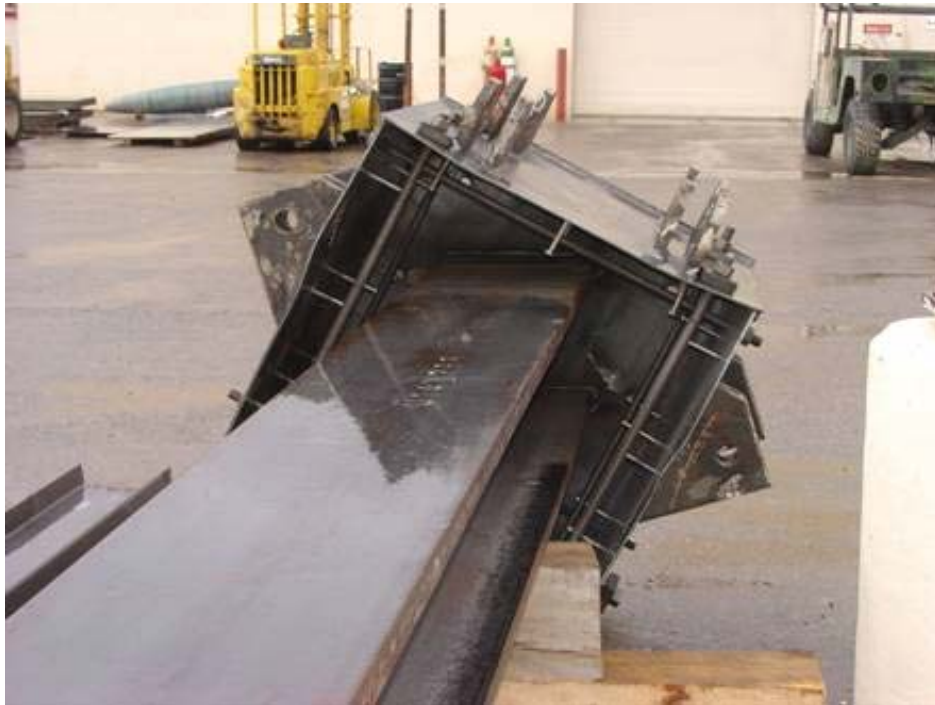
Figure 2-3. Photograph of the column base and header assemblies prior to filling with concrete.

(a) Base assembly.

(b) Header assembly.

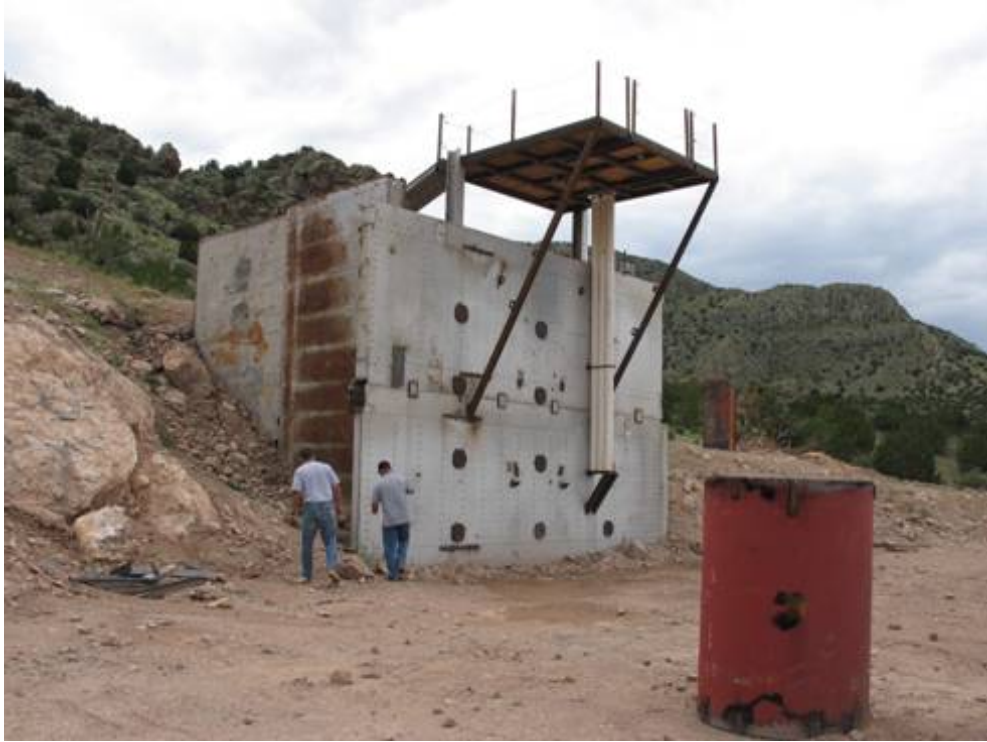
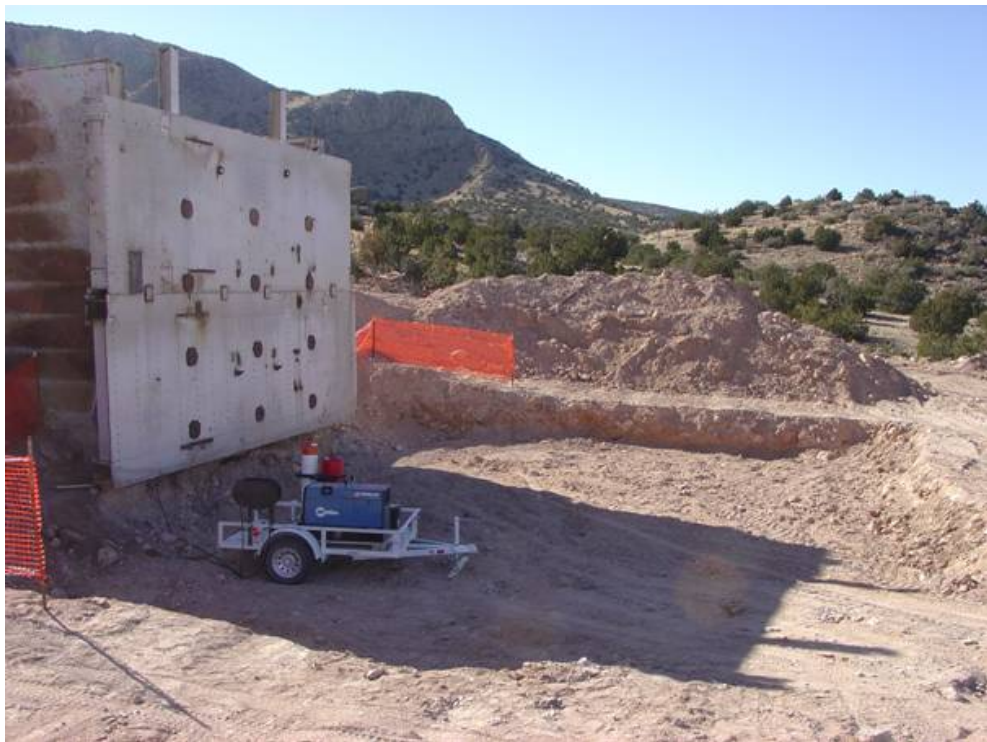
Figure 2-4. Reaction wall at the MBTF site at EMRTC.

(a) Prior to modifications.

(b) After modifications.

The column specimen was installed at the Multi-Bay Test Facility (MBTF) located within the EMRTC Field Laboratory in Socorro, NM. The reaction wall at the MBTF site is a large and massive structure capable of developing large reactive loads and was designed for the high explosive (HE) testing of components placed at short distances to the front of its armor steel plate wall. For the AISC column test, the structure was modified to accommodate the column specimen and associated connection hardware for the header, base, the RC slab, and the eight header reaction struts. Two photographs of the MBTF reaction wall are shown in Figure 2-4; the

first taken before the modifications and the second after the modification but before the installation of the test specimen. These modifications included:

- removal of the existing platform, support bracing and other unnecessary components;
- earth-moving work to form a uniform, horizontal surface between the charge location and test specimen as well as for adequate in-fill behind the reaction wall;
- placement of the 2-ft thick trapezoidal shaped reinforced concrete slab beginning 3 ft before the structure; and
- preparation and installation of the bolted steel channels to the armor steel plate wall for the upper strut reaction system.

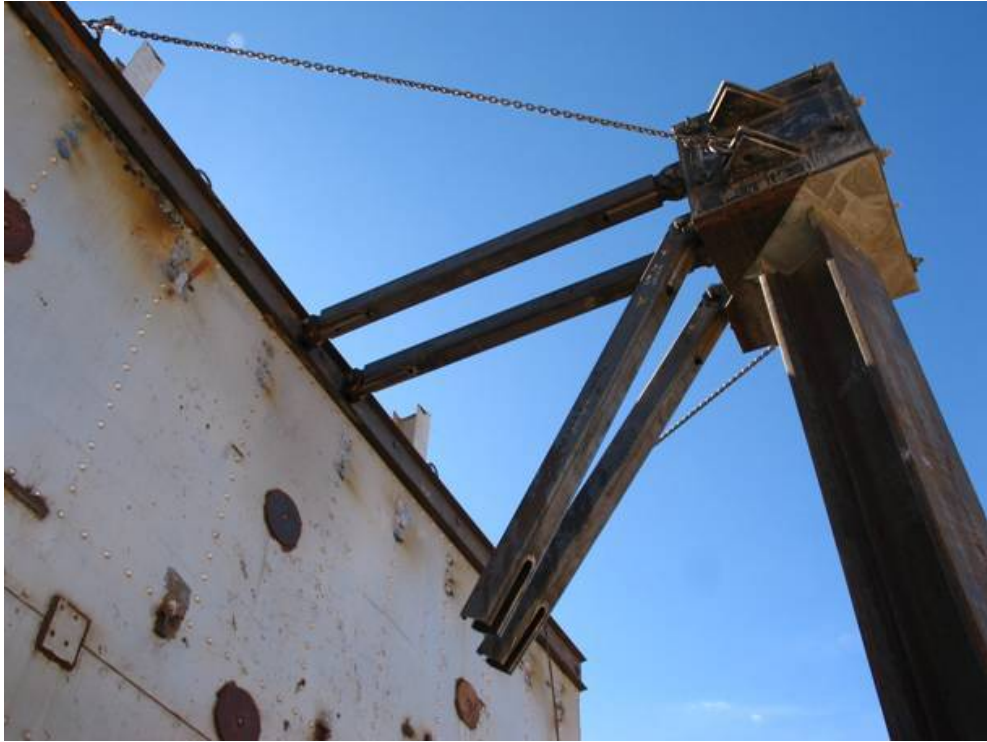
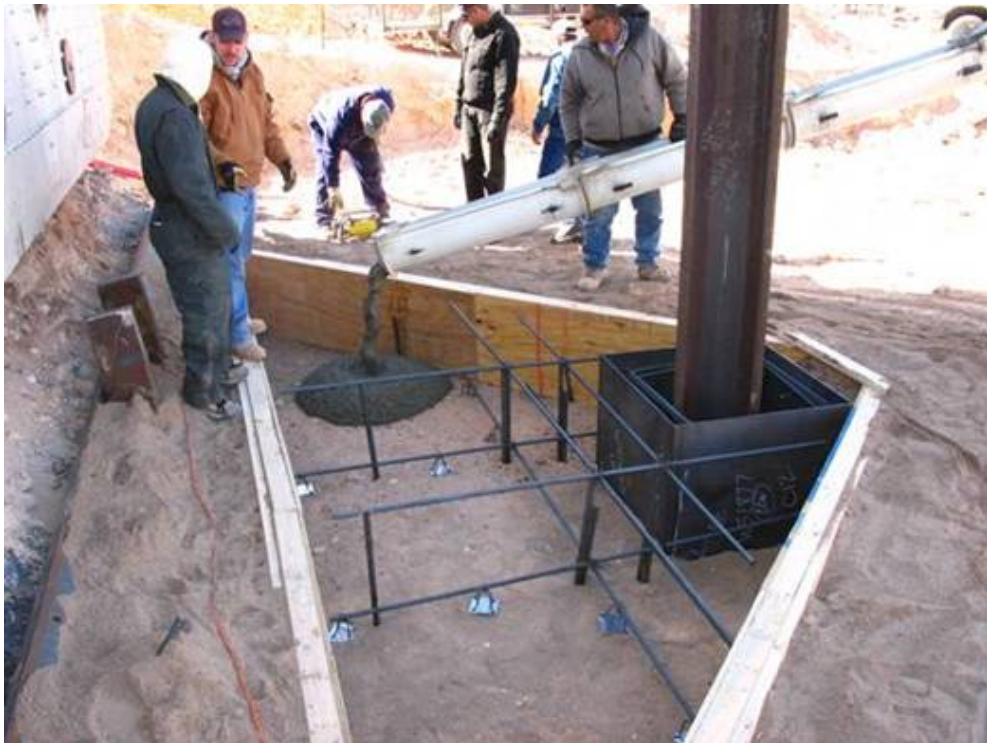
Figure 2-5. Photographs of the installation of the test article to the MBTF reaction wall.

(a) Attachment of the rear reaction struts.

(b) Pouring of the base concrete.

The column was erected at the MBTF site on 03 February 2006. As shown in Figure 2-5, the column's top-most rear reaction struts were connected to the reaction wall to stabilize the column while the concrete base and trapezoidal slab on grade poured with concrete. Figure 2-6 shows the column during the curing of the footing.

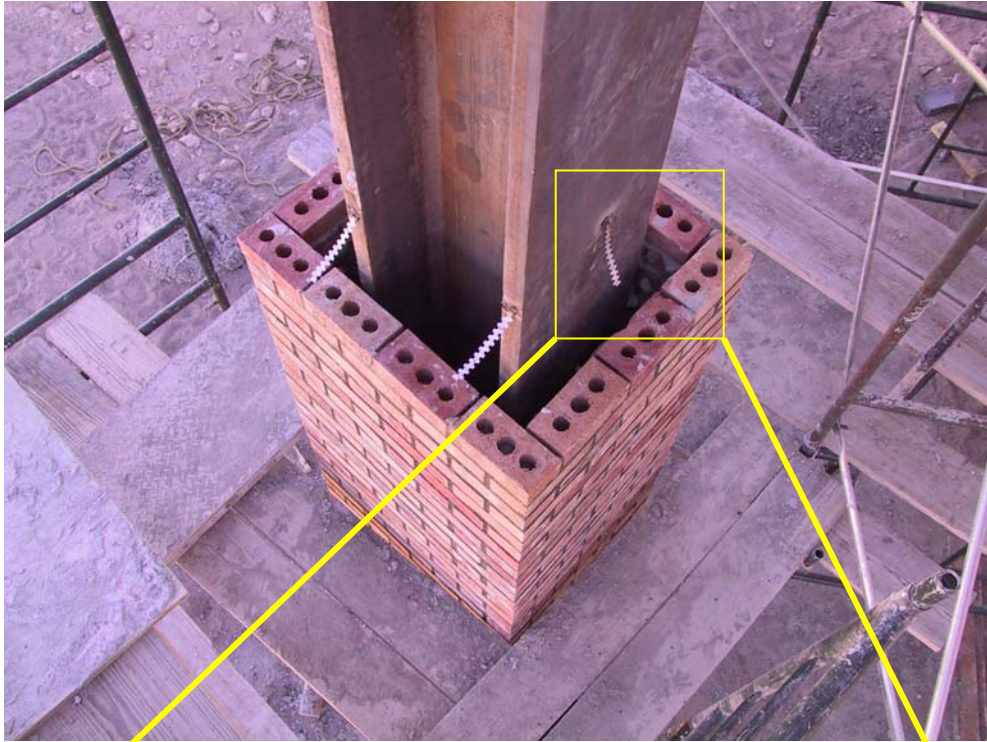
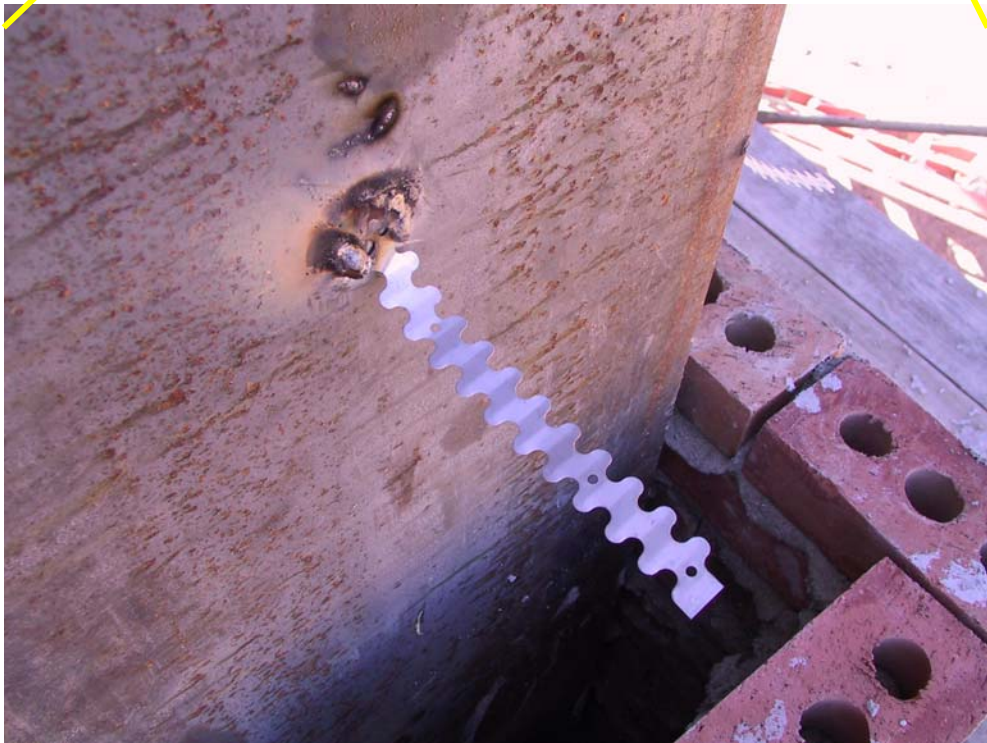
Figure 2-7. Installation of the brick cladding enclosure around the test column.

(a) Corrugated wall ties used to provide lateral support to brick cladding.

(b) Close-up view of wall tie attachment to column.

Construction on the cladding began during the curing of the concrete at the base. A photograph after the first lift is shown in Figure 2-7. Grout was not used to fill the voids in the brick, thus the brick density was not increased. Each face of the cladding enclosure was attached to the column with steel corrugated wall ties that were tack welded to the column at each lift—a detail used in the FEMA/DHS building. This connection was provided to supply lateral stability to the cladding as is commonly done in practice.

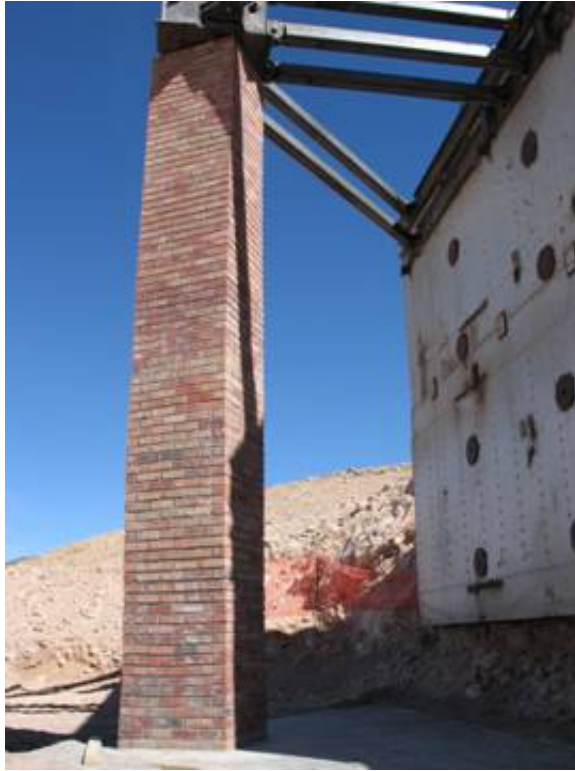
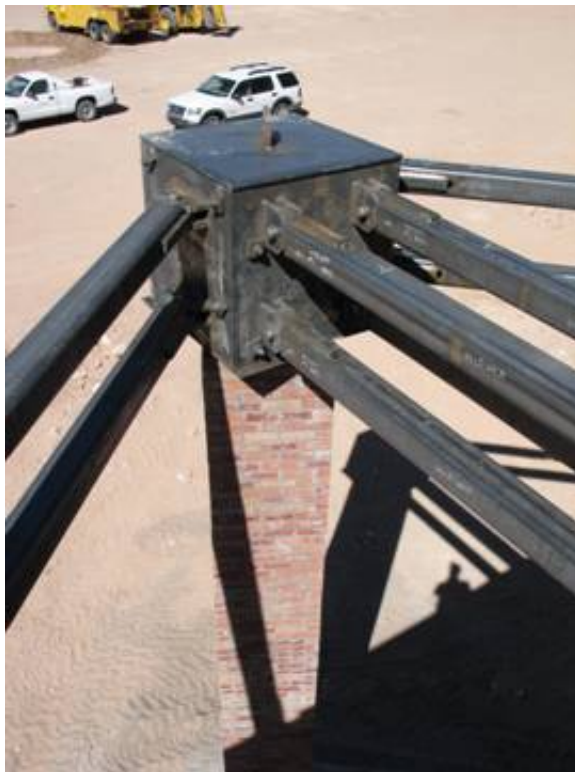
Figure 2-9. Photograph of the completed test column including the cladding enclosure.

(a) View from grade.

(b) View from top of reaction wall.

Figure 2-8 are chronological stills that show the progress of the cladding installation. A photograph of the completed test column, including both the cladding and the completed reaction strut assembly, is shown in Figure 2-9.

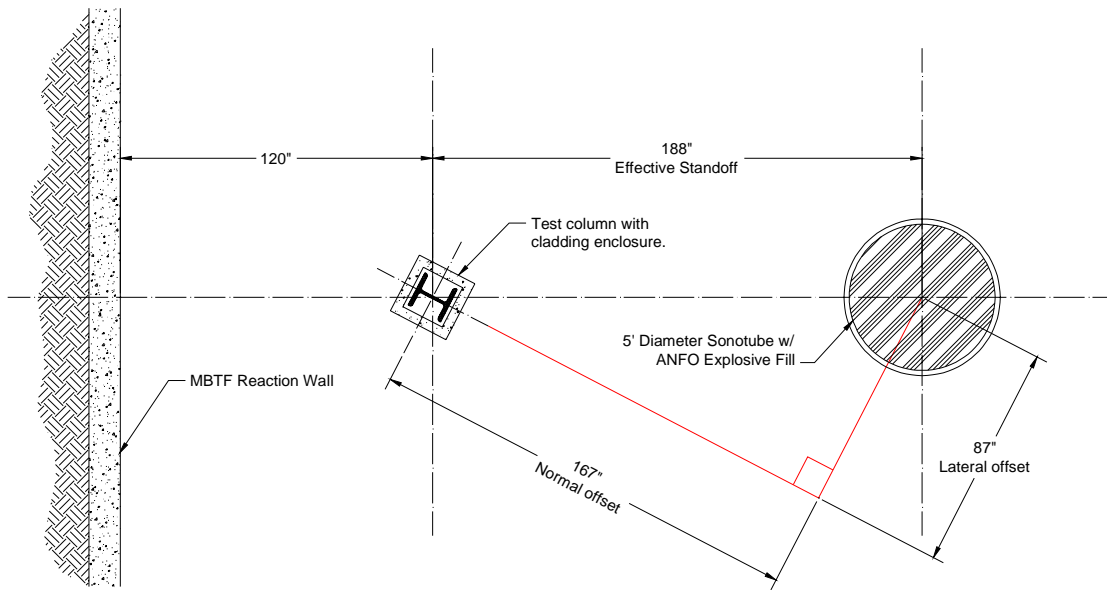
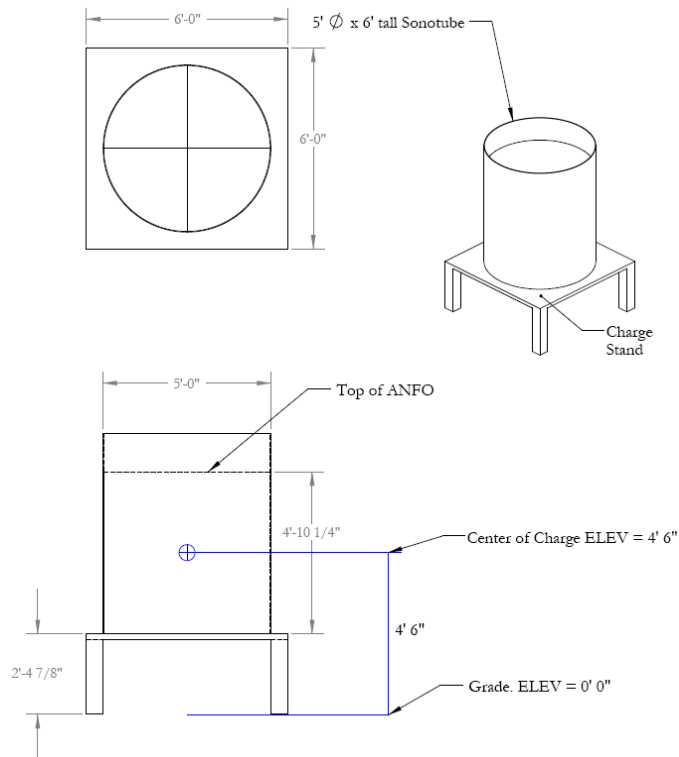
(a) Charge standoff and layout.

(b) Charge stand showing the HOB.

Figure 2-10. Illustration of the positioning of the explosive to achieve an effective slant standoff of 15'-6" measured from the center of the column to the center of the charge. The normal offset was 167 inches (13.9 feet), the lateral offset was 87 inches (7.25 feet), and the height of burst (HOB) was 54 inches (4.5 feet).

The explosive used for the column test was 4,860 pounds of ANFO, which approximately equates to 4,000 pounds of equivalent-TNT. During the design of the test article, the column was oriented roughly 27 degrees from a normal directed outward away from the MBTF reaction wall. This is shown in Figure 2-10. This was done so that the charge, the header reaction assembly, and the strut reaction system would remain perfectly normal to the wall, thus minimizing eccentric loading into the upper reaction system. For this reason, the charge was placed 167 inches from the center of the column in a direction normal to the strong axis of the column with an 87-inch offset to achieve the 188-inch (15'-6") effective slant standoff to the center of the charge, as shown in Figure 2-10a.

The explosive was poured into a 5-foot diameter container, to create an ideal cylindrically-shaped charge, up to a height slightly over 4'-10", as shown in Figure 2-10b. Hence, the aspect ratio of the charge was approximately 1 to 1. The charge was placed atop a wooden stand sitting directly on grade, which corresponded with the top surface of the column footer. The charge stand was constructed with 2"x4" bracing, 4"x4" legs, and a 3/4 inch plywood top, to achieve the desired height of burst (HOB) of 4'-6".

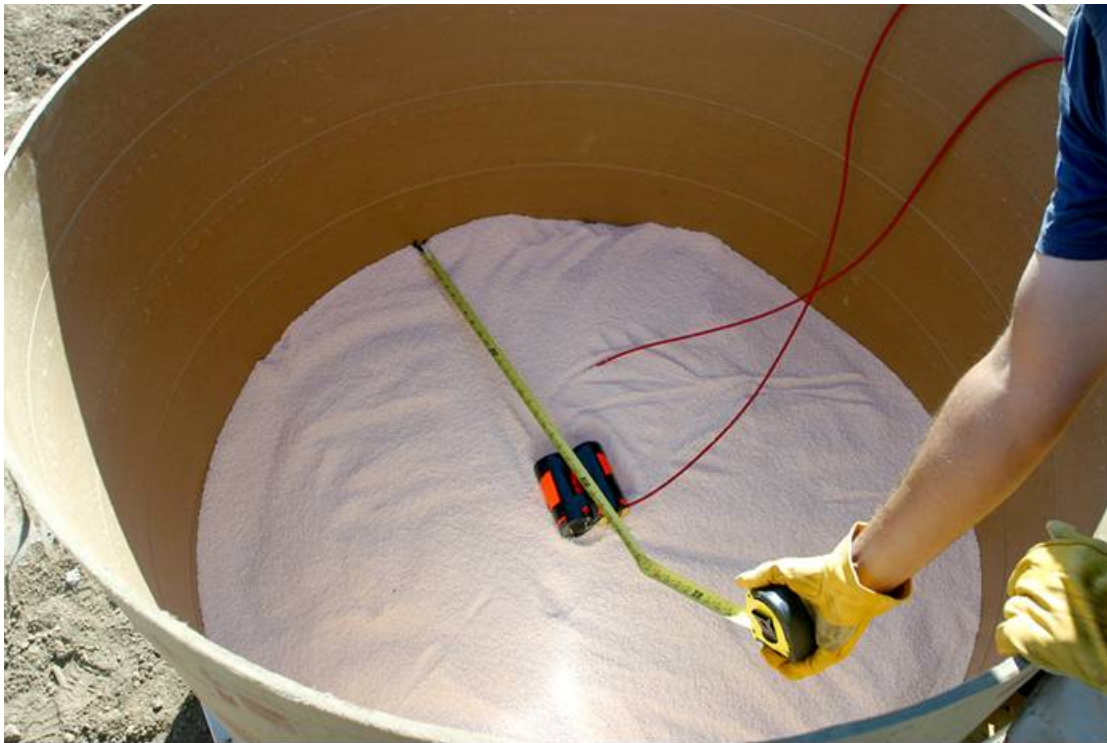
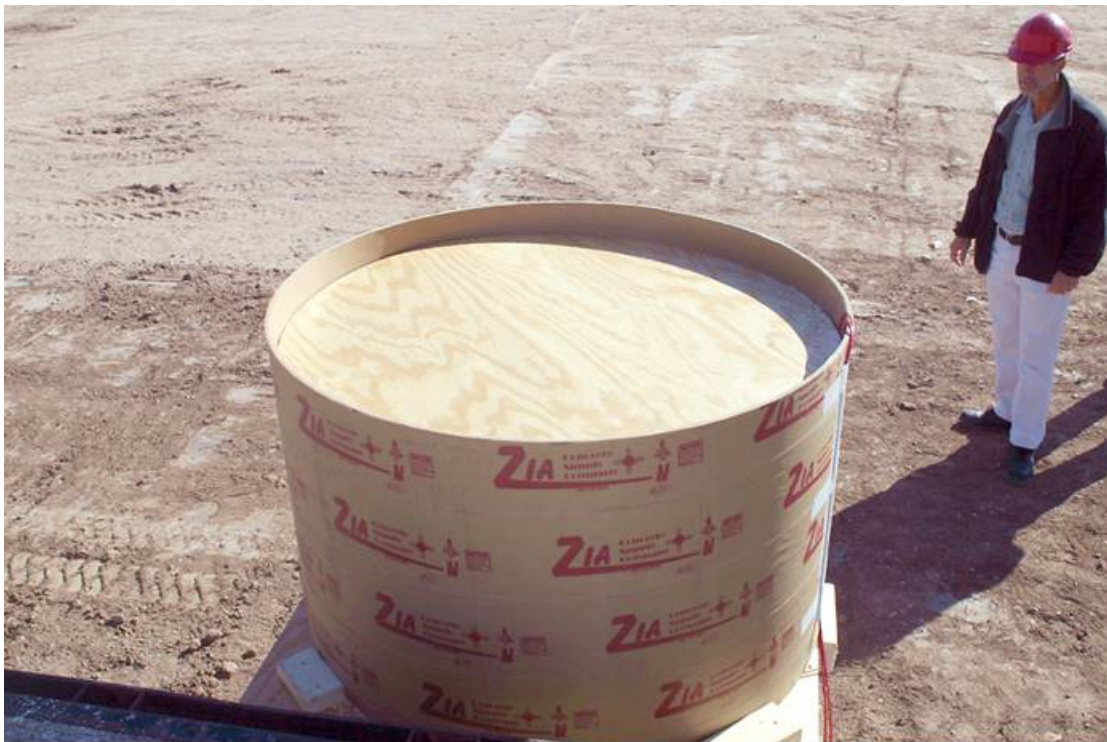
Figure 2-11. Photograph of a similar ANFO explosive setup using a Sonotube.

(a) ANFO is filled halfway and the booster placed.

(b) ANFO is then completely filled and capped with plywood.

On the day of the test, the charge stand was positioned as described in the preceding paragraphs. The charge was built by first placing half of the ANFO into the container. A 15-pound C-4 booster charge that featured two RP 83 detonators, wired in series, was then placed on the surface of the ANFO at its center. Next, an RG 58 detonation cable was spliced to the detonator wires and routed across the surface of the ANFO and up one side of the Sonotube, attaching it to the inside surface with tape. The remainder of the ANFO was then added to the Sonotube to complete the charge for the test. A similar setup is shown in Figure 2-11. Two views of the completed test bed are shown in Figure 2-12.

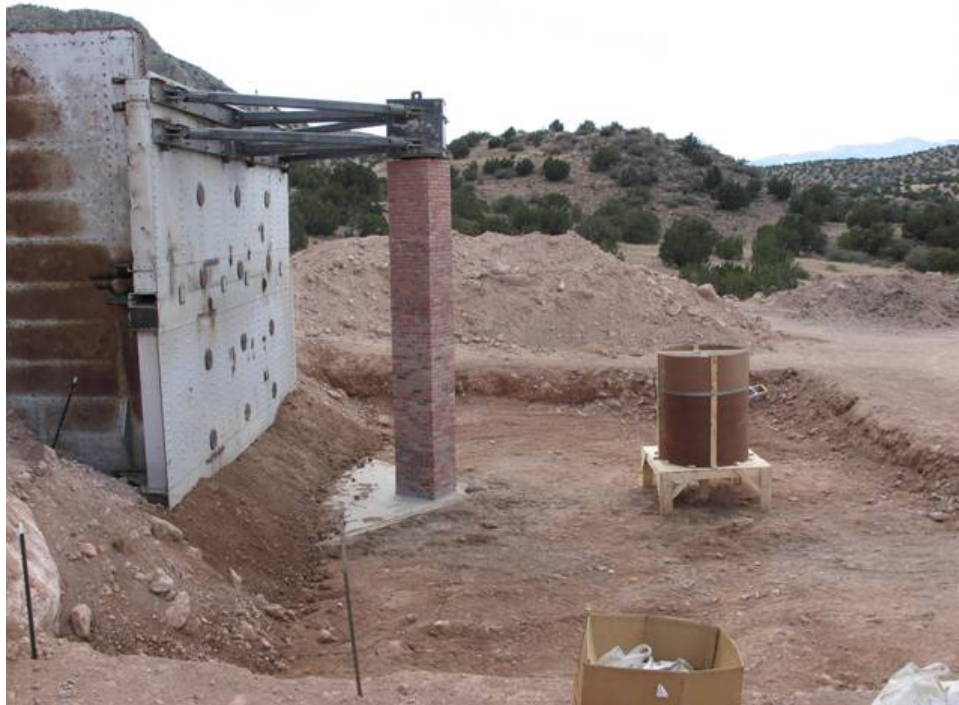
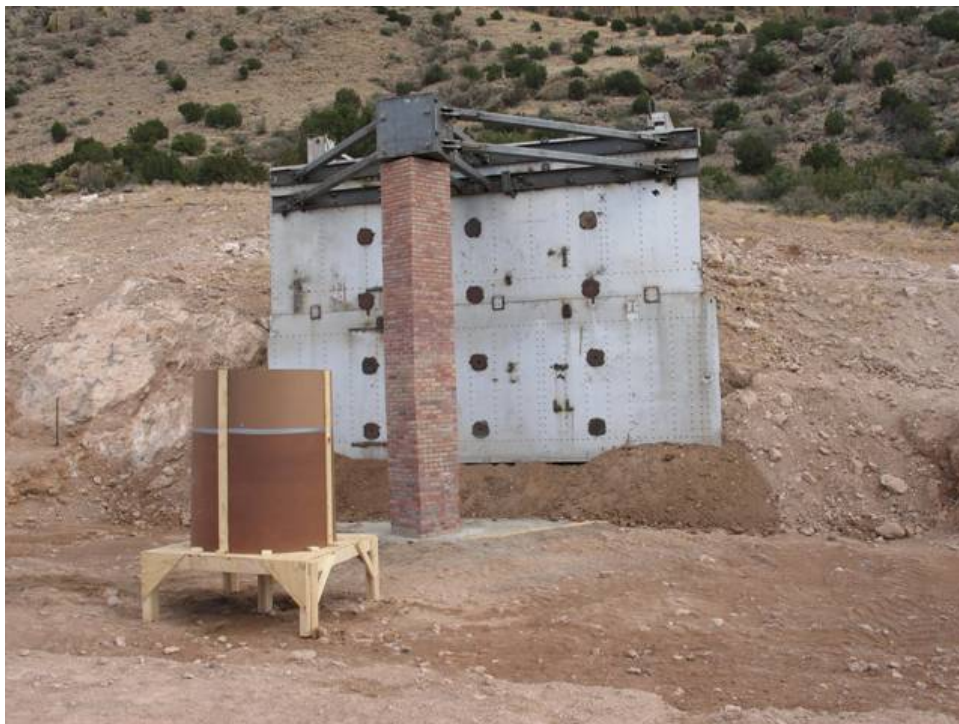
(a) South view of the test article.

(b) Northeast view of the test article.

Figure 2-12. Pretest photograph of the charge stand and explosive positioned at an effective slant standoff of 15'-6" measured from the center of the column to the center of the charge in the direction normal to the MBTF reaction wall.

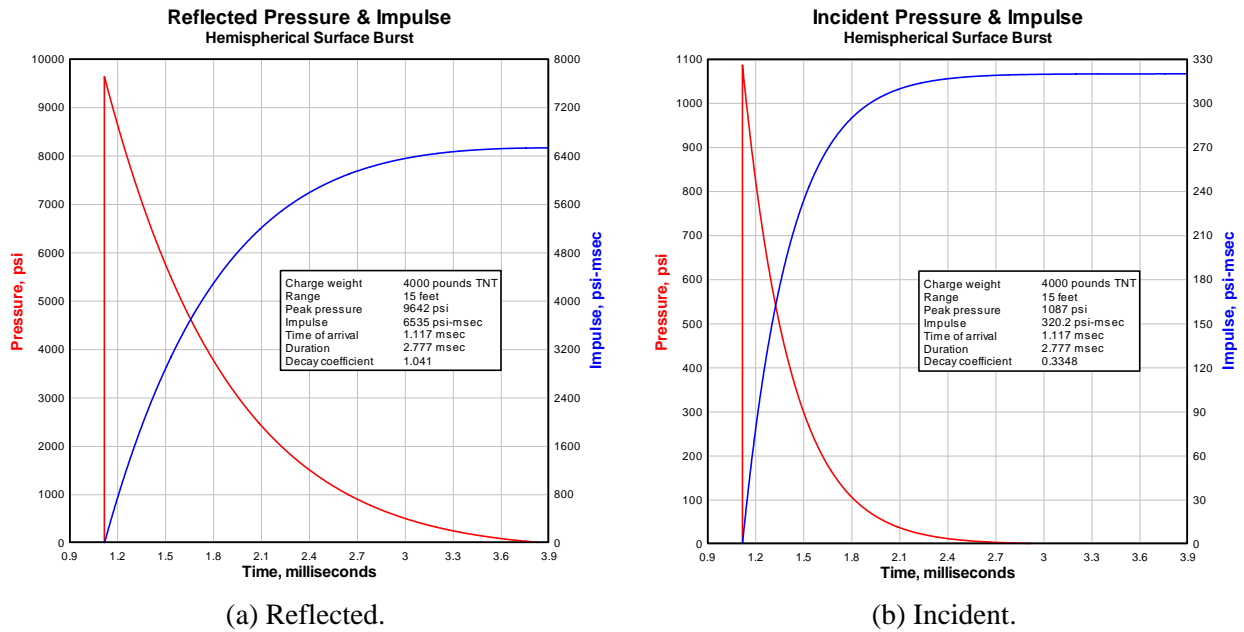
Figure 2-13. Estimate of the air blast loadings from 4,000 lb TNT at 15' standoffs for an ideal hemisphere on the ground surface.

Anticipated airblast loads were computed with the fast-running computer program ConWep [4]. ConWep is a program that uses the Kingery-Bulmash curves found in TM 1300 [5] and TM 5-855-1 [6], which are equations for airblast loadings based on explosive tests using charge weights from less than 1 kg to over 400,000 kg. As no pressure sensors were fielded for this test, these predictions are provided for reference purposes, only. These loads will only provide an estimate of the actual loads, since the charge is placed at a very short scaled range from the test article (less than 1.0 in this case), and the shape of the explosive and its detonation mechanism will have a clear effect on the loading distribution. Only a detailed hydrocode calculation using computational fluid dynamics (CFD) is capable of predicting this loading with reasonable accuracy. Due to budgetary constraints, this type of calculation was not performed. Instead, an ideal hemisphere of explosive situated on the ground is assumed, whereas, the actual charge is an elevated cylinder 4.5 feet above the ground surface. Figure 2-13a presents the reflected pressure and impulse history loadings for a 4,000-pound TNT equivalent charge at a standoff of 15 feet given these simplifications. Similarly, Figure 2-13b presents the incident pressure and impulse history loading for the same charge and standoff. Figure 2-14 is a more generalized plot that shows the reflected and incident pressures and impulses as a function of standoff for the 4,000-pound charge. The complete output text file from the ConWep program, which lists several other airblast loading parameters, is listed in Figure A-5 of Appendix A.

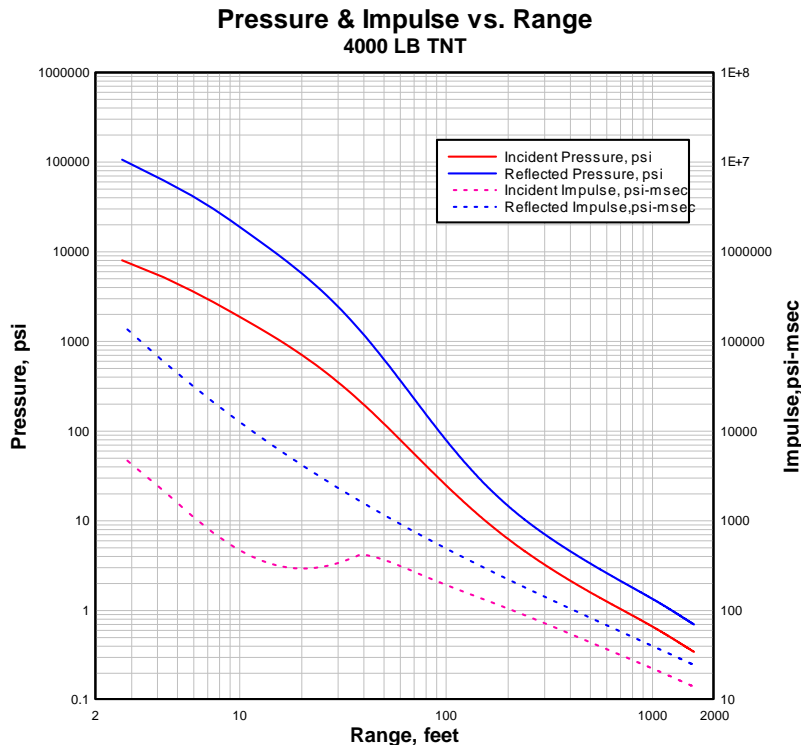
Figure 2-14. Air blast loadings versus range for an ideal 4,000-pound TNT hemisphere on the ground surface.

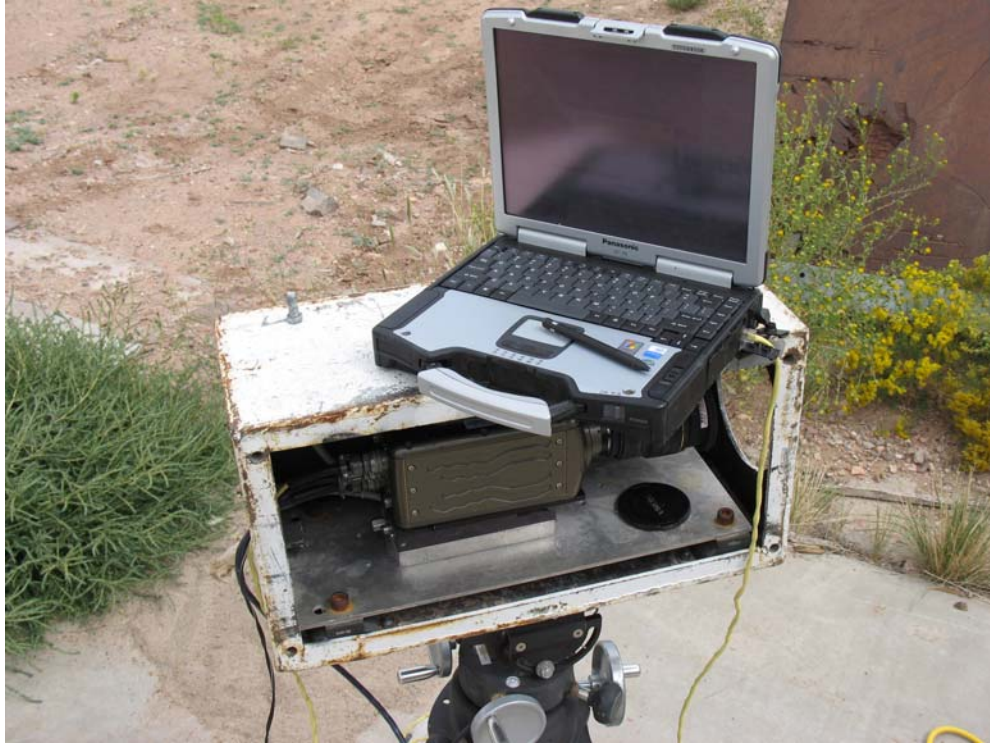
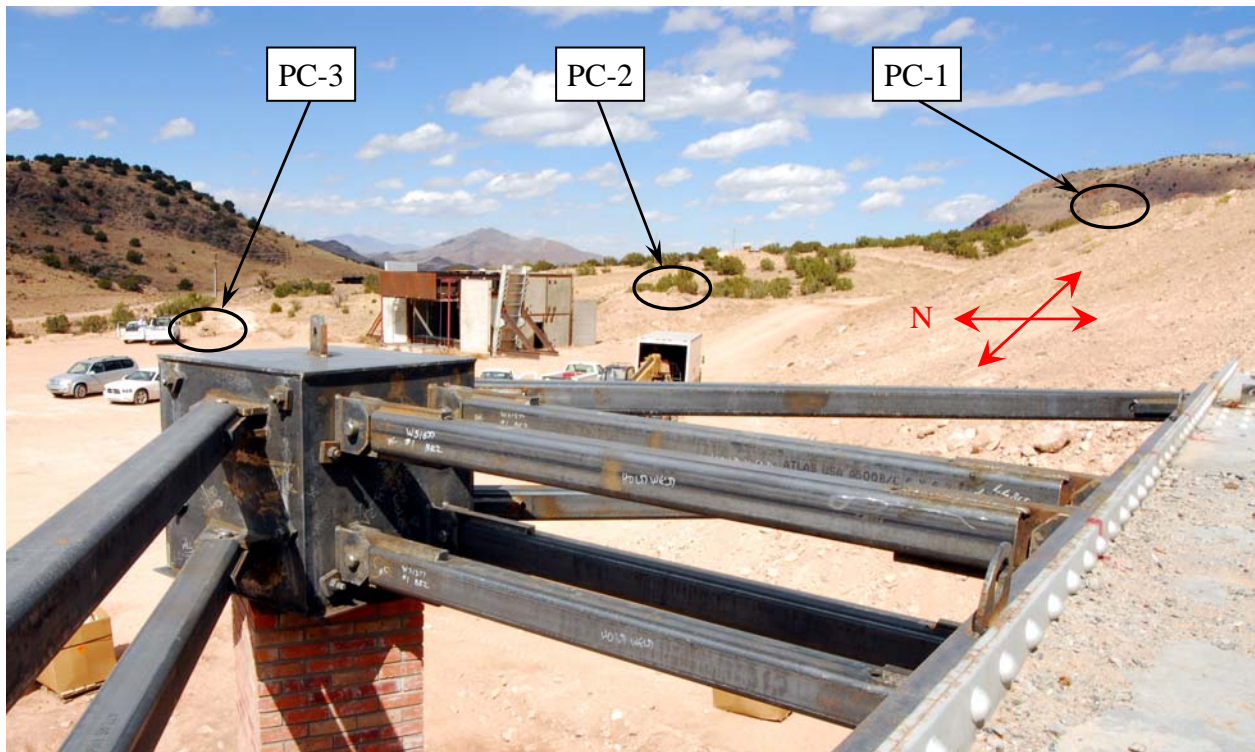
Figure 2-15. High-speed video camera details.

(a) Typical Phantom[®] high-speed digital camera w/ laptop computer shown installed in a protective steel box.

(b) Locations of the three Phantom[®] high-speed video cameras

Due to program funding limitations, the column test specimen was not instrumented with any active channels for accelerometers, linear variable-displacement transducers (LVDT), or pressure gages. However, three high-speed digital cameras (Phantom v7.0 Series by Vision Research, Inc.) were employed to record both close-in and overall test bed views of the explosive event. These cameras are capable of capturing high-quality video at frame rates exceeding 100,000 frames per second. Typical frame rates used for coverage of past structural response tests range from 1,000 – 4,000 frames per second.
