EXPERIMENTAL RESULTS OF THE AISC FULL-SCALE COLUMN BLAST TEST

Joseph M. Magallanes
Ruben Martinez
John W. Koenig

March 21, 2006

The American Institute of Steel Construction
1 East Wacker Drive., Suite 700
Chicago, IL 60601

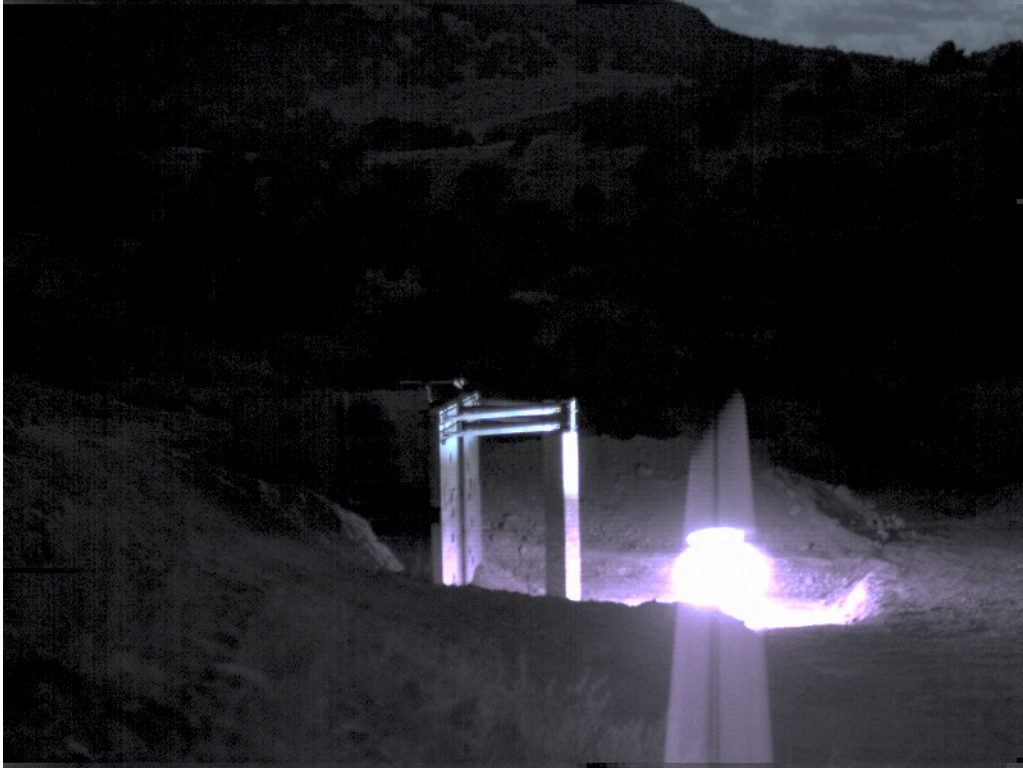
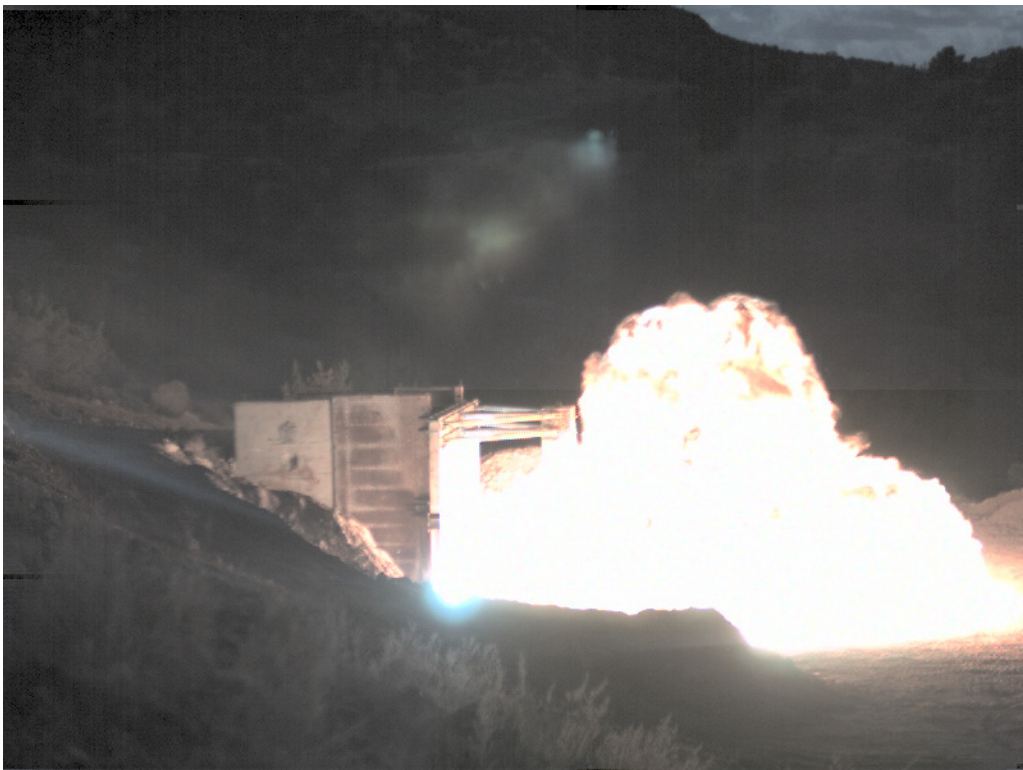
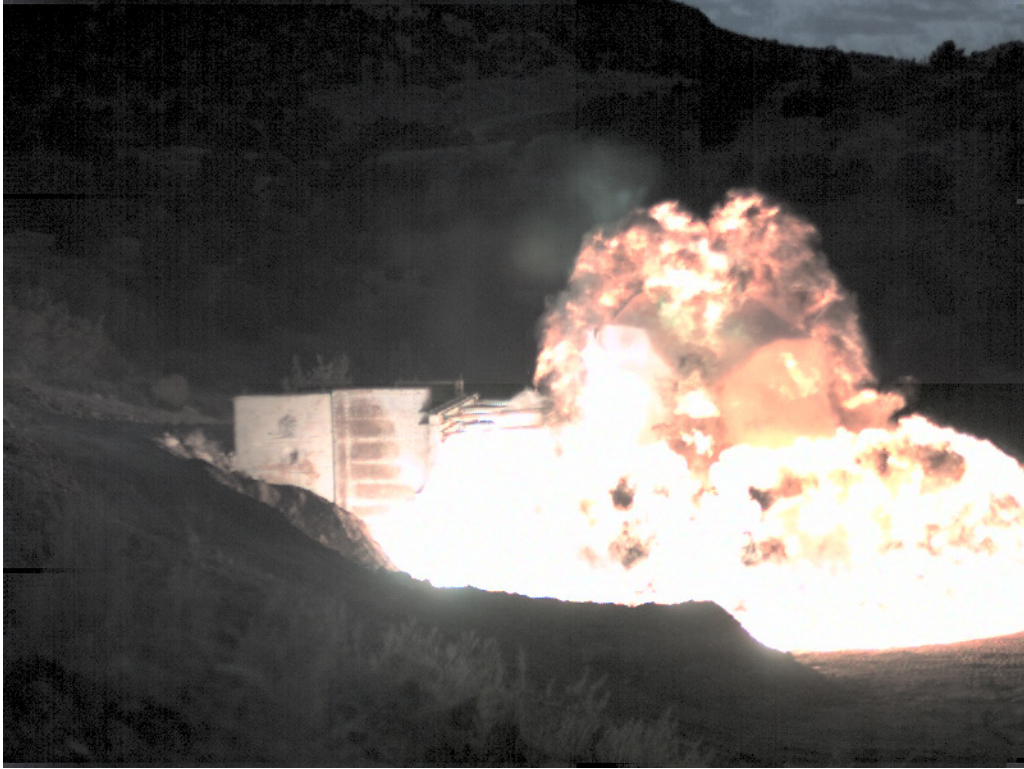
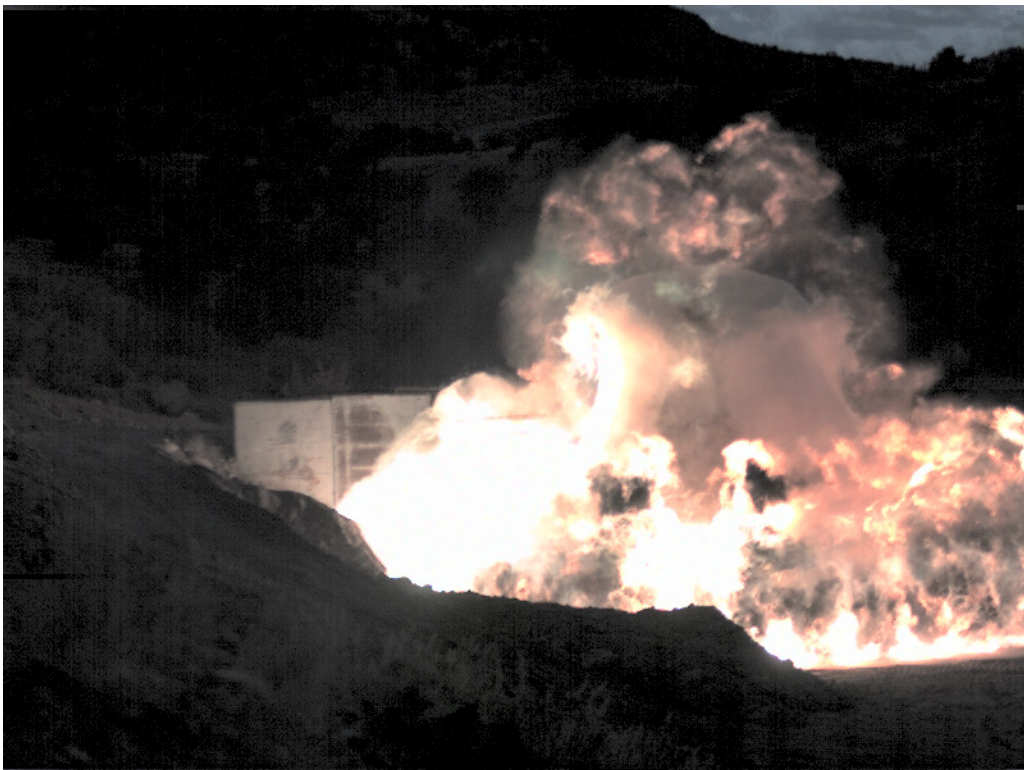
Figure 3-1. Close-up video stills of the test bed moments after detonation.

(a) $t = 0.137$ ms.

(b) $t = 2.63$ ms.

(c) $t = 4.09$ ms

(d) $t = 6.39$ ms

The test was executed on 2 March 2006 at 1430. Figure 3-1 shows a close-up view of the column taken from PC-1, taken moments after the detonation of the explosive. At 0.137 ms, the first light of the detonation process is visible in Figure 3-1a. Figure 3-1b, taken at 2.63 ms, shows the burning detonation products which have almost completely engulfed the column. The shockwave front has already impinged on the surface of the cladding at this time, although the interaction is obscured by the fireball. Unfortunately, this obscured view continues in the following sequences taken at 4.09 ms and 6.39 ms, as shown in Figure 3-1c and Figure 3-1d. These views, however, give a good visual of both the early time detonation process and the interaction of the test specimen with the detonation products.

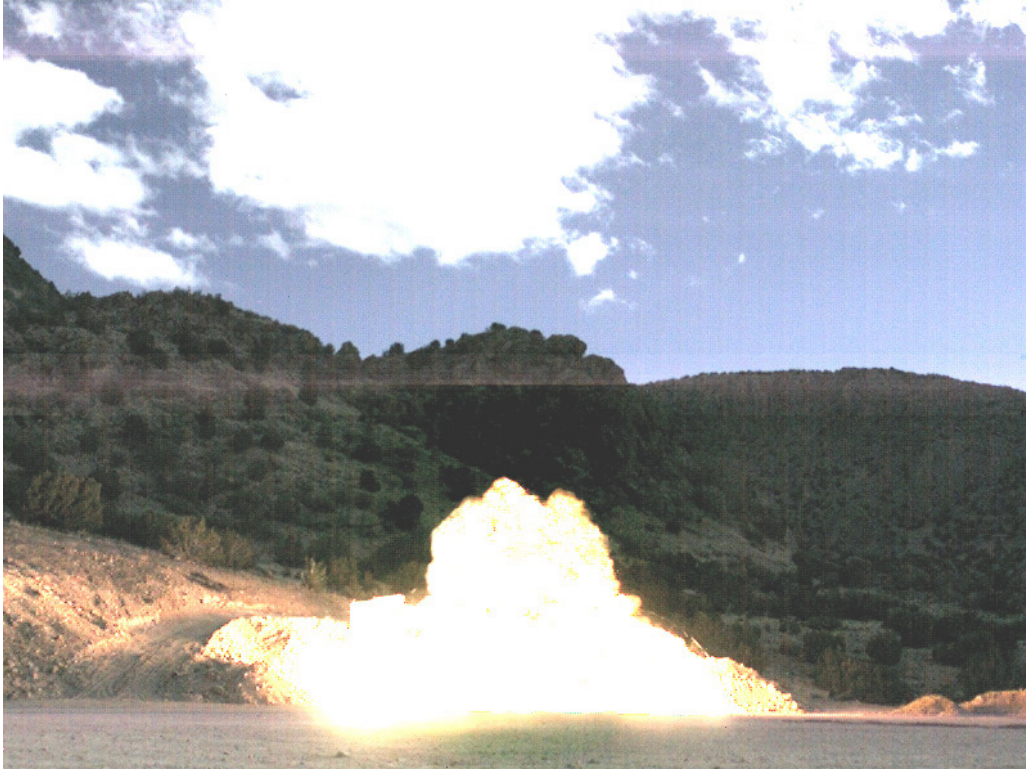
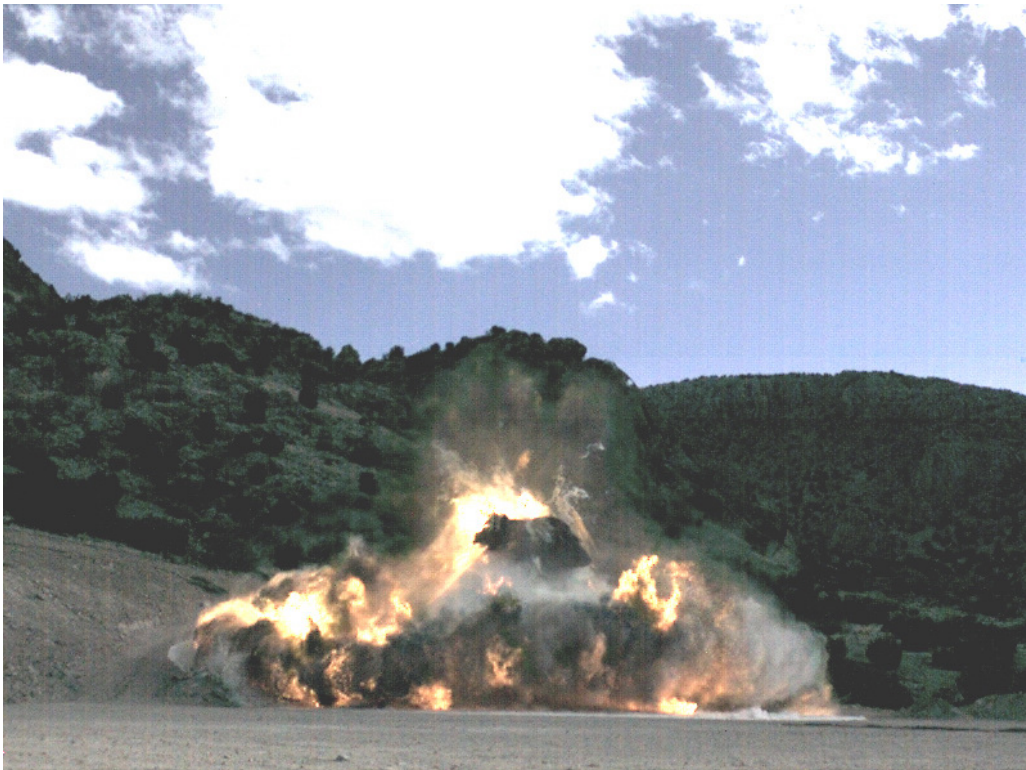
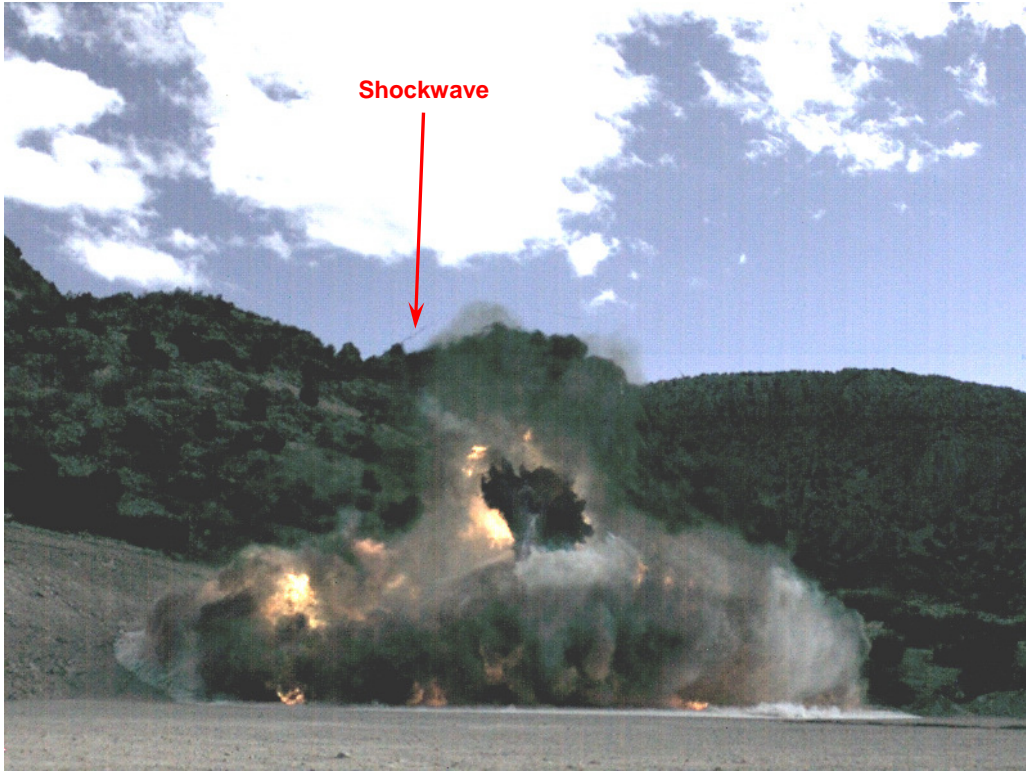
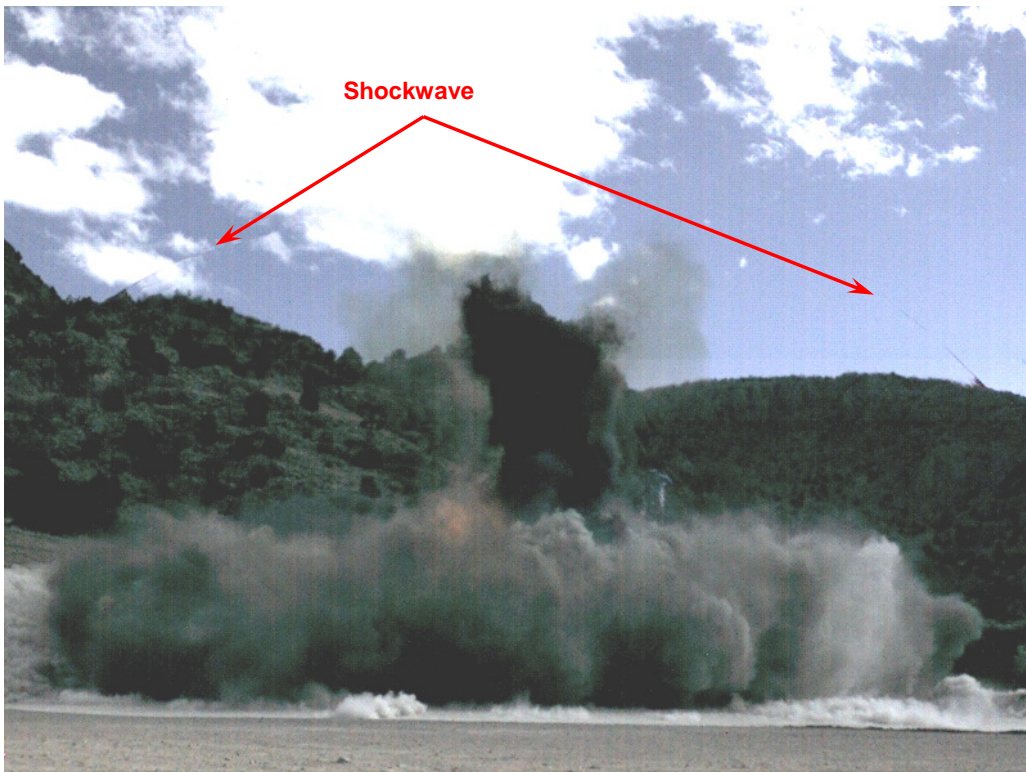
Figure 3-2. Video stills of the test bed moments after detonation.

(a) $t = 4.19$ ms

(b) $t = 10.9$ ms

(c) $t = 14.2$ ms

(d) $t = 30.9$ ms

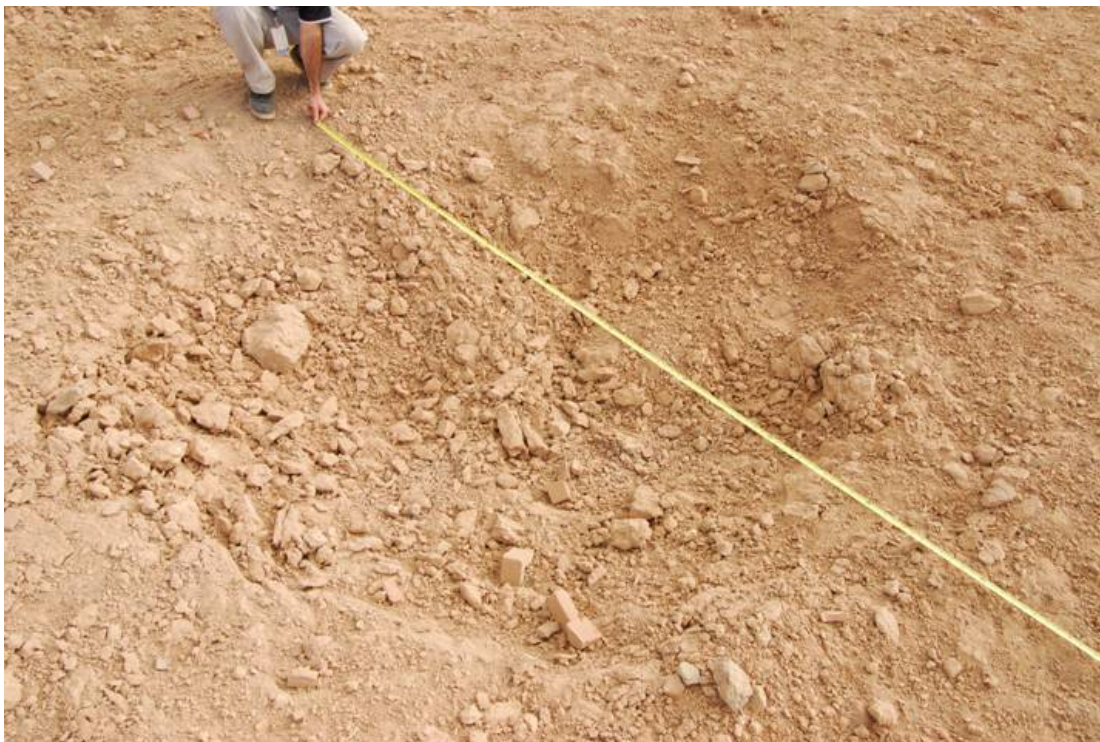
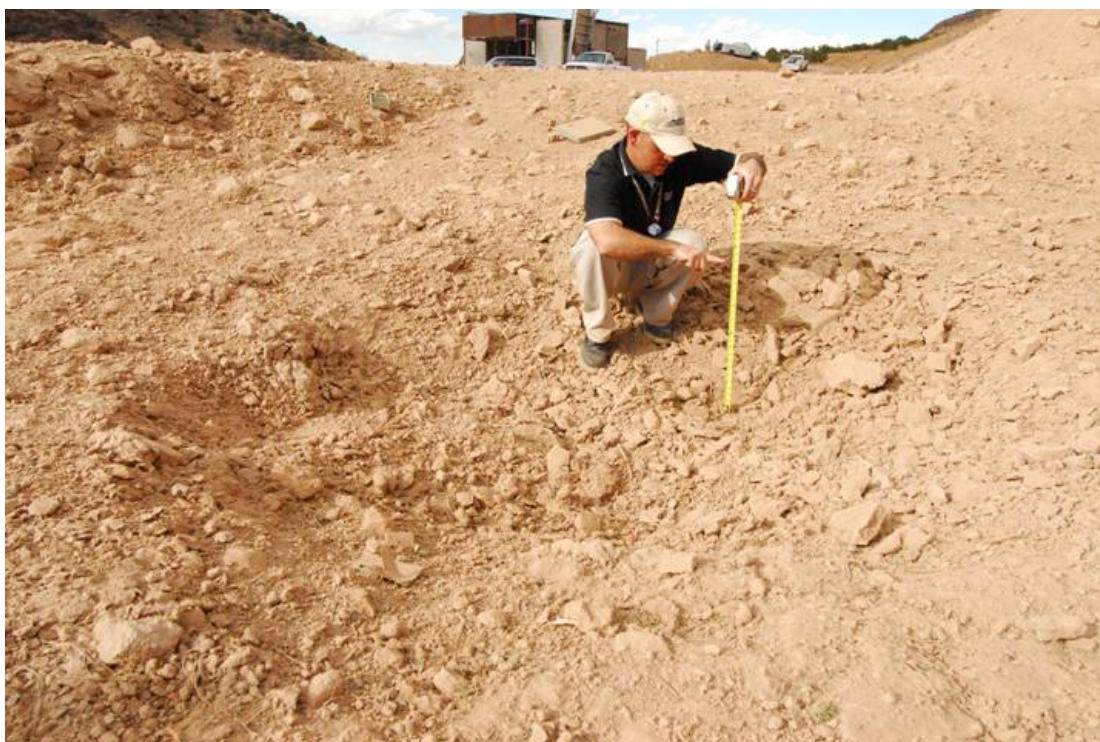
Figure 3-3. Posttest photograph of the detonation crater left by the explosion.

(a) View of detonation crater diameter.

(b) View of detonation crater depth.

The crater generated by the explosion is shown in Figure 3-3. The crater was essentially circular, having a diameter of roughly 108 inches and a depth of 14 inches. Generally it is difficult to measure the actual size of a detonation crater because significant amounts of loose ejecta typically fall back in place. It is thus likely that the actual crater was slightly larger than that indicated by the posttest measurements.

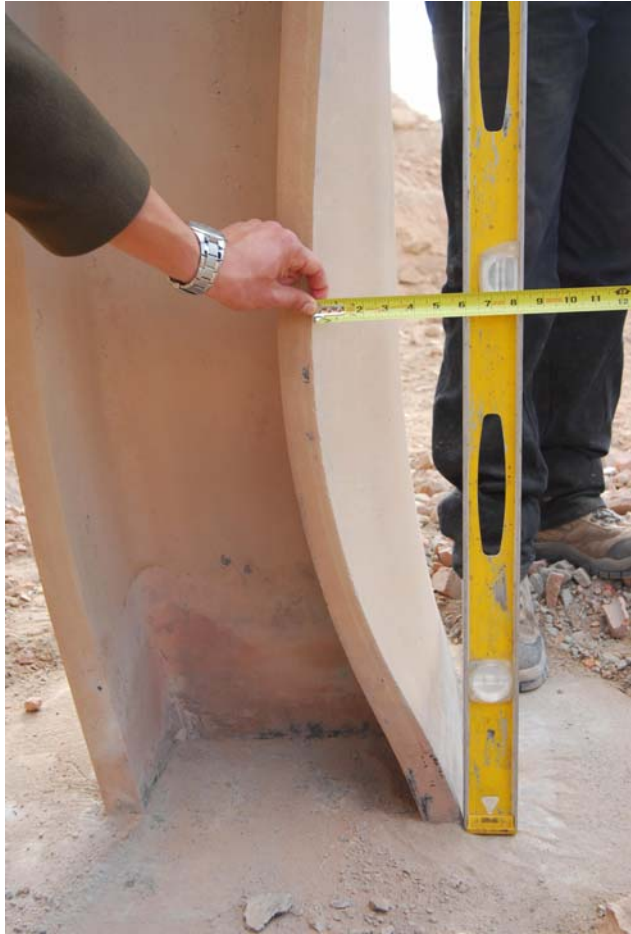
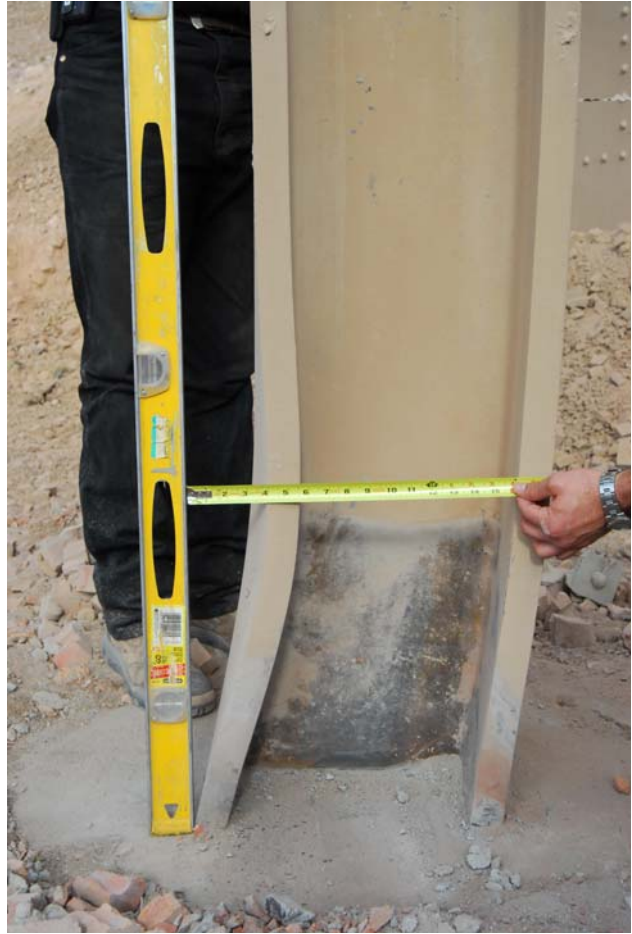
Figure 3-8. Process of conducting the posttest survey of the column to quantify the residual deflection of the column's front flange as a function of height along the column.

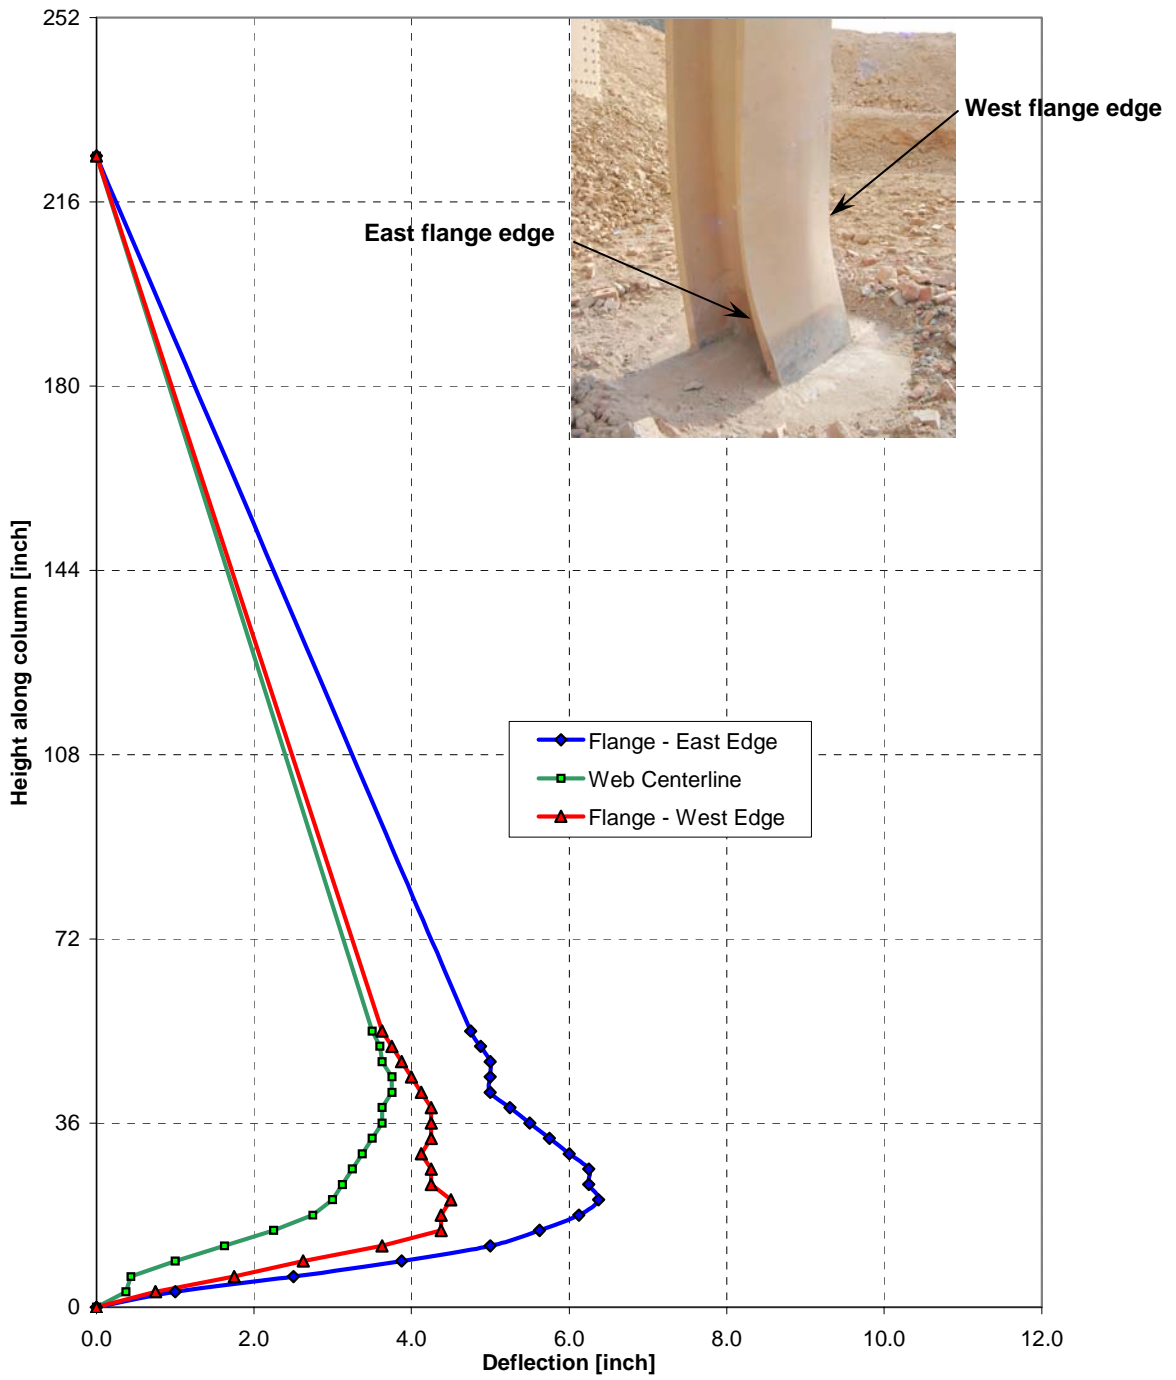
Figure 3-9. Residual deflection of the column's front flange as a function of height along the column.

- The front flanges of the column incurred localized deformations in the direction away from the explosive source which were much more dominant in the east-most flange tip (furthest from the explosion) than in the west-most flange tip. Specifically, the east-most flange tip deflected 2.63 inches more than the flange centerline, while the west-most flange tip deflected only 0.75 inches more than the flange centerline. The rear flange did not exhibit this behavior, and was clearly more uniform across the flange. This type of "flange-folding" behavior has been observed in other explosive tests on steel columns [10, 13, 15].

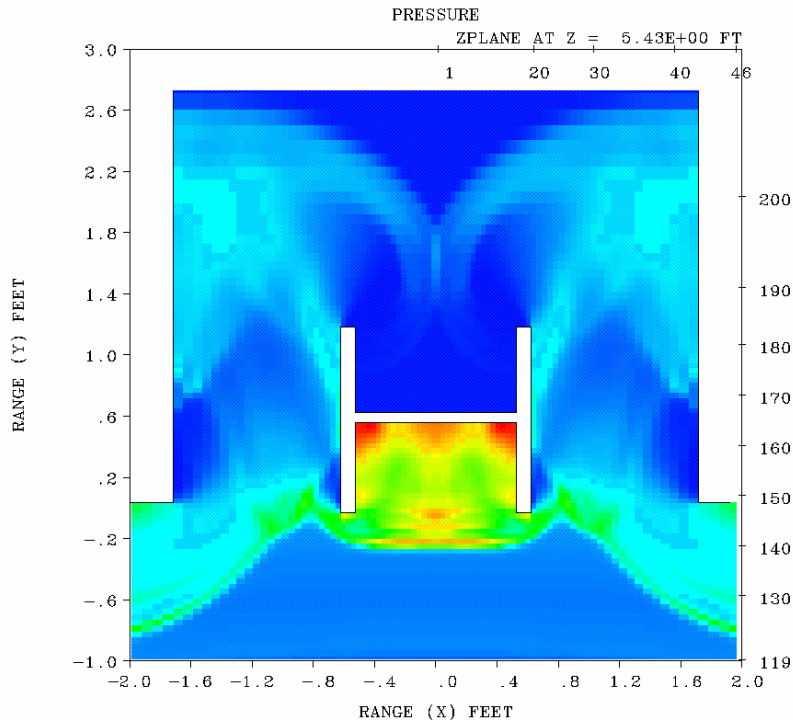
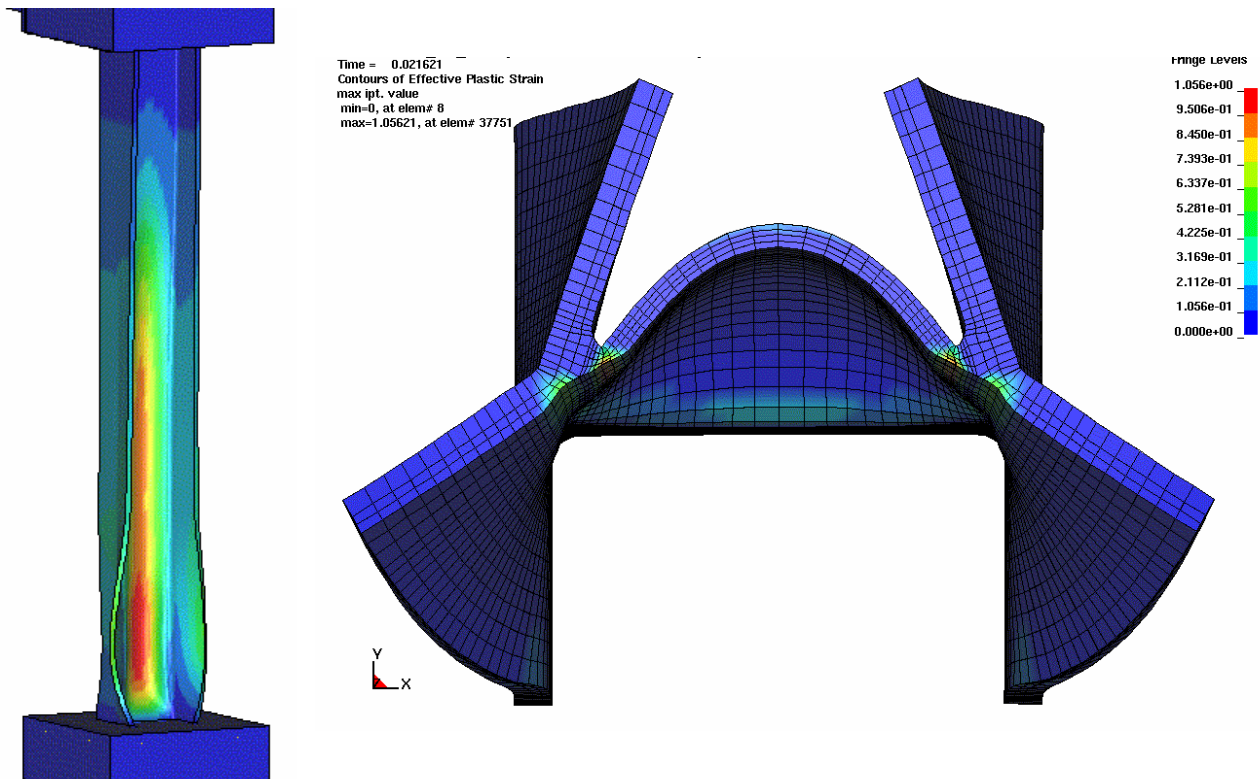
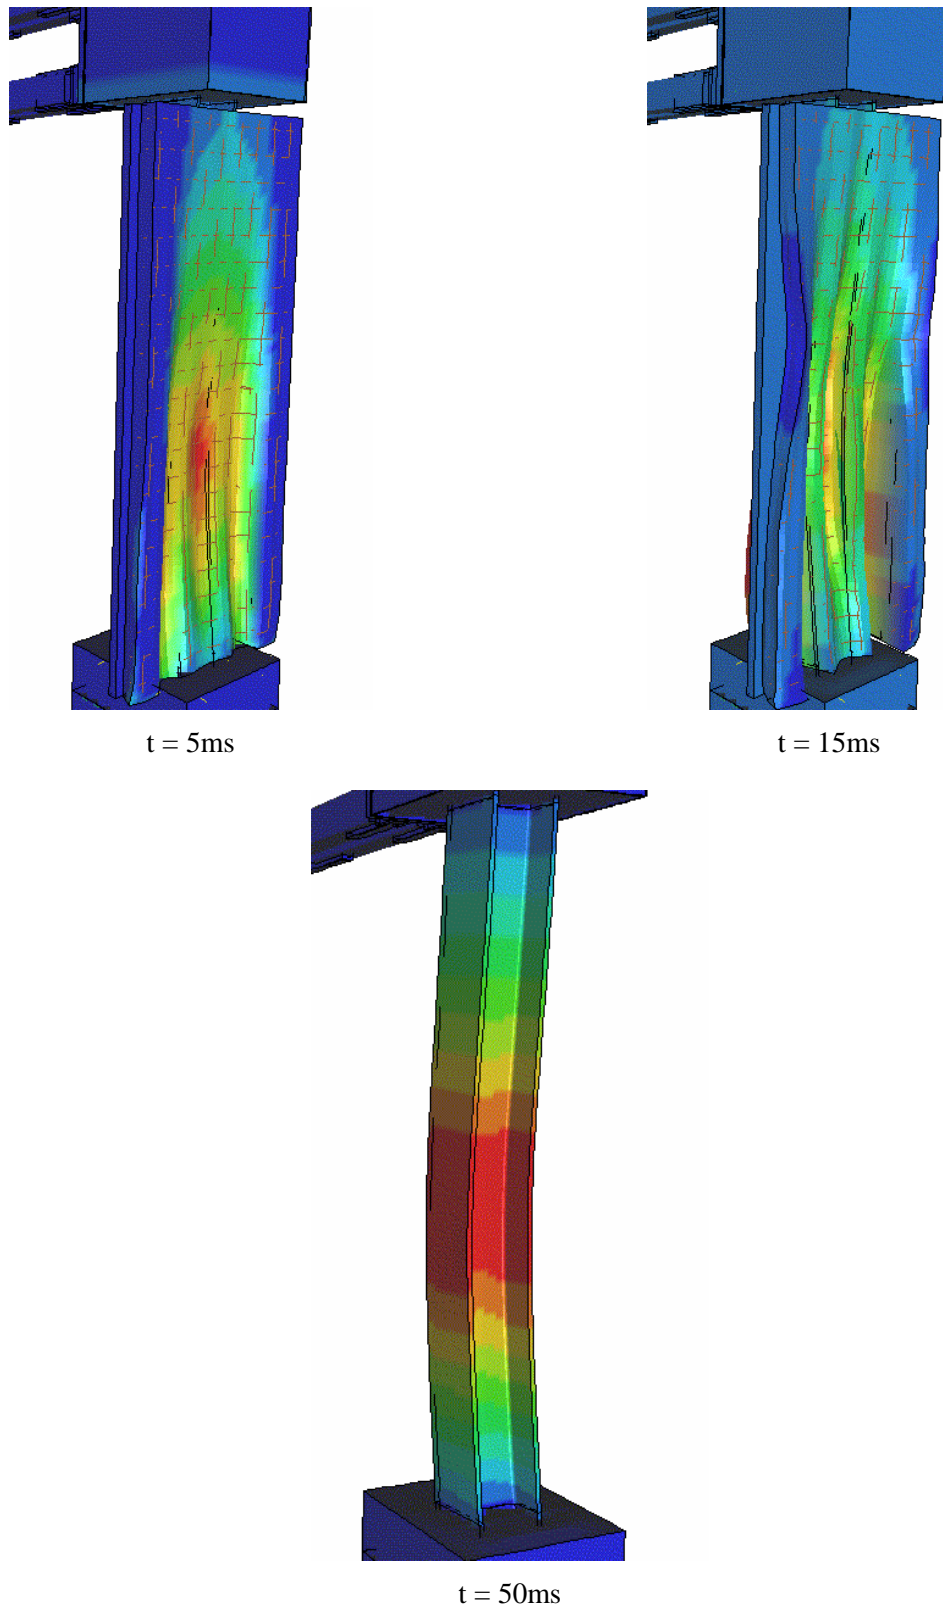
Figure 4-1. Variations in the response of steel wide-flange columns with and without cladding.

(a) Shockwave impingement on section without cladding, computed using HFPB CFD calculations.

(b) Response of column without cladding, computed with HFPB CSD calculations.

(c) Response of column with cladding, computed using HFPB CSD calculations.
Figure 4-1. Variations in the response of steel wide-flange columns with and without cladding (Continued).

For these cases, the shock interaction with the column section is precluded, as cladding is typically massive enough to reflect the shockwave and shield the section from the initial shock front. Still, as illustrated in Figure 4-1c, the column is eventually loaded by the impact of the cladding with the column—an entirely different mechanism than the former. Consequently, the amount of loading can vary depending on the strength and fracture characteristics of the cladding material, any reinforcement placed in the cladding such as in RC precast panels, and the overall mass of the cladding material. For these reasons, columns having cladding have been observed, both experimentally and analytically, to sustain much more residual deflections at the global level, but much less residual deflection at the local section level. This is observed by comparing Figure 4-1c and 4-1b which were subjected to the same explosive charge and standoff.

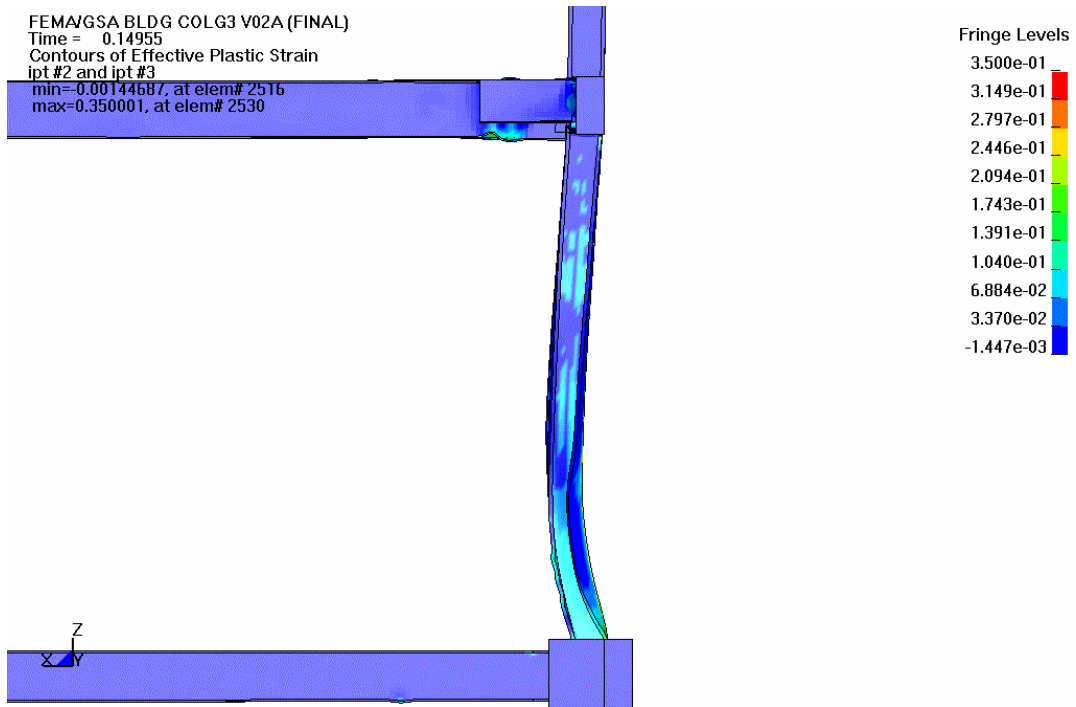
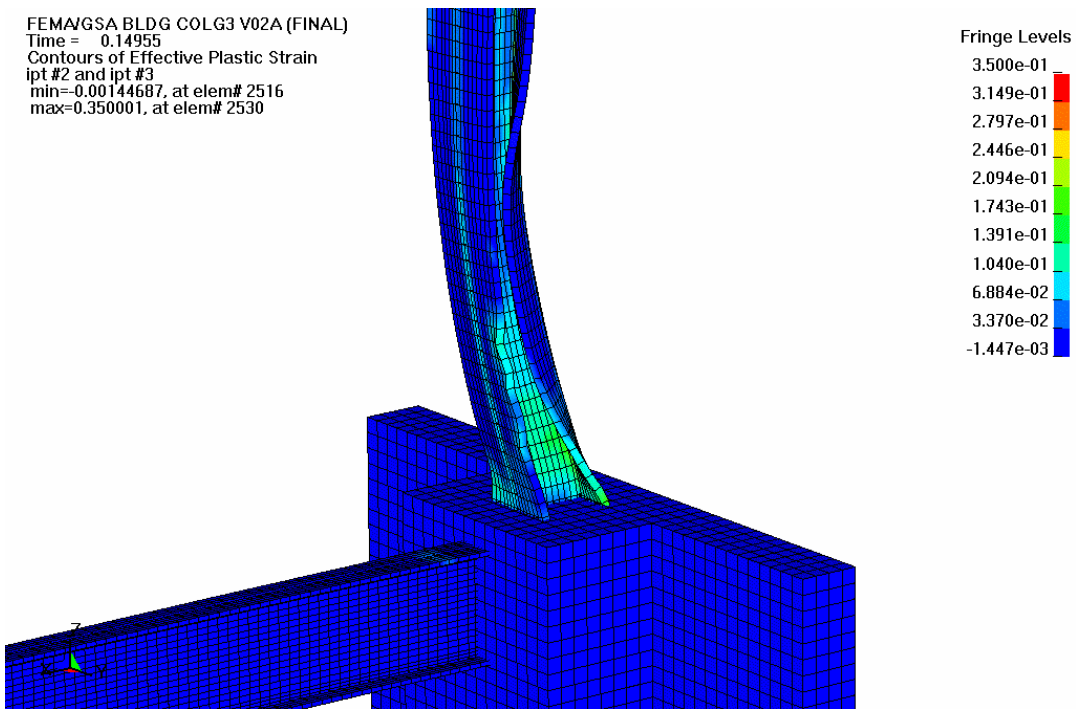
(a) Side view of column deformation.

(b) Isometric view of base deformation.

Figure 4-2. Response of the 14WF228 column as computed using simplified HFPB FE calculations for the FEMA/GSA effort that include simplify loading methodologies [7].

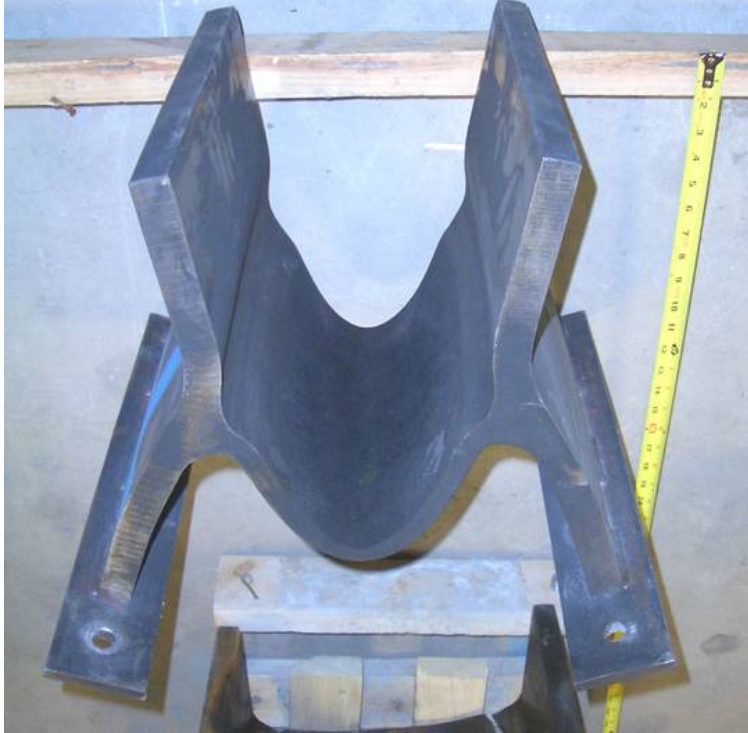
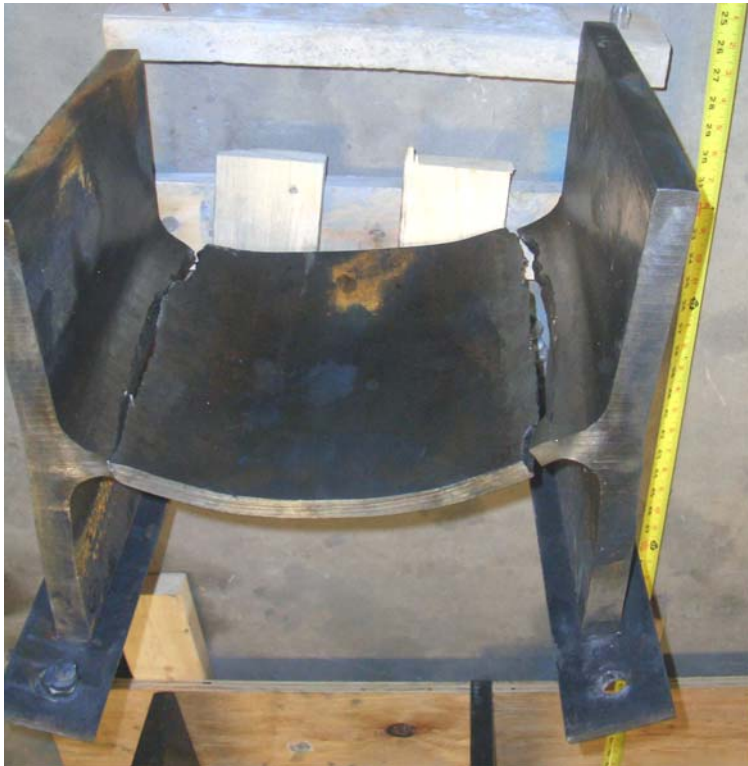
(a) Ductile section response.

(b) Ductile fracture in K-line.

Figure 4-3. Failure modes of wide-flange sections as observed in a separate test program funded by AISC [8].

Although some regions of the AISC column incurred high strain-rates and large local deformations, most notably near the base, areas of reduced ductility, such as the K-line region were not loaded with this same intensity. A separate set of tests on wide-flange sections subjected to small and close-in explosives [8, 9], showed a propensity for ductile fractures (i.e., fractures that result from stresses that exceed the ultimate shear and tensile strengths of the steel, not brittle cleavage fracture) to occur in the K-line region of the sections for worst-case loading orientations. Some of the failure modes observed in that limited test program are shown in Figure 4-3. Similar local failure modes are also being observed in a series of full-scale steel column tests subjected to large vehicle bombs funded by the Defense Threat Reduction Agency (DTRA) [10-15].
