PROGRESSIVE COLLAPSE ANALYSIS OF AN EXISTING BUILDING

Halil Sezen (PI) and Kevin A. Giriunas (student researcher)

The Ohio State University

May 2009

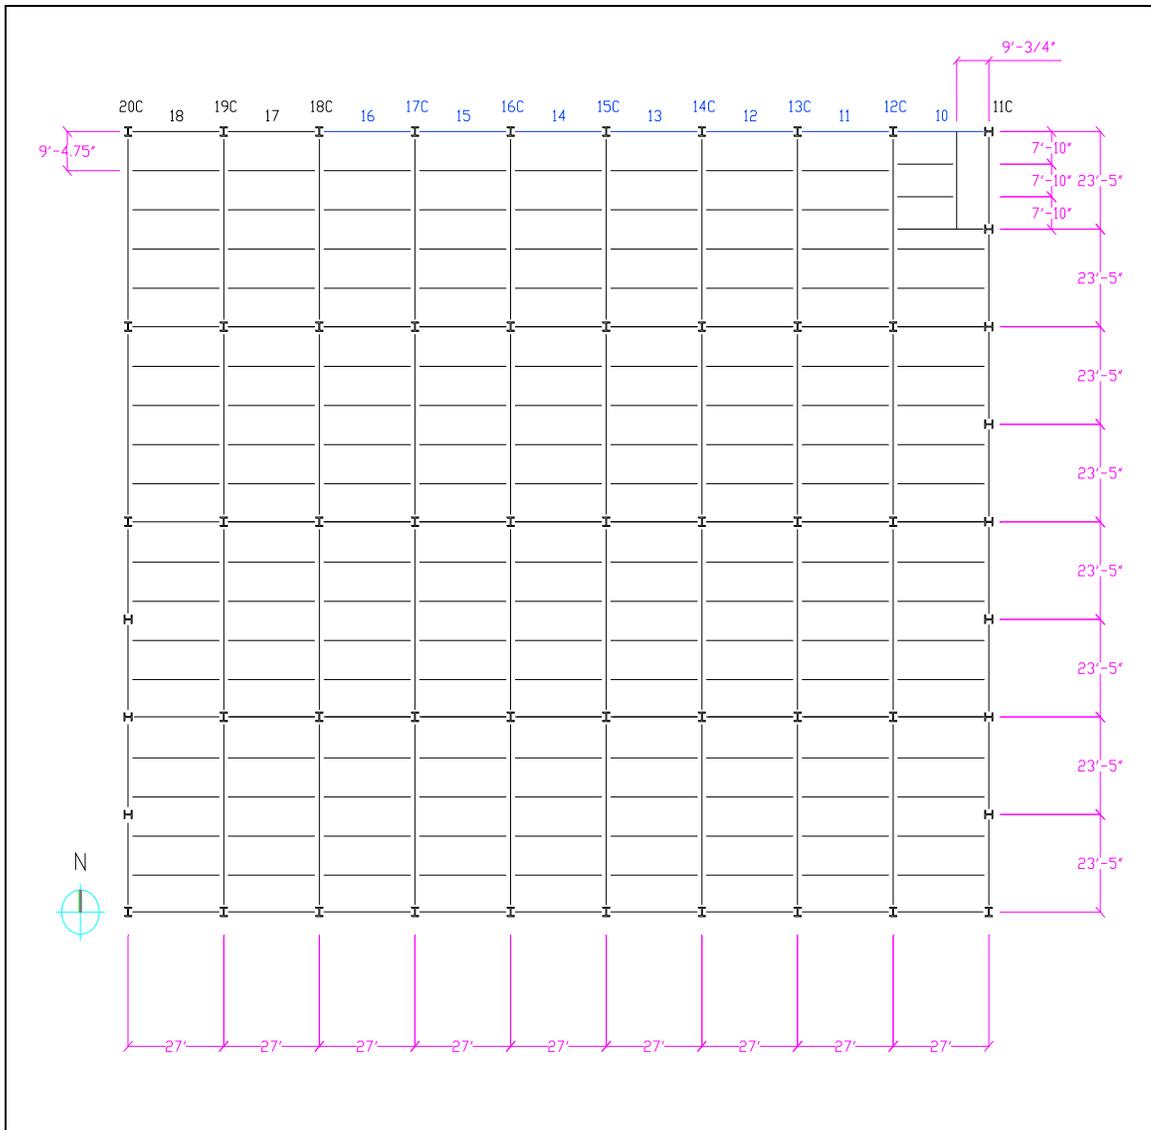
Figure 2.1- Dimensions for the Second Floor of the Bankers Life and Casualty Company Building and Experiment Location is Highlighted in Blue.

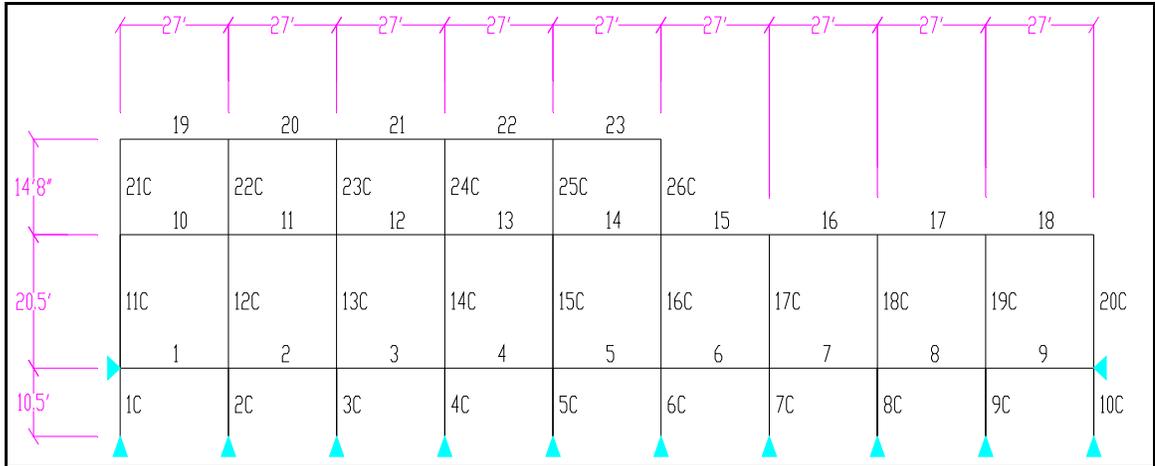
Figure 2.2- Elevation of North End Frame of the Bankers Life and Casualty Company Building.

Figure 2.3- Beam and Column Designation of the Bankers Life and Casualty Company Building Corresponding with Figure 2.2.

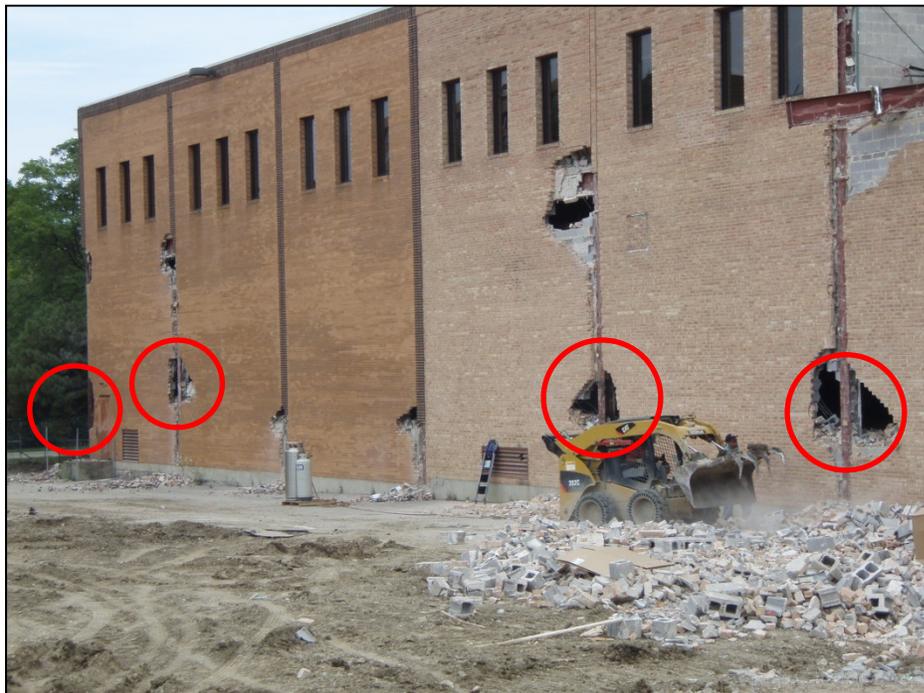
Figure 2.5- The Circled Columns on North Side of the Building were Removed During the Experiment.

The entire experiment involves recording the strain on various structural members as four columns are removed from the North side of the building shown in Figures 2.4 and 2.5. The Environmental Cleansing Corporation was hired to demolish the Bankers Life and Casualty Company insurance building. They agreed to help with the study, tearing out the four columns as specified in this research using GSA (2003) as a guideline. Figure 2.5 highlights the four columns selected for removal.

The experiment conducted as part of this study involves the instantaneous removal of four columns shown in Figures 2.5 and 3.7. The two columns removed, 15C and 16C, were located near the middle of the North side of the building. One Column, 11C, was removed at the Northeast corner, and another Column, 12C, was removed directly adjacent to the Northeast corner on the North side of the building. These columns were chosen following Figure 4.1 as close as feasibly possible.

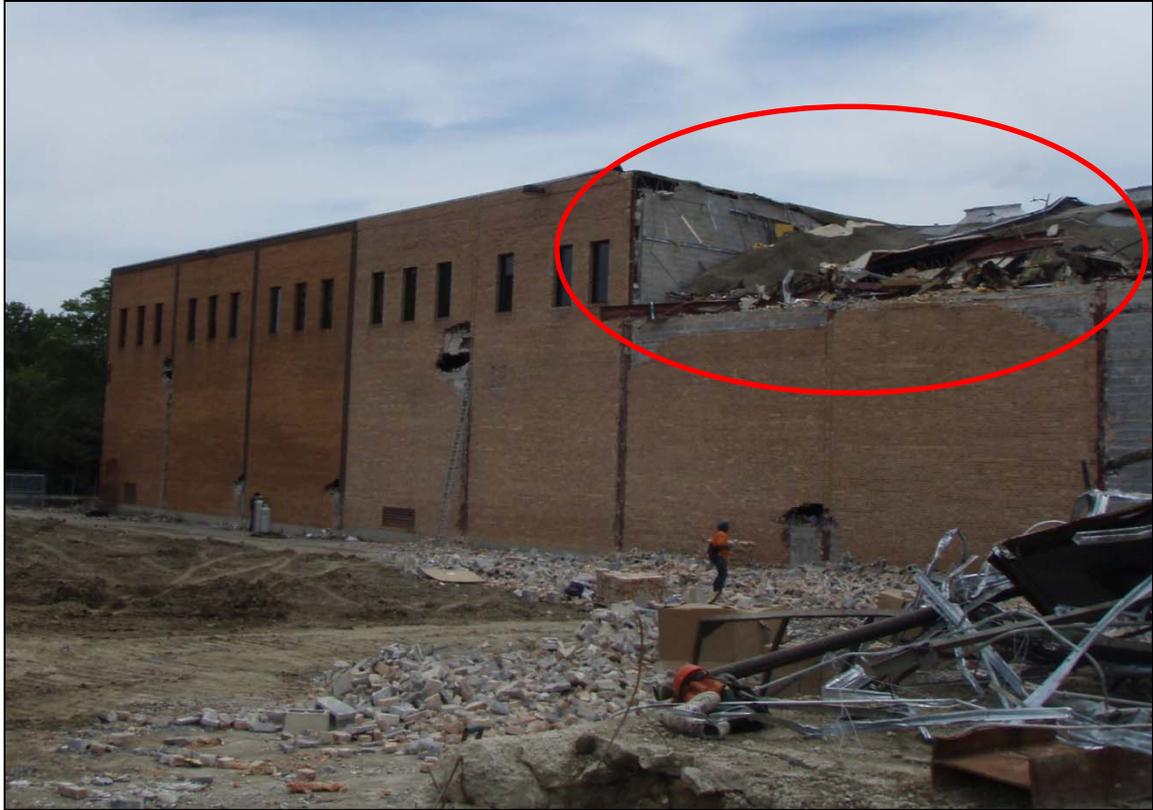
Figure 2.6- The Rubble Mass is Circled on the North Side of the Bankers Life and Casualty Company Building.

Prior to removing the columns, the demolition team tore down the second floor near the Northwest corner of the structure due to a miscommunication between the owner and the demolition team. As a result, all of the building materials remained on the second floor concrete slab. The joists, bridging joists, roofing, bricks, tie rods, and concrete masonry units (CMU) created a rubble mass on the second floor slab. This rubble spans the area of four bays east from the northwest corner and approximately two bays south, resulting in a slightly different loading scenario for the four columns nearest the Northwest corner. Figures 2.6 and 2.7 show the rubble mass at the North side of the building.

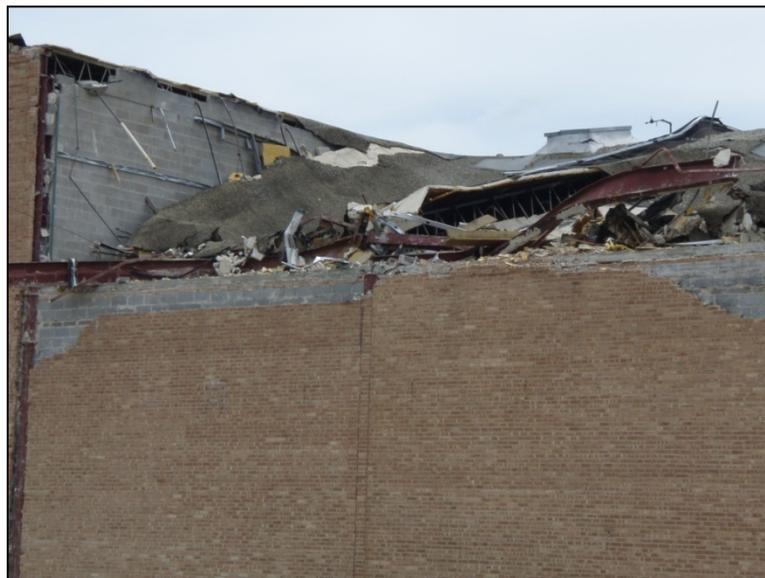
Figure 2.7- Close Up View of the Rubble at the North Side of the Building.

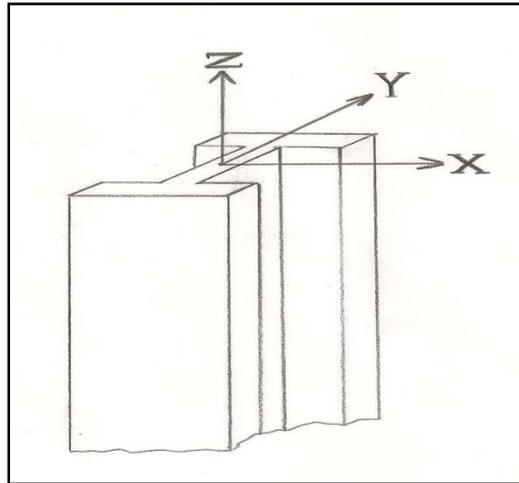
Figure 3.1- Axis Labels for Columns and Beams.

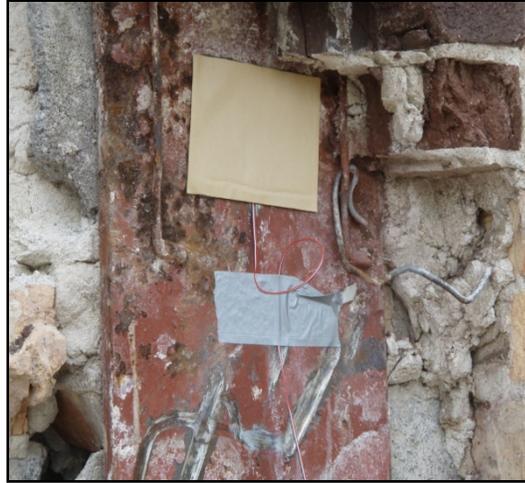
Figure 3.2- Strain Gauge Attached to a Column with a Cover Shield Applied.

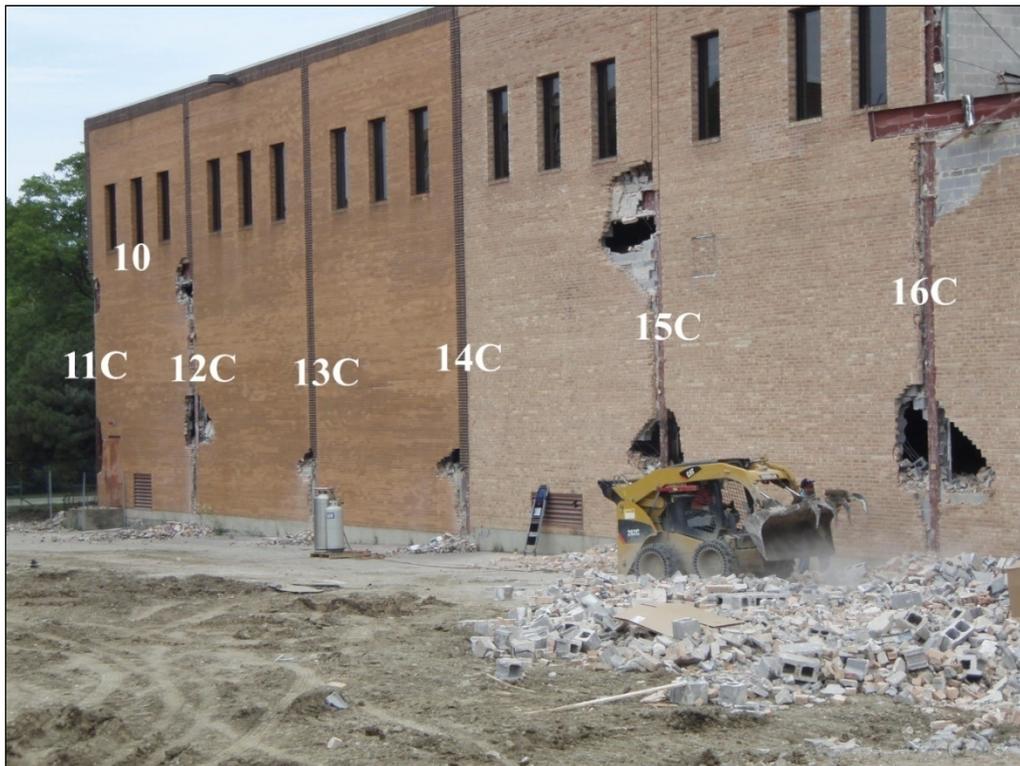
Figure 3.3- Exposed Columns and Beam Labeled.

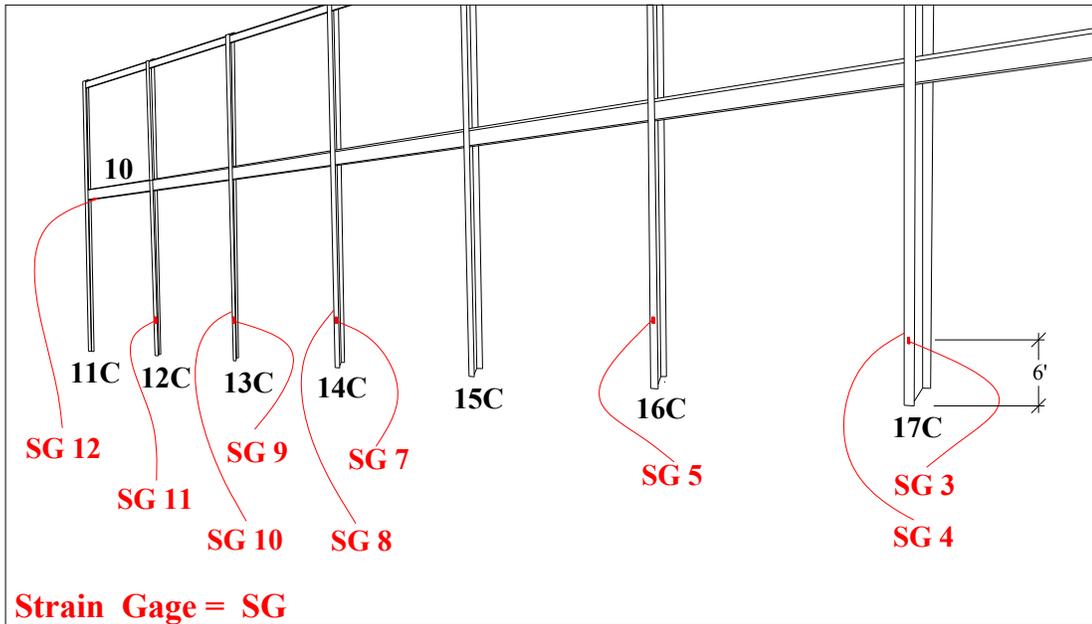
Figure 3.4- Strain Gauge Placement with Columns and Beam Labeled.

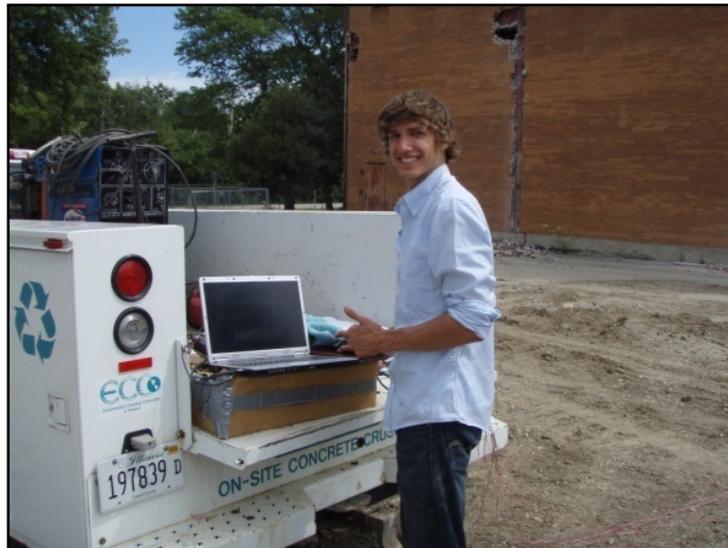
Figure 3.5- Computer Station and Data Acquisition System.

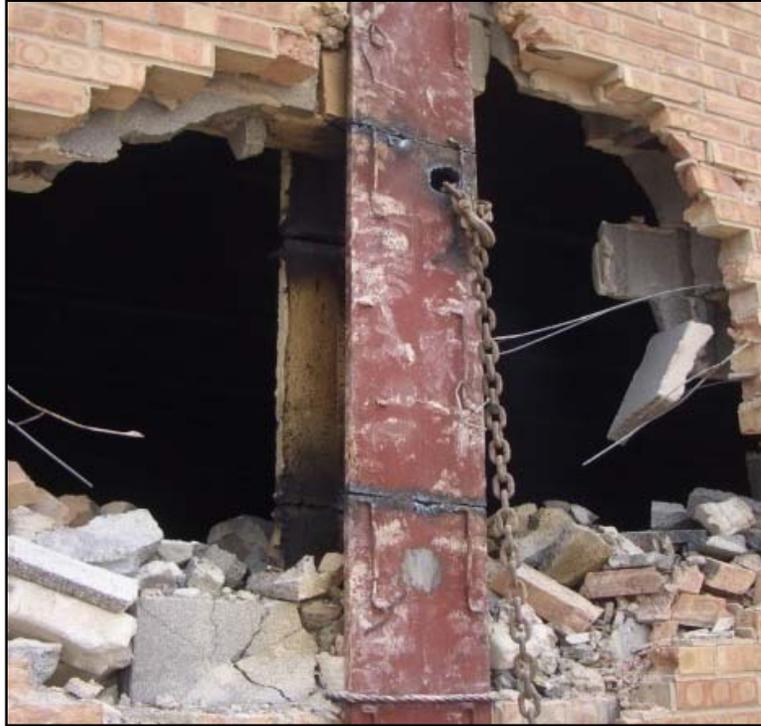
Figure 3.6- Torched Column Ready to be Pulled Out.

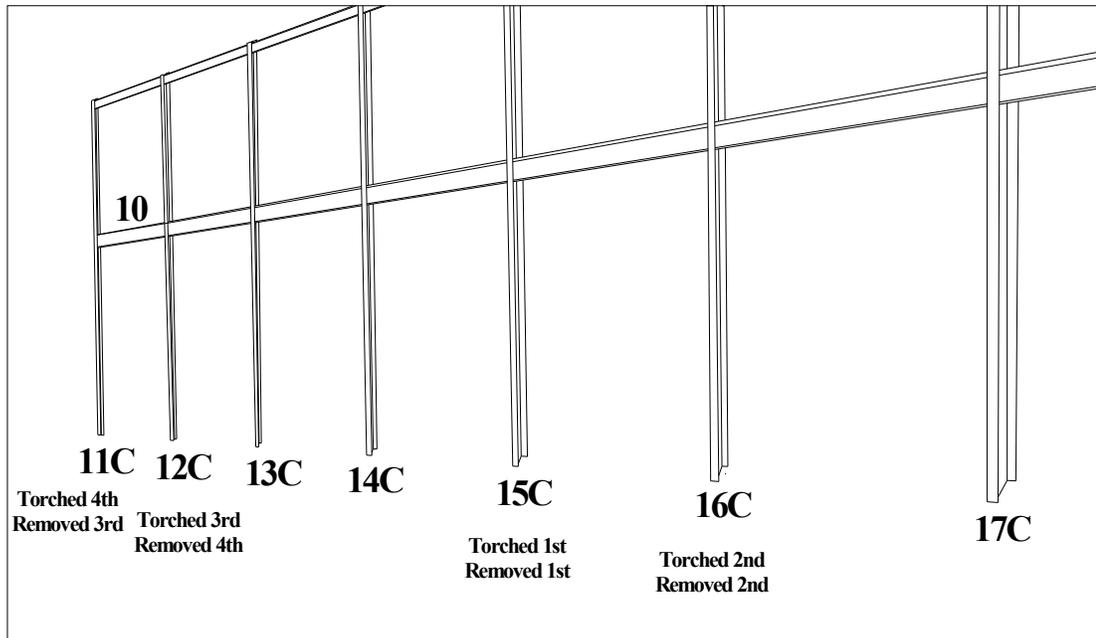
Figure 3.7- Order of Column Torching and Removal.

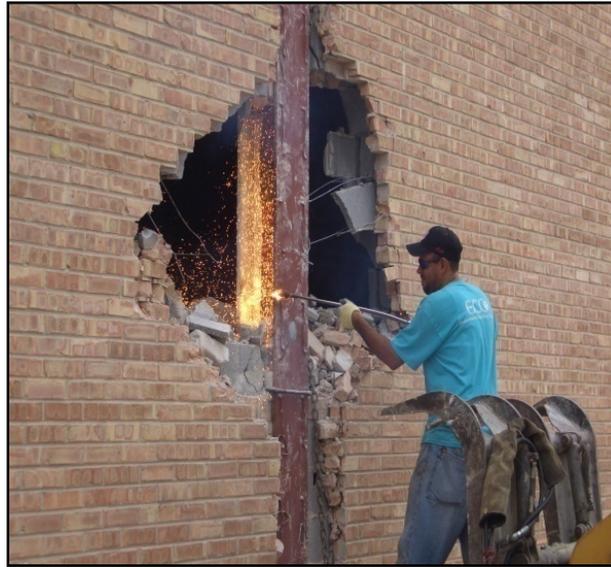
Figure 3.8- Column 16C Being Torched.

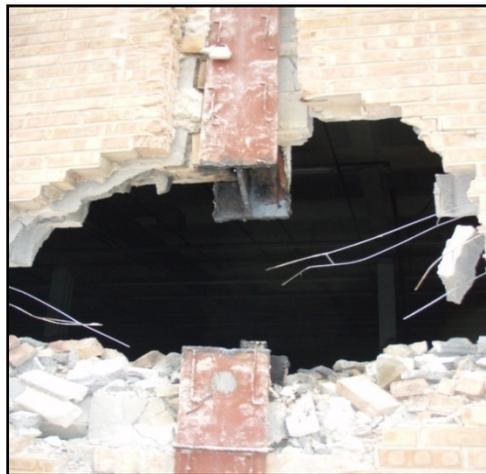
Figure 3.9- Column 16C Removed.

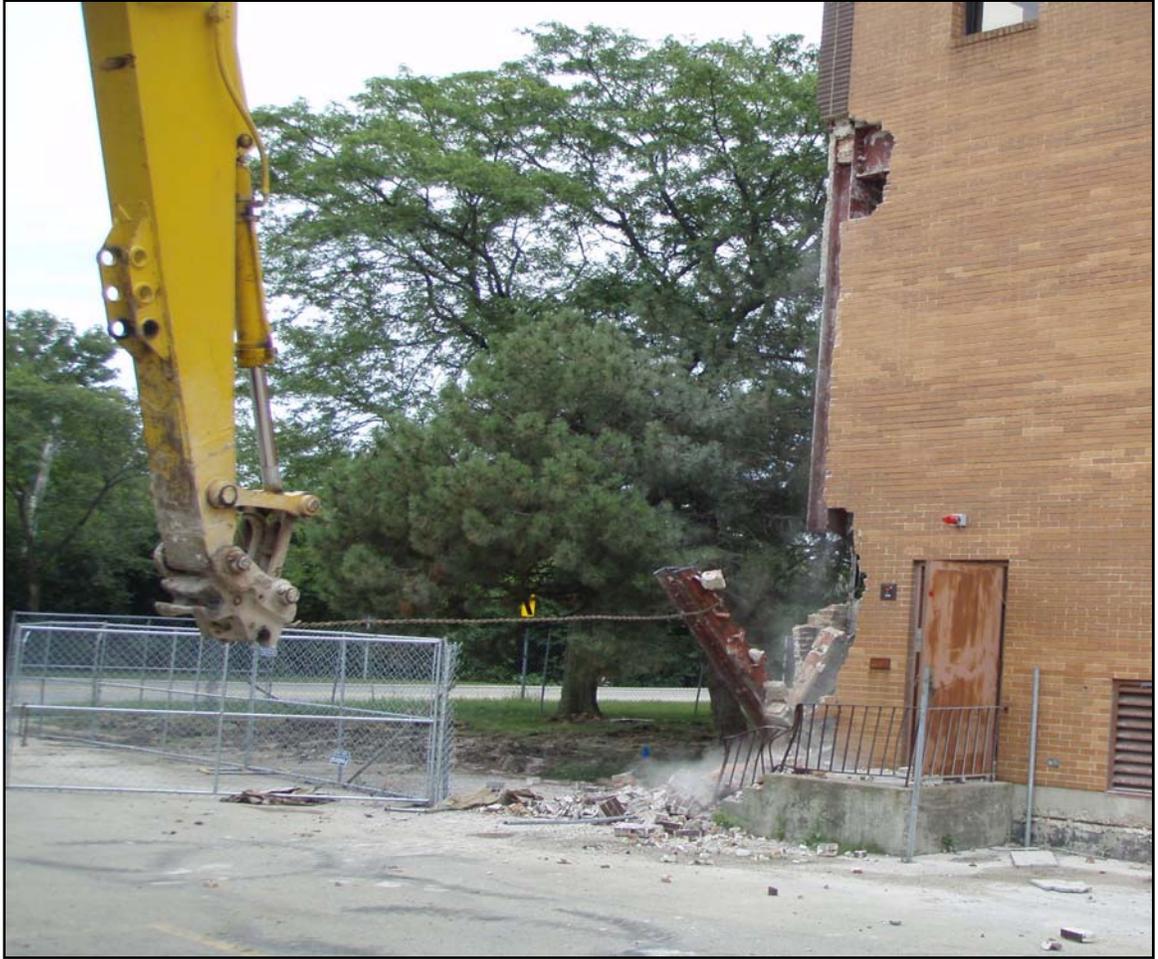
Figure 3.10- Torched Section of Column 11C Being Removed.

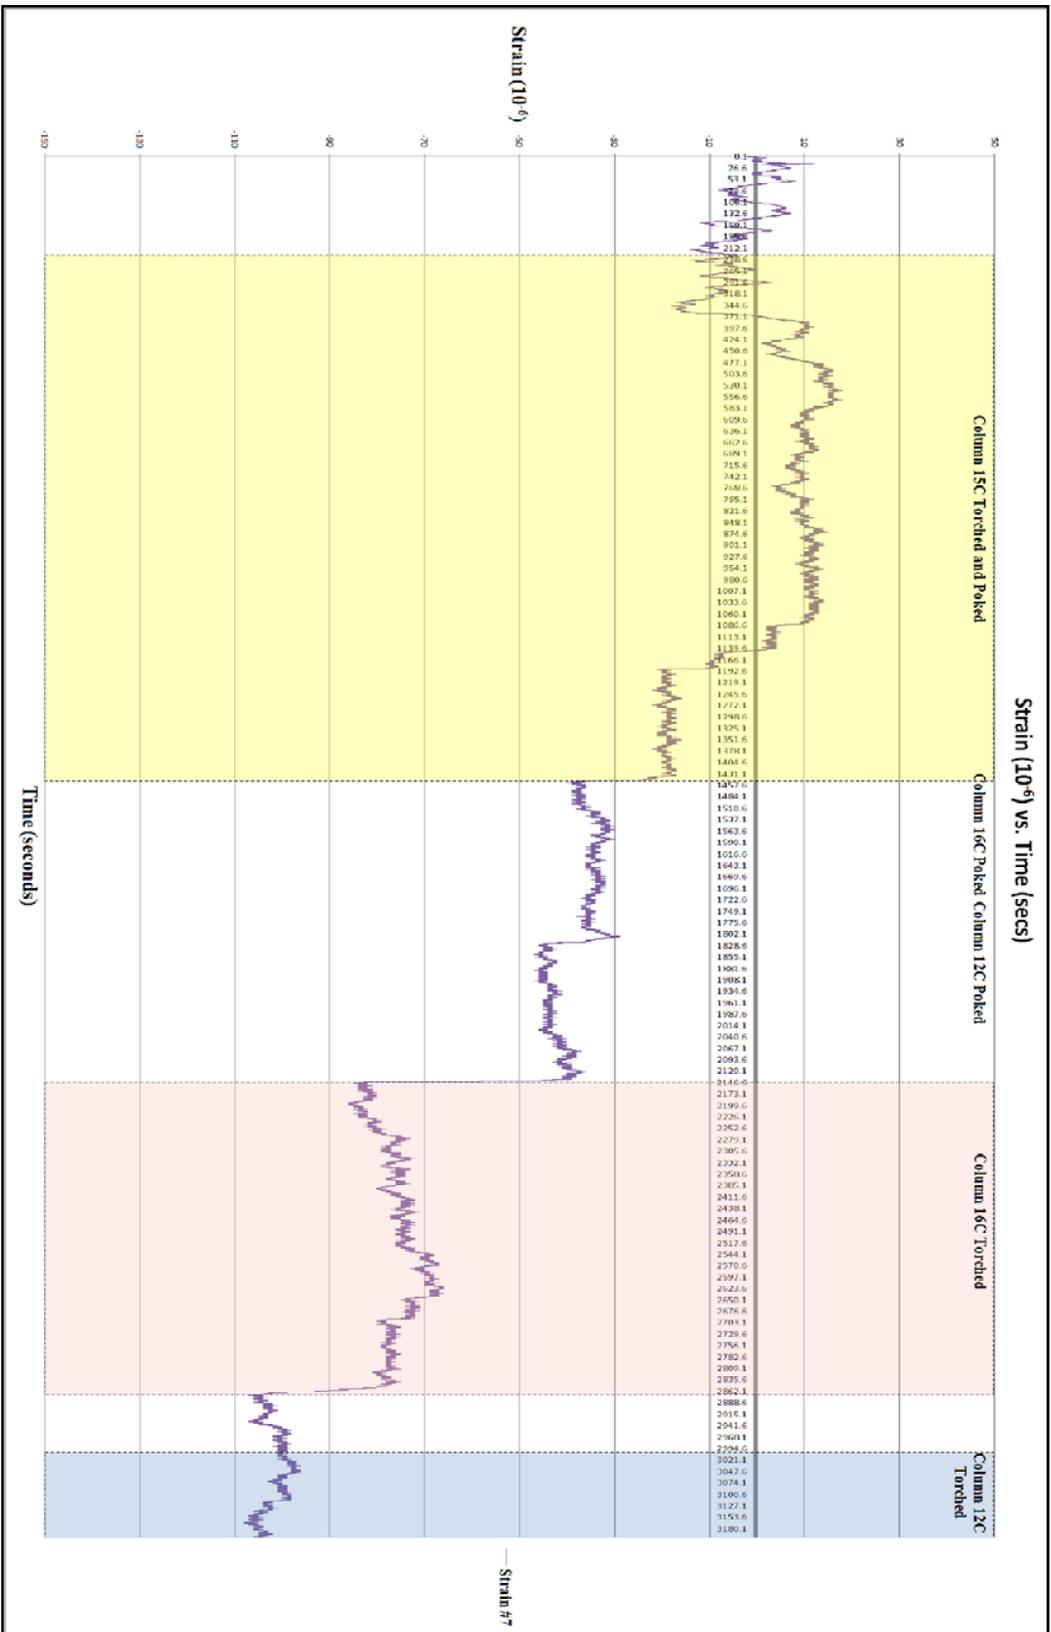
Figure 3.11 - Strain versus Time Chart for Strain Gauge 7: Measurements during Torching (Time: 0-3200 seconds).

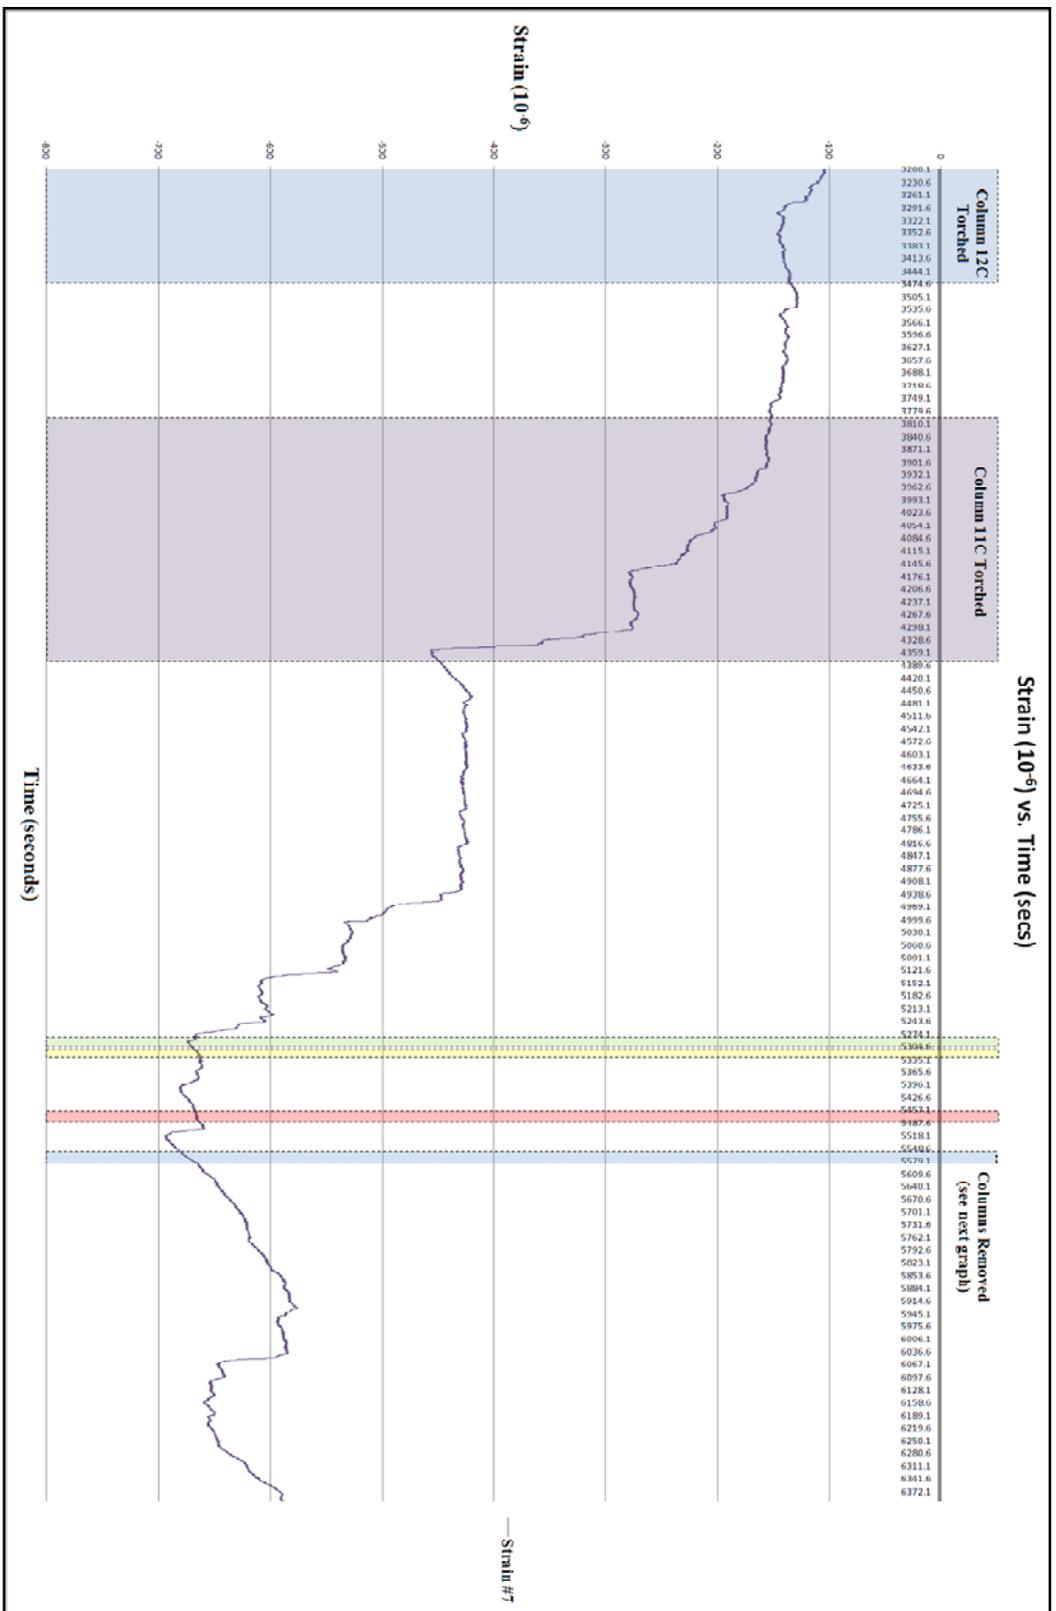
Figure 3.12- Strain versus Time Chart for Strain Gauge 7: Measurements during Torching (Time: 3200-6398 seconds).

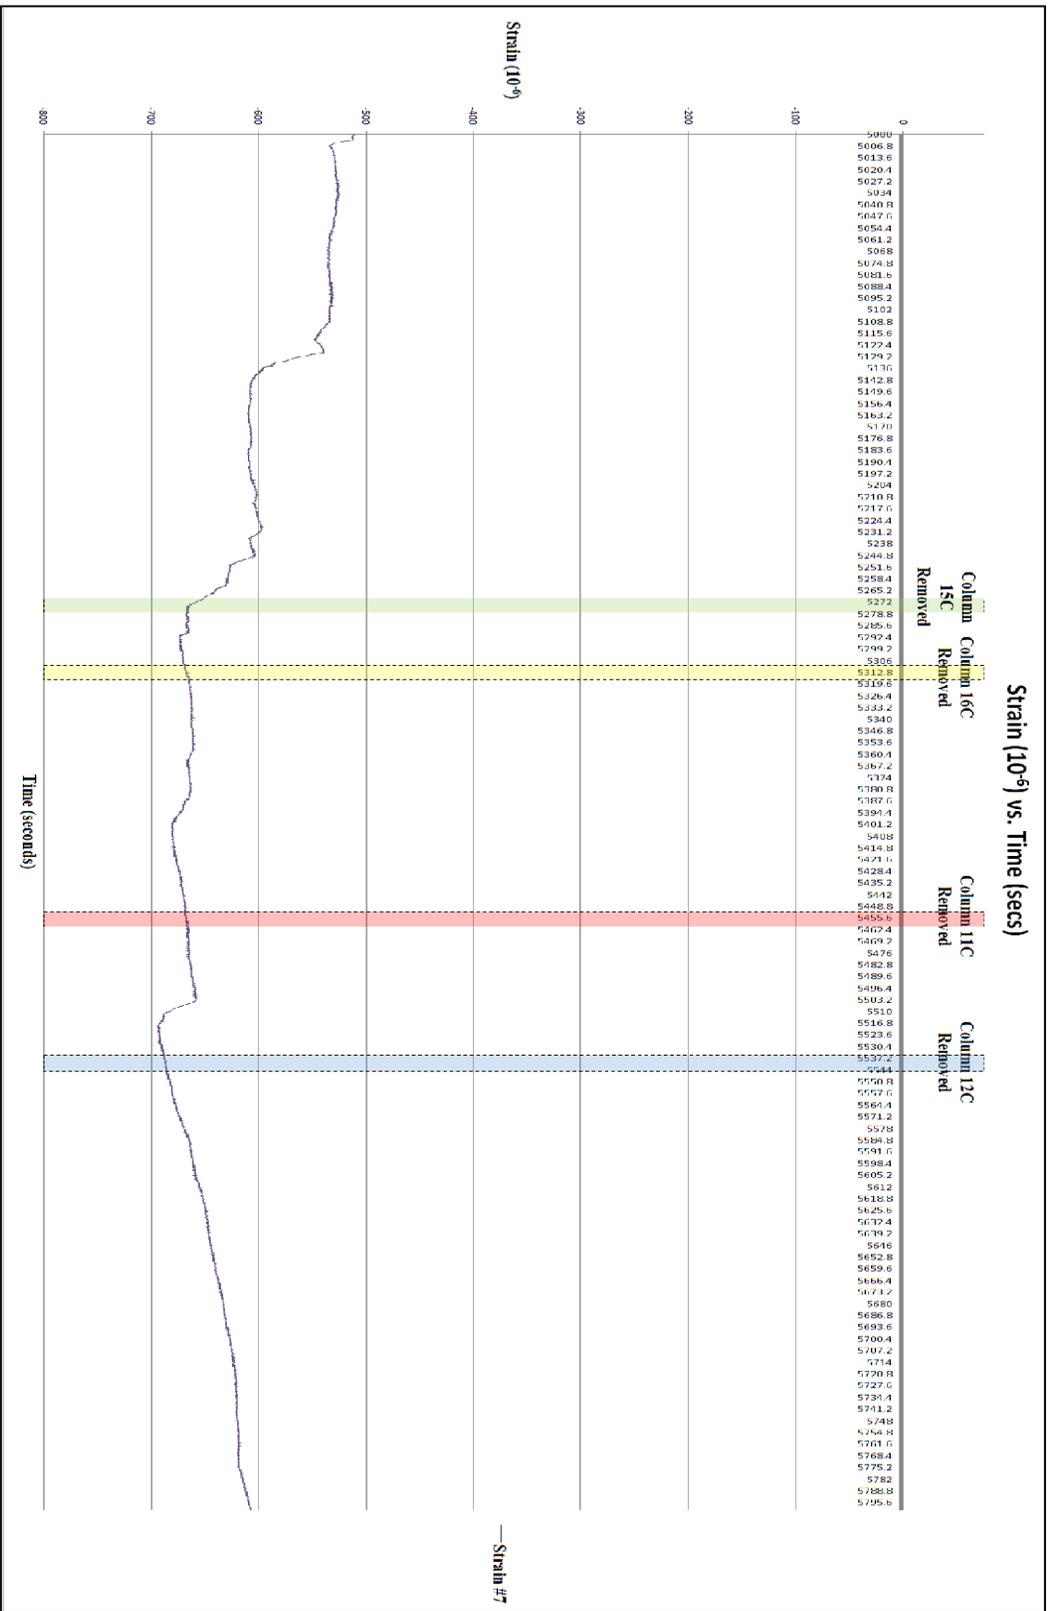
Figure 3.13- Strain versus Time Chart for Strain Gauge 7: Measurements during Column Removal (Time: 5000-5800 seconds).

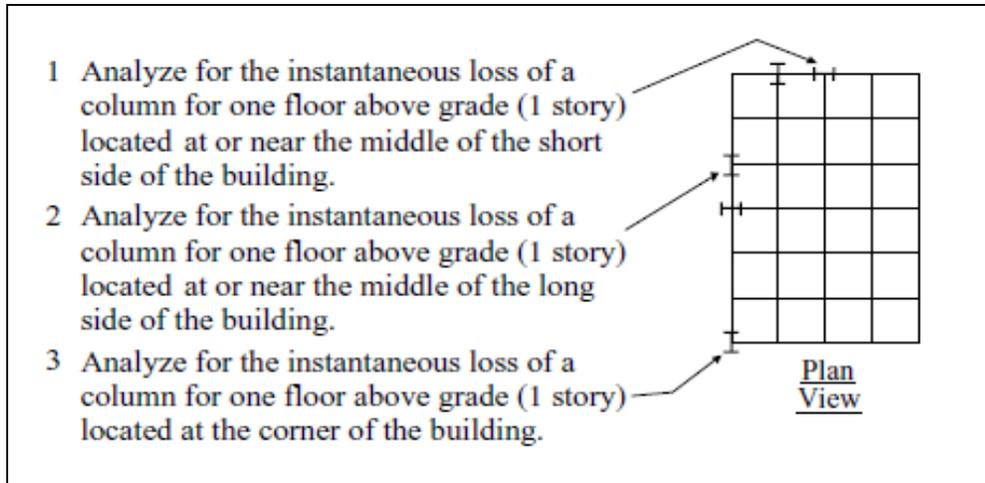
Figure 4.1- GSA (2003) Recommendation for Column Removal for Steel Frame Buildings.

The GSA Progressive Collapse Analysis and Design Guidelines (2003) define analysis procedures to evaluate the vulnerability of a structure against progressive collapse. GSA (2003) recommends that a structure be analyzed by instantaneously removing a column from the middle of the traverse side of the building, near the middle of the longitudinal side of building, and at the corner of the building (Figure 4.1).

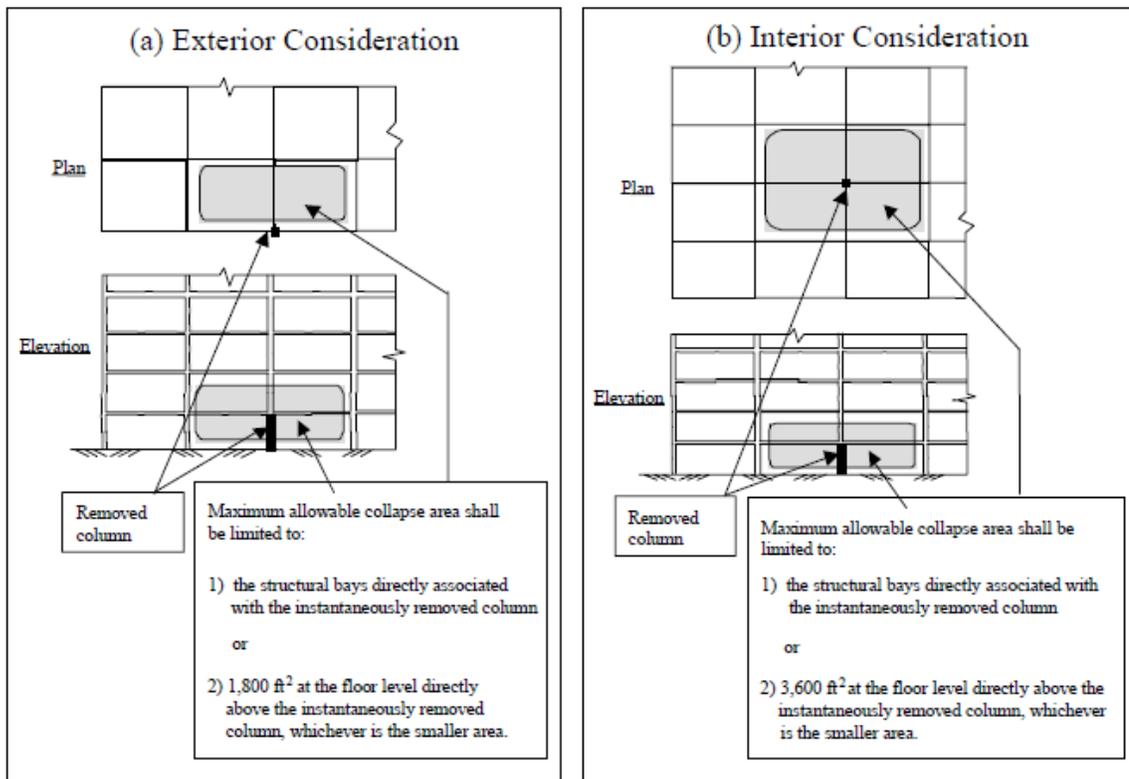
Figure 4.2- GSA (2003) Allowable Extent of Collapse from Column Removal for Steel Frame Buildings.

Equation 4.1 is used for all loads acting on the structure, and increases the loading condition to account for irregularities in the structure. This equation presents the worst case scenario for the structure being tested for progressive collapse potential. Using Equation 4.1, the allowable extents of collapse resulting from instantaneous removal of primary exterior vertical supports are found in Figure 4.2.

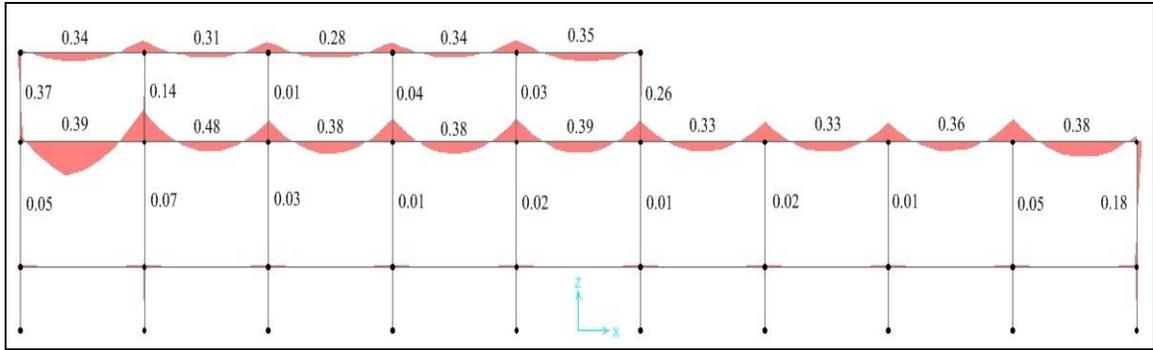
Figure 5.1- SAP2000 Model of Original Intact Building with DCR Values.

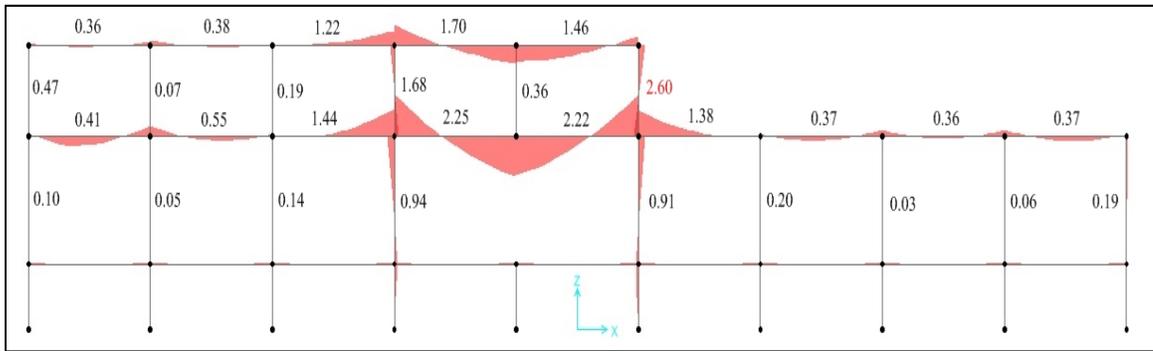
Figure 5.2- SAP2000 Model after Column 15C Removed with DCR Values.

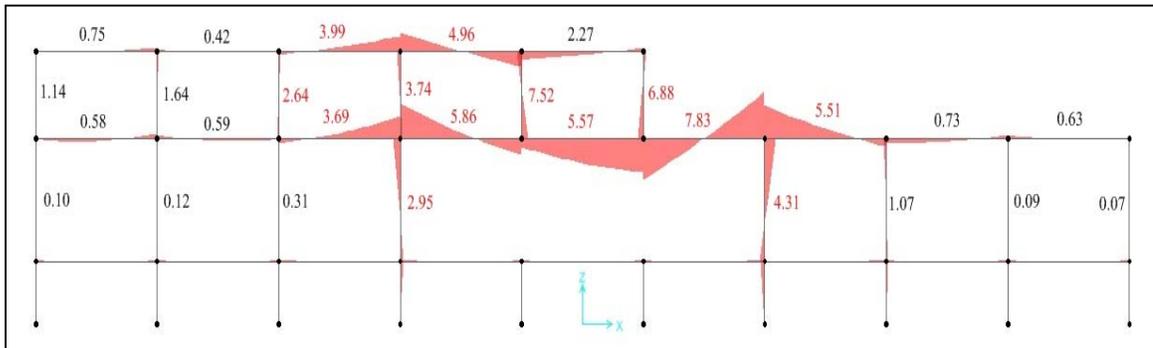
Figure 5.3- SAP2000 Model after Columns 15C and 16C Removed with DCR Values.

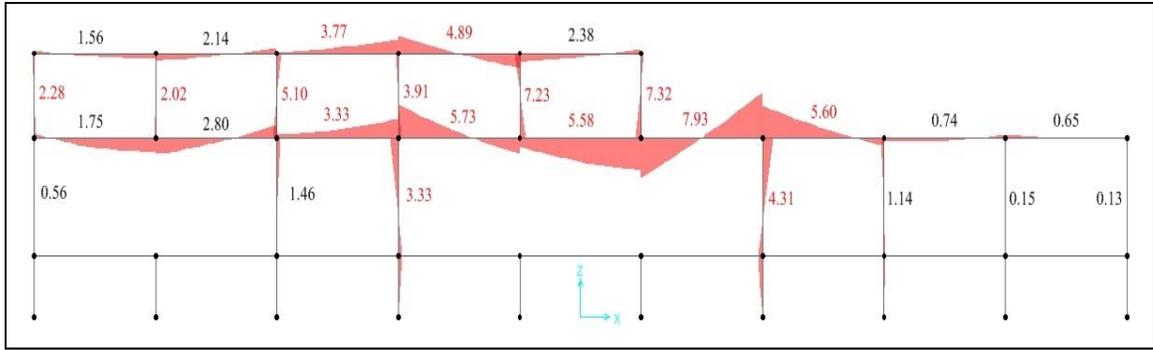
Figure 5.4- SAP2000 Model after Columns 12C, 15C, and 16C Removed with DCR Values.

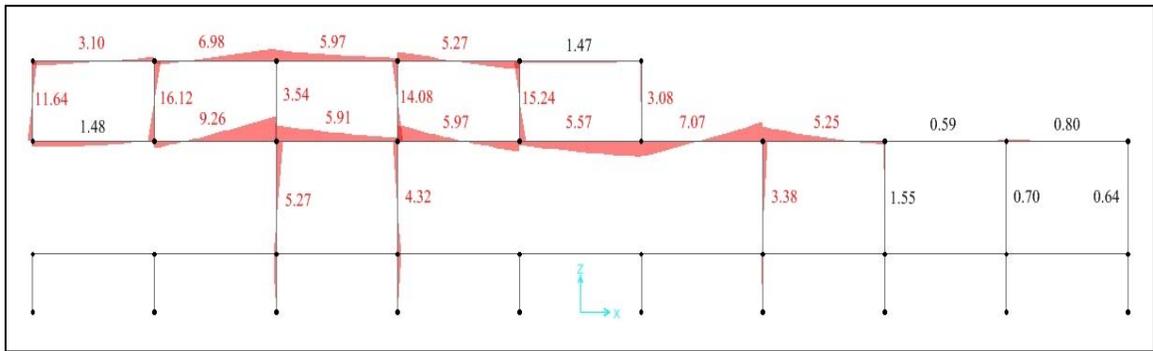
Figure 5.5- SAP2000 Model after Columns 11C, 12C, 15C, and 16C Removed with DCR Values.

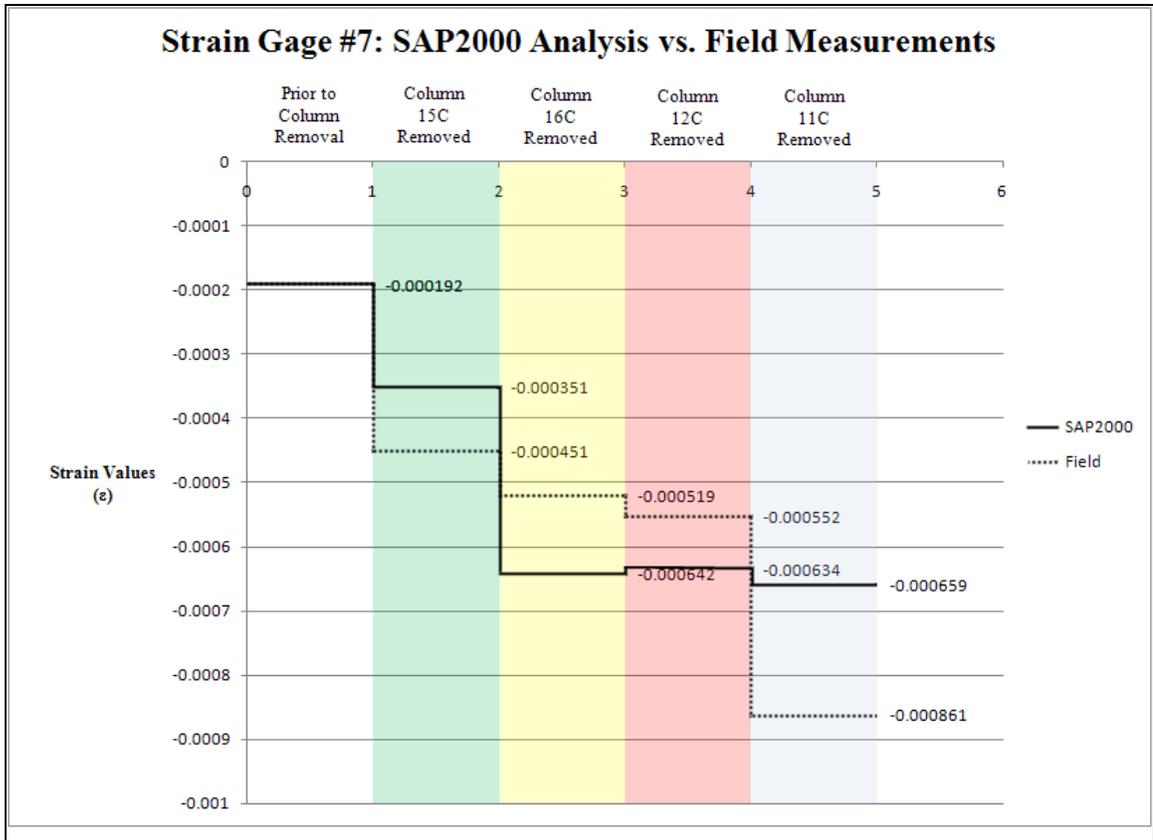
Figure 5.6- SAP2000 and Field Strain Values Shown for Strain Gauge 7 (21% Error between SAP2000 Results and Actual Measurements).

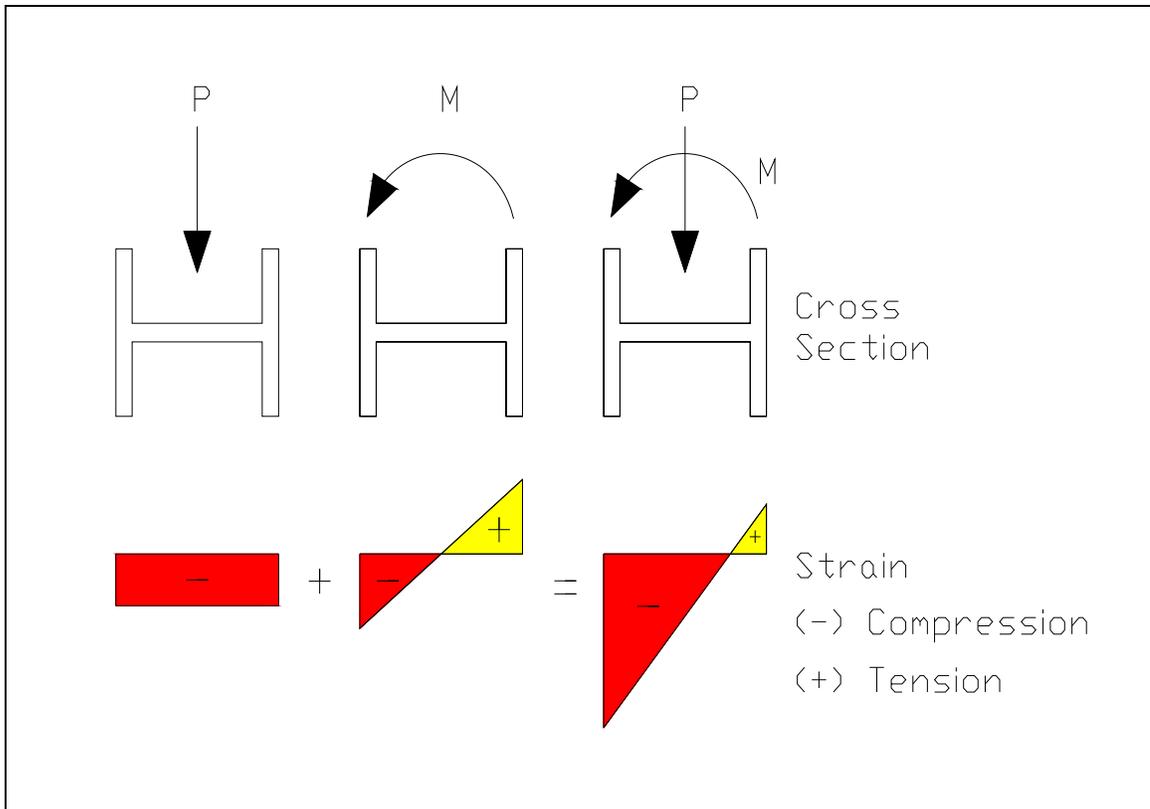
Figure 6.2- Strain from Combination of Axial Load (P) and Bending Moment (M).

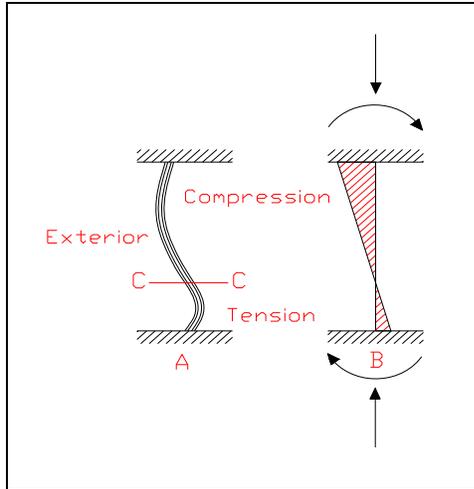
Figure 6.3- (a) is Orientation of a Column, (b) is the Bending Moment Diagram of the Column.

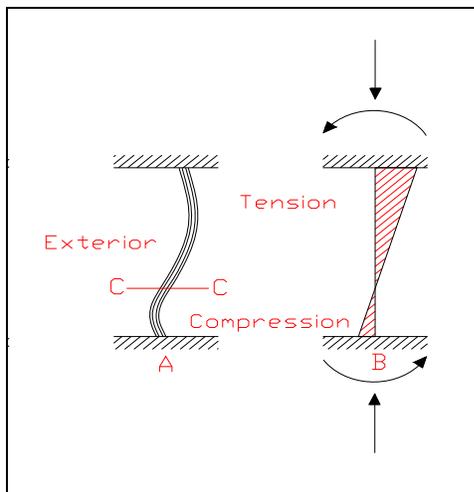
Figure 6.4- (a) is Orientation of a Column, (b) is the Bending Moment Diagram of the Column.

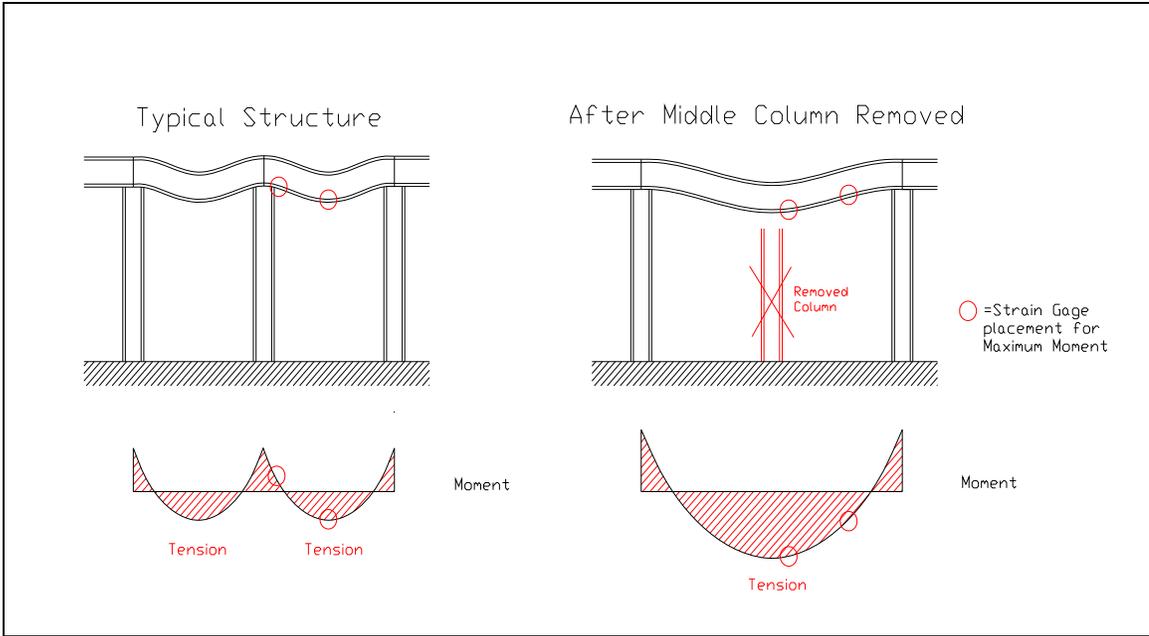
Figure 6.5- Beam Deflection and Moment Diagrams before and after Column Removal.

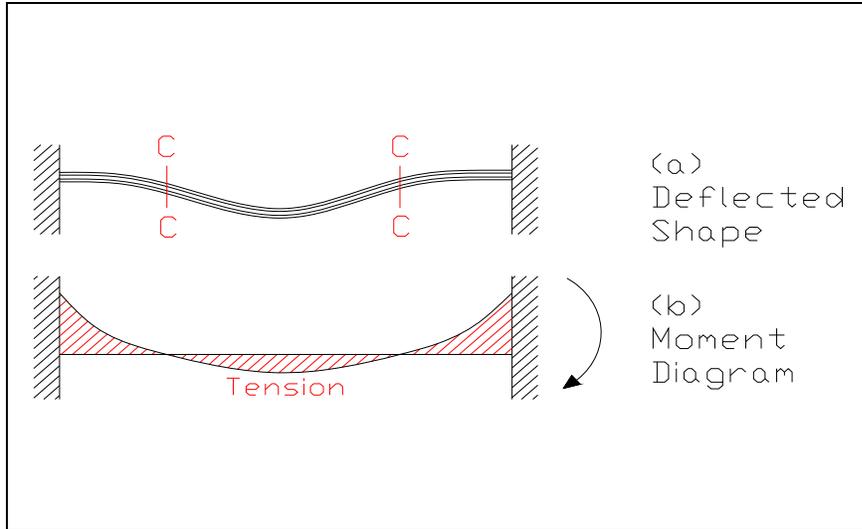
Figure 6.6- (a) Deflected Shape of a Fixed Ended Beam Under Uniform Vertical Load, (b) Moment Diagram of the Beam.

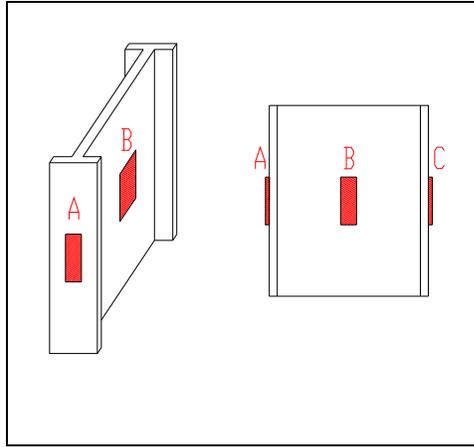
Figure 6.7- Strain Gauge Instrumentation on a Column.

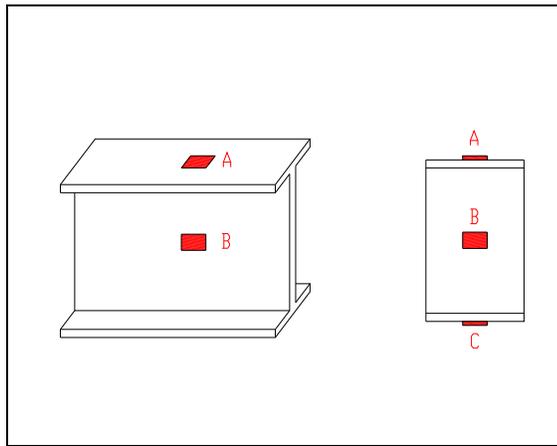
Figure 6.8- Strain Gauge Instrumentation on a Beam.
