PROGRESSIVE COLLAPSE ANALYSIS OF AN EXISTING BUILDING

Halil Sezen (PI) and Kevin A. Giriunas (student researcher)

The Ohio State University

May 2009

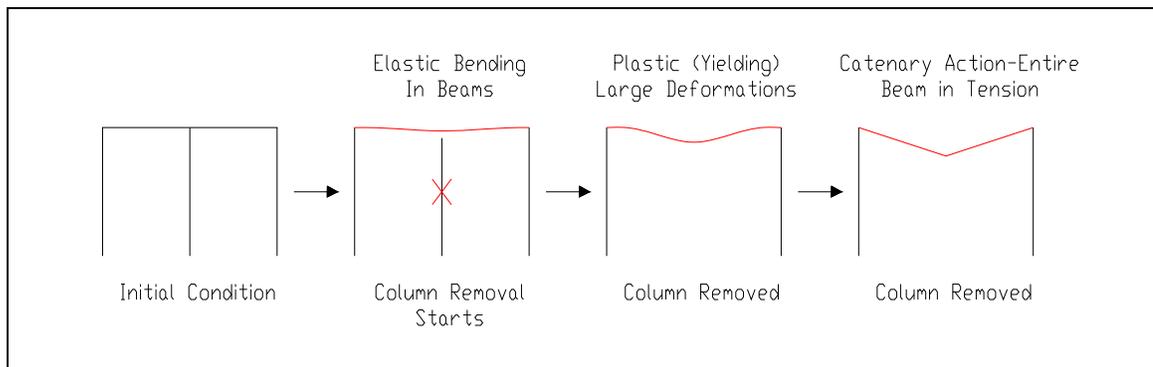
Figure 6.9- Stages of Beam Response.

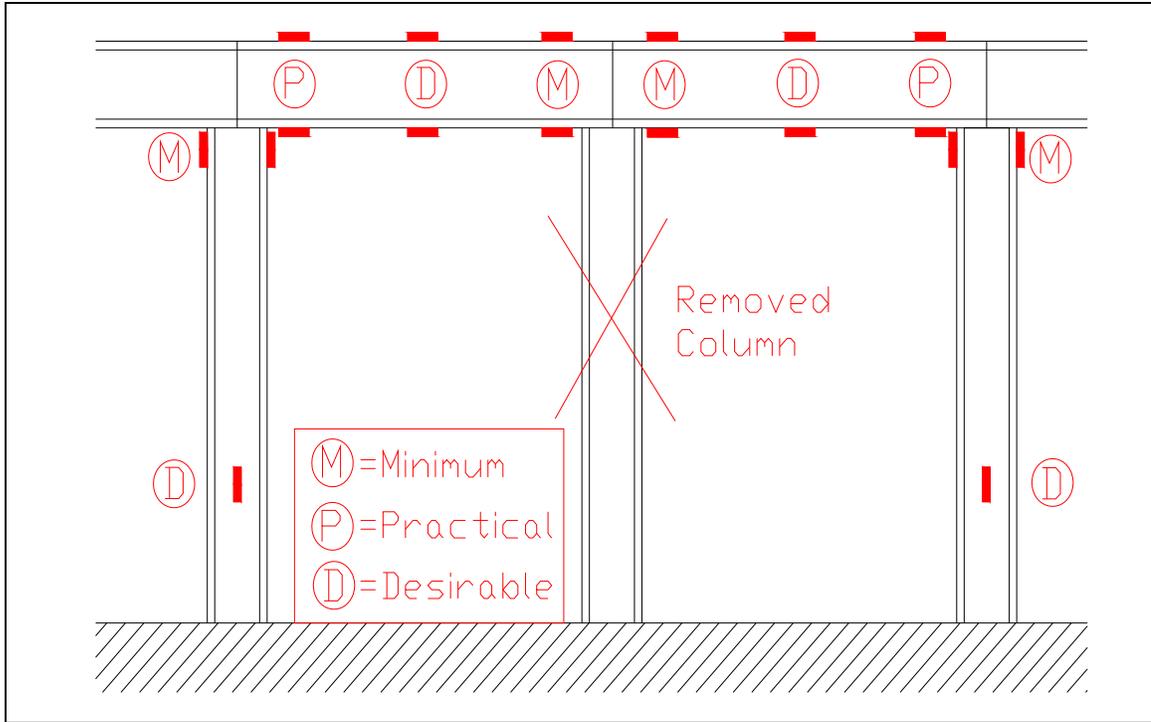
Figure 6.10- Strain Gauge Instrumentation for Columns and Beams Labeled by Importance Corresponding with Table 6.1.

Table 6.1 provides recommendation for the amount of strain gauges to use depending on availability. The minimum number of strain gauges used in a progressive collapse experiment for one column removal is eight, shown in Table 6.1. If the minimum amount of strain gauges is to be used, strain gauges need to be attached near the most critical sections where columns will be removed labeled M in Figure 6.10 following the guidelines presented in this chapter

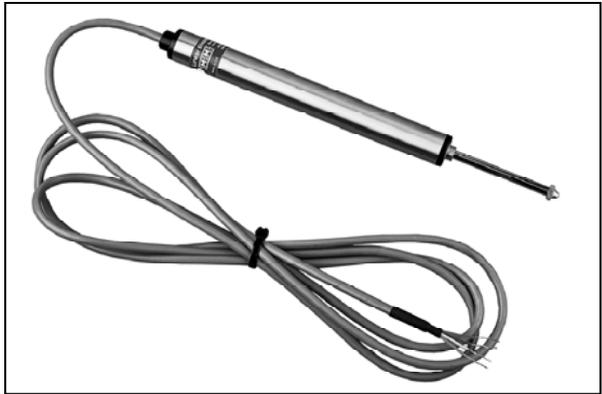
Figure 6.11- Linear Displacement Sensor.

Linear displacement sensors (LDS) are used to measure the vertical or horizontal displacement of beams or columns. Linear displacement sensors are connected to the same data acquisition system and computer station the strain gauges are, and the computer program records the displacements and strains simultaneously. The varying models of LDS can record a displacement ranging from 0.25 in. to 4 in., and can work in almost any temperature conditions. A LDS is shown in Figure 6.11.

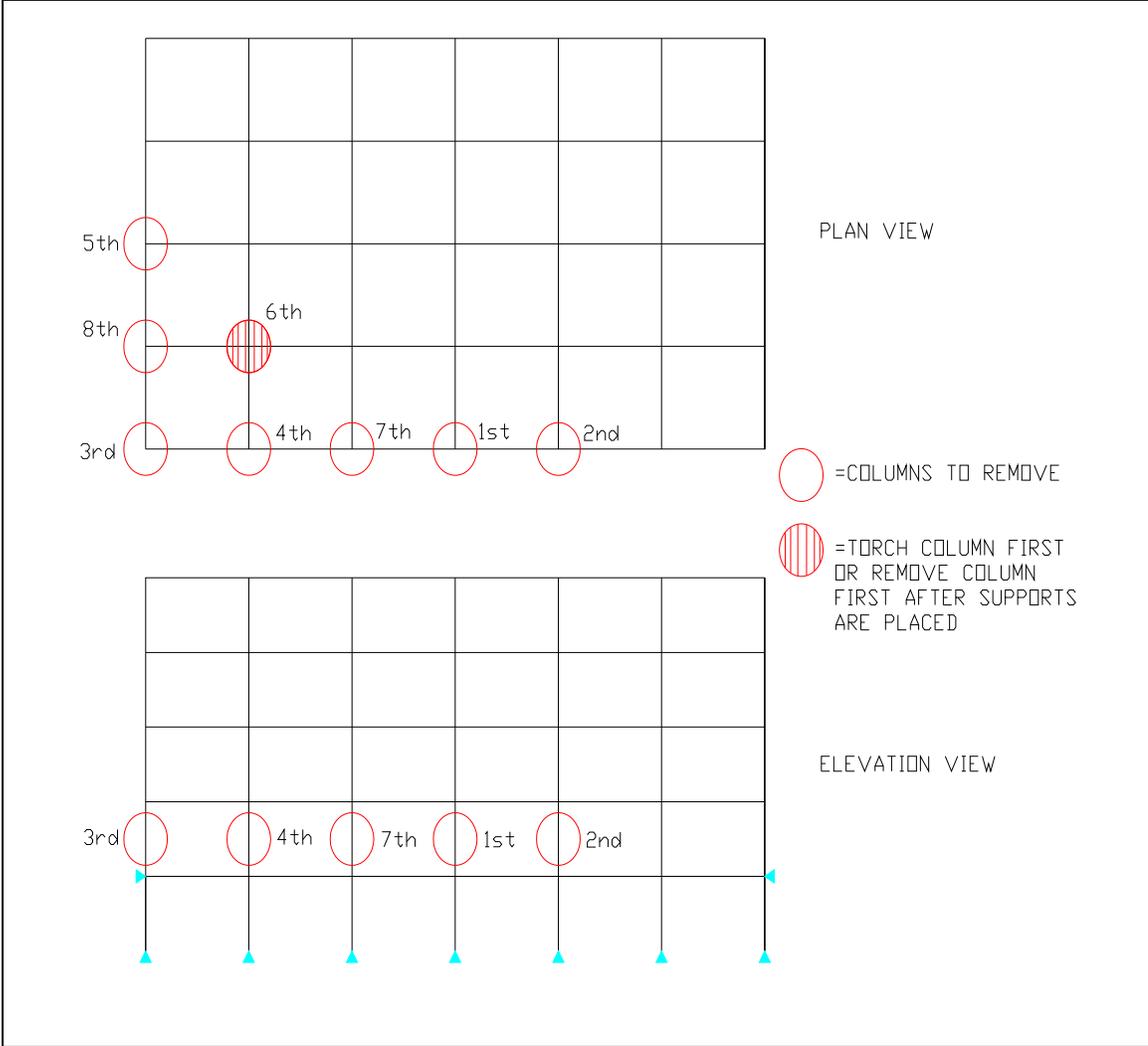
Figure 6.12- Suggested Order of Column Removal for the First Floor.

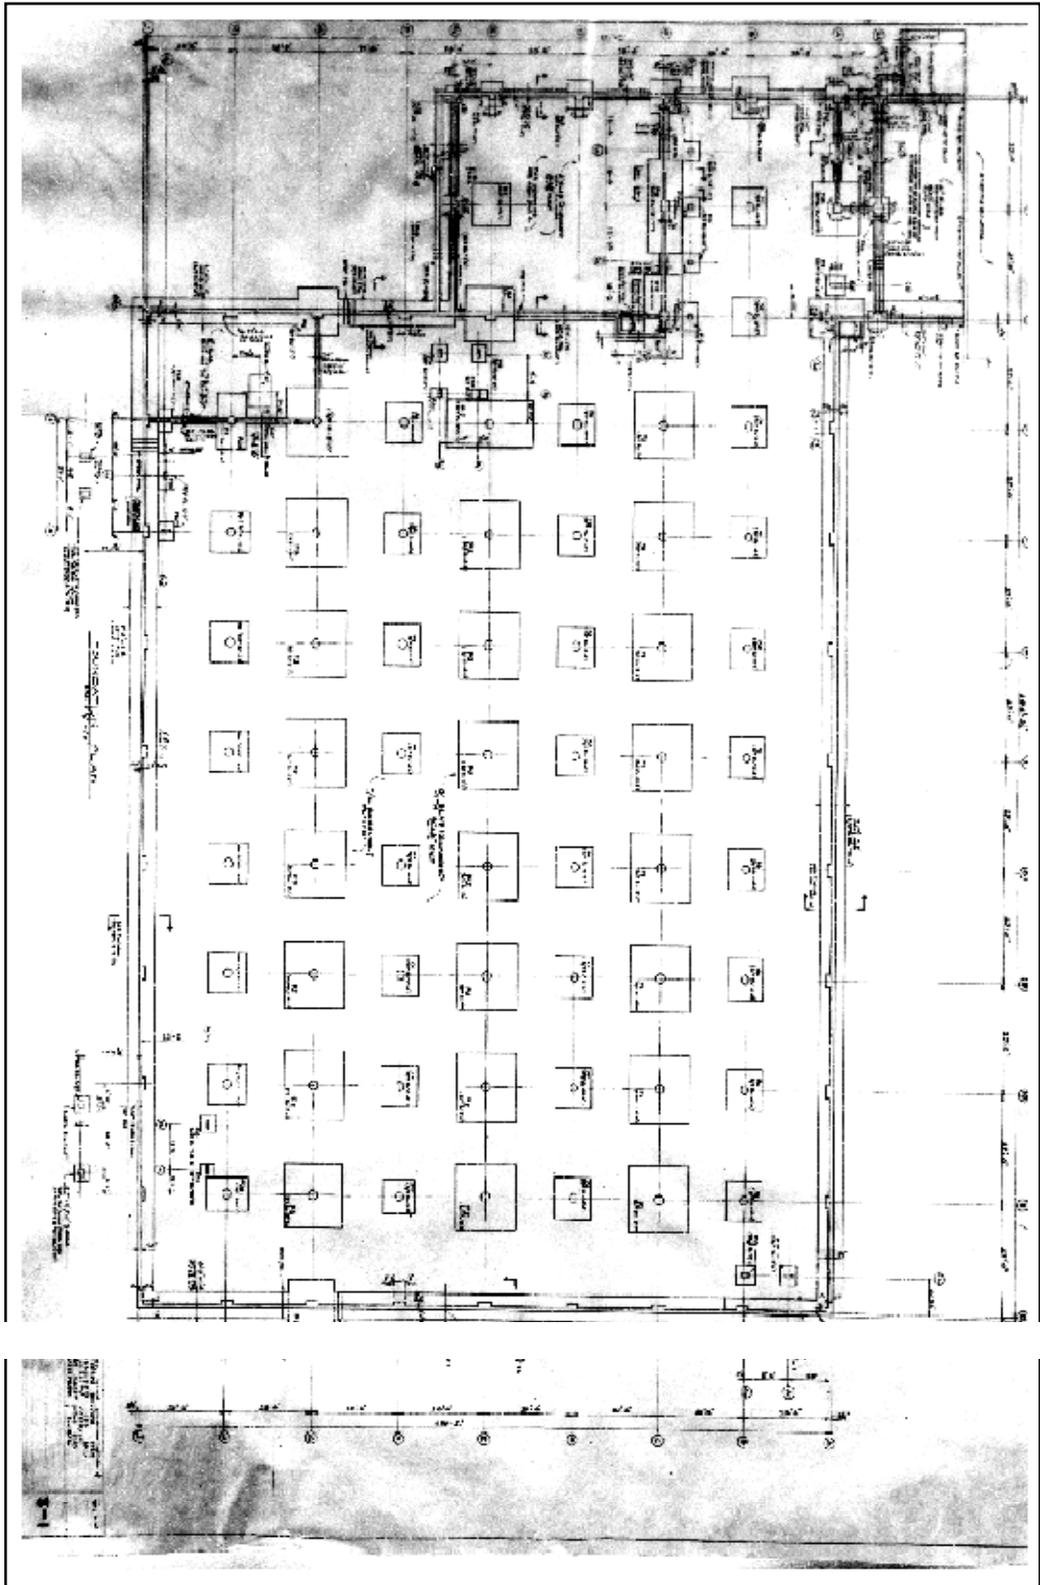
Figure A.1 - Foundation Plan (Structural).

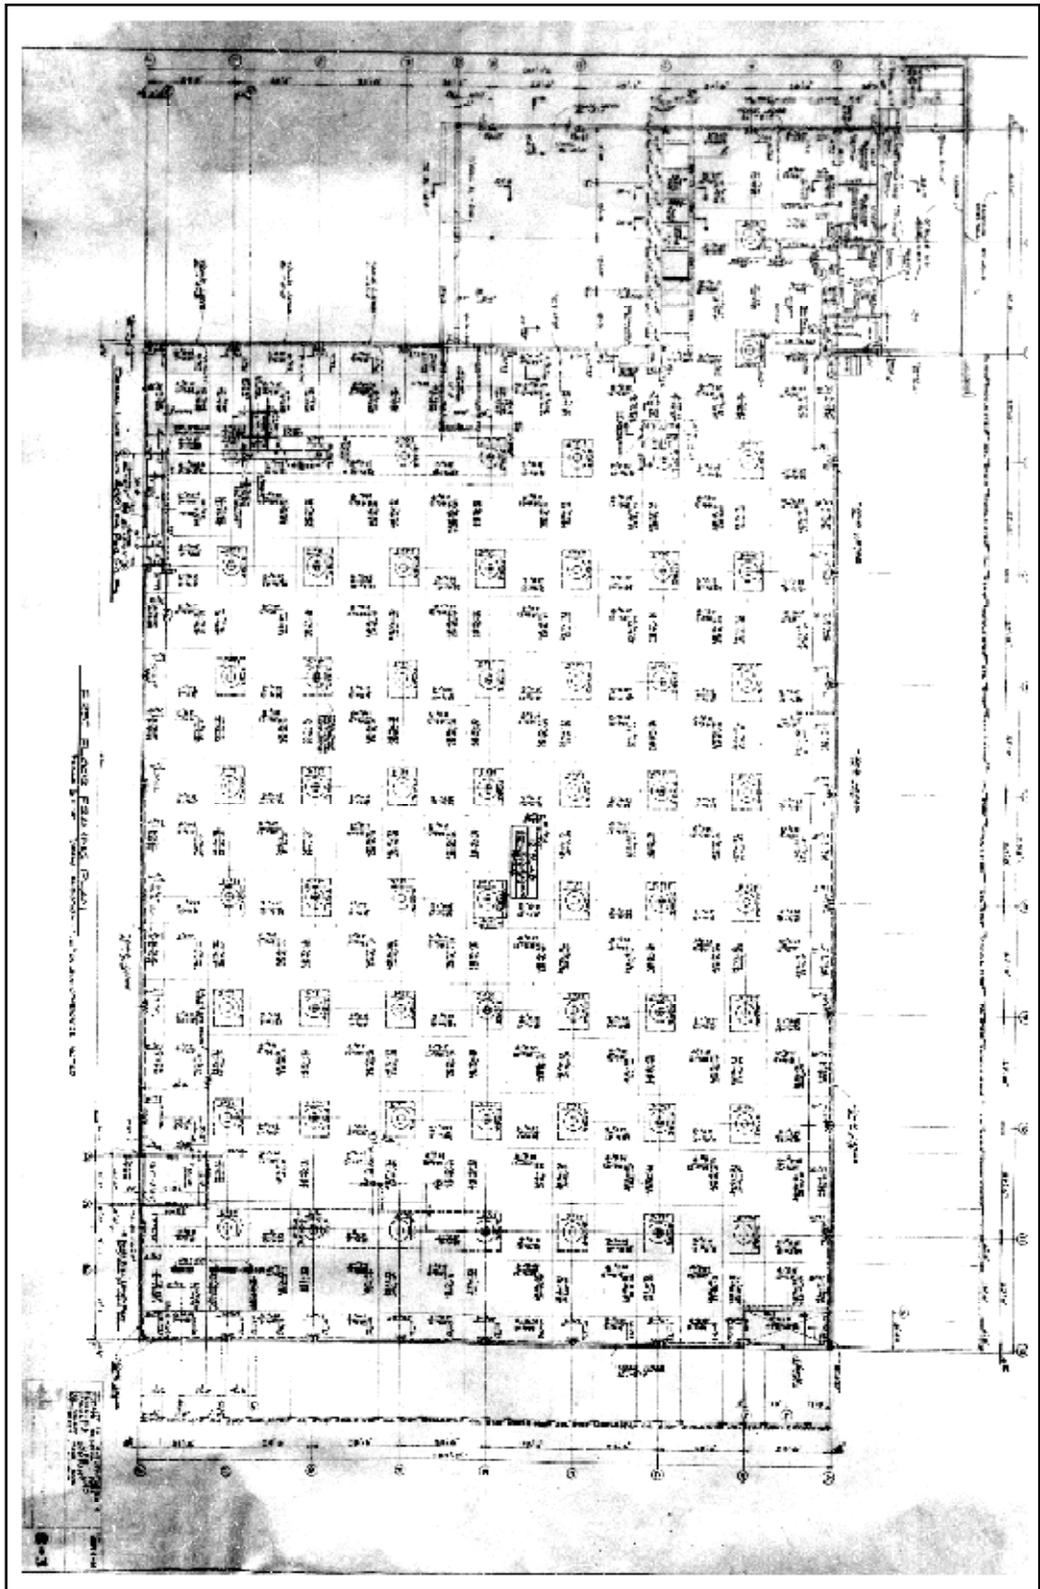
Figure A-2- First Floor Framing Plan (Structural).

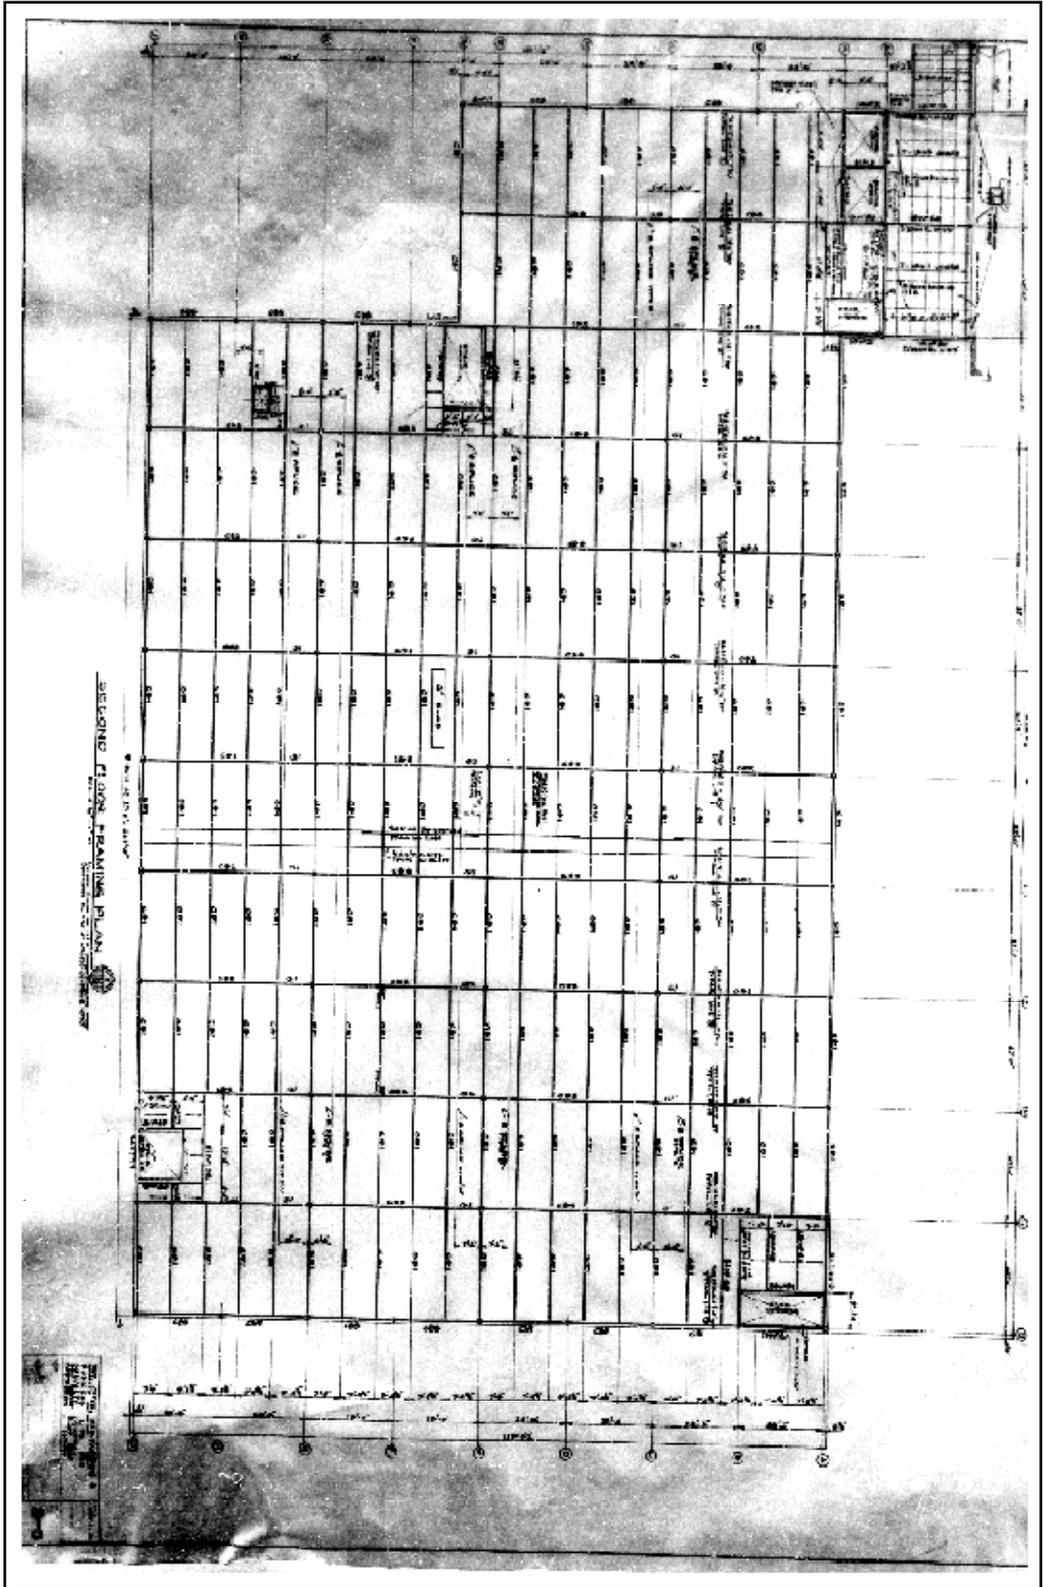
Figure A.3- Second Floor Framing Plan (Structural).

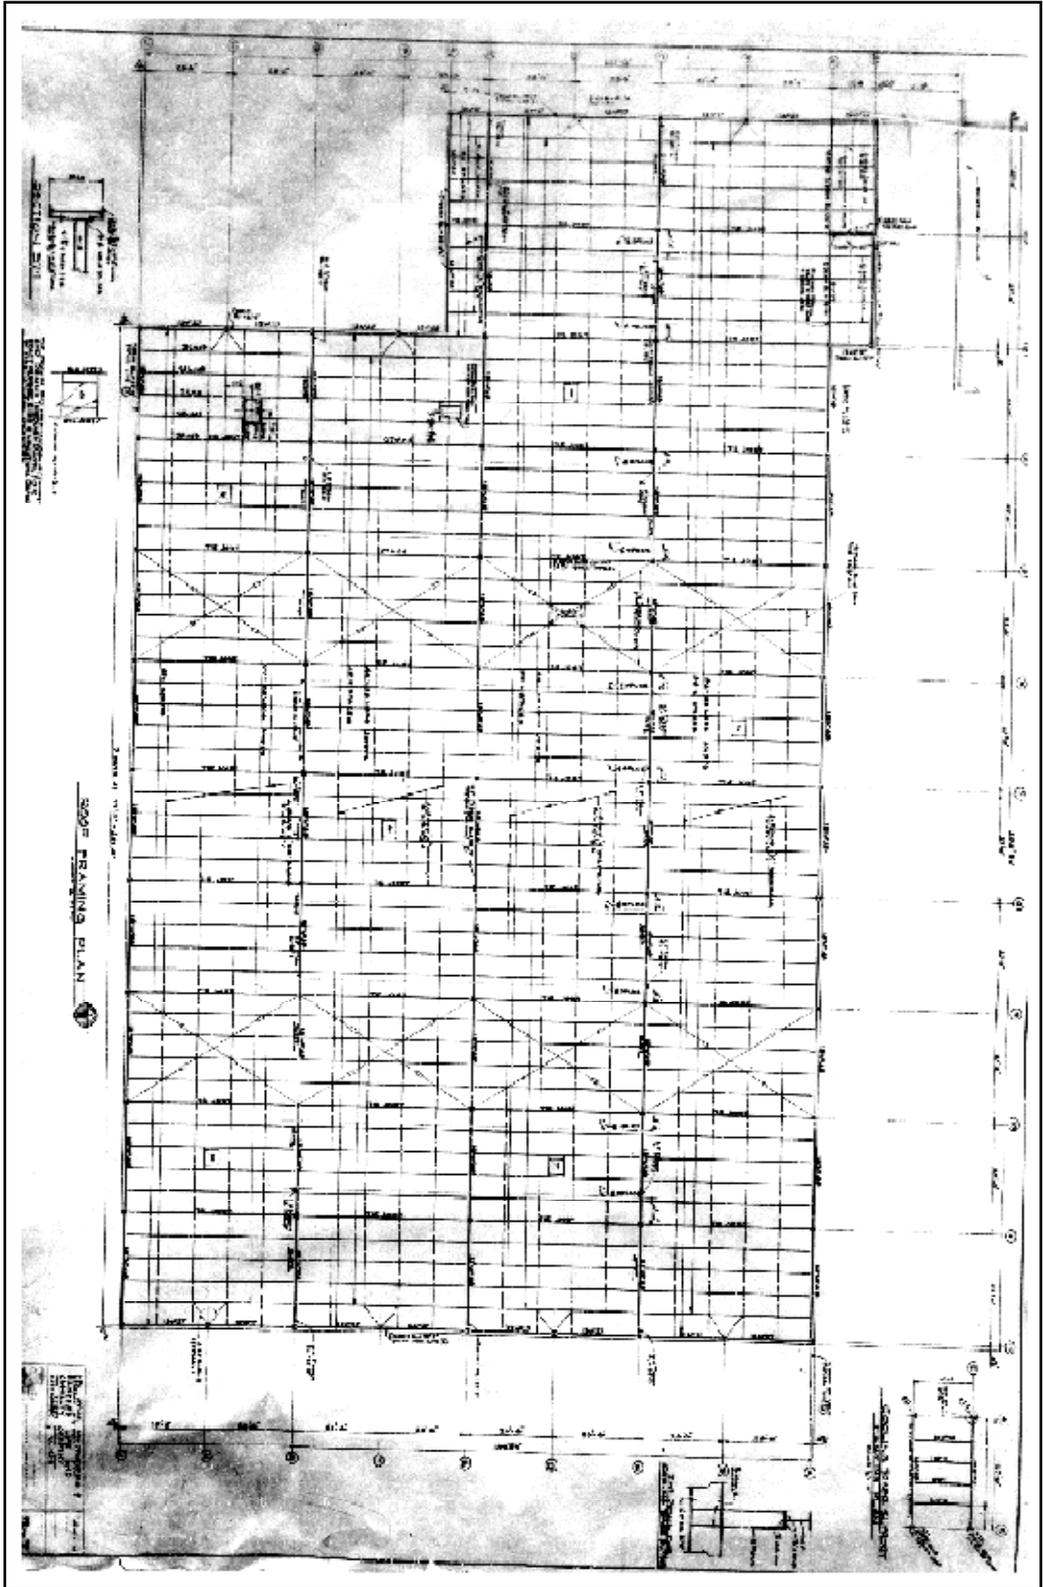
Figure A.4- Roof Framing Plan (Structural).

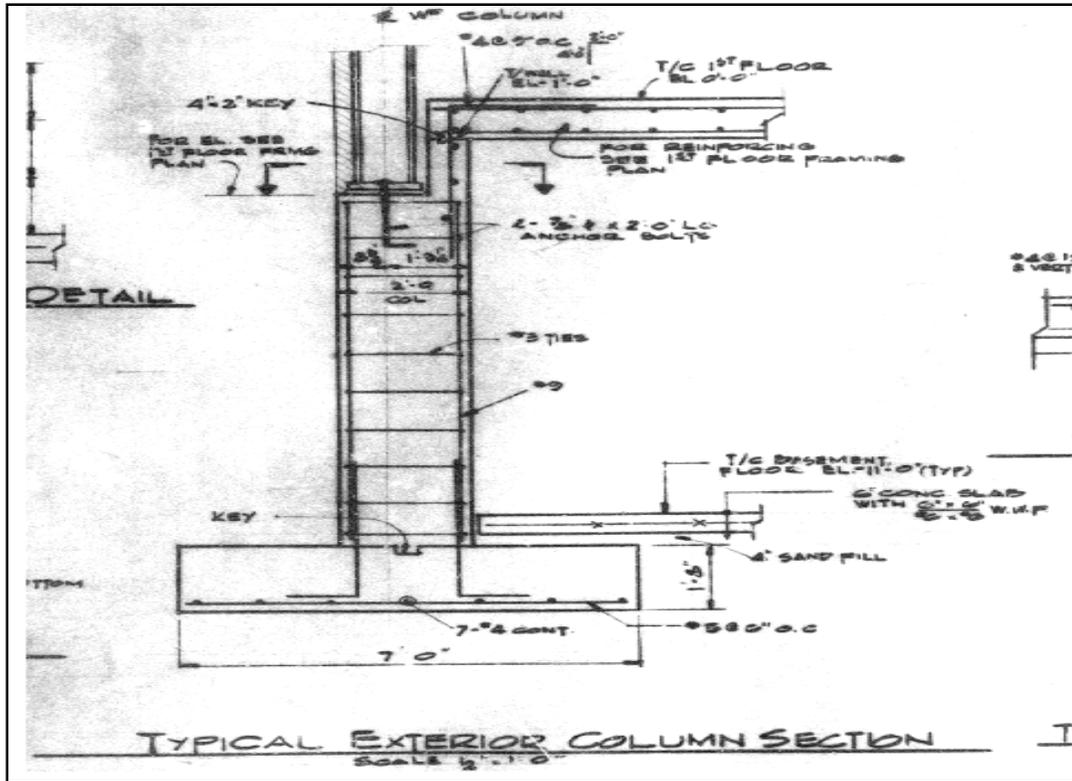
Figure A.5- Typical Exterior Column Section (Structural).

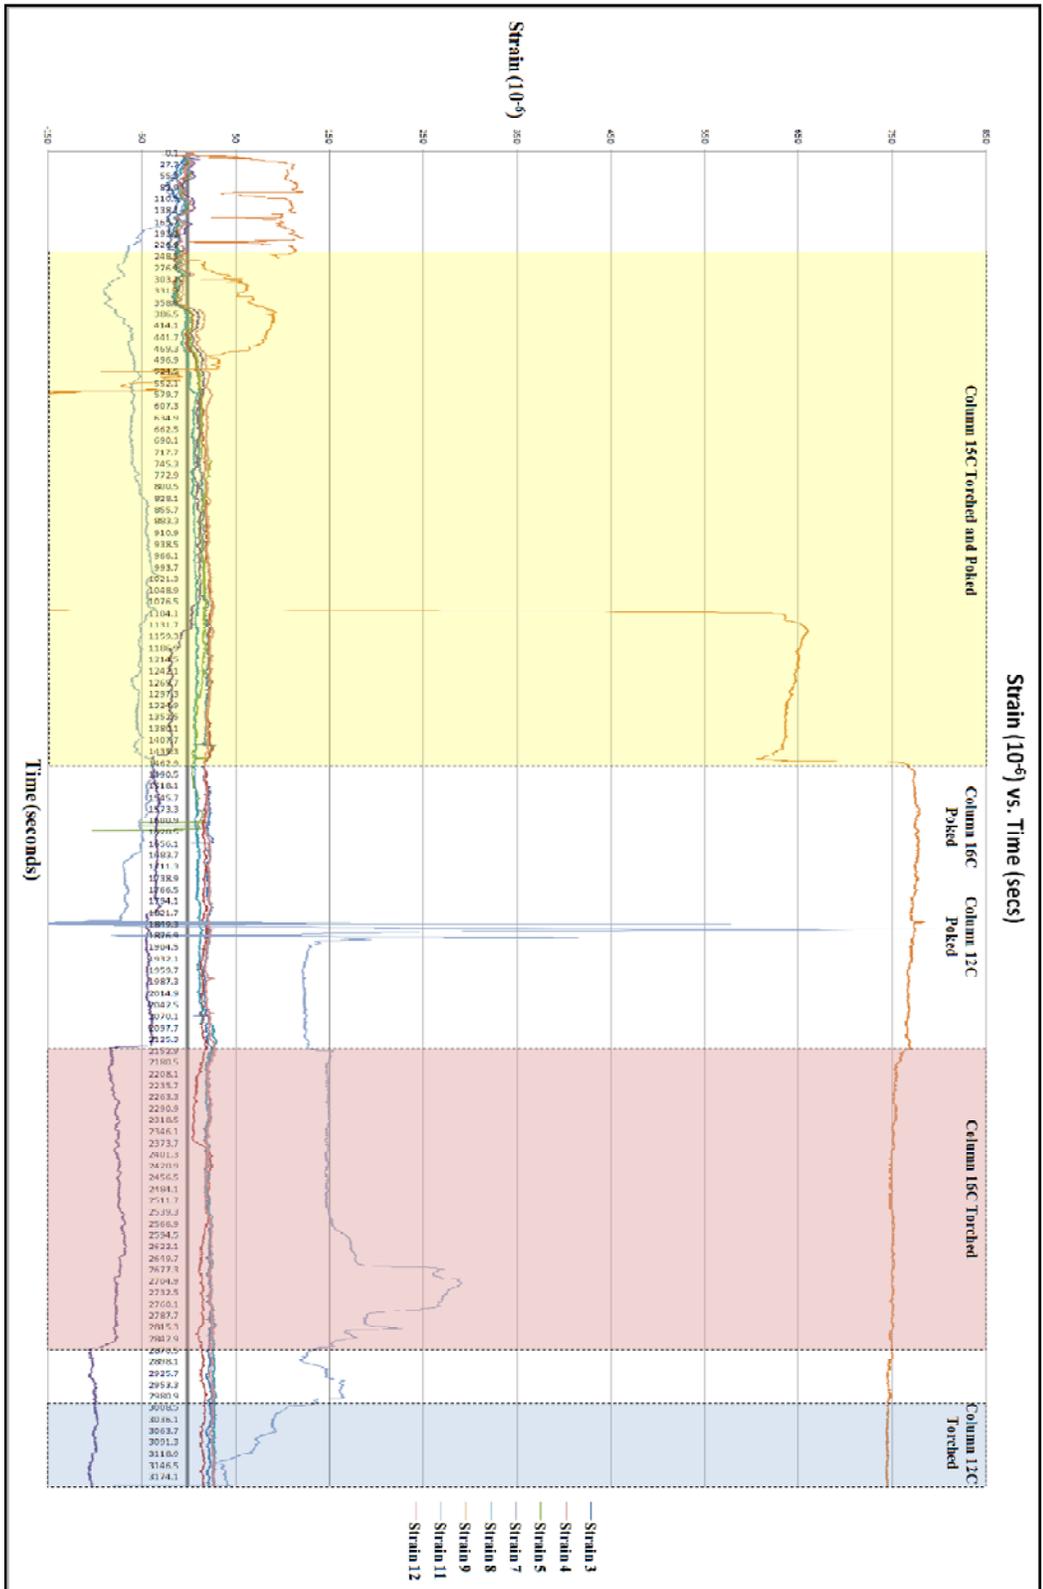
Figure B.1 - Strain versus Time Chart Measurements during Torching, (Time: 0-3200 seconds).

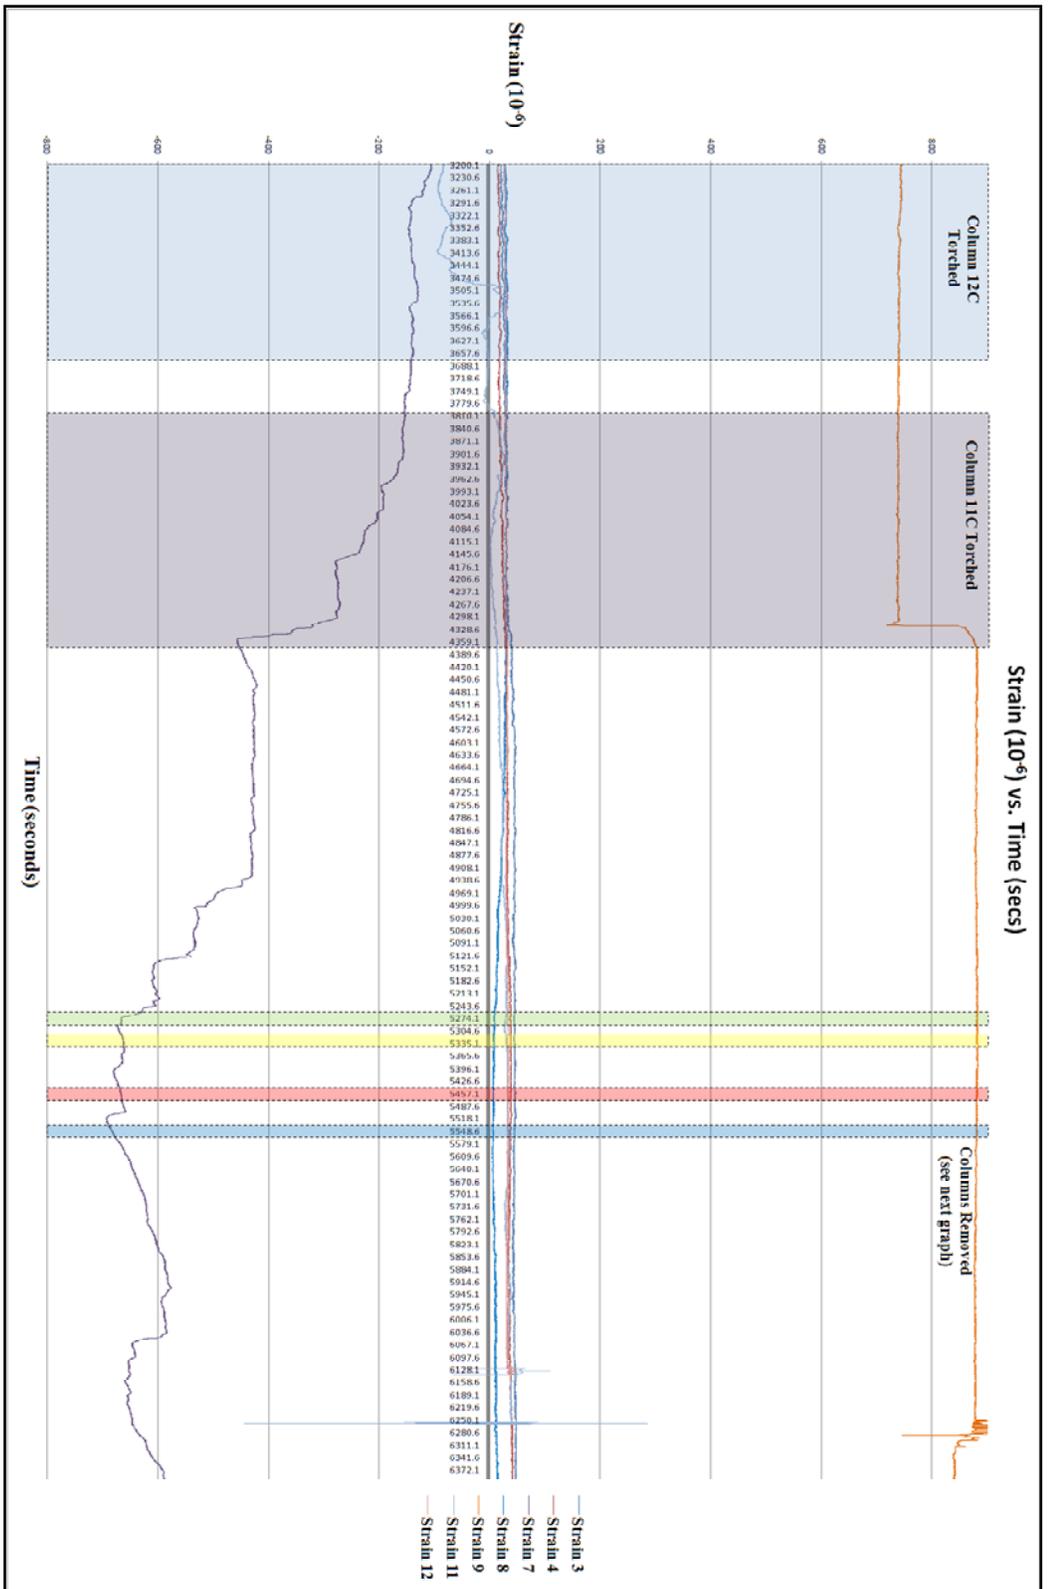
Figure B.2- Strain versus Time Chart Measurements during Torching, (Time: 3200 – 6398 seconds).

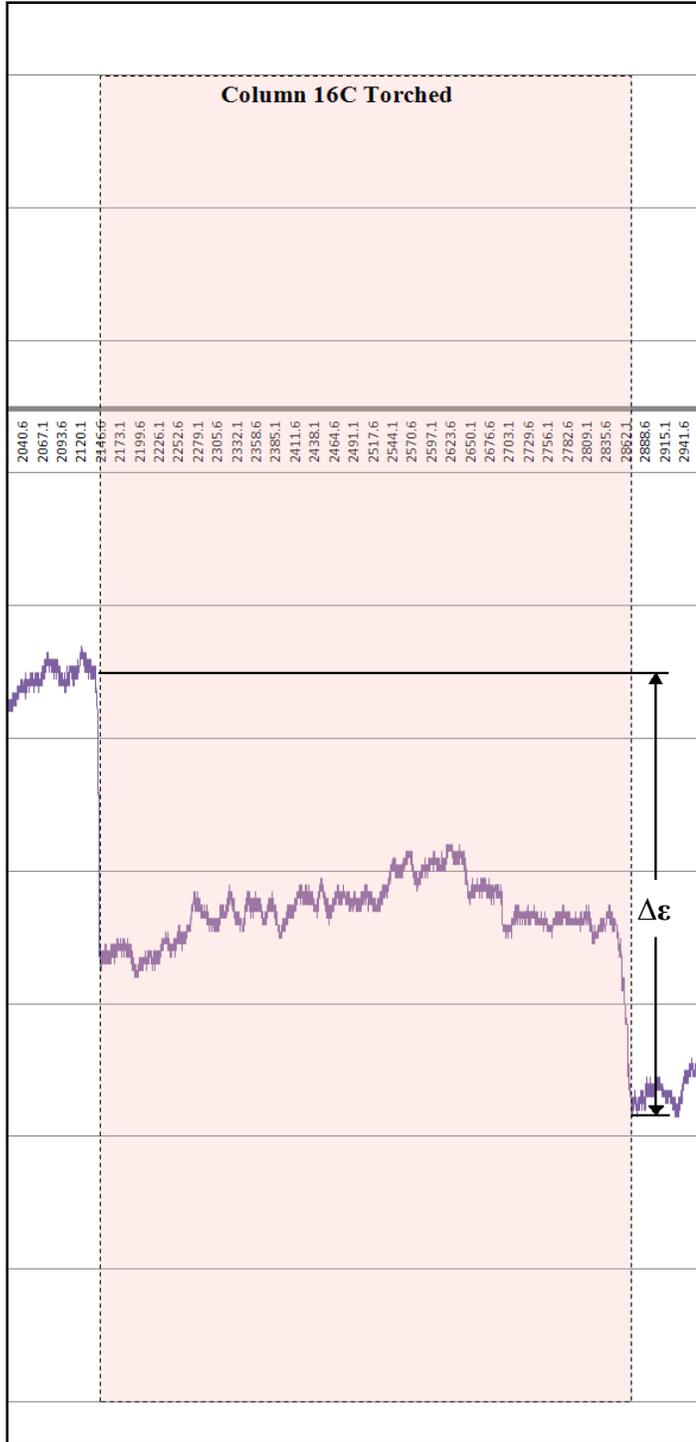
Figure B.4- Change in Strain ($\Delta\epsilon$) Measurement.
