**STRUCTURAL SYSTEMS
RESEARCH PROJECT**

Final Report
SSRP-19/03

**Alternative Weld Details and Design for
Continuity Plates and Doubler Plates for
Applications in Special and Intermediate
Moment Frames**

Final Report Submitted to AISC

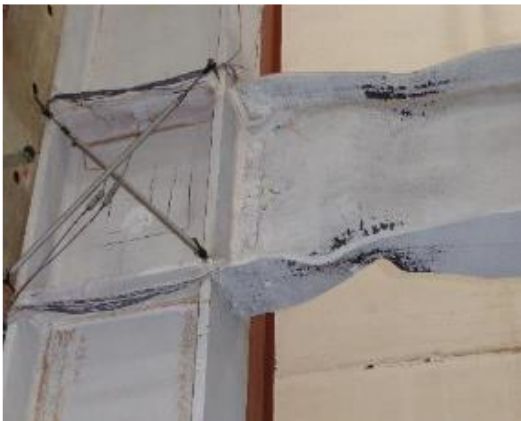
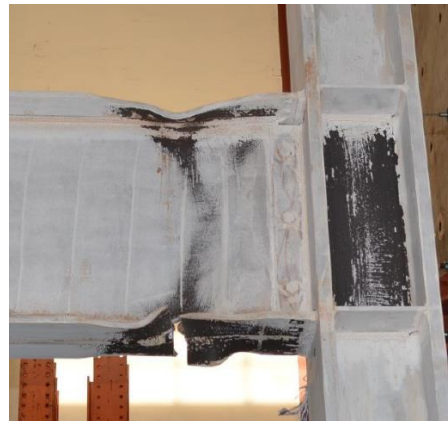
Figure 1.7 Flexibility Method Verification (Mashayekh and Uang 2018)

(a) Specimen C1

(b) Specimen C2

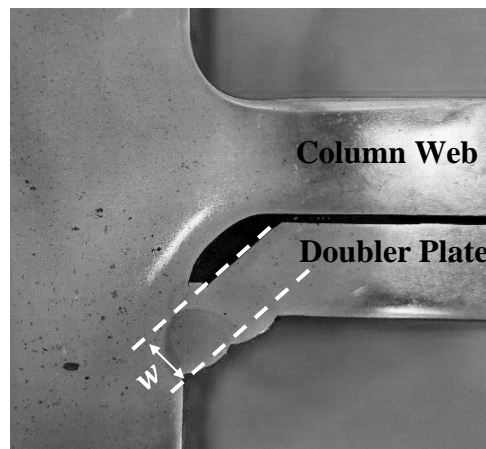
Figure 2.5 Doubler Plate Vertical Fillet Welds

(b) Specimen C7

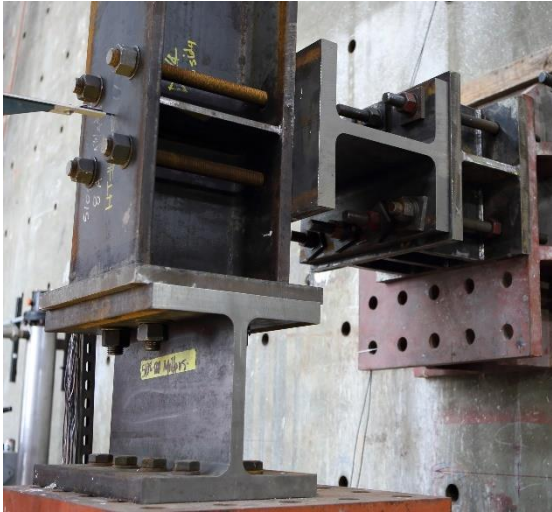
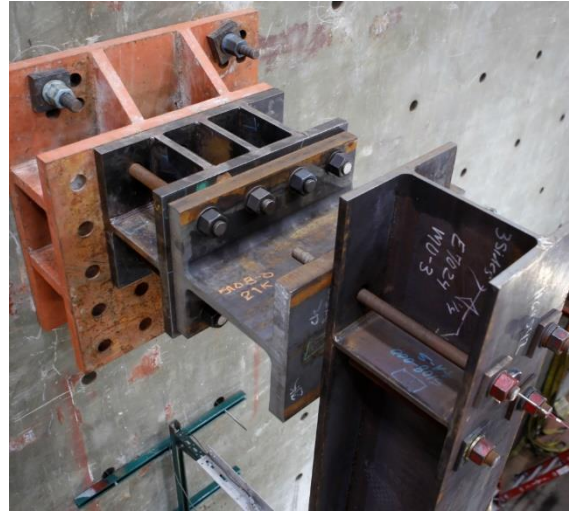
Figure 3.2 Column Support (Phase 1)

(a) Lower End

(b) Upper End

The Phase 1 test setup is shown in Figure 3.1; each specimen was tested in the upright position. Frame inflection points are assumed to exist at the mid-height of each story, which are simulated by using three W14×257 hinge supports. The W14 shapes were mounted under the column and at the top and bottom as shown in Figure 3.2. The beam length represents half of the bay width, assuming an inflection point at the midspan of the beam. The loading end (south end of the specimen) is loaded through a 220-kip hydraulic actuator with an inline load cell. The load from the actuator is delivered to the free end of the beam through a loading corbel (see Figure 3.3). An intermediate top flange lateral restraint placed about 18 in. away from the RBS cut used for Specimens C3 and C5 is seen Figure 3.4. The top-flange lateral bracing outside of the RBS simulates the lateral restraint provided by a composite concrete slab in a real application. To increase the stiffness of the intermediate lateral restraint, the two lateral columns were tied together. For the remainder of the specimens both the top and bottom flange of the beam was braced as the same location just beyond the reduced beam section (see Figure 3.5). A modular frame provides lateral bracing at the loading corbel at the end of the beam. All lateral restraints use a polished, greased sliding surface to minimize friction.

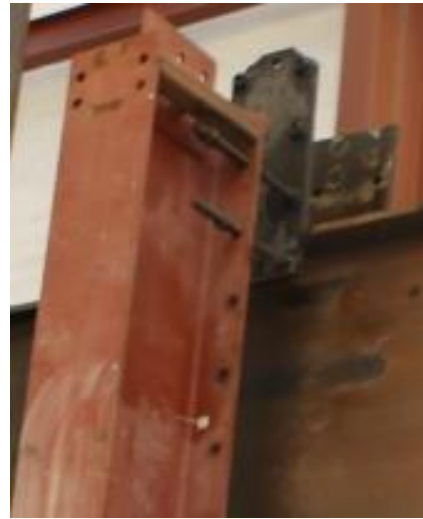
Figure 3.4 Top Flange Intermediate Lateral Restraint (Specimens C3 and C5)

(b) Detail

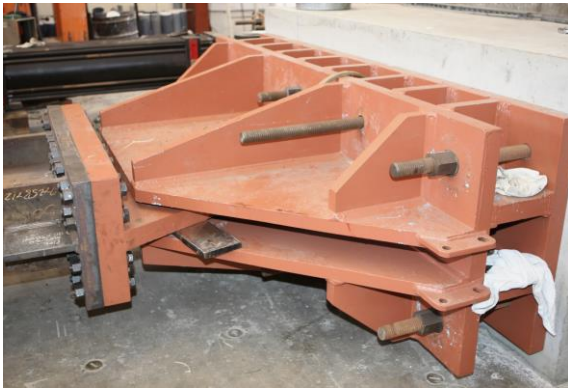
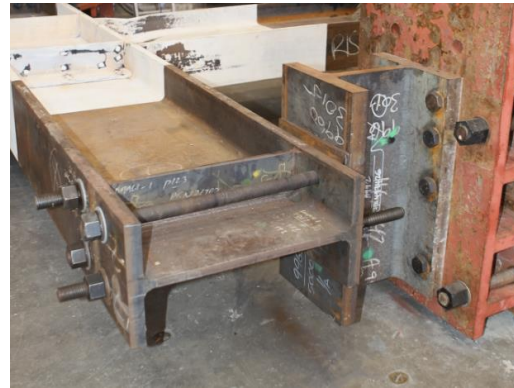
Figure 3.8 Column Supports (Phase 2)

(a) Column Base Support Clevis

(b) Top Column Support

The Phase 2 test setup is shown in Figure 3.6; each specimen was tested in the horizontal position. As in Phase 1, frame inflection points are assumed to exist at the mid-height of each story. The lower end of the specimen is mounted in a clevis while the upper end uses a W14×311 hinge (see Figure 3.8). The clevis uses a 9-in. greased pin and a matching tang, which was designed to attach to the bottom of the specimens through a bolted base plate. The beam ends are loaded through loading corbels which slide on a greased plate elevated by a sliding block (see Figure 3.9). The load is delivered to the

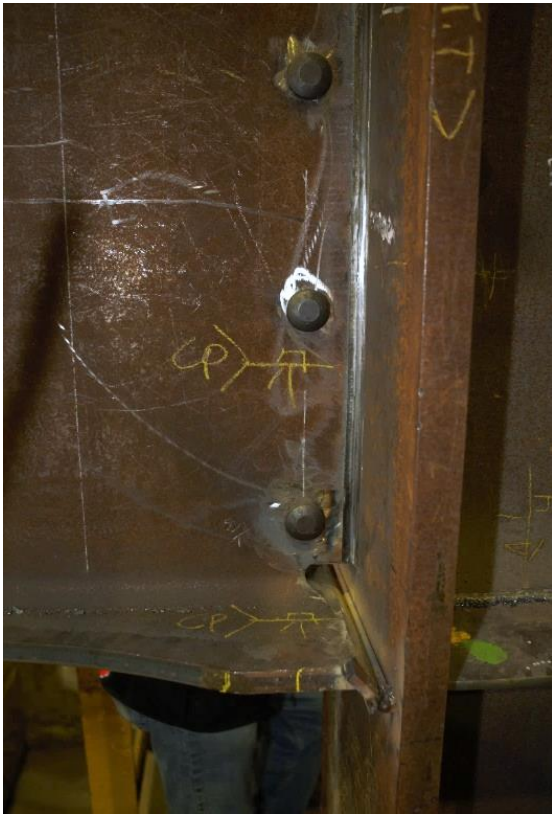
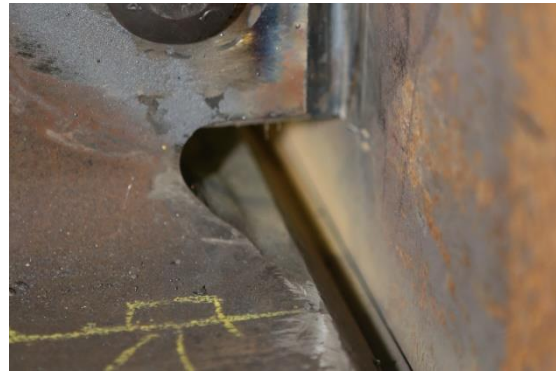
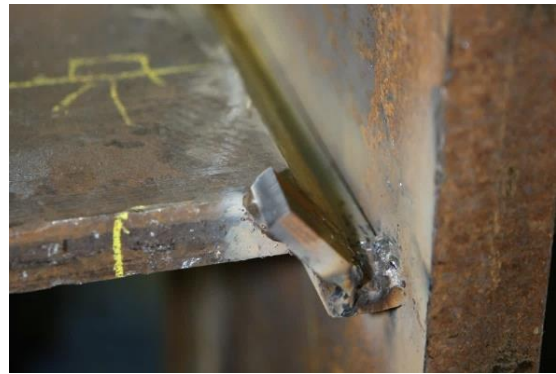
Figure 3.10 Beam Bottom Flange and Web CJP Weld Preparation (Specimen C5)

(a) Overview

(b) Weld Access Hole

(c) Run off Tab

The San Bernardino location (San Bernardino Steel) of The Herrick Corporation fabricated the test specimens. For reasons of economy, the field welding was simulated at Herrick's shop. The simulated field welding of Specimen C5 was observed on October 25 of 2018. Figure 3.10 to Figure 3.16 show the observed simulated field welding. At the time of welding, a visual inspection was performed by West Coast Inspection Services. After a 24-hour cool-down period, UT and magnetic particle testing were also performed by West Coast Inspection Services. Weld inspection of the Phase 2 specimens was completed by the Smith & Emery Company. See Appendix B for all Weld Inspection Reports. The inspections did not reveal any actionable flaws in the welding.

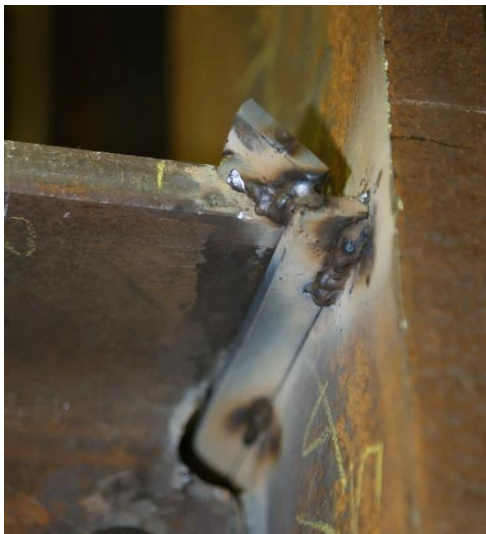
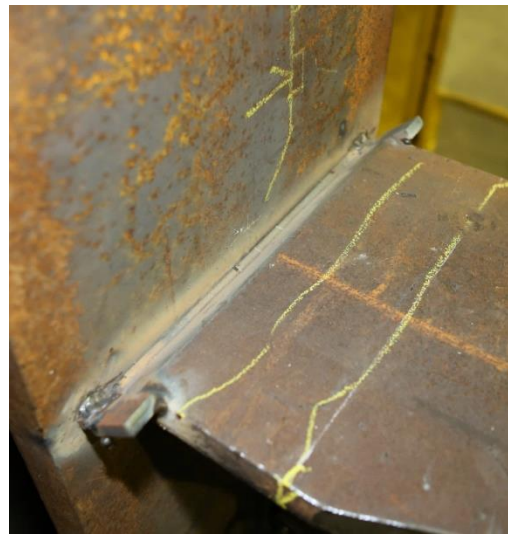
Figure 3.11 Beam Top Flange CJP Weld Preparation (Specimen C5)

(a) Backing Bar

(b) Groove

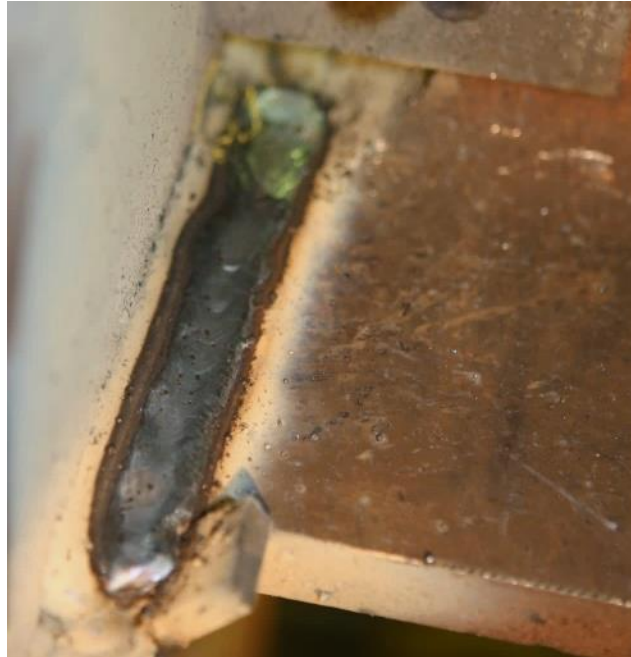
Figure 3.12 Beam Flange CJP Weld during Groove Welding (Specimen C5)

(a) Beam Bottom Flange

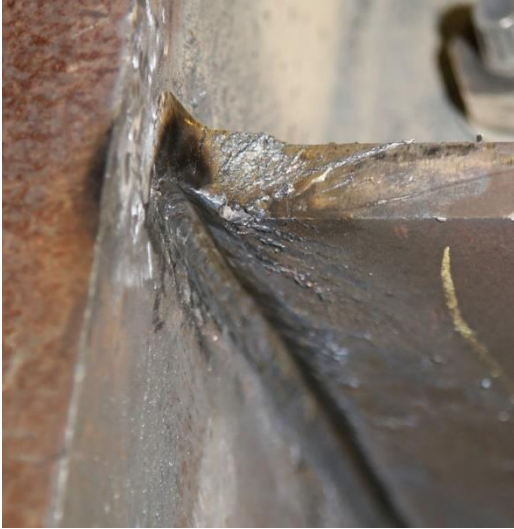
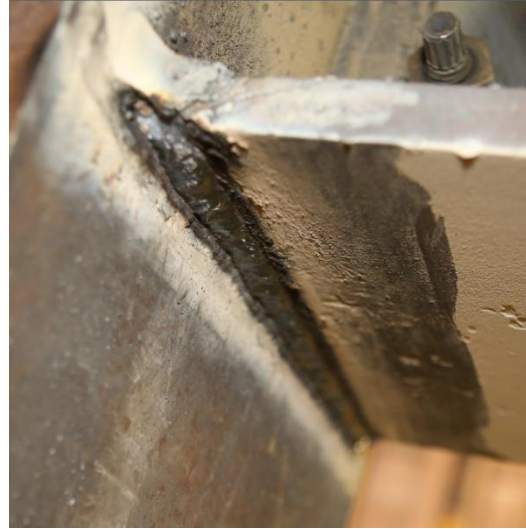
Figure 3.13 Beam Bottom Flange Underside CJP Weld Treatment (Specimen C5)

(a) Backgouging

(b) Reinforcing Fillet

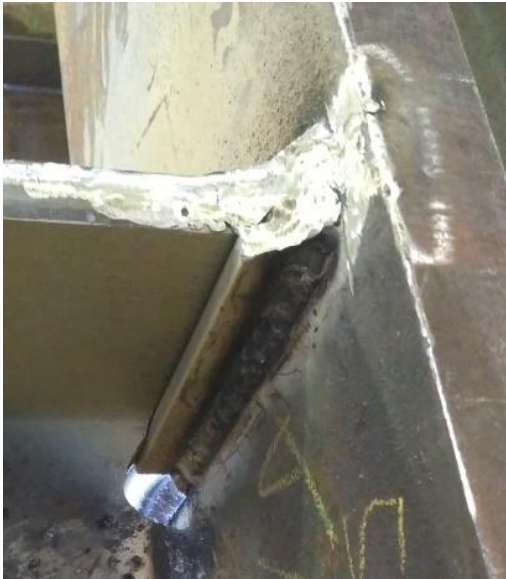
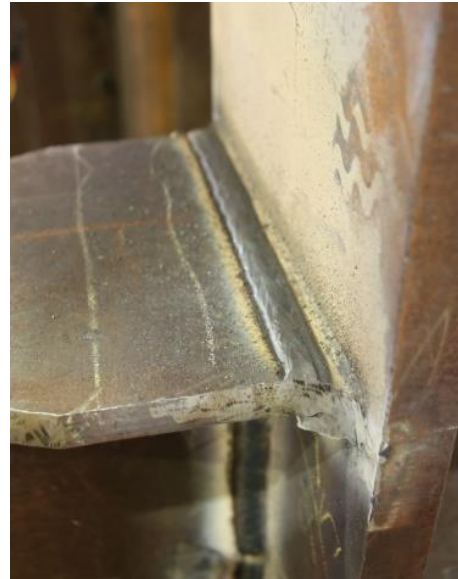
Figure 3.14 Beam Top Flange Underside CJP Weld Treatment (Specimen C5)

(a) Reinforcing Fillet

(b) after Cleanup

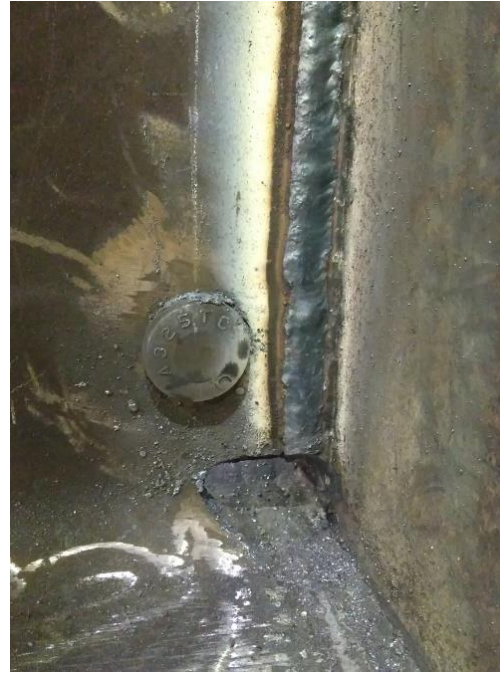
Figure 3.15 Beam Web Weld (Specimen C5)

(b) after Cleanup

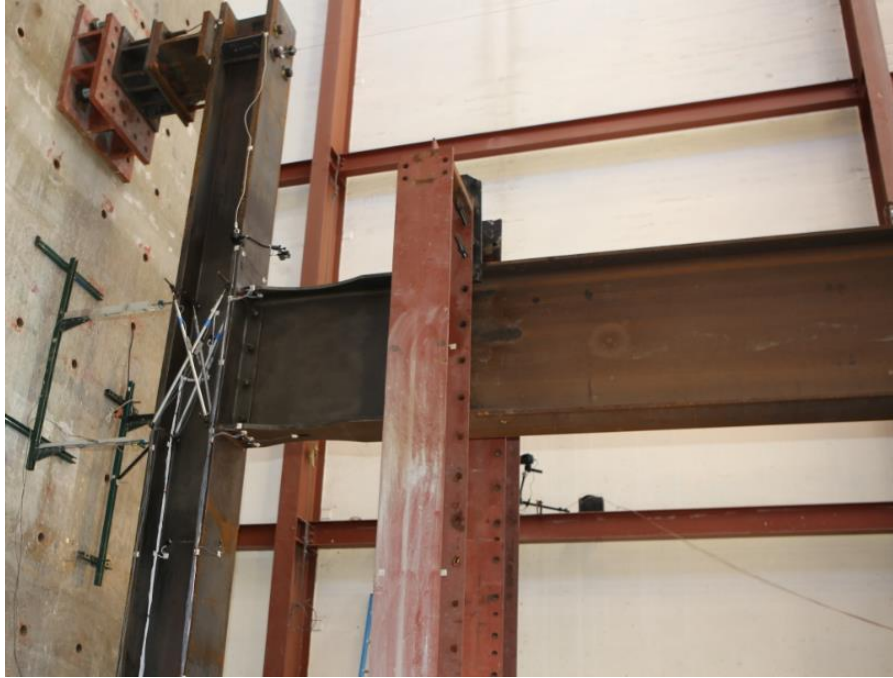
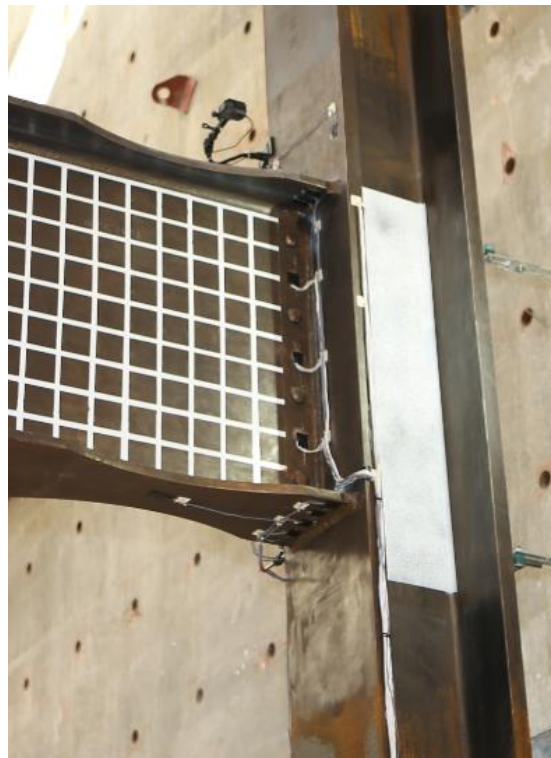
Figure 4.1 Specimen C3: Specimen before Testing

(a) West Side

(b) East Side

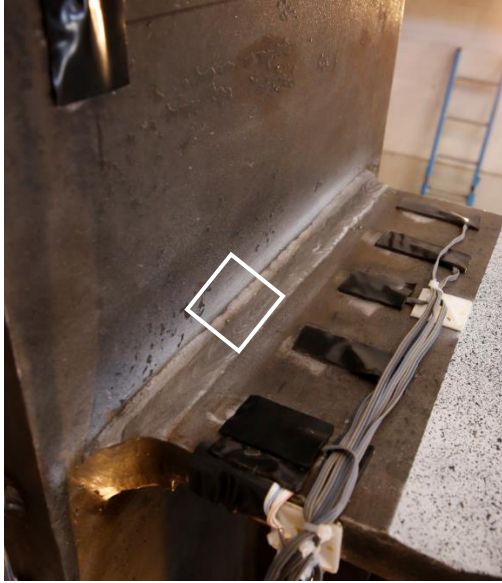
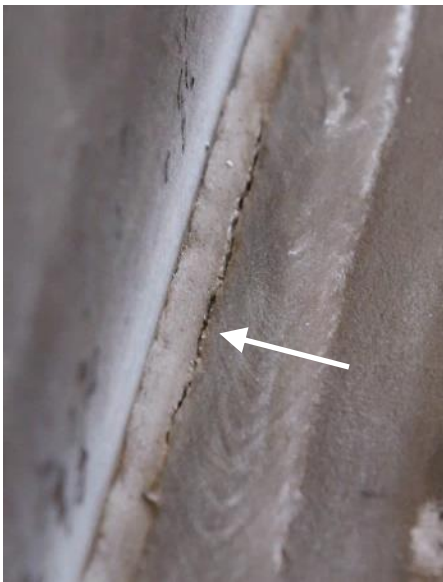
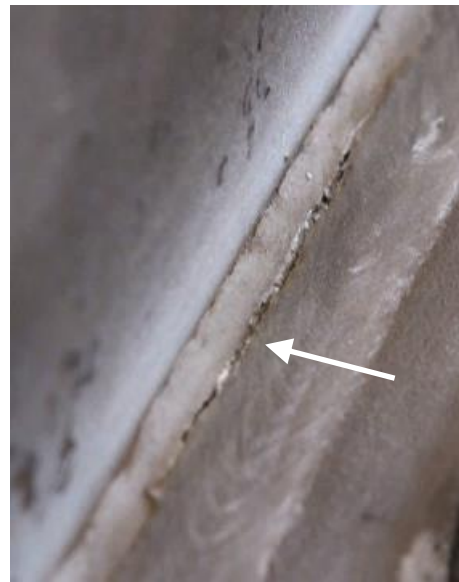
Figure 4.3 Specimen C3: Beam Top Flange Weld Tearing

(a) Overview

(c) -0.04 rad (1st Cycle)

(d) -0.04 rad (2nd Cycle)

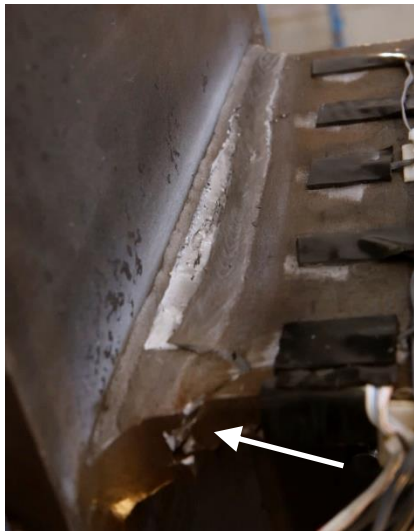
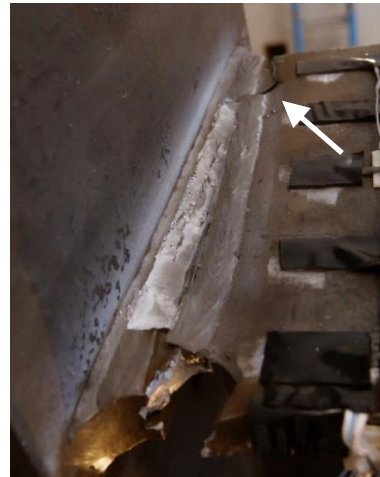
Figure 4.5 Specimen C3: Beam Top Flange Fracture

(a) -0.05 rad (1st Cycle)

(b) -0.013 rad (during 2nd Cycle at 0.05 rad Drift)

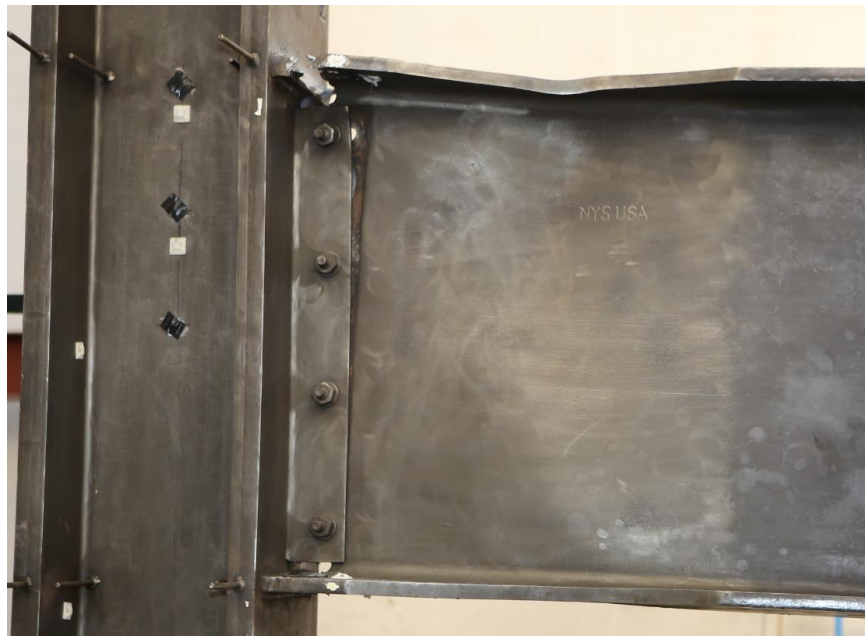
Figure 4.6 Specimen C3: Connection at End of Test

(b) West Side

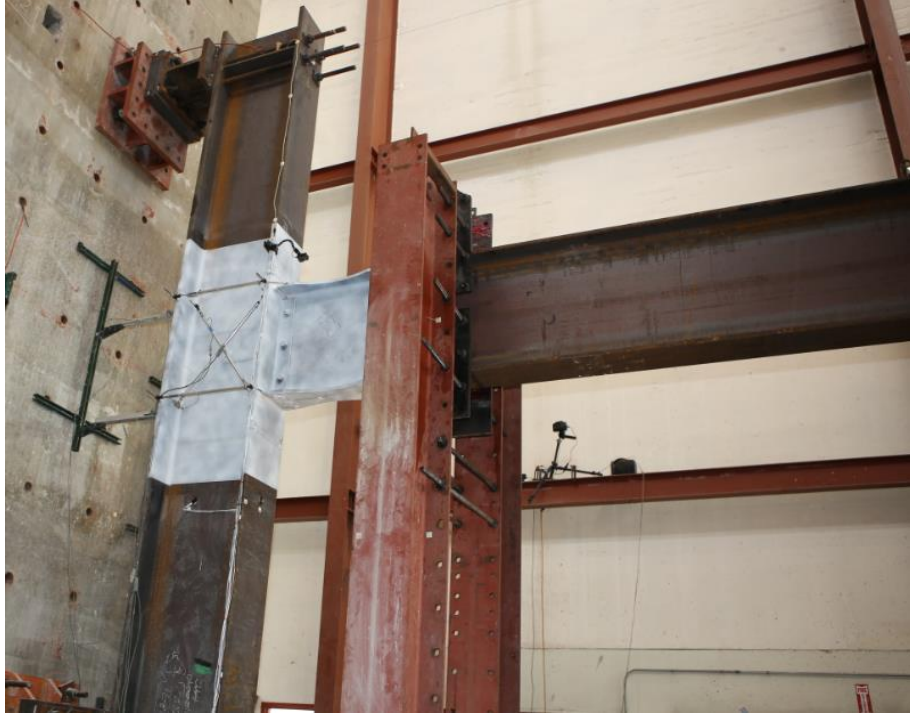
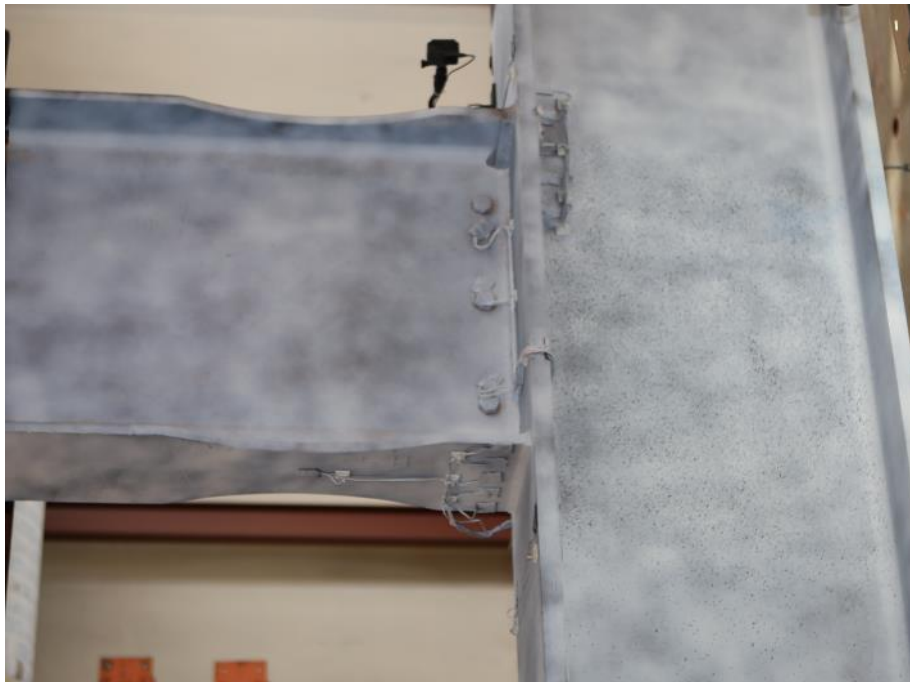
Figure 4.21 Specimen C4: Specimen before Testing

(a) West Side

(b) East Side

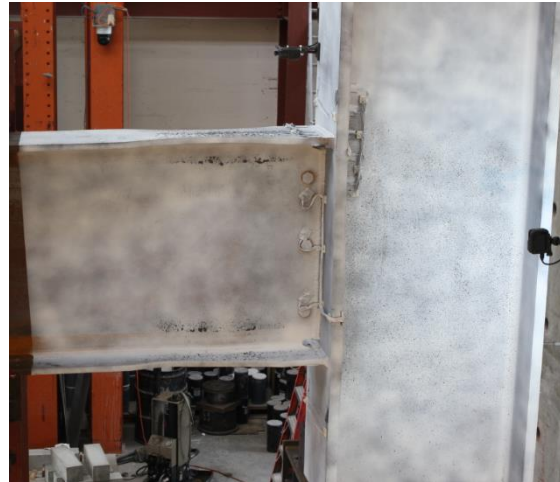
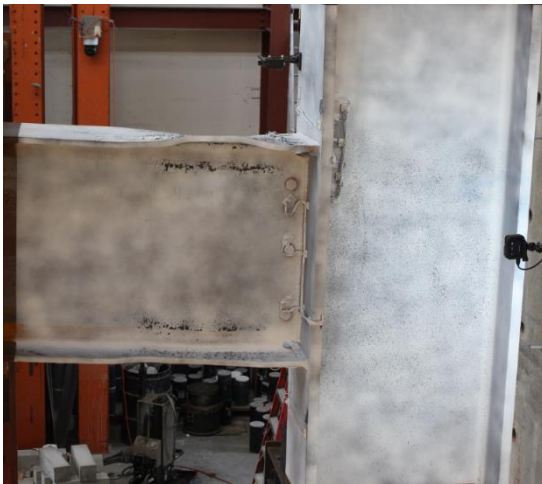
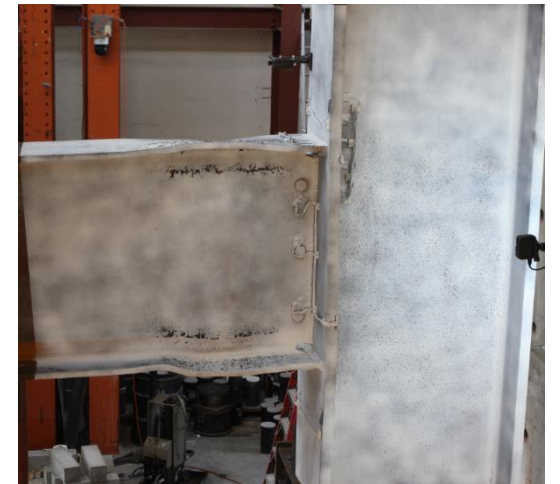
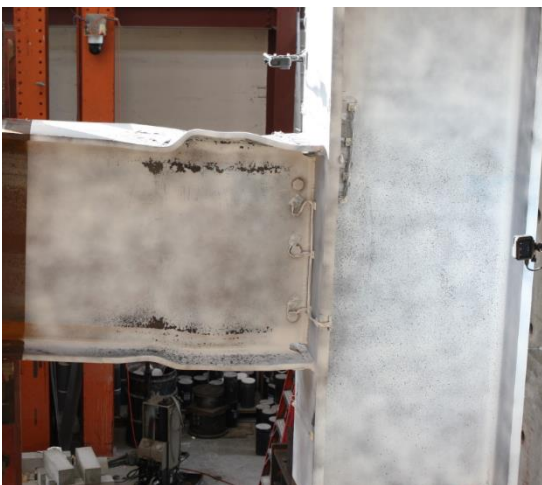
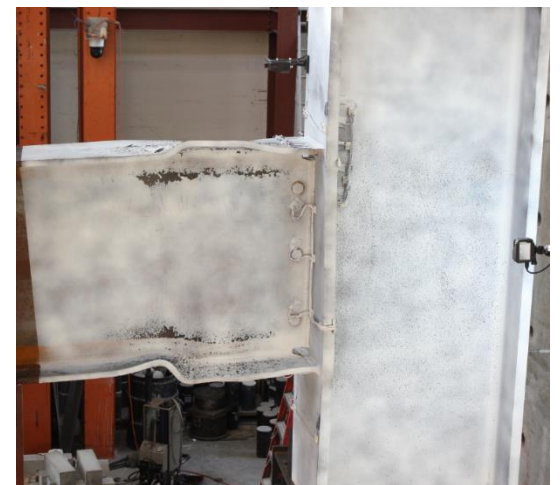
Figure 4.22 Specimen C4: East Side of Connection

(b) -0.03 rad (2nd Cycle)

(c) +0.04 rad (2nd Cycle)

(d) -0.04 rad (2nd Cycle)

(e) +0.05 rad (1st Cycle)

(f) -0.05 rad (1st Cycle)

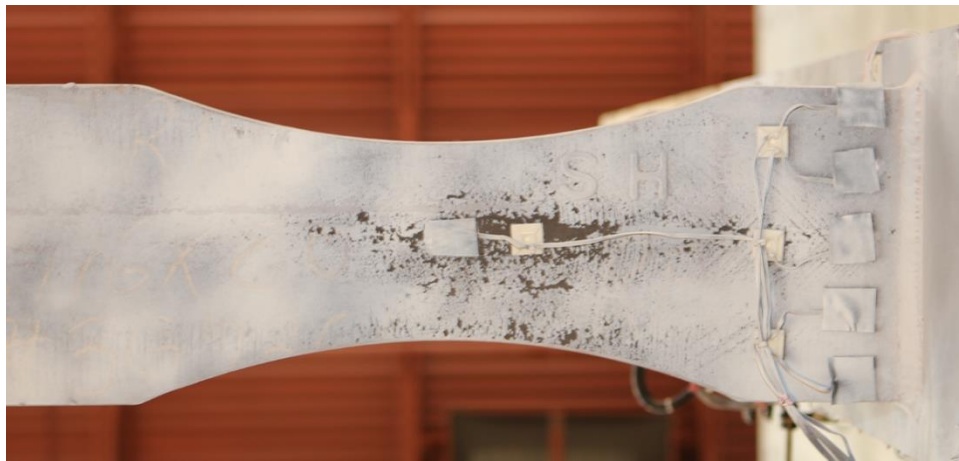
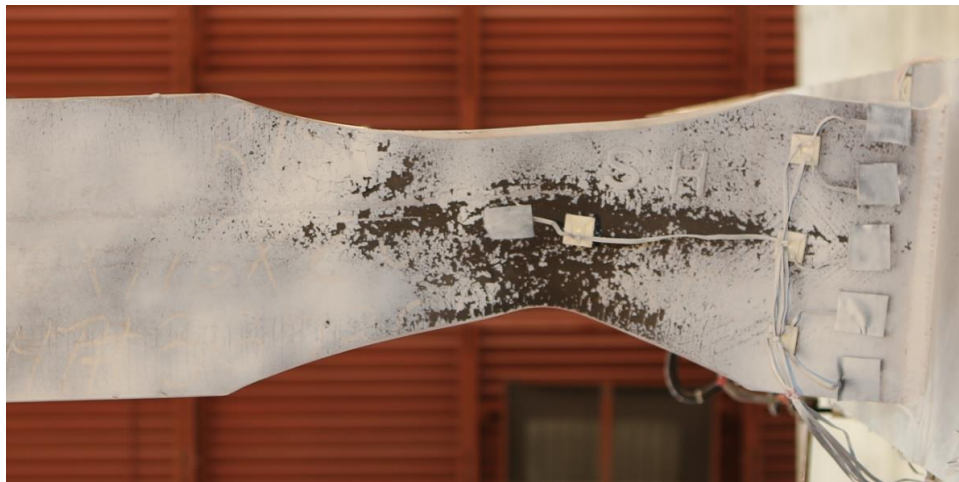
(a) -0.015 rad (2nd Cycle)

(b) -0.02 rad (2nd Cycle)

(c) -0.04 rad (2nd Cycle)

Figure 4.23 Specimen C4: Beam Bottom Flange Yielding and Buckling

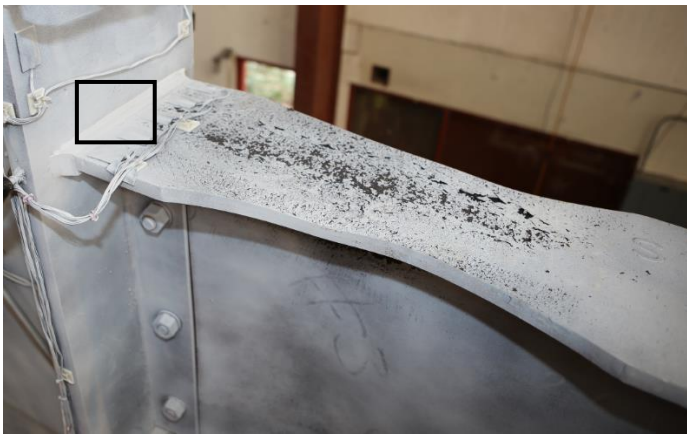
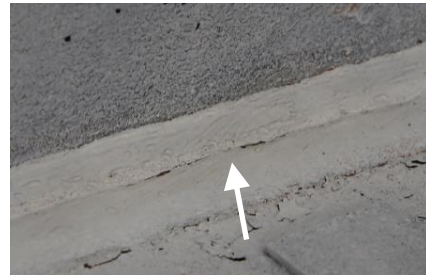
(a) Overview

(b) CJP Weld

Figure 4.25 Specimen C4: Beam Top Flange at -0.04 rad (1st Cycle)

- Significant beam top flange yielding was observed during the 0.04 rad drift cycles. Some minor distress was observed at the toe of an unintentional cover weld (see Figure 4.25). This distress did not progress further.

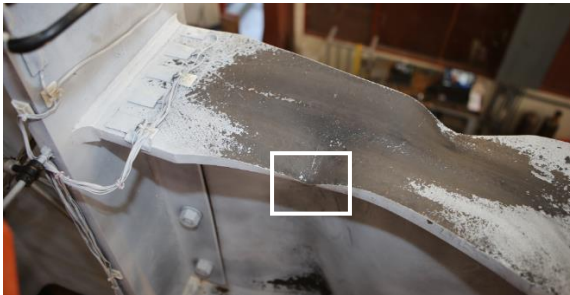
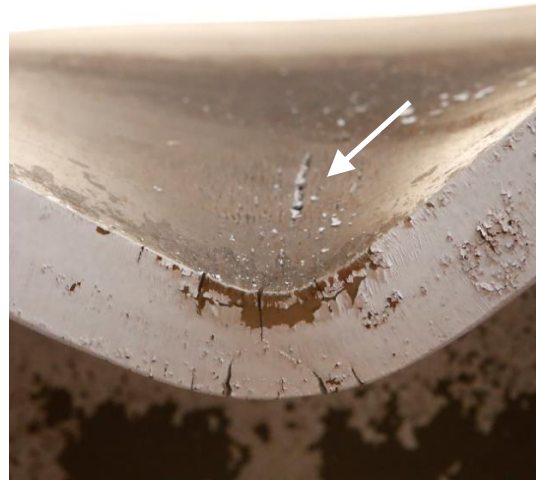
(a) Overview

(b) Ductile Tearing

Figure 4.29 Specimen C4: Beam Top Flange at -0.06 rad (2nd Cycle)

- Figure 4.29 shows ductile tearing of the beam top flange similar to the condition of the beam bottom flange prior to fracture. It was observed that significant tearing occurs in the ‘compression’ side of the local buckling during load reversals.

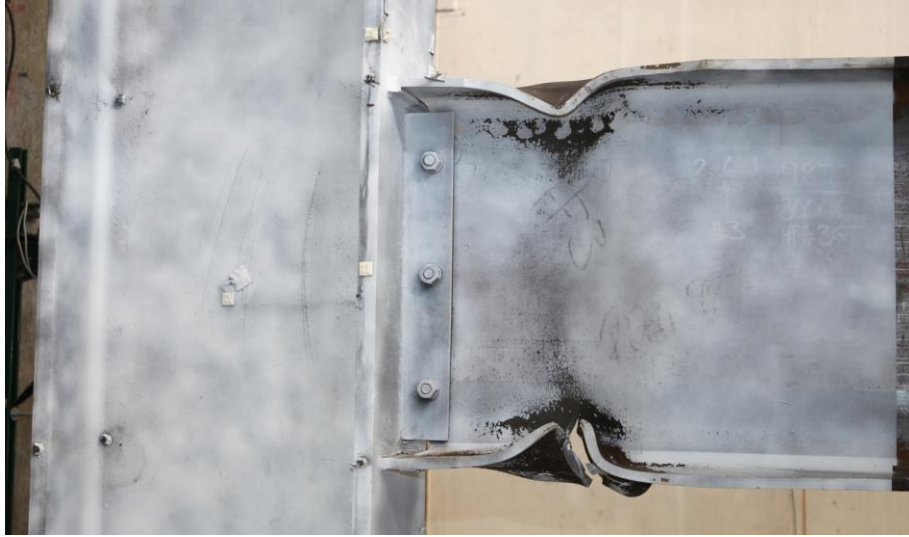
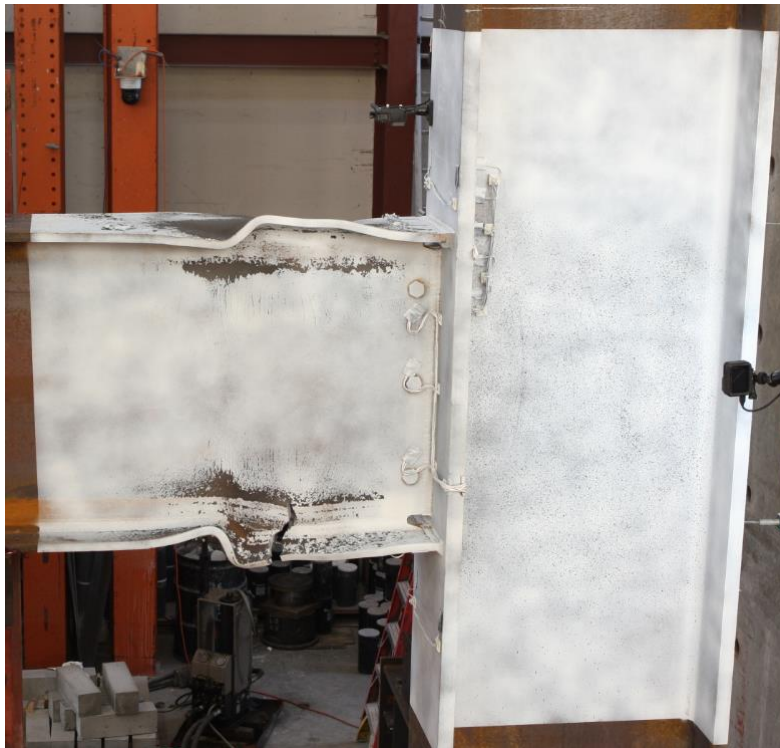
(a) West Side

(b) East Side

Figure 4.30 Specimen C4: Connection at End of Test

- During the unloading portion at -0.047 rad after the 1st negative excursion to 0.06 rad the beam bottom flange partially fractured due to load cycle fatigue (see Figure 4.28). This fracture occurred at the apogee of the local buckling as the tension in the flange started to pull the curvature out. It is predicted that the fracture started at the underside of the flange at the most extreme curvature and propagated through. Upon resuming load, the remainder of the beam bottom flange immediately fractured (Figure 4.30). This fracture occurred near the smallest section of the reduced beam. Minor panel zone yielding was observed at the end of test [see Figure 4.30(a)].

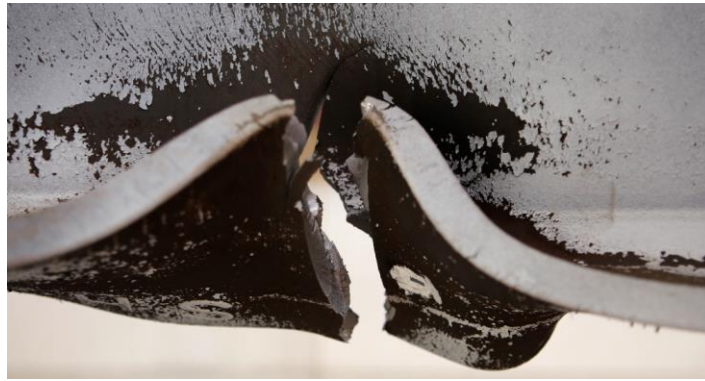
(a) Overview

Figure 4.31 Specimen C4: Beam Bottom Flange Fracture (End of Test)

- The complete bottom flange tear was accompanied with a 4-in. propagation into the web (see Figure 4.31). Most of the fracture surface consists of cleavage fracture with shear fracture surfaces at the peripheral edges of the flange.

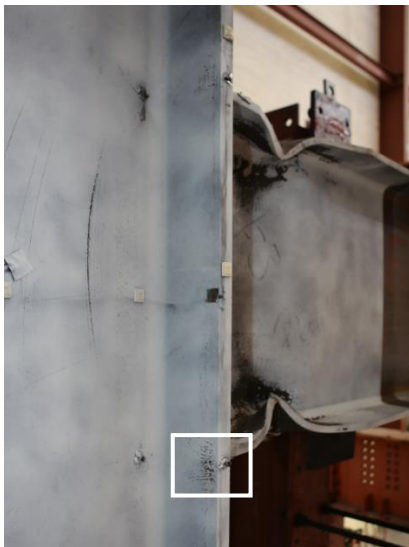
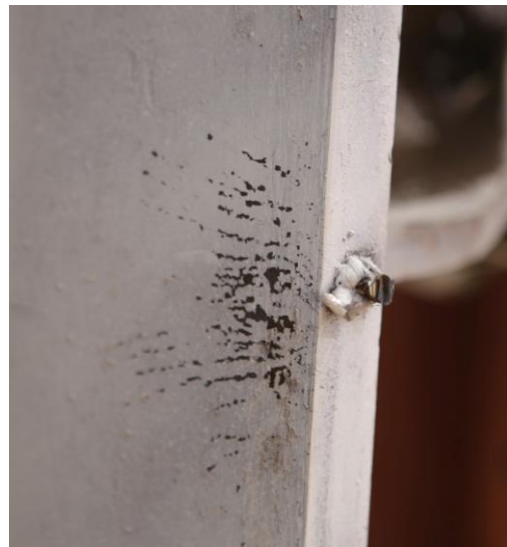
(a) Overview

(b) Flange Local Bending

Figure 4.32 Specimen C4: Column Flange (End of Test)

- Column flange yielding behind the beam flanges, similar to a flange local bending phenomenon, was observed during the 0.05 rad cycles. Figure 4.32 shows the yielding of the column flanges at the end of the test.

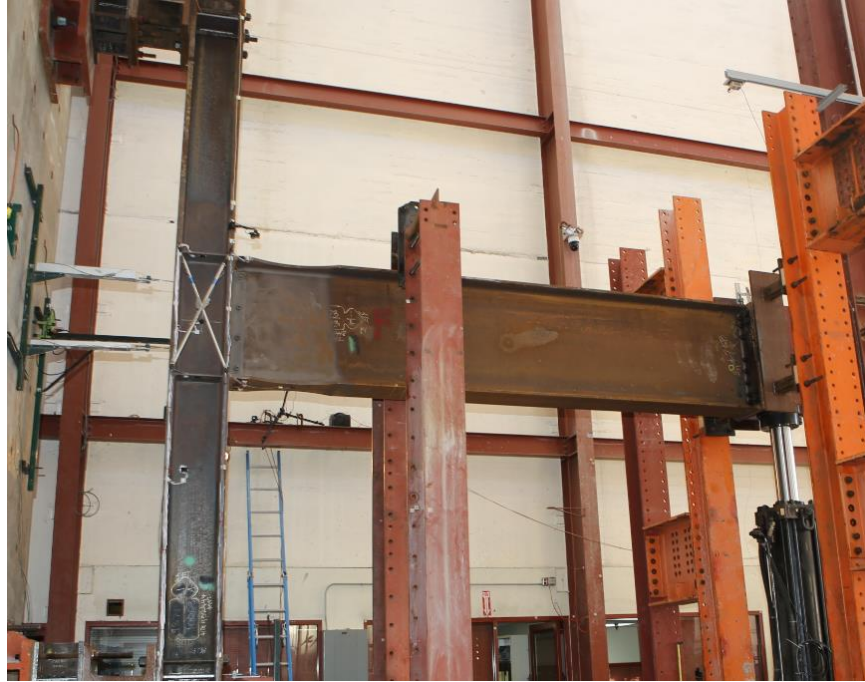
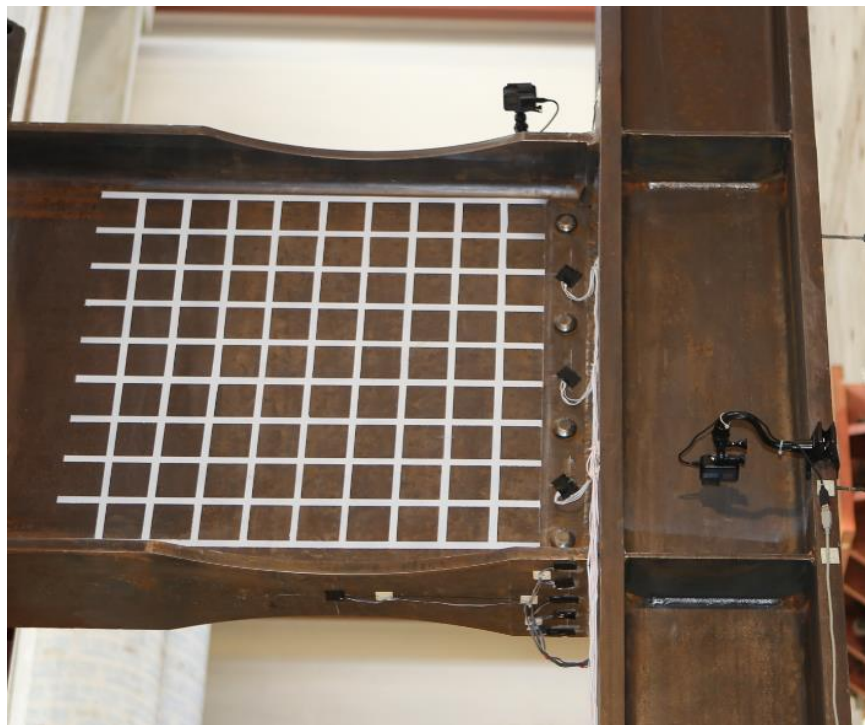
(a) West Side

(b) East Side

Figure 4.46 Specimen C5: Specimen before Testing

Specimen C5 was designed to investigate the validity of using the plastic distribution to estimate the required strength of the continuity plate. The continuity plates were designed to satisfy the governing AISC 360 §J10 concentrated force column limit state; WLY, was the governing limit state exceed by the flange force. The panel zone strength of Specimen C5 was intentionally designed weak with a *DCR* of 1.18. The continuity plate was welded to the column flange and web using a fillet weld of size $w = 0.8t_{cp}$, which was the closest standard fillet weld size to $w = 0.75t_{cp}$. The specimen failed by fracture of the beam top flange CJP weld after completing two cycles of 0.05 rad drift. Figure 4.46 shows the connection before testing.

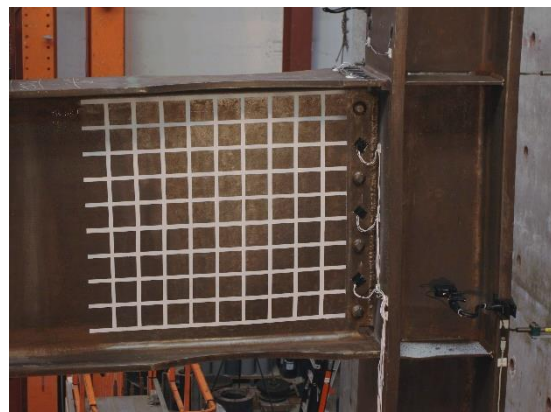
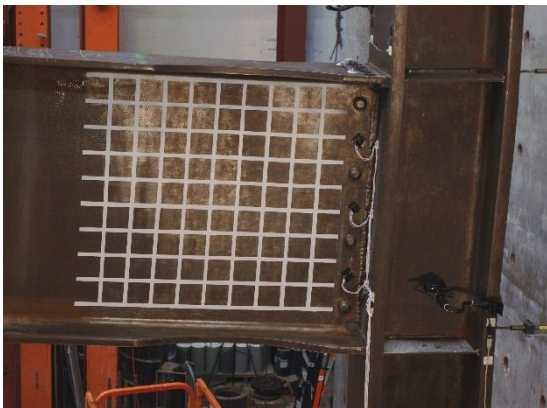
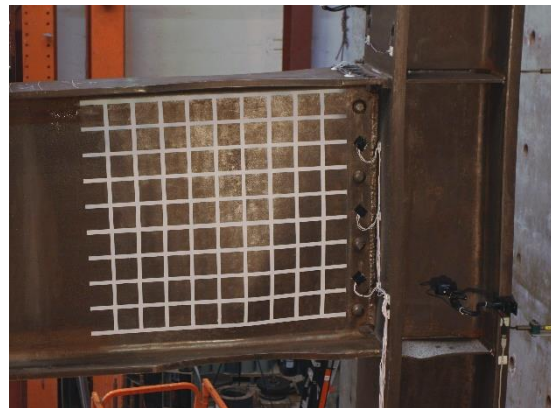
(c) +0.04 rad (2nd Cycle)

(d) -0.04 rad (2nd Cycle)

(e) +0.05 rad (1st Cycle)

(f) -0.05 rad (1st Cycle)

Figure 4.47 Specimen C5: East Side of Connection

- Figure 4.47 shows the east side of the specimens at the peak excursions during the later cycles of the loading protocol. The specimen met the AISC acceptance criteria. It was observed that beam web buckling initiated during the first cycle of 0.04 rad drift. Flange local buckling initiated at the beam bottom flange within the RBS cut during the second cycle of 0.04 rad drift. By 0.05 rad drift flange local buckling was observed in both flanges.

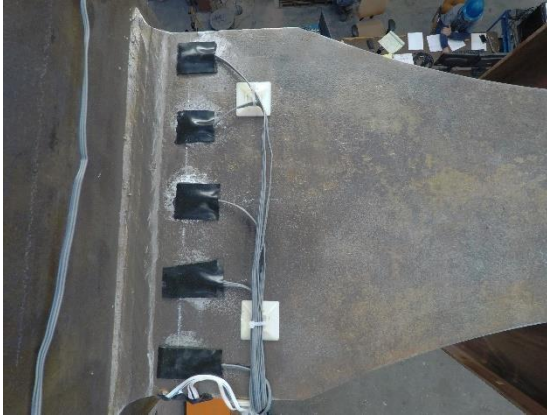
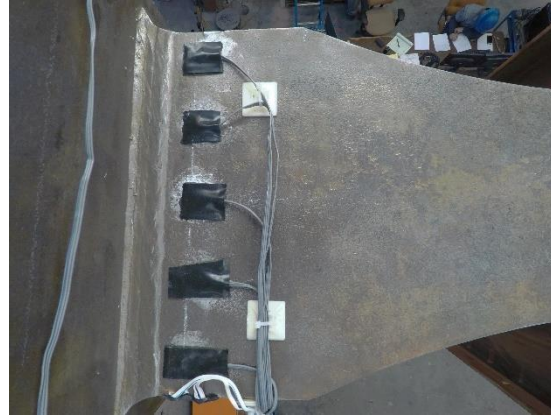
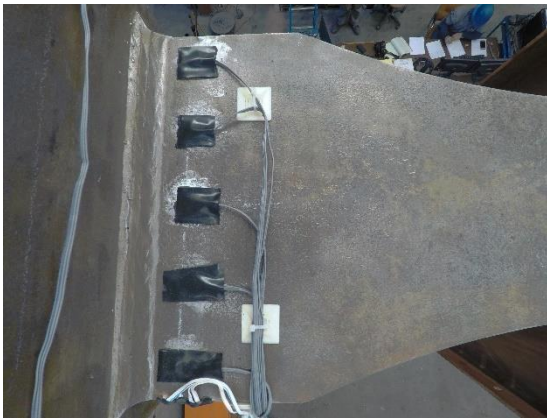
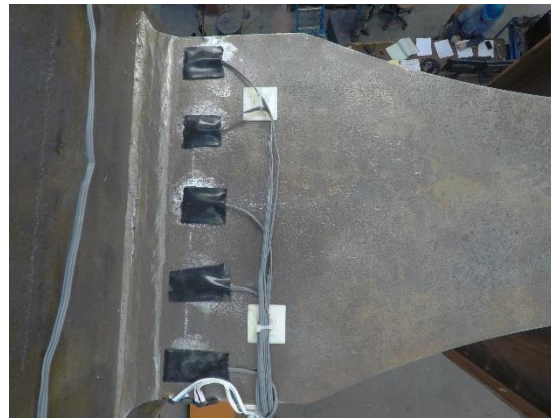
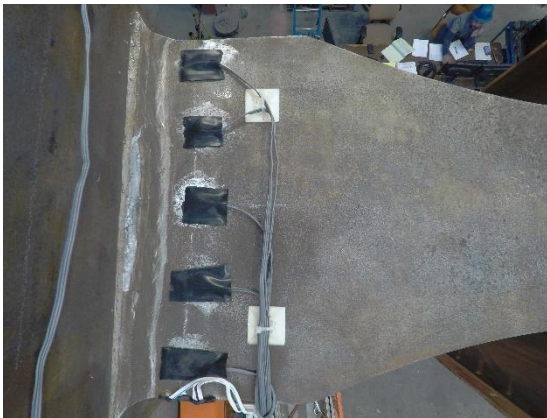
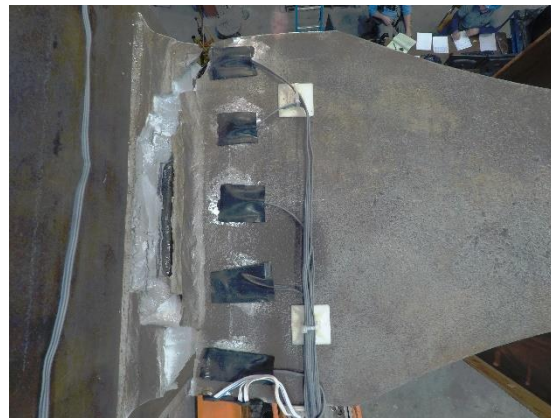
(a) -0.03 rad (1st Cycle)

(b) -0.03 rad (2nd Cycle)

(c) -0.04 rad (1st Cycle)

(d) -0.04 rad (2nd Cycle)

(e) -0.05 rad (1st Cycle)

(f) -0.05 rad (2nd Cycle)

Figure 4.48 Specimen C5: Beam Top Flange

- Figure 4.48 shows ductile tearing of the beam top flange CJP weld that was first observed during the 2nd negative excursion of 0.03 rad drift. Minor growth of this fracture occurred during the 0.04 rad cycles during testing.

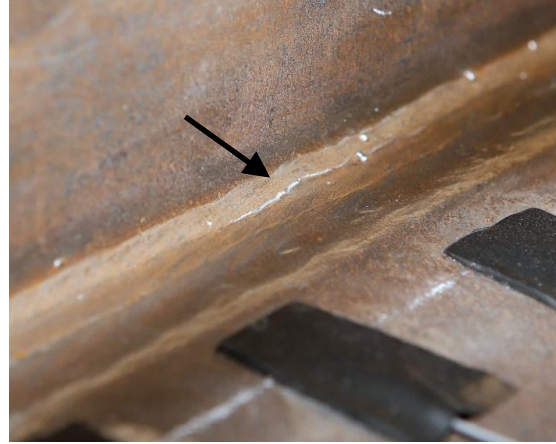
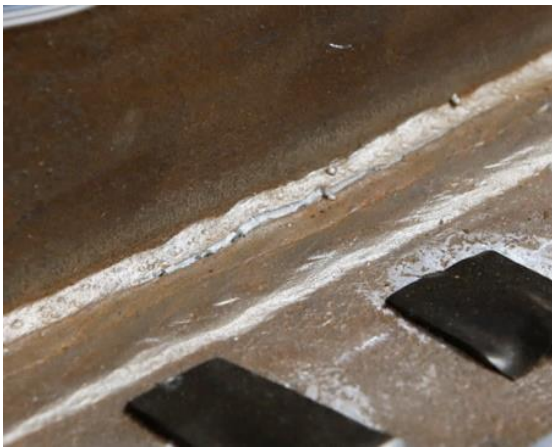
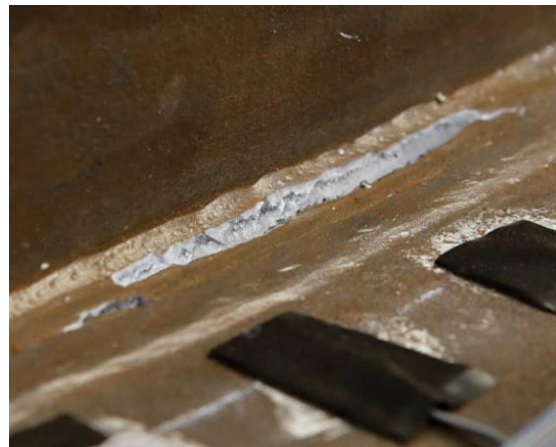
(b) -0.03 rad (2nd Cycle)

(c) -0.04 rad (2nd Cycle)

(d) -0.05 rad (1st Cycle)

Figure 4.49 Specimen C5: Beam Top Flange CJP Weld Fracture Progression

- Figure 4.49 shows gradual progression of tearing of the beam top flange CJP weld. Figure 4.49(e) shows the complete beam top flange fracture. This shear type fracture originated at a toe of the prominent weld pass against the column and propagated through the flange at a 35-degree angle through the base metal. At the flange tips the fracture took on a cup and cone with interlocking shear lips through the base metal of the beam.

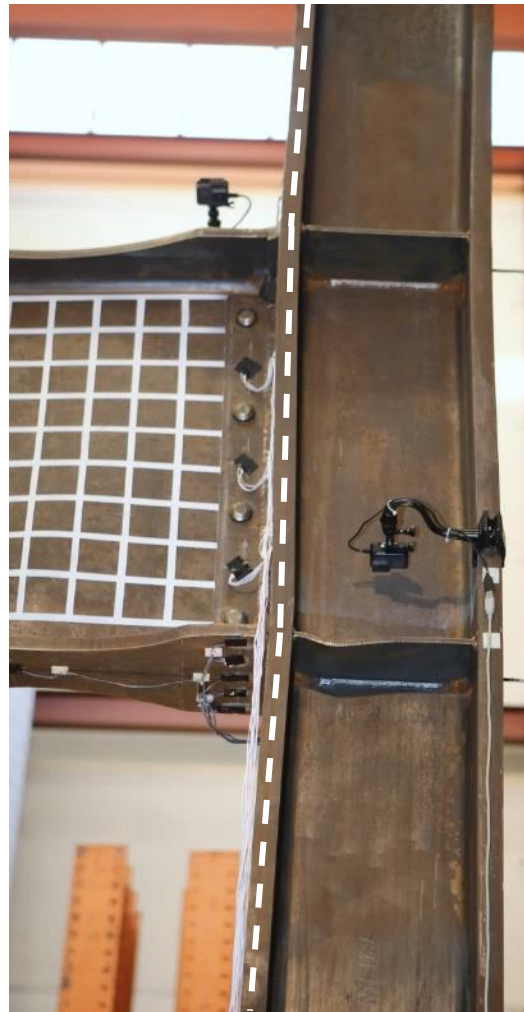
(b) -0.05 rad (2nd Cycle)

Figure 4.50 Specimen C5: Column Kinking due to Panel Zone Deformation

- Significant column kinking was observed during the testing of the specimen (see Figure 4.50).

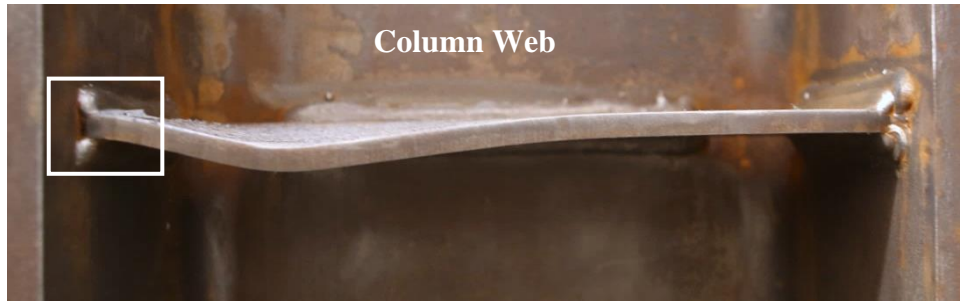
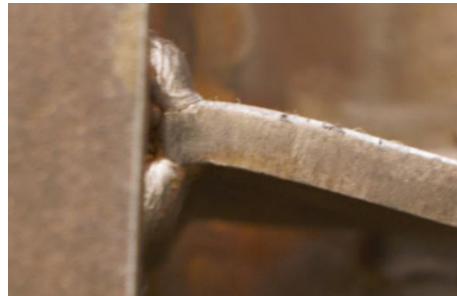
(a) East Bottom Flange Continuity Plate

(b) Enlarged View of Weld

- Figure 4.52 shows the slight beam lateral-torsional buckling at the end of testing.
- At the end of testing no damage was observed in any of the fillet welds fastening the continuity plates to the column. Figure 4.53 shows the continuity plates after testing. The east bottom flange and west top flange continuity plate experienced local plate buckling. The east bottom flange continuity plate started developed local buckling during the first negative excursion of 0.04 rad drift. At the time of failure, the specimen was experiencing a negative excursion which pulled the west top flange continuity plate straight with minor residual deformation. The east bottom flange shows the full extent of the buckling as this plate was in compression at the point of failure. Despite the significant plate buckling and column flange kinking, the continuity plate to column flange welds have remained intact [see Figure 4.53(b)].
