**STRUCTURAL SYSTEMS
RESEARCH PROJECT**

Final Report
SSRP-19/03

**Alternative Weld Details and Design for
Continuity Plates and Doubler Plates for
Applications in Special and Intermediate
Moment Frames**

Final Report Submitted to AISC

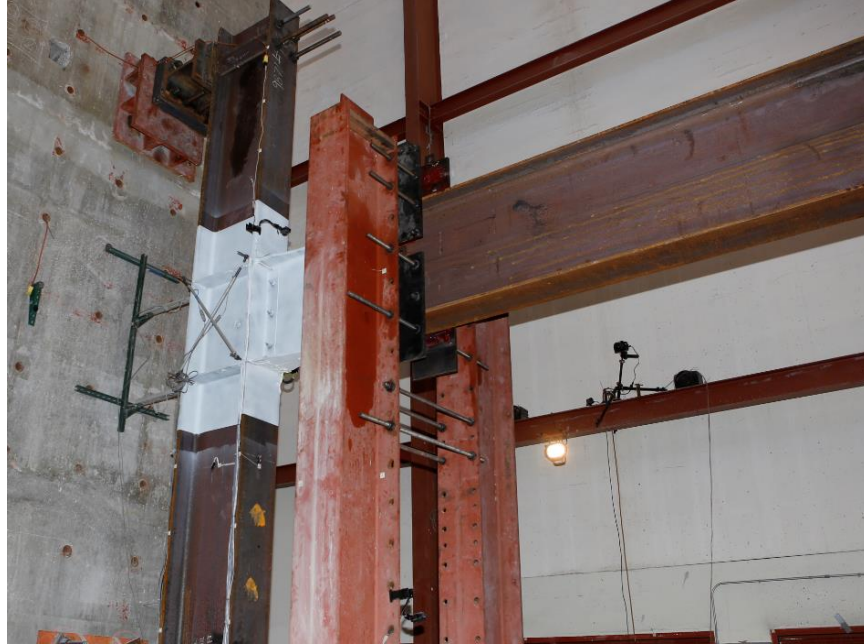
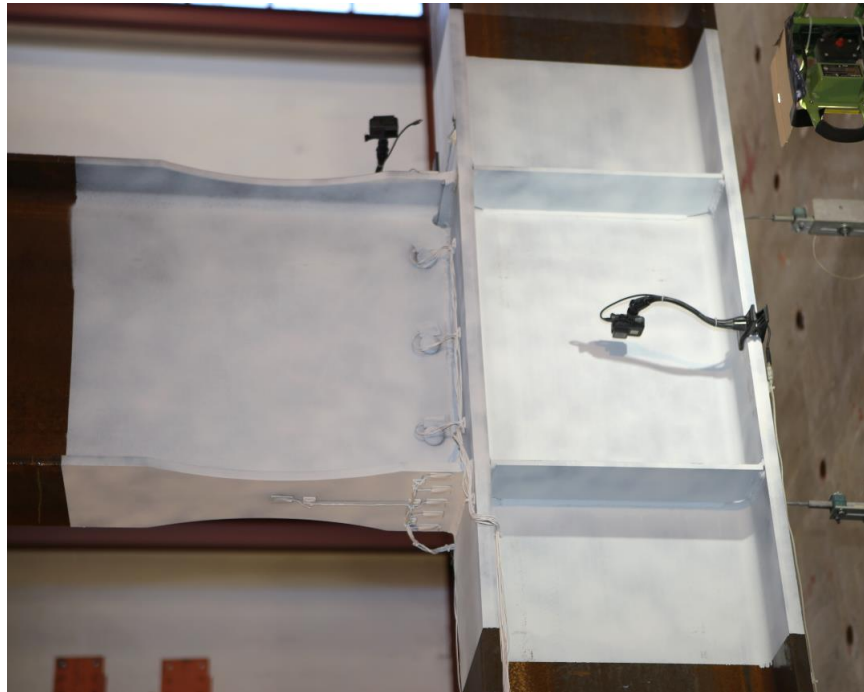
(a) West Side

(b) East Side

Figure 4.70 Specimen C6: Specimen before Testing

Specimen C6 was designed to investigate the validity of using the plastic distribution to estimate the required strength of the continuity plate. The continuity plates were designed to satisfy the governing AISC 360 §J10 concentrated force column limit state; both the FLB and WLY limit dictate the need of a continuity plate in this specimen. The continuity plate was welded to the column flange and web using a fillet weld of size $w = 1.0t_{cp}$, which was oversized on purpose to ensure survivability of the fillet weld for this specimen and Specimen C6-G, which was essentially an identical twin of this specimen. The specimen eventually failed by fracture of the beam top flange CJP weld during the first negative excursion to 0.05 rad drift during the first excursion to 0.05 rad. Figure 4.70 shows the connection before testing.

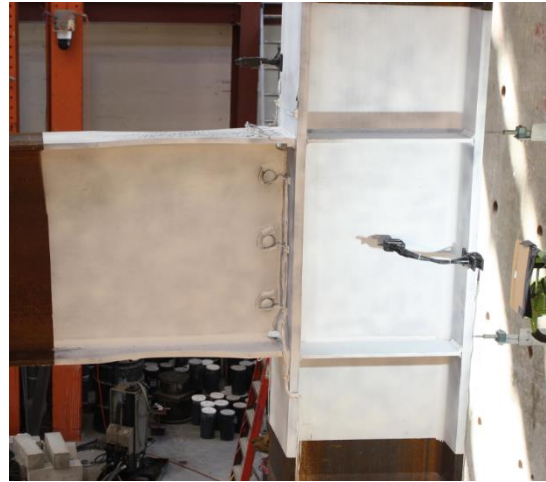
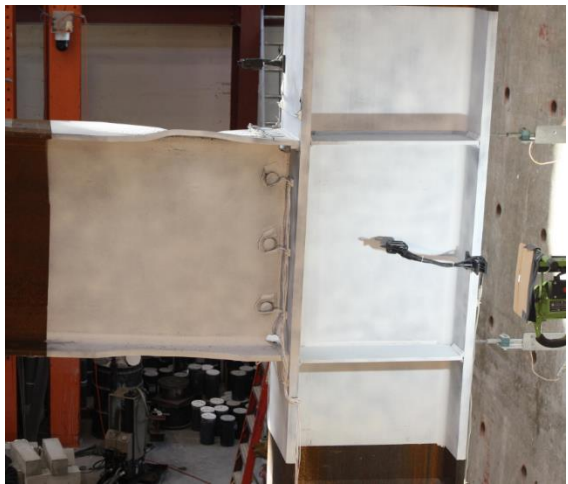
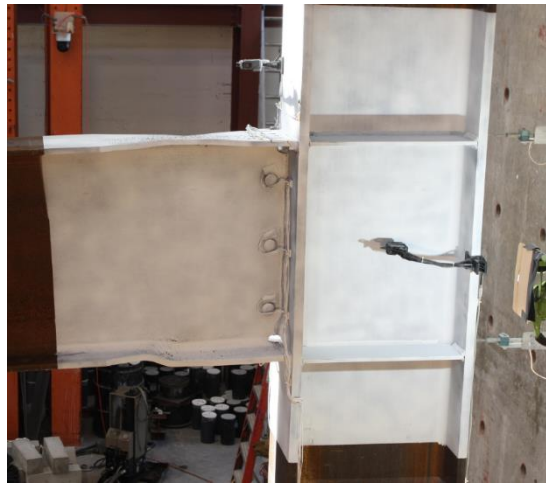
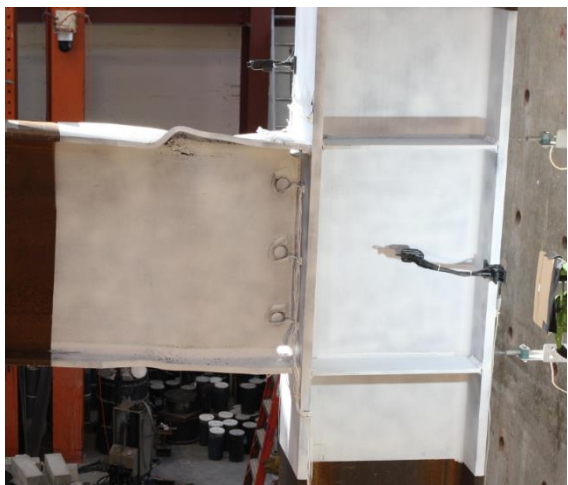
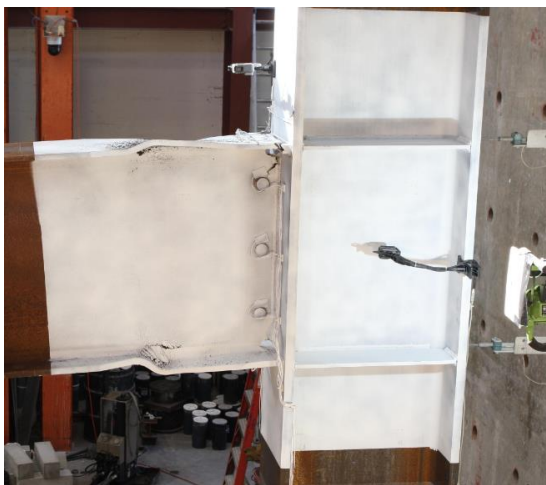
(b) -0.03 rad (2nd Cycle)

(c) +0.04 rad (2nd Cycle)

(d) -0.04 rad (2nd Cycle)

(e) +0.05 rad (1st Cycle)

(f) -0.05 rad (1st Cycle)

Figure 4.71 Specimen C6: East Side of Connection

- Figure 4.71 shows the east side of the specimen at the peak excursions during the later cycles of the loading protocol. The specimen met the AISC acceptance criteria. It was observed that beam web buckling and beam flange local buckling both initiated during the first cycle of 0.04 rad drift. Flange local buckling initiated at the beam bottom flange within the RBS cut during the second cycle of 0.04 rad drift. At 0.05 rad drift modest beam flange and beam web local buckling was observed.

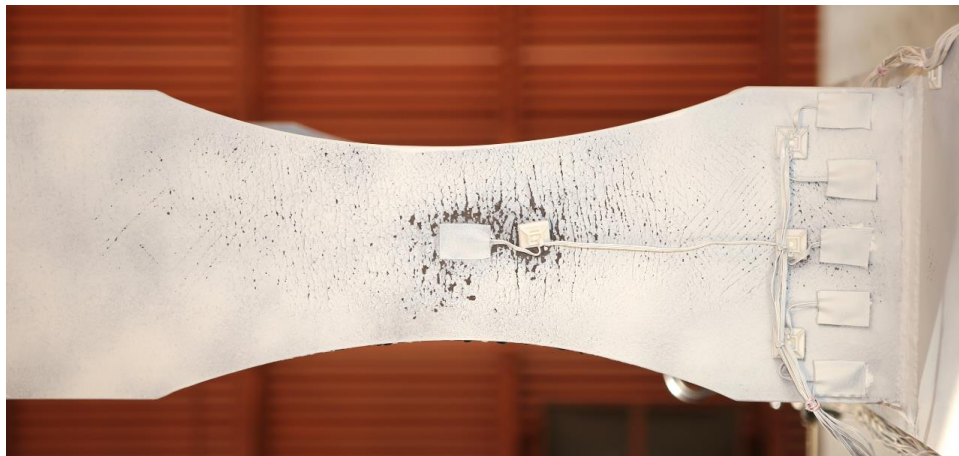
Figure 4.74 Specimen C6: Beam Bottom Flange Yielding

- Beam bottom flange yielding started during the 0.01 rad cycles within the reduced beam section and near the column flange (see Figure 4.74). This yielding progresses through testing. Minor lateral-torsional buckling was observed during testing.
- Figure 4.75 shows panel zone yielding on the west side of the specimen. This yielding commenced during the 0.015 rad drift cycles and progressed through testing. Figure 4.76 shows the beam flange and beam web local buckling.
- Figure 4.77 shows the connection after testing. Significant flange local buckling occurred during the first cycle of 0.05 rad drift.
- Figure 4.78 shows the continuity plates and their fillet welds after testing. No damage to the fillet welds was observed. Additionally, yielding of the continuity plates was not observed.

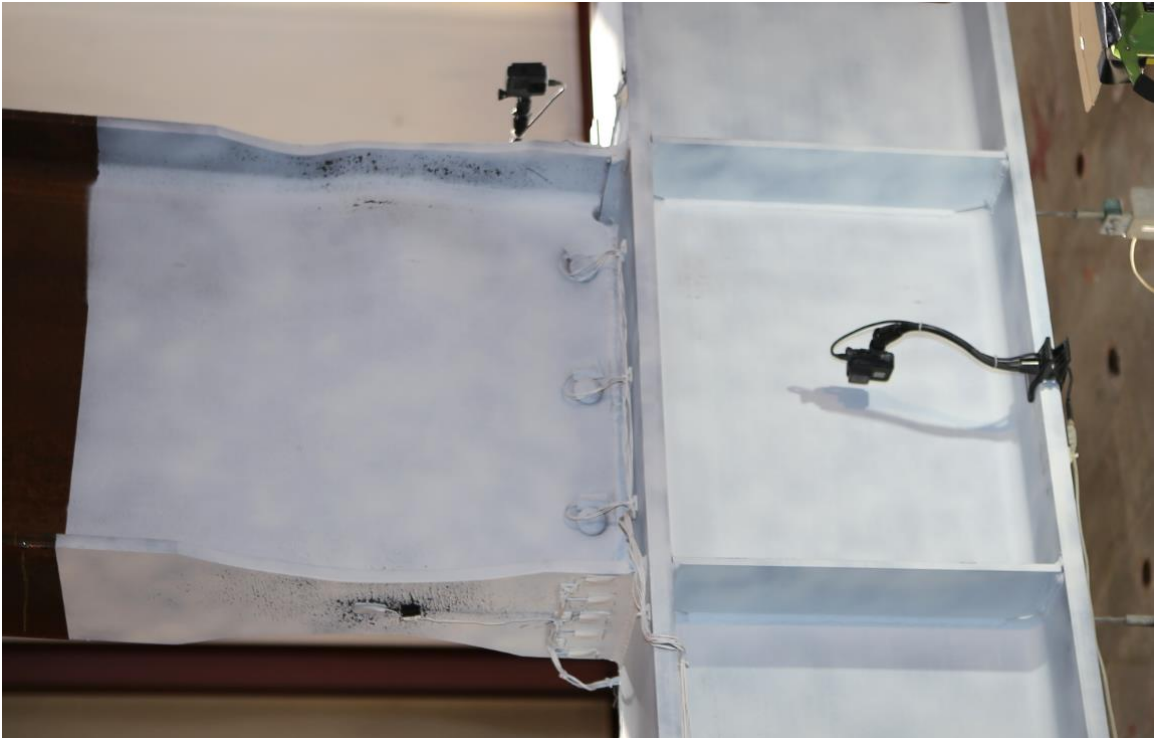
Figure 4.76 Specimen C6: Beam Web and Flange Local Buckling at +0.04 rad (2nd Cycle)

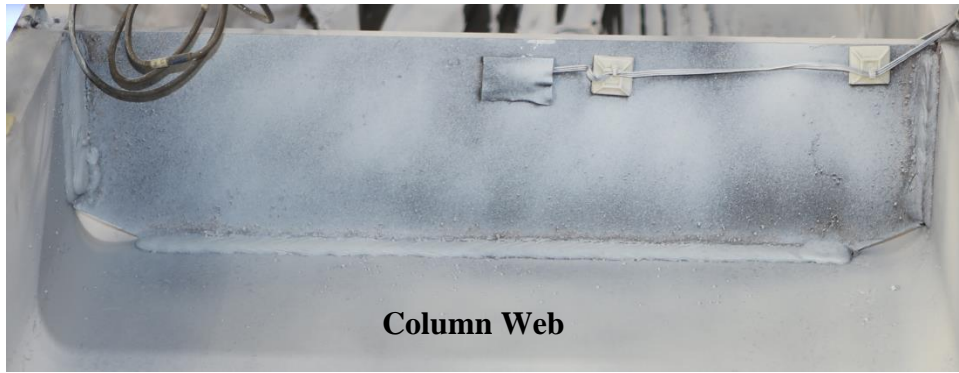
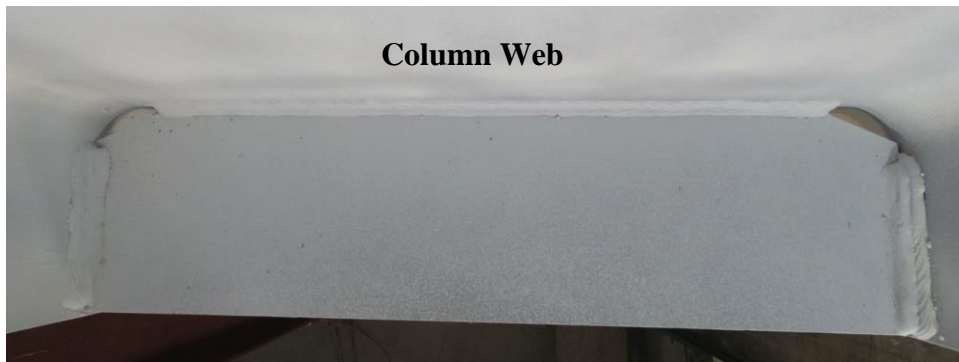
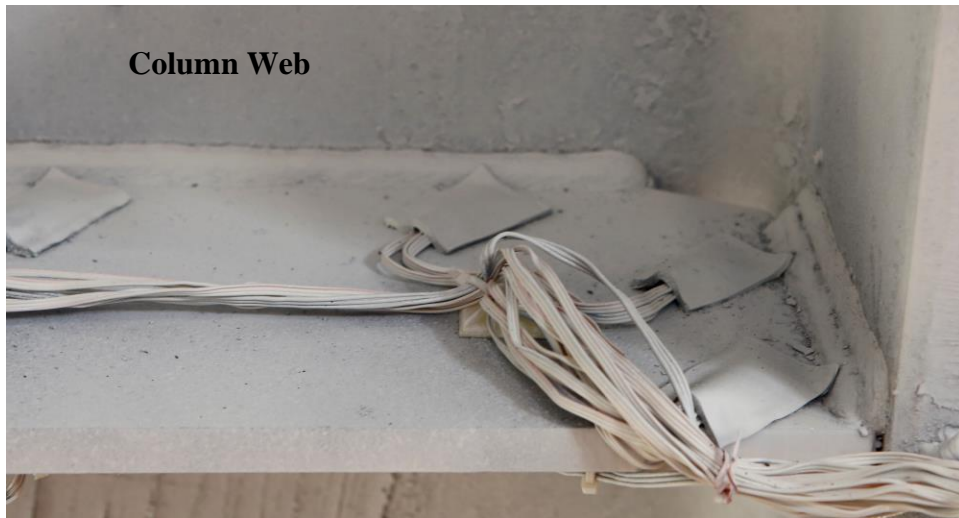
Figure 4.78 Specimen C6: Continuity Plate (End of Test)

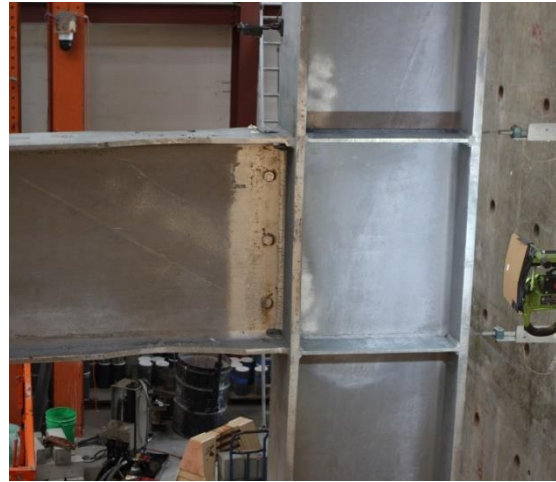
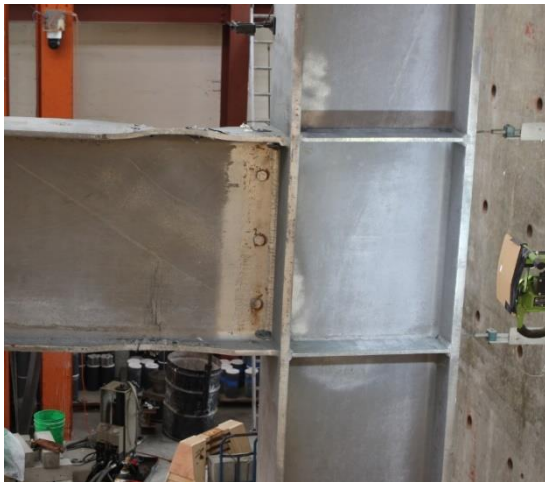
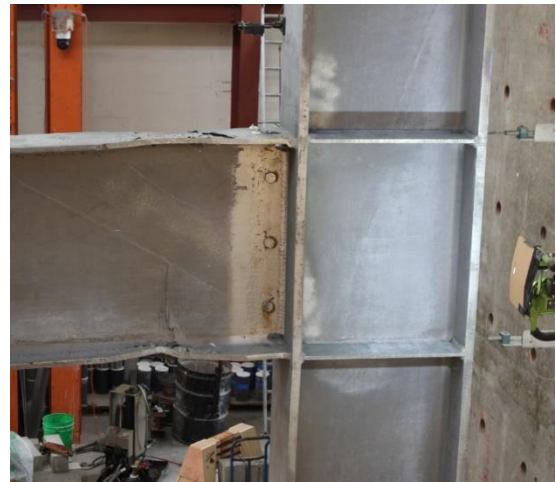
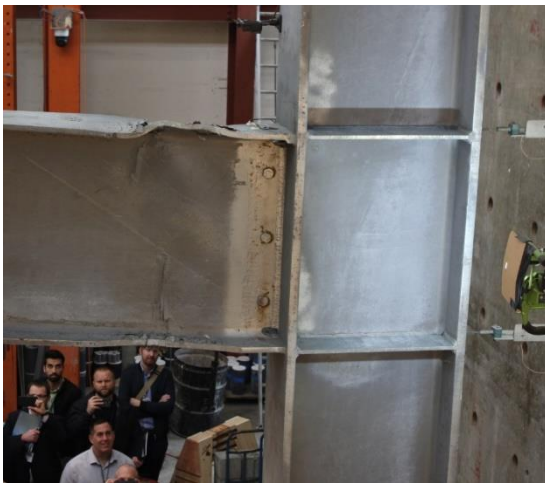
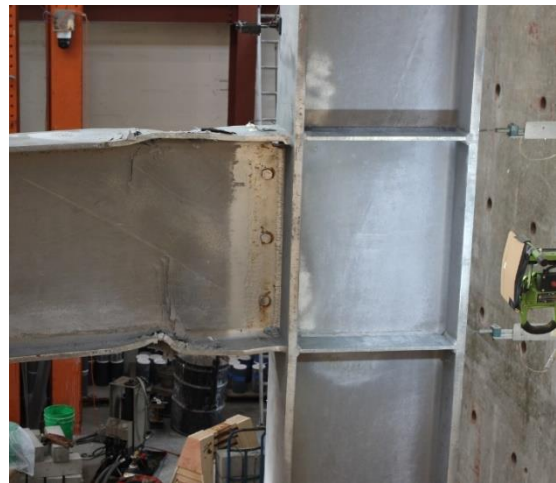
Figure 4.96 Specimen C6-G: East Side of Connection

- Figure 4.96 shows the east side of the specimen at the peak excursions during the later cycles of the loading protocol. The specimen met the AISC acceptance criteria. It was observed that beam web buckling initiated during the first cycle of 0.04 rad drift. Flange local buckling initiated at the beam bottom flange within the RBS cut during the first cycle of 0.04 rad drift.

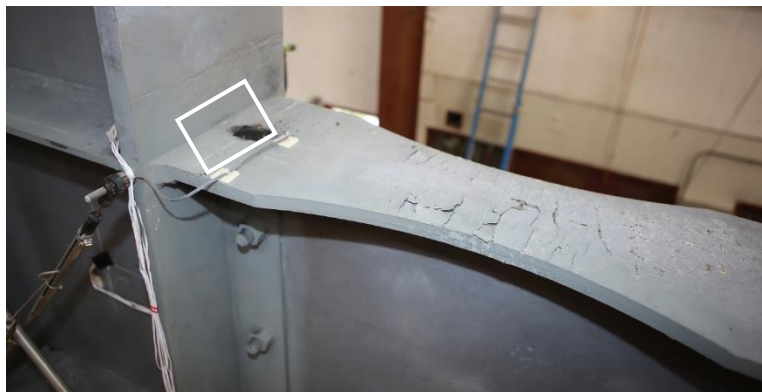
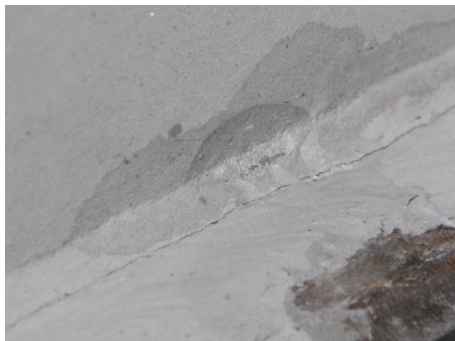
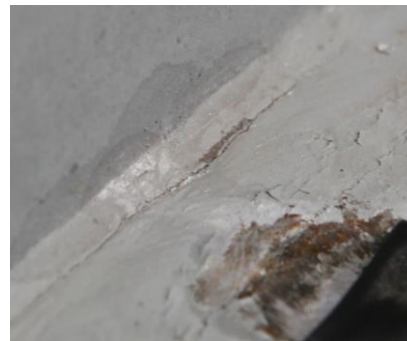
- A hairline crack was observed at the beam top flange CJP weld at the negative excursion of 0.03 rad drift (see Figure 4.98). This crack did not progress significantly during testing [see Figure 4.98(c)].

Figure 4.98 Specimen C6-G: Hairline Crack at Beam Top Flange CJP Weld

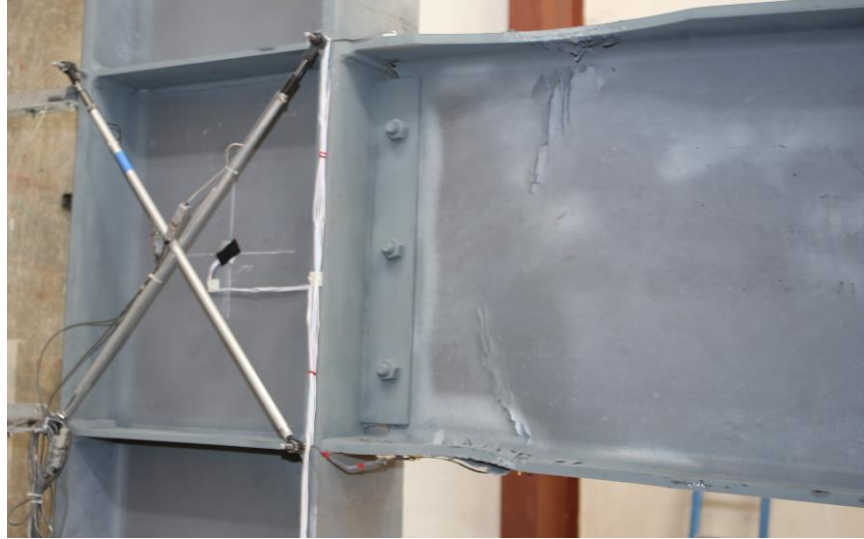
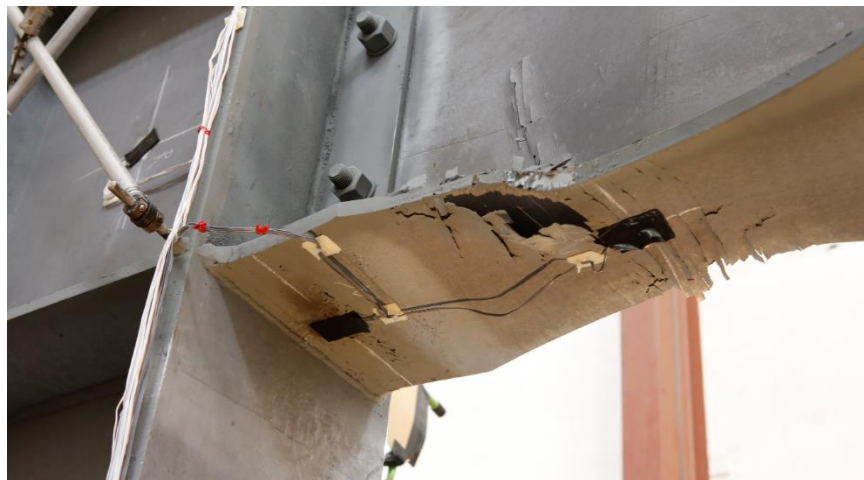
- Figure 4.99 shows the initiation of flange local buckling during the first negative excursion of 0.04 rad drift. Also demonstrated in this figure was flaking of the galvanization in the beam web in the regions of higher curvature due to beam web buckling. The shedding of the galvanization in sheets during yielding was observed in Figure 4.99(b).

Figure 4.99 Specimen C6-G: Flange Local Buckling

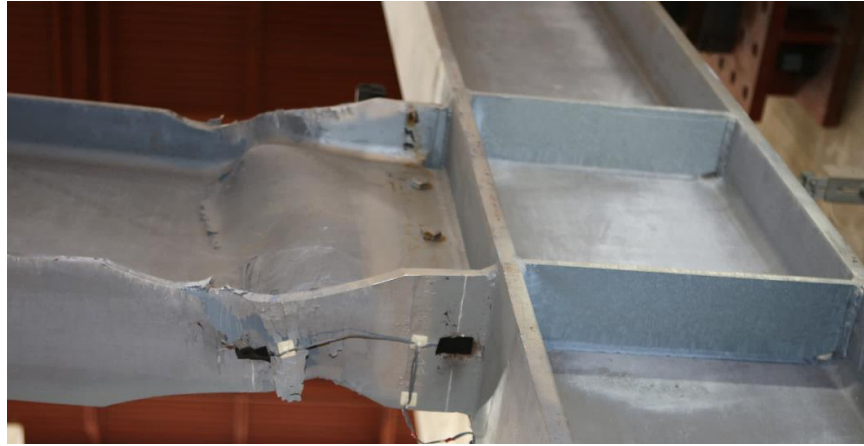
- Beam web buckling was first observed during the 0.04 rad cycles. During the second cycle at -0.05 rad drift web buckling was pronounced and interacting with beam lateral-torsional buckling to create a step in the web (see Figure 4.100).

Figure 4.100 Specimen C6-G: Web Local Buckling

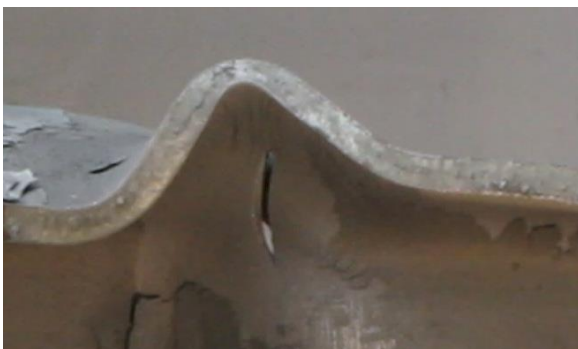
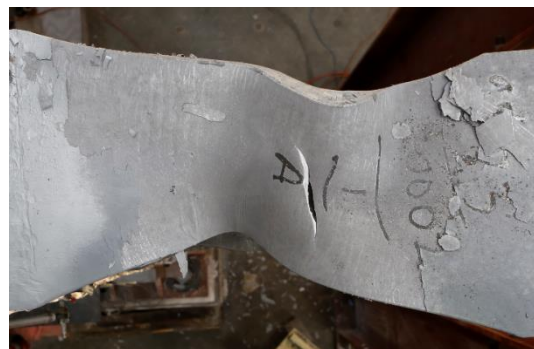
- During the first negative excursion of 0.06 rad drift the beam web k-area fractured in a region of high local curvature due to beam web buckling (see Figure 4.101). This fracture propagated to the top surface of the beam top flange [see Figure 4.101(c)]. The remainder of the top flange fractured once the negative excursion was resumed

Figure 4.101 Specimen C6-G: Beam Flange Partial Fracture at -0.06 rad (1st Cycle)

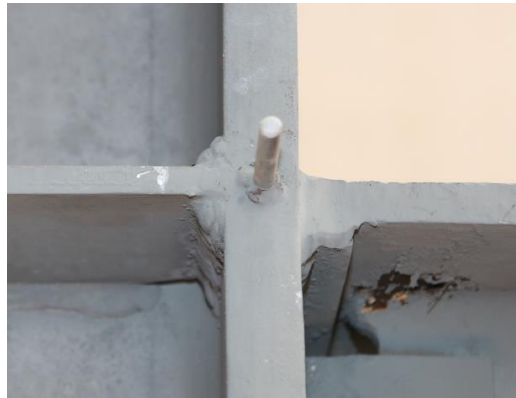
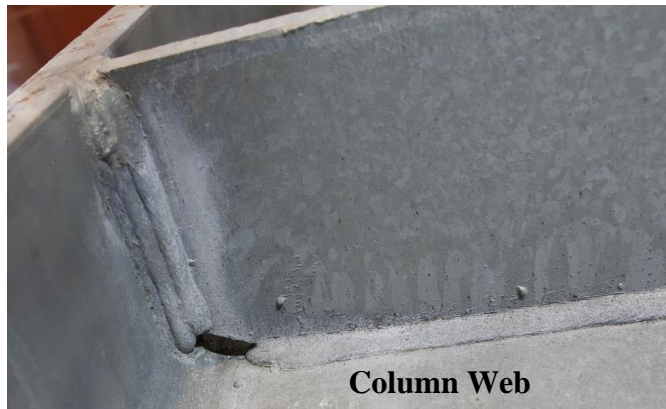
- Figure 4.103 shows the east side of the specimen at the end of testing. No damage was observed to the continuity plate fillet welds at the end of testing (see Figure 4.104).

Figure 4.104 Specimen C6-G: Continuity Plate Welds at End of Test

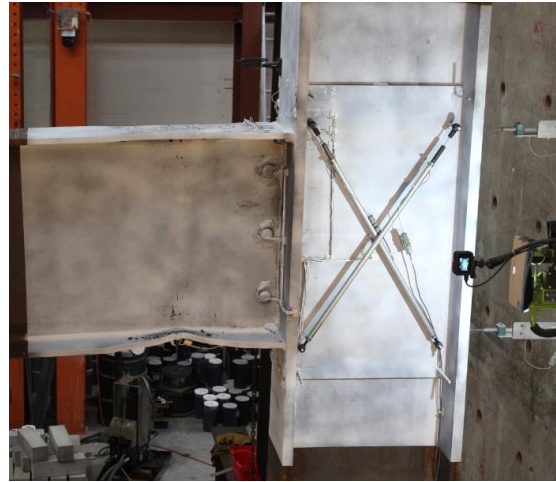
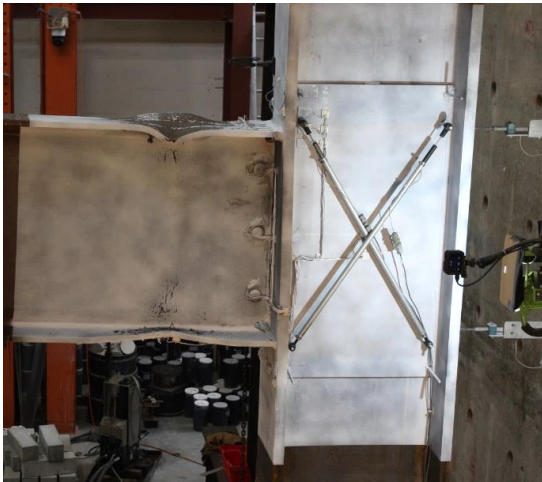
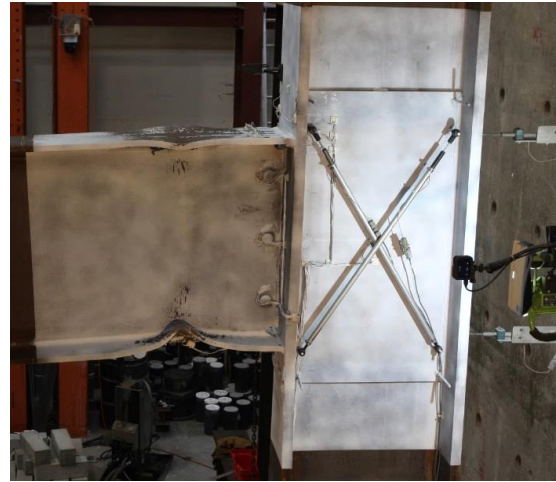
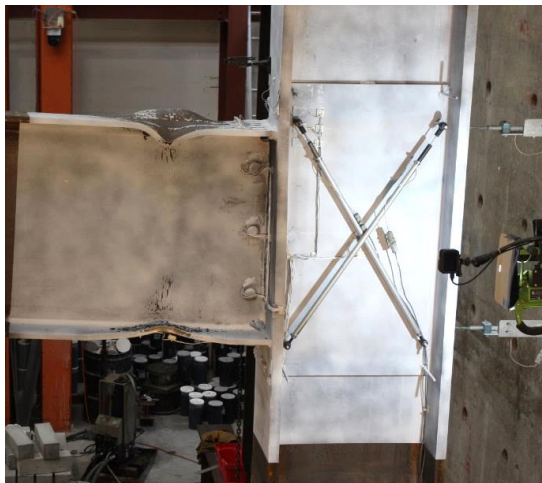
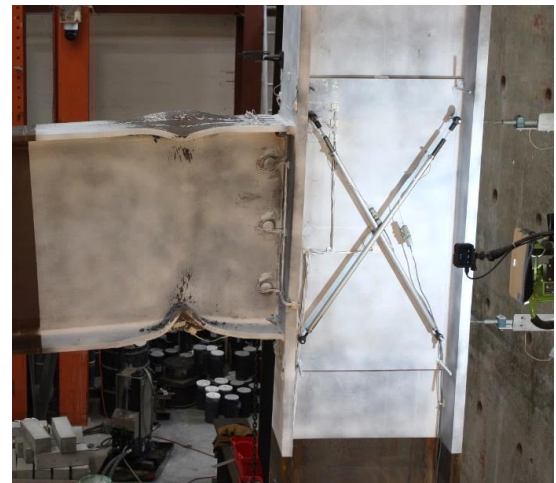
Figure 4.113 Specimen C7: East Side of Connection

- Figure 4.113 shows the east side of the specimen at the peak excursions during the later cycles of the loading protocol. The specimen met the AISC acceptance criteria. It was observed that beam web buckling and beam flange local buckling both initiated during the first cycle of 0.04 rad drift. Flange local buckling initiated at the beam bottom flange within the RBS cut during the second cycle of 0.03 rad drift. Web local buckling started during the 0.03 rad drift cycles. The beam bottom flange developed a partial rupture during the unloading portion of the second cycle of 0.05 rad drift.

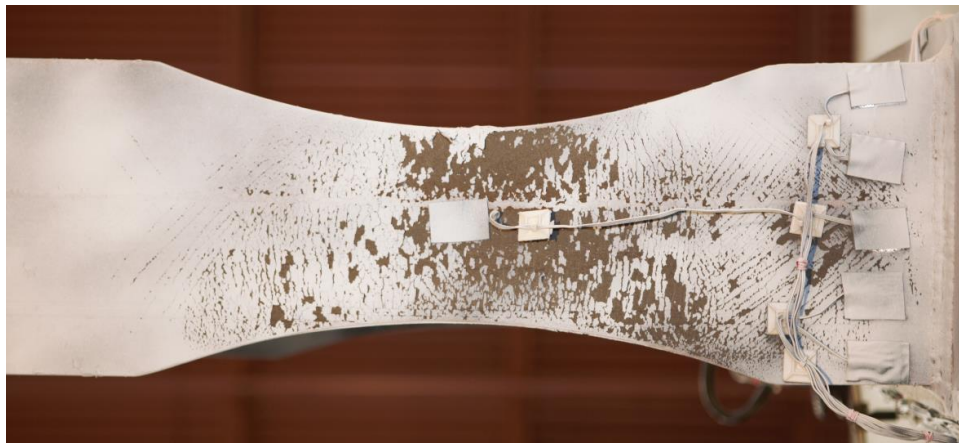
- Beam bottom flange yielding initiated at 0.005 rad drift cycles two inches from the column flange [see Figure 4.114(a)]. At 0.01 rad drift this yielding had spread outward and into the reduced beam section [see Figure 4.114(b)]. Figure 4.114(c) shows that the yielding had distributed through most of the reduced beam section by 0.04 rad drift. Similar yielding observations occurred on the beam top flange (see

Figure 4.114 Specimen C7: Beam Bottom Flange Yielding

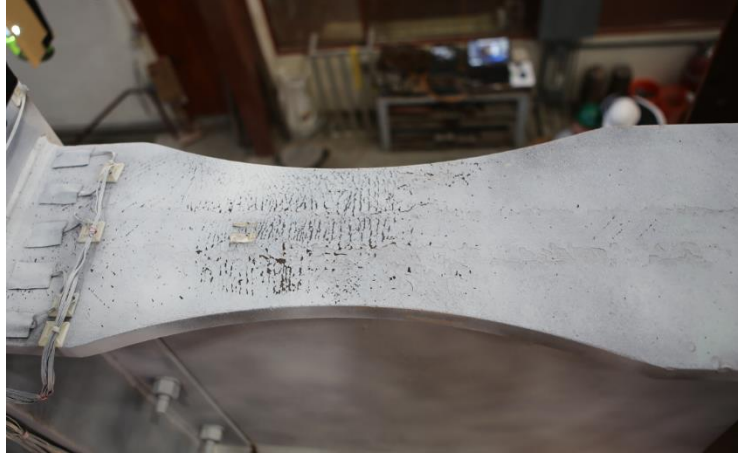
Figure 4.115). By 0.02 rad drift the yielding had spread through the flange, showing yield lines on the underside of beam top flange (see Figure 4.116).

Figure 4.115 Specimen C7: Beam Top Flange Yielding at -0.015 rad (2nd Cycle)

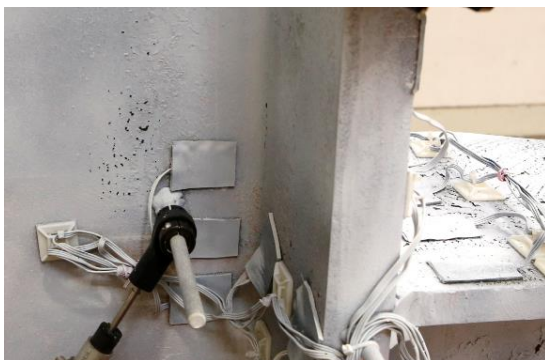
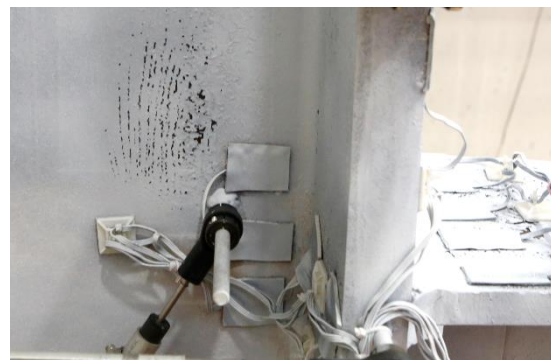
- Figure 4.117 shows web local yielding at the beam top flange location. The WLY was first observed at 0.02 rad drift and progressed slightly with each drift level. Figure 4.118 shows the WLY patterns at the end of testing. It was observed that the yielding was localized at the elevation just outside of the beam flange. Yielding was only observed on the side of the column which did not have a doubler plate.

Figure 4.117 Specimen C7: Colum WLY at Beam Top Flange Level

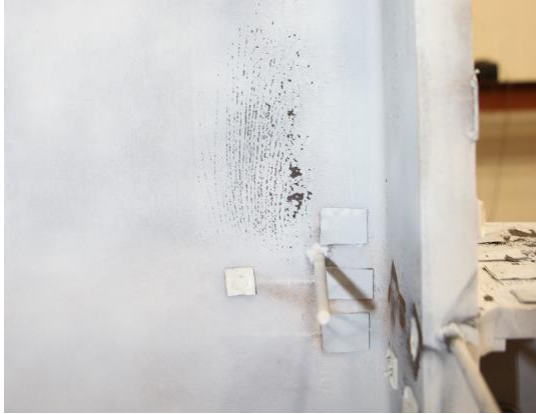
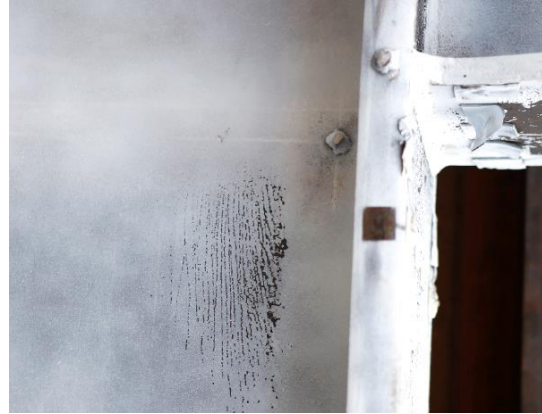
Figure 4.118 Specimen C7: Colum WLY at End of Test

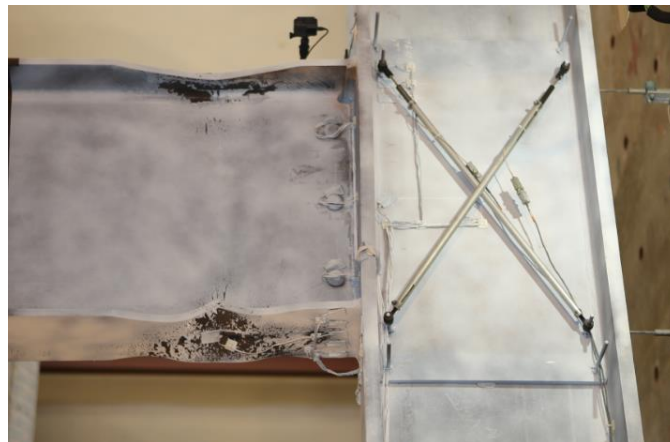
Figure 4.119 Specimen C7: Beam Flange Local Bucking

- Web and flange local buckling started during the 0.03 rad drift cycles (see Figure 4.119). The flange local buckling continued to amplify during later cycles. A partial beam bottom flange occurred during the negative excursion of the second cycle of 0.05 rad.

(b) -0.04 rad (1st Cycle)

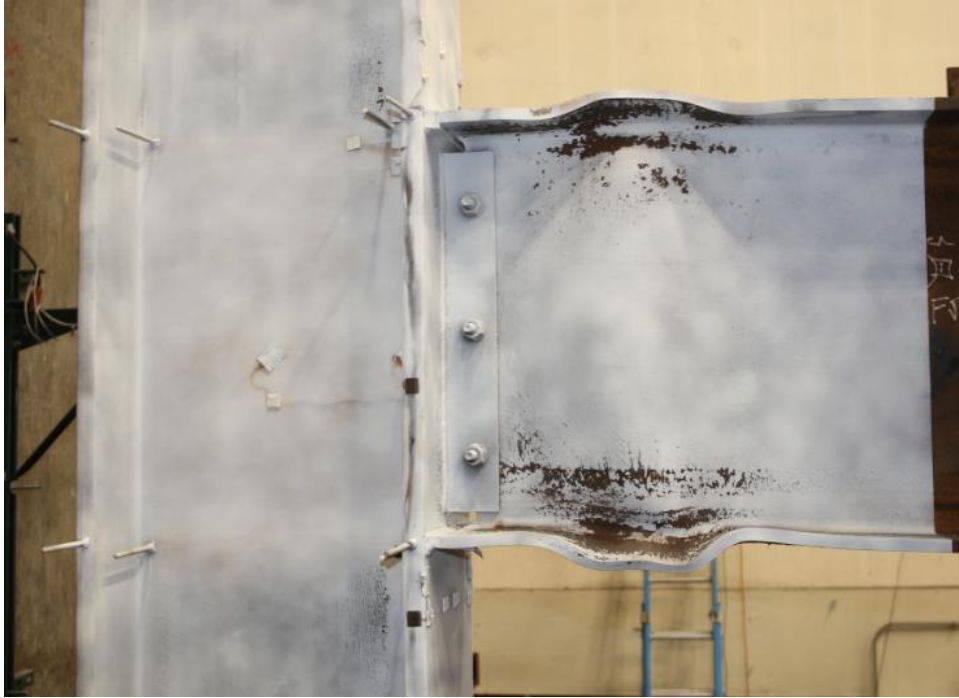
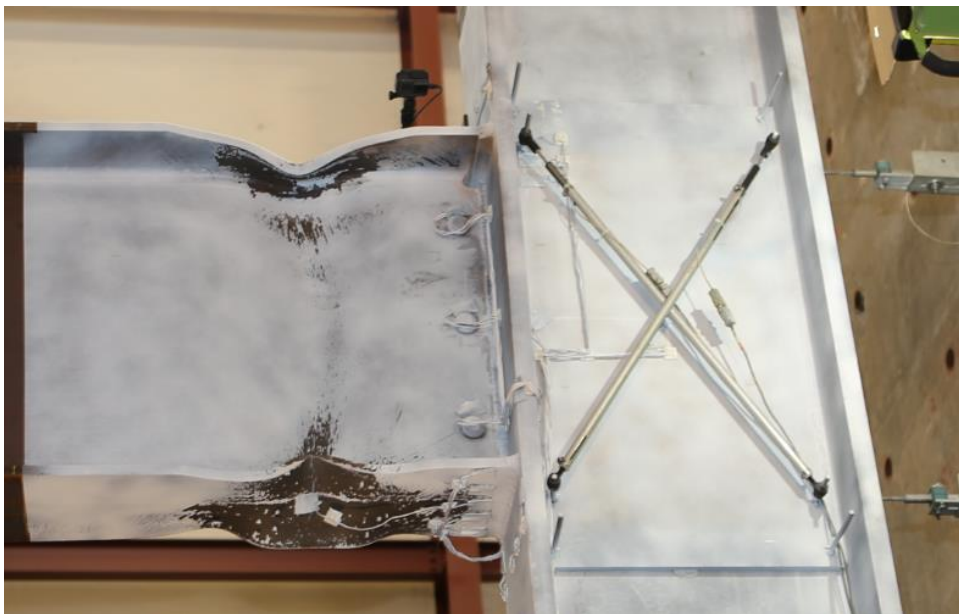
Figure 4.120 Specimen C7: Connection at End of Test

- Figure 4.120 shows the condition of the connection at the end of testing.
- The partial beam flange tear was observed in Figure 4.121.
- The west side of the column demonstrated a yielding along a vertical line that runs the length of the beam web. This yield line was 2.5 in. from the beam web (see Figure 4.122).

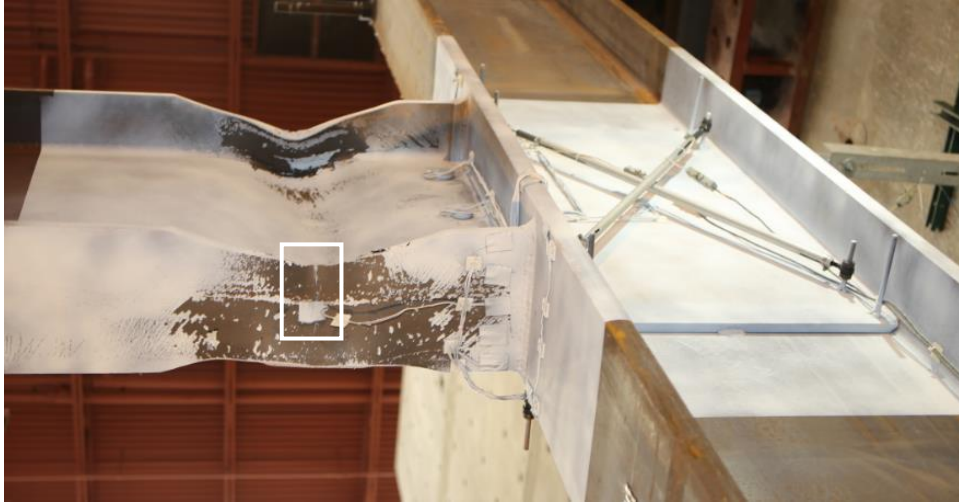
Figure 4.121 Specimen C7: Beam Flange Partial Fracture

(a) Overview

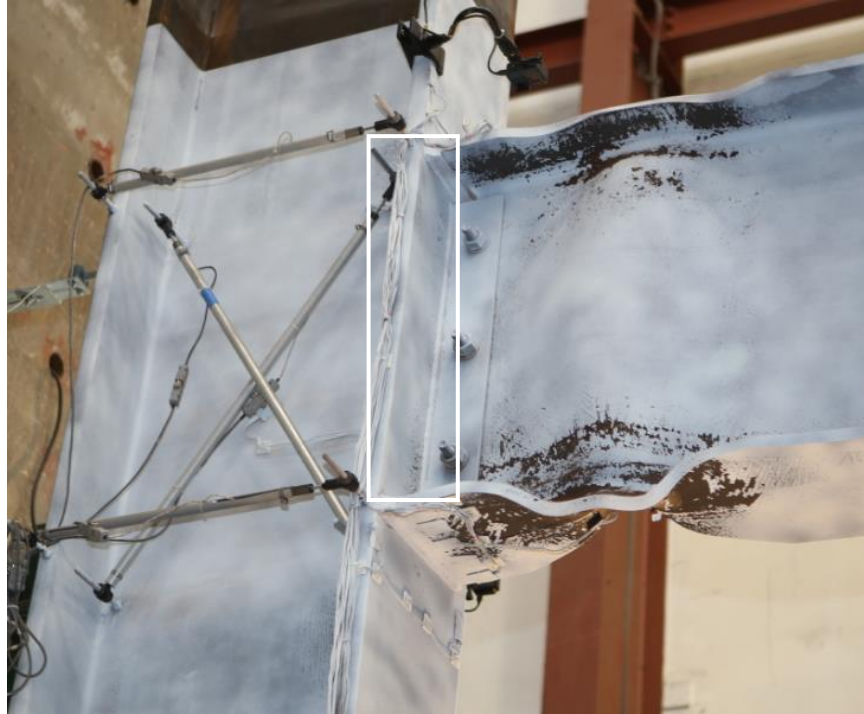
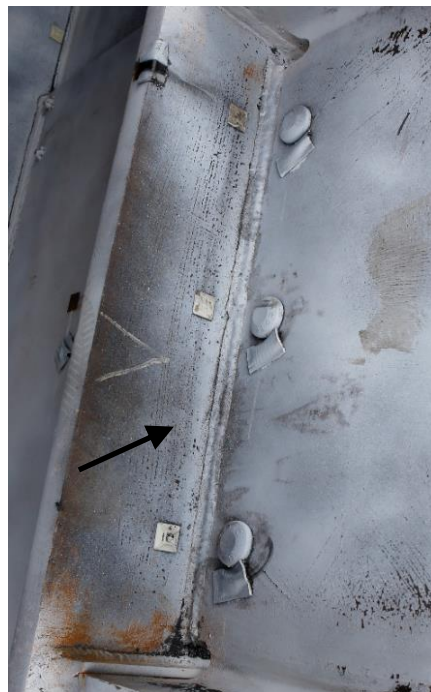
Figure 4.122 Specimen C7: Column Yielding (End of Test)

(b) Column Yielding

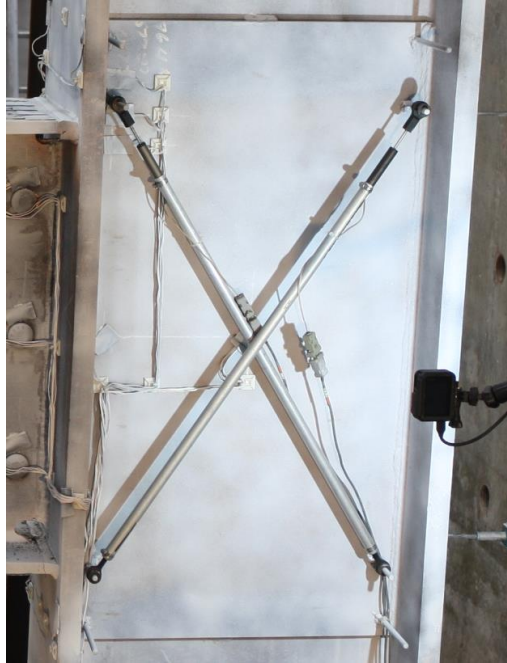
Figure 4.123 Specimen C7: Doubler Plate at End of Test

- No damage was observed in the doubler plate fillet welds at the end of testing (see Figure 4.123).

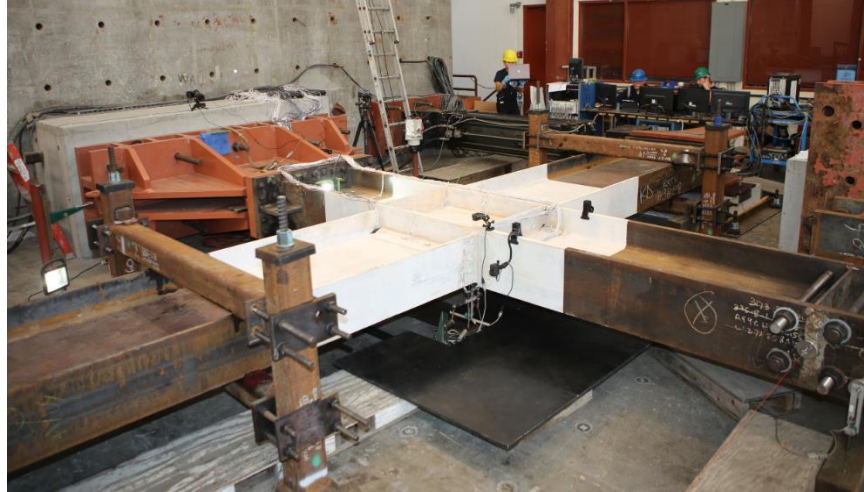
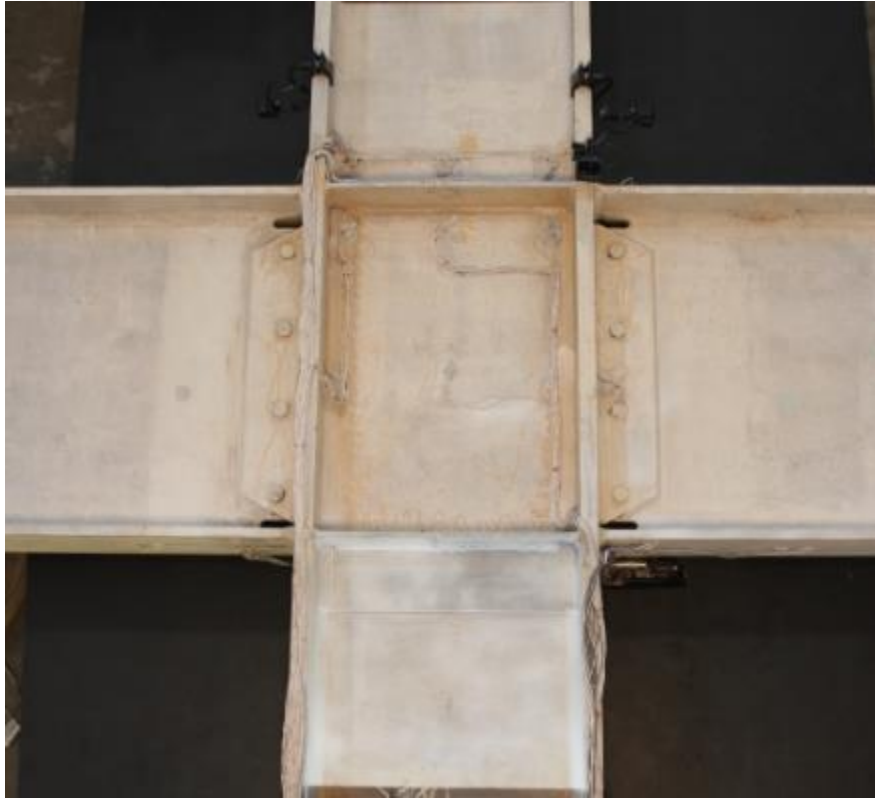
Figure 4.138 Specimen W1: Connection before Testing

Specimen W1 was designed to investigate use of the plastic methodology to design continuity plates. The resulting continuity plates were thinner than required by the current AISC 341 Provisions. Continuity plate double-sided fillet welds were sized such that $w = 0.75t_{cp}$. A pair of doubler plates stiffen the web of the column for panel zone yielding—these plates were extended 6 in. above and below the beam flange elevations. The doubler plate vertical welds use a PJP groove weld, and no horizontal welds were used in accordance with the current Provisions. Specimen W1 failed by a fracture of the east beam top flange CJP weld during the second cycle of 0.04 rad drift. Figure 4.138 shows the specimen before testing.

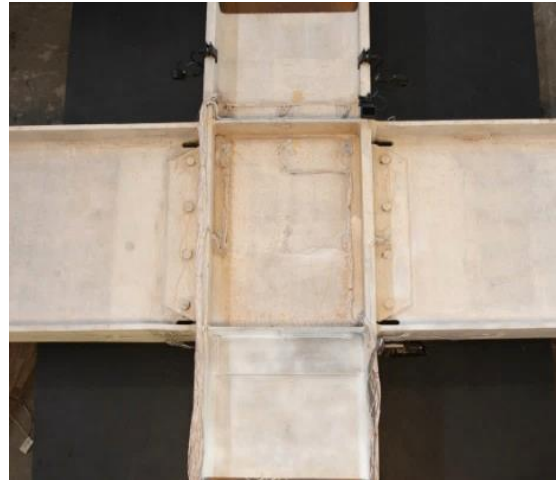
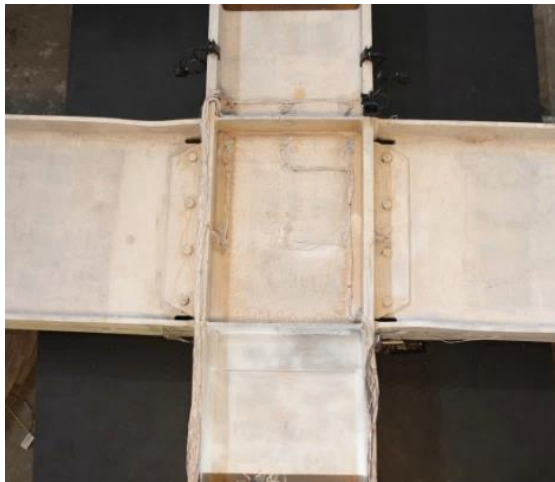
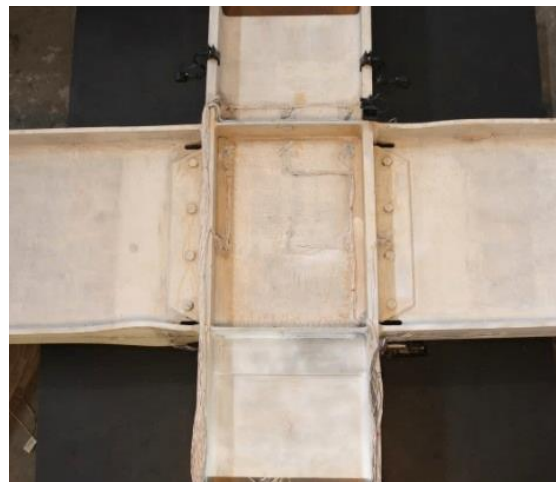
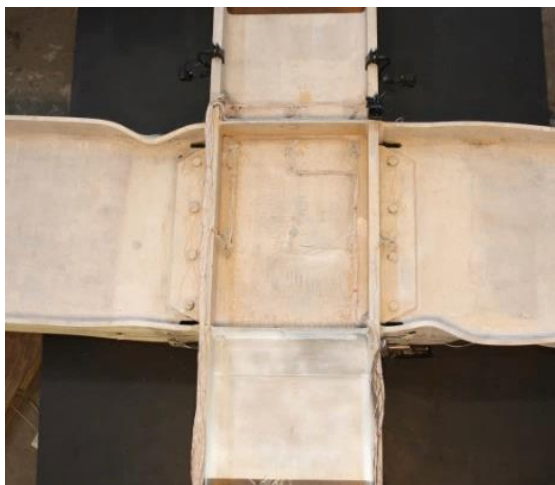
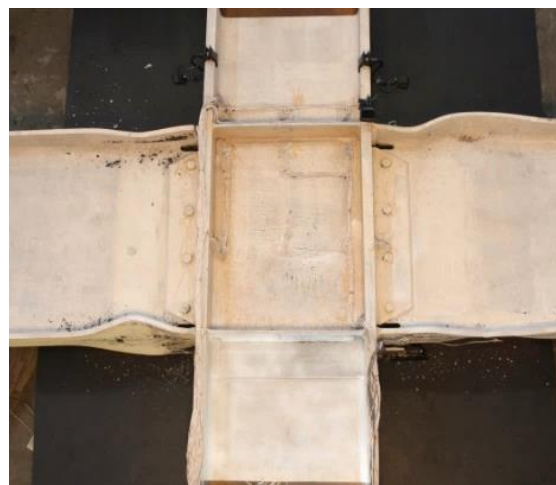
Figure 4.139 Specimen W1: Connection during Testing

- Figure 4.139 shows the connection during testing. The loading protocol was applied symmetrically such that a clockwise rotation is a positive excursion on the east beam and a negative excursion on the west beam. The response is described such that a positive excursion refers to a clockwise rotation of the joint. The specimen met the AISC acceptance criteria by completing one complete cycle at 0.04 rad drift while the flexural strength at either column face did not degrade below 80% of the beam nominal flexural strength. Beam flange and web local buckling initiated at 0.03 rad drift and progressed throughout testing.

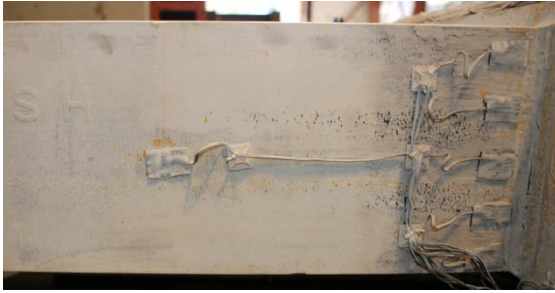
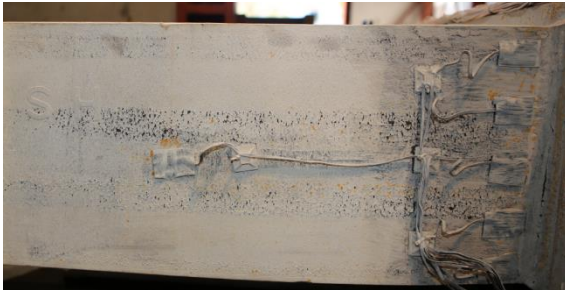
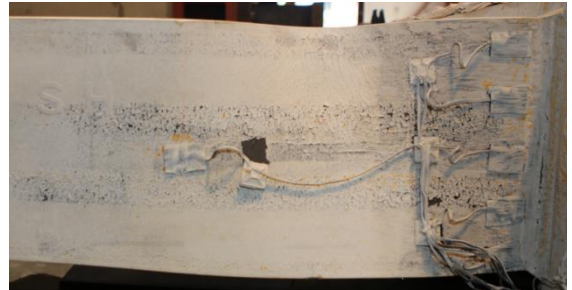
Figure 4.140 Specimen W1: East Beam Bottom Flange Yielding

- Figure 4.140 and Figure 4.141 show the progressive beam yielding during testing. Yielding starts adjacent to the column flange and propagates outward, concentrating down the center of the beam.

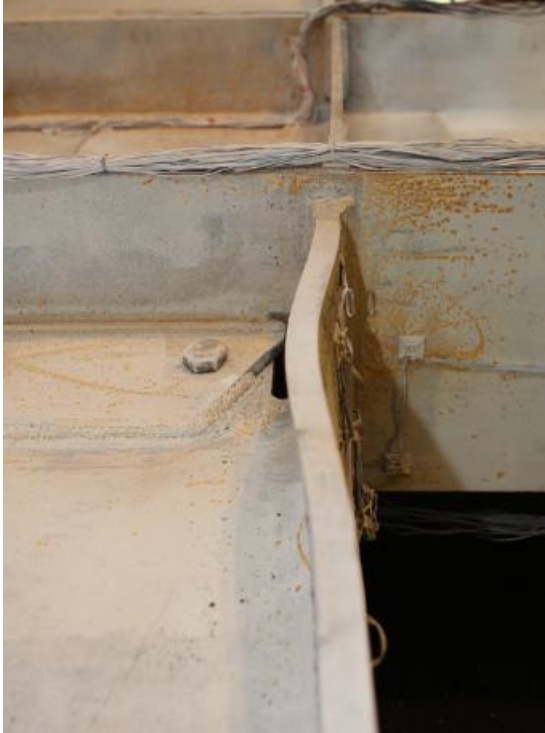
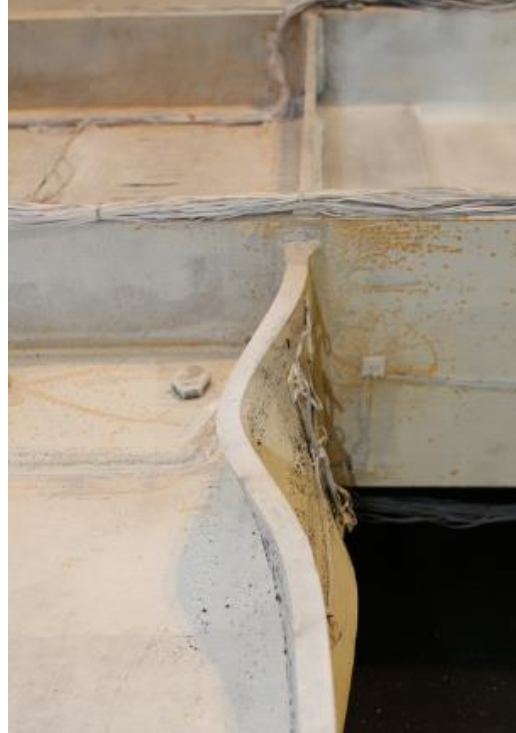
Figure 4.142 Specimen W1: East Beam Bottom Flange Local Buckling

- Figure 4.142 shows the progression of flange local buckling that developed in the east beam bottom flange. The local buckling develops in a opposite sense between the east and west beams depending on which flange of the beam was in compression.

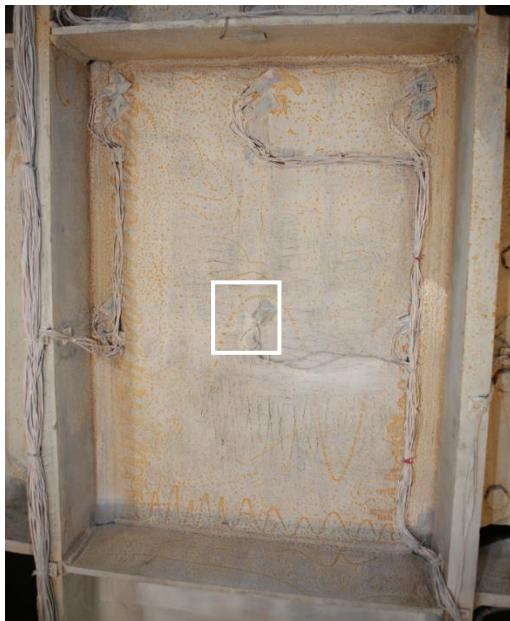
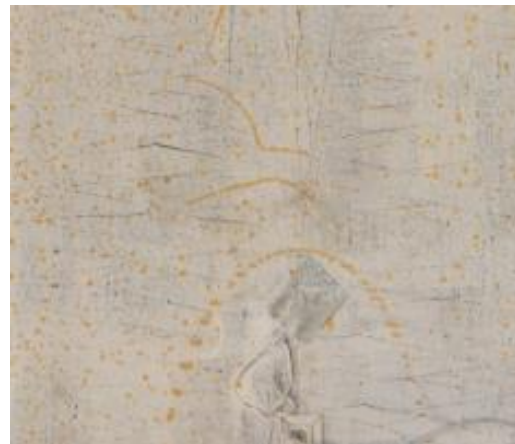
Figure 4.143 Specimen W1: Panel Zone Yielding at +0.03 rad (2nd Cycle)

- Figure 4.143 shows yielding in the panel zone observed at a at 0.03 rad drift. The yielding did not progress significantly further by the end of testing.

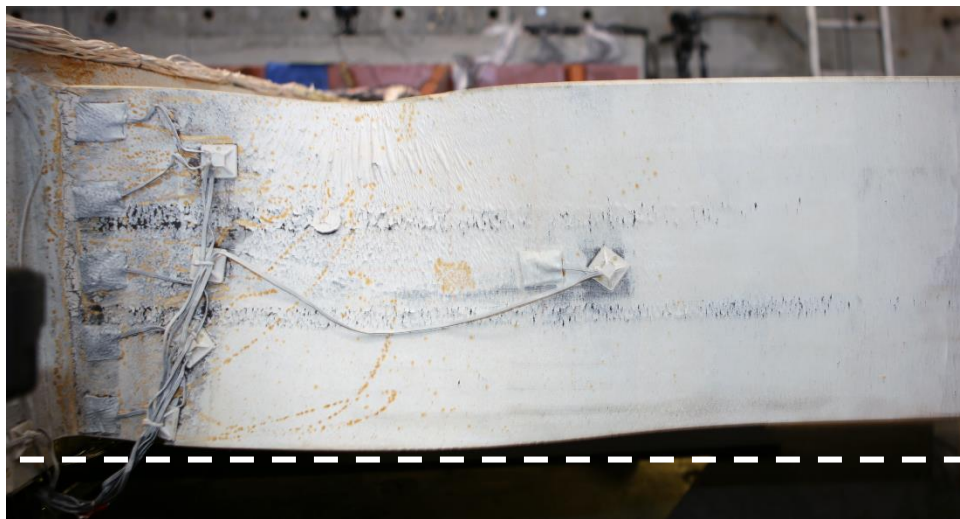
Figure 4.144 Specimen W1: Lateral-Torsional Buckling

- Figure 4.144 shows the minor lateral-torsional buckling that developed in beam top flanges during the 0.04 rad drift cycles. The buckling was mirrored between positive and negative joint rotations, reflecting when the top flange experienced compression.

(a) East Beam Top Flange at +0.04 rad (2nd Cycle)
