**STRUCTURAL SYSTEMS
RESEARCH PROJECT**

Final Report
SSRP-19/03

**Alternative Weld Details and Design for
Continuity Plates and Doubler Plates for
Applications in Special and Intermediate
Moment Frames**

Final Report Submitted to AISC

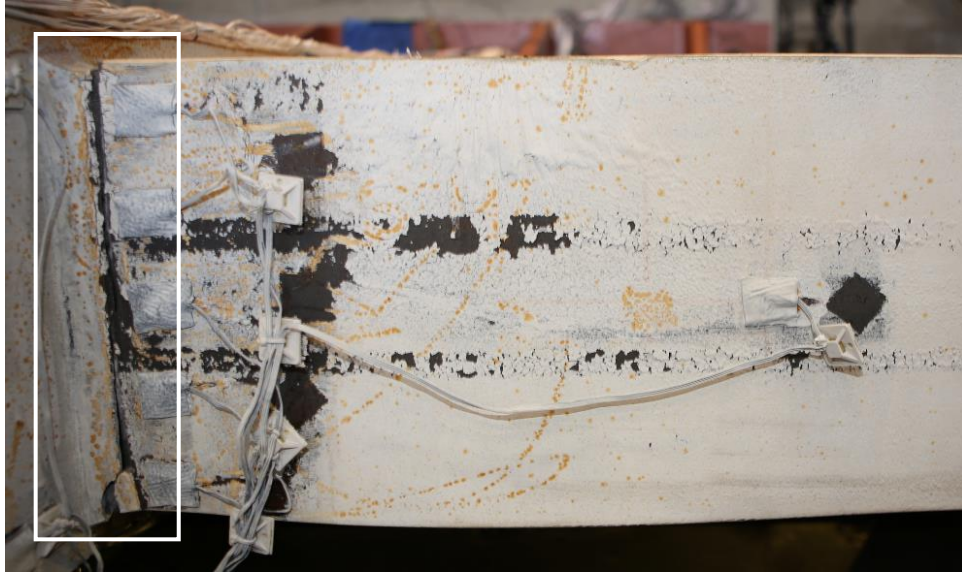
- Figure 4.145 shows the fractured east beam top flange CJP weld at -0.03 rad during the second negative excursion to 0.04 rad drift. The fracture started at the CJP Weld root on the underside of the specimen, on the tension side of the lateral-torsional buckling and propagated along the beam flange following the 30° bevel of the CJP weld. The progression of the fracture was observed in Figure 4.146. After initiating in the weld metal as a ductile tear the fracture transitioned to the bevel of the CJP weld after 0.75 in. The fracture continued its tearing in a ductile fashion until 50% of the flange was fractured when a secondary ductile fracture appeared in the reentrant corner in the center of the flange. The remainder of the fracture propagated due to cleavage through the flange (see Figure 4.147).

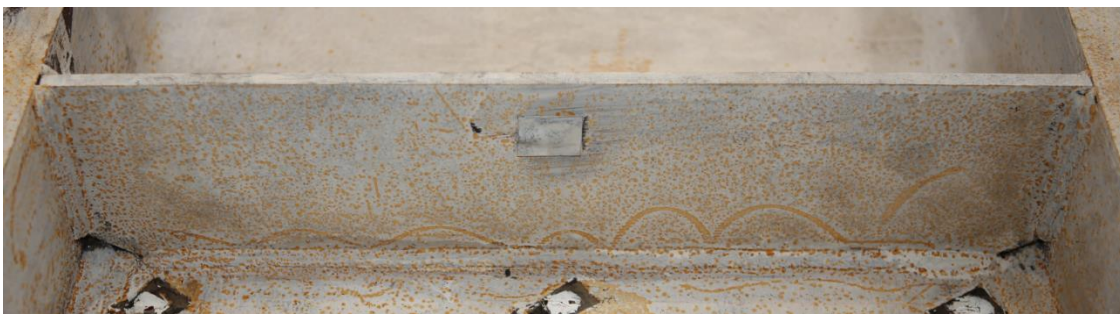
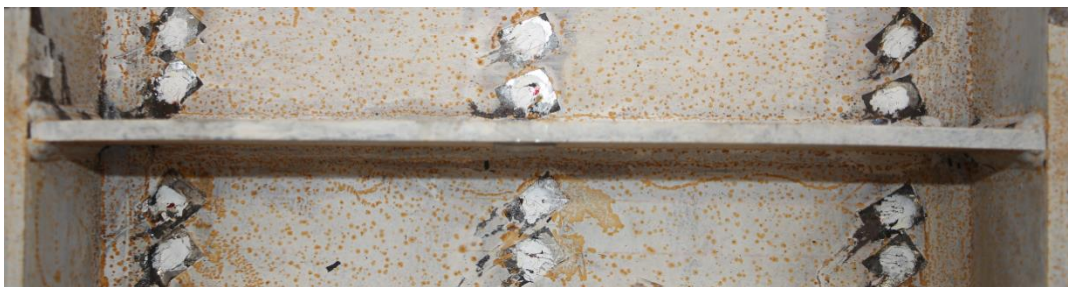
Figure 4.149 Specimen W1: Top Flange Continuity Plate (End of Test)

- Continuity plates did not demonstrate yielding nor damage to any of the fillet welds during testing (see Figure 4.149 to Figure 4.151). A slight bow present in the continuity plates occurred before testing of the specimen and was not due to local buckling of the plate.

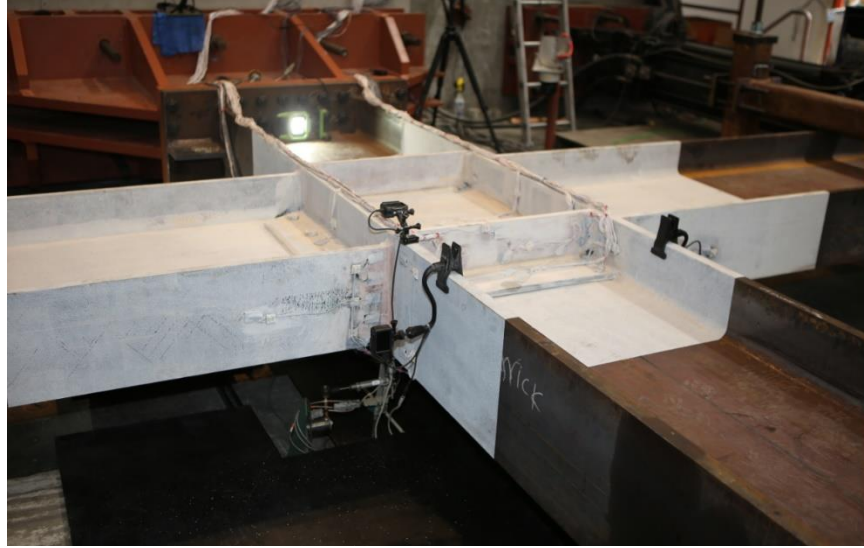
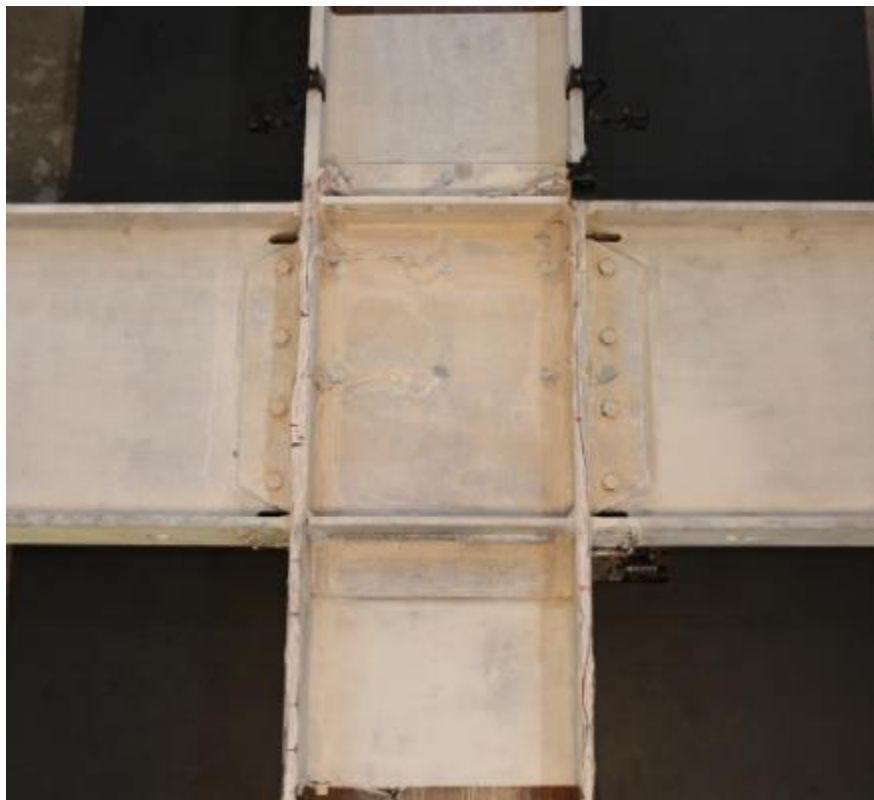
Figure 4.172 Specimen W2: Connection before Testing

Specimen W2 was designed to investigate use of the plastic methodology to design continuity plates. The continuity plate thickness was chosen to match the minimum thickness requirement of AISC 341, for which the plastic methodology results in an undersized continuity plate with a DCR of 1.43. Continuity plate double-sided fillet welds were sized such that $w = 0.75t_{cp}$. A pair of doubler plates stiffen the web of the column for panel zone yielding—these plates were extended 6 in. above and below the beam flange elevations. The doubler plate vertical welds use a PJP groove weld, and no horizontal welds were used in accordance with the current Provisions. Specimen W2 failed by a fracture of the east top and west bottom beam flange CJP weld during the second cycle of 0.06 rad drift. Figure 4.172 shows the specimen before testing.

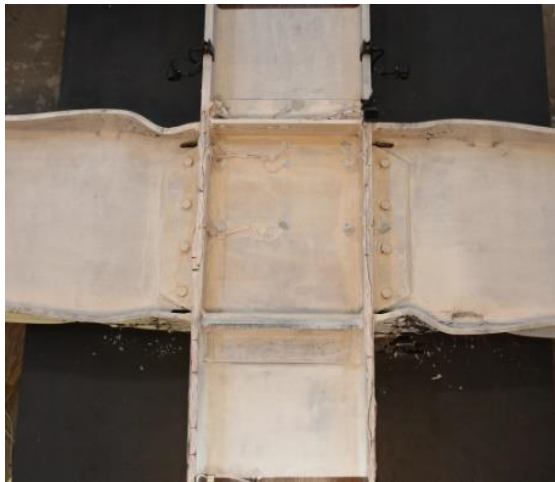
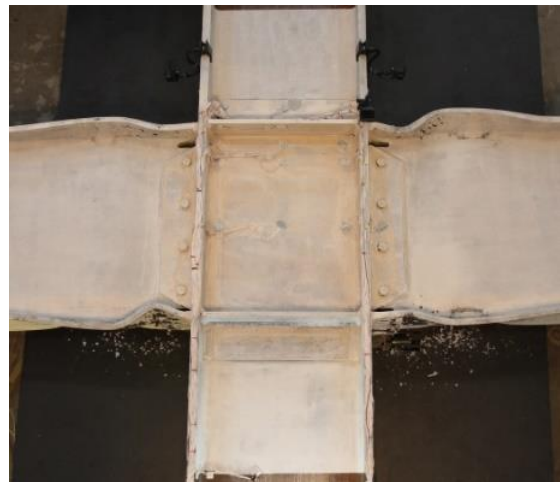
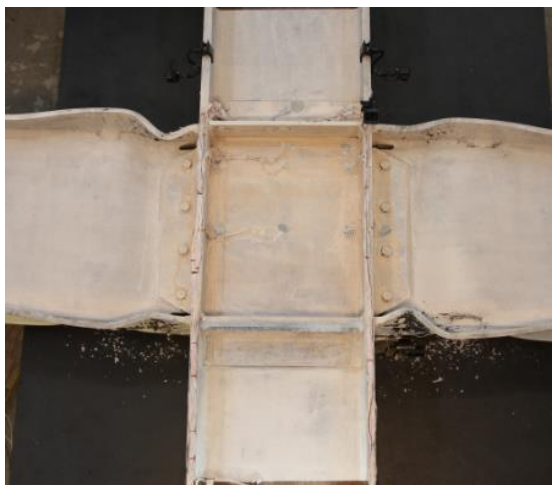
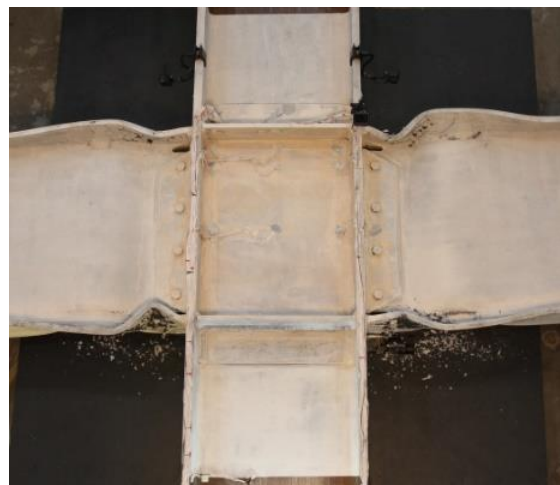
Figure 4.173 Specimen W2: Connection during Testing

- Figure 4.173 shows the connection during testing. The specimen met the AISC acceptance criteria by completing one complete cycle at 0.04 rad drift while the flexural strength at either column face did not degrade below 80% of the beam nominal flexural strength. Beam flange and web local buckling initiated at 0.03 rad drift and progressed throughout testing.

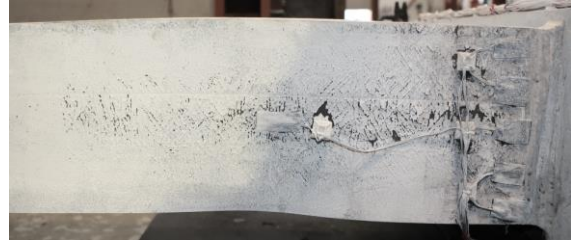
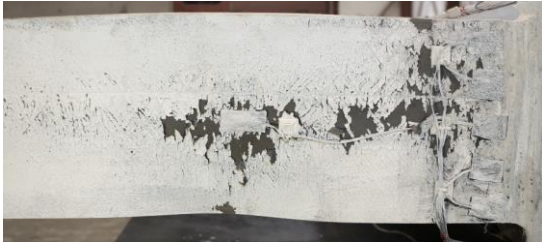
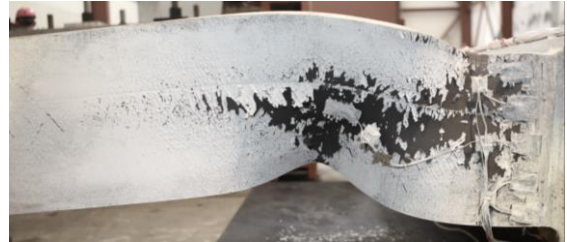
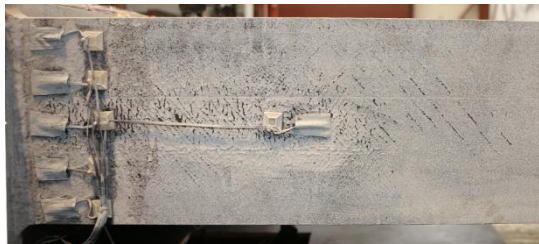
Figure 4.174 Specimen W2: East Beam Bottom Flange Yielding

- Figure 4.174 and Figure 4.175 shows the bottom flange yielding and buckling of the east and west beams. The yielding of the flanges initiated during the 0.0075 rad drift cycles. It was observed that significant lateral-torsional buckling initiates at 0.04 rad drift and progresses in the later drift cycles.

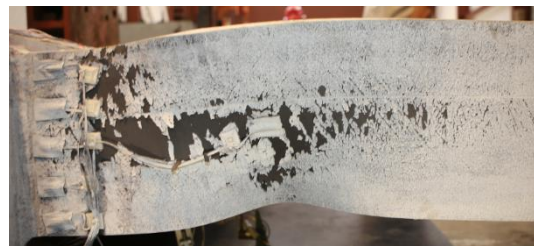
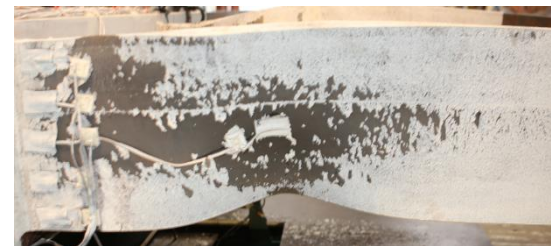
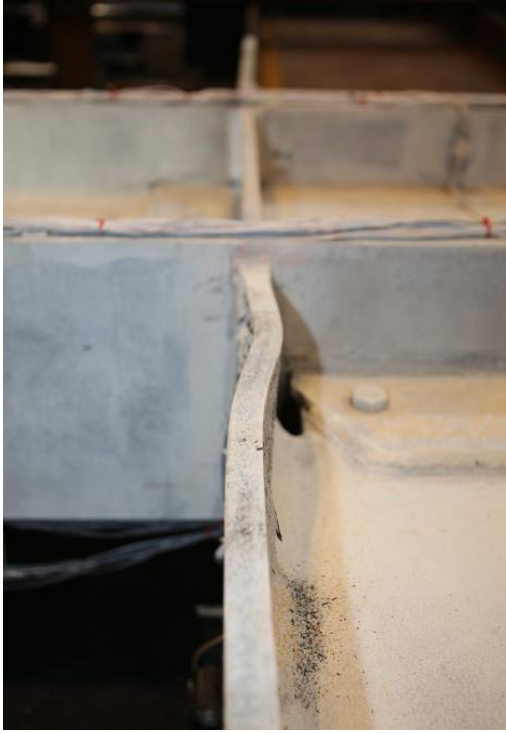
Figure 4.175 Specimen W2: West Beam Bottom Flange Yielding

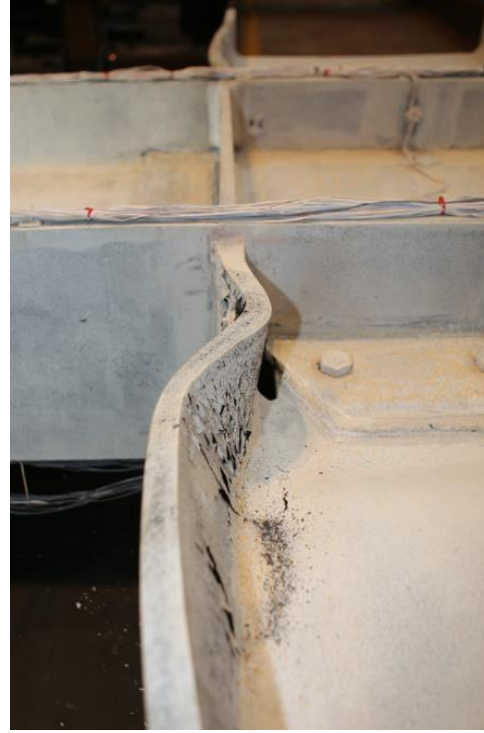
Figure 4.176 Specimen W2: East Beam Top Flange Local Buckling

- Figure 4.176 shows the progression of flange local buckling that developed in the east beam top flange. The local buckling develops in the flange of the beam in compression during that excursion and then is pulled relatively straight during the tension excursions.

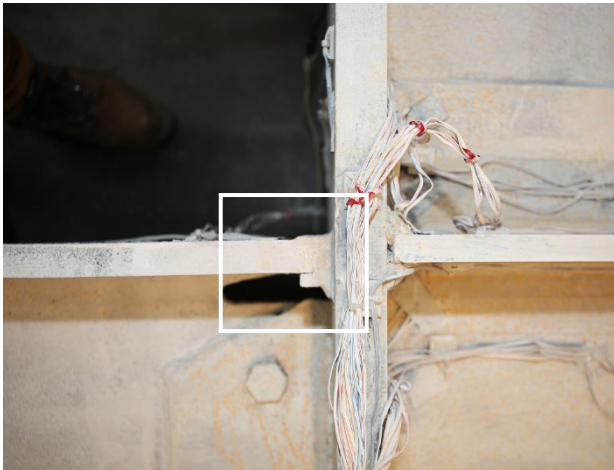
Figure 4.177 Specimen W2: East Beam Top Flange CJP Weld Tear at -0.03 rad (2nd Cycle)

- Figure 4.177 shows the initiation of a weld fracture during the second cycle of 0.03 rad drift. The fracture originates at the fusion face of the CJP weld and backing bar on the flange bevel side. Figure 4.178 shows the progression of this tear during the 0.04 rad and 0.05 rad drift cycles. At 0.05 rad drift cycles a weld tear on the top side

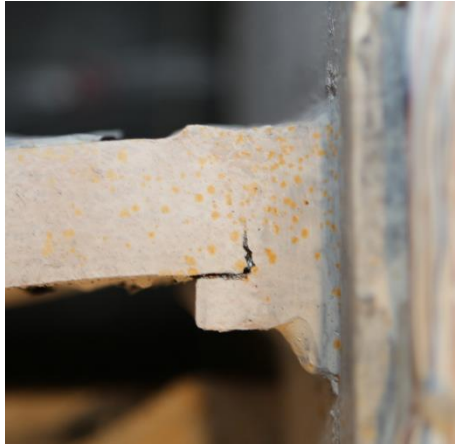
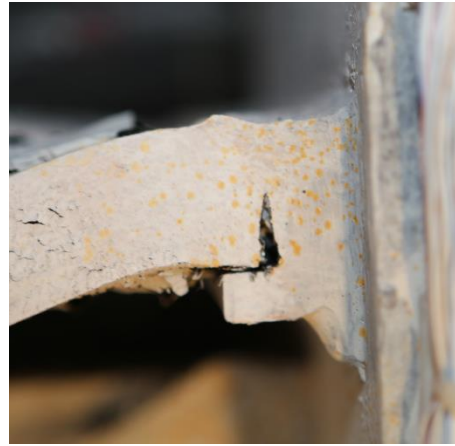
Figure 4.178 Specimen W2: East Beam Top Flange CJP Weld Tear Progression

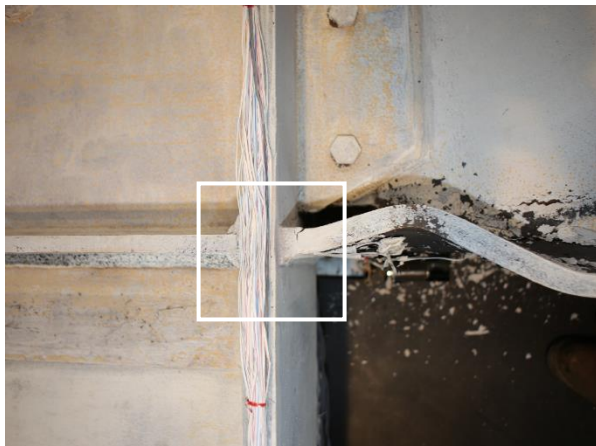
Figure 4.179 Specimen W2: West Beam Bottom Flange CJP Weld Fracture at: -0.05 rad (2nd Cycle)

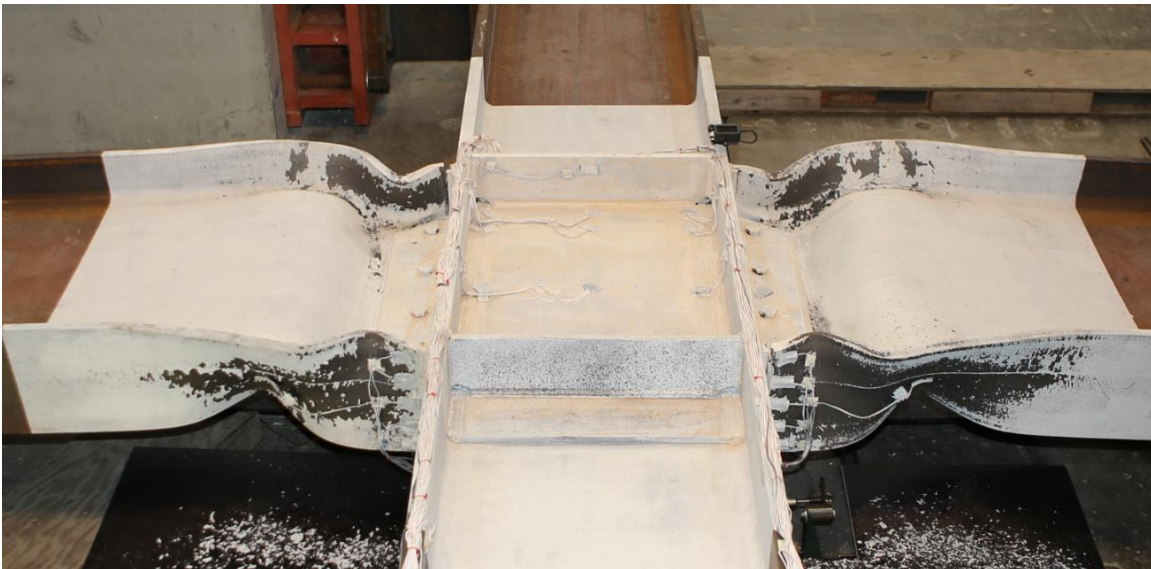
Figure 4.185 Specimen W2: Connection at End of Test

- Figure 4.185 shows the connection after testing. Minor panel zone yielding was observed in the doubler plate after testing (see Figure 4.186). This picture also demonstrates that no continuity plate yielding was evident.

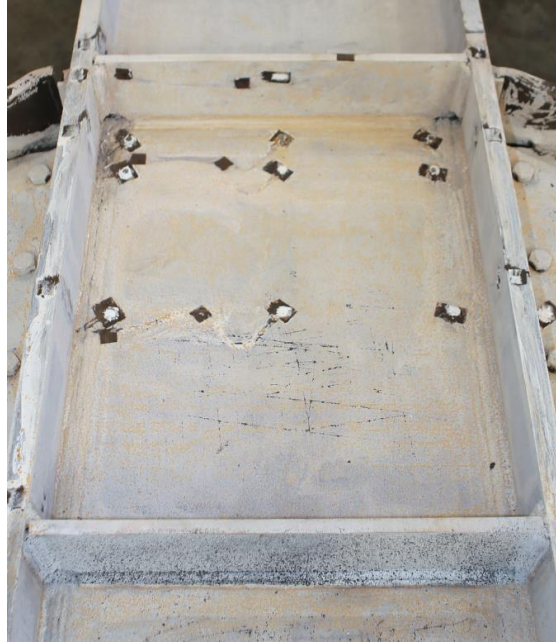
Figure 4.186 Specimen W2: Panel Zone (End of Test)

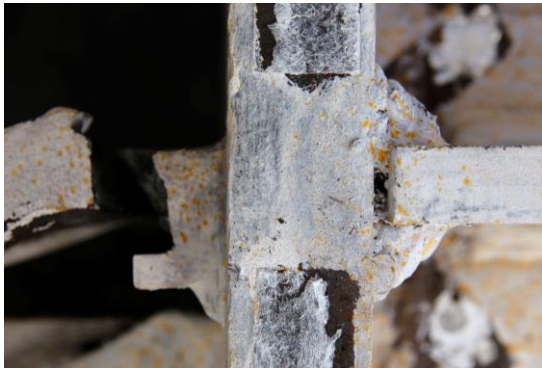
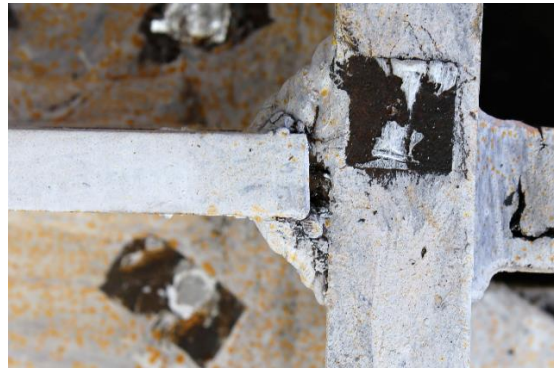
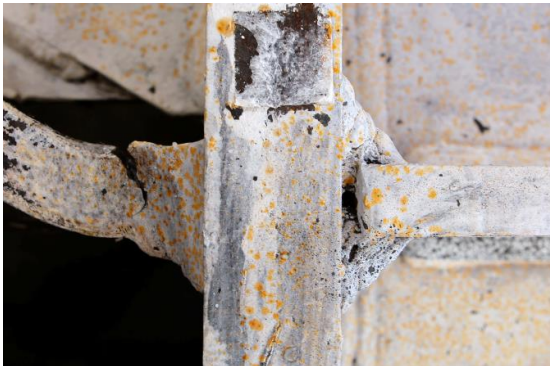
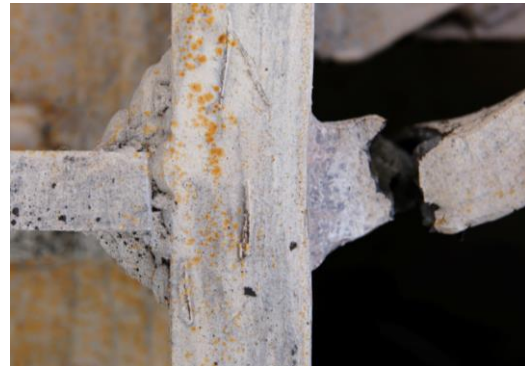
Figure 4.187 Specimen W2: Continuity Plate Fillet Welds (End of Test)

- No damage to the continuity plate fillet welds was observed during the testing or after test visual inspection (see Figure 4.187).

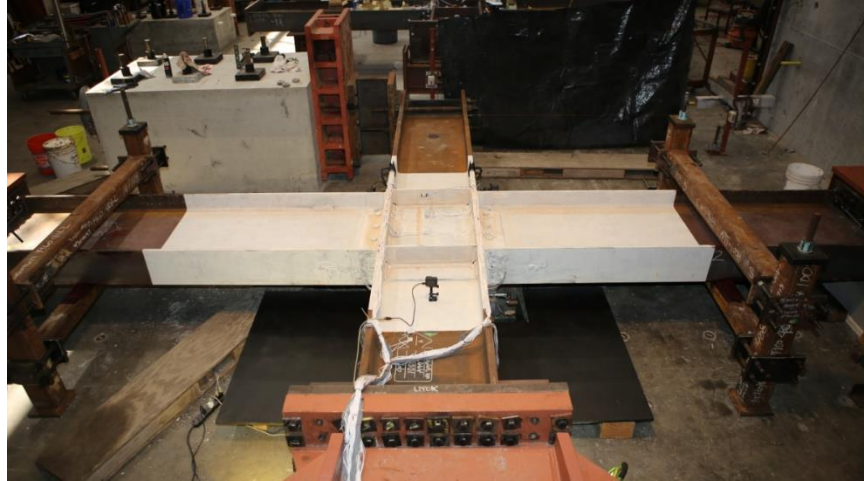
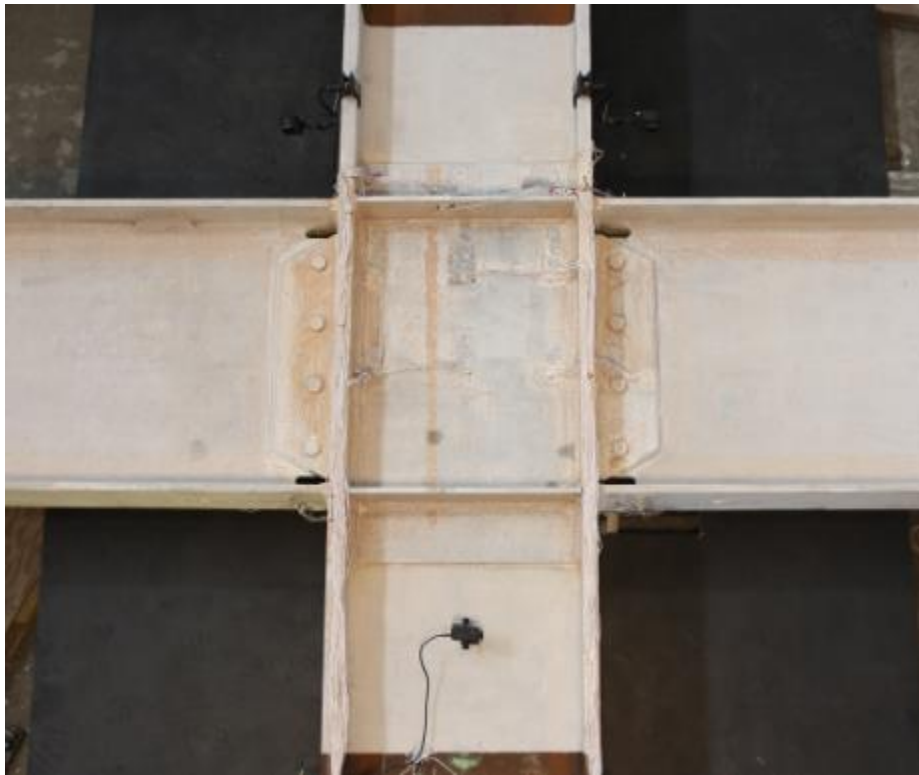
Figure 4.208 Specimen W3: Connection before Testing

Specimen W3 was designed to investigate use of the plastic methodology to design continuity plates. The resulting continuity plates were thinner than the current AISC 341 Provisions. Continuity plate double-sided fillet welds were sized such that $w = 0.75t_{cp}$. A pair of doubler plates stiffen the web of the column for panel zone yielding—these plates were extended 6 in. above and below the beam flange elevations. The doubler plates were designed to result in a weak panel zone, with a resulting DCR of 1.07; additionally, the stability criteria of the doubler plates were violated. The doubler plate vertical welds use a fillet weld sized to develop the shear strength of the plate, and no horizontal welds were used in accordance with the current Provisions. Specimen W3 failed by a fracture of the east beam top flange CJP weld during the second cycle of 0.06 rad drift. Figure 4.208 shows the specimen before testing.

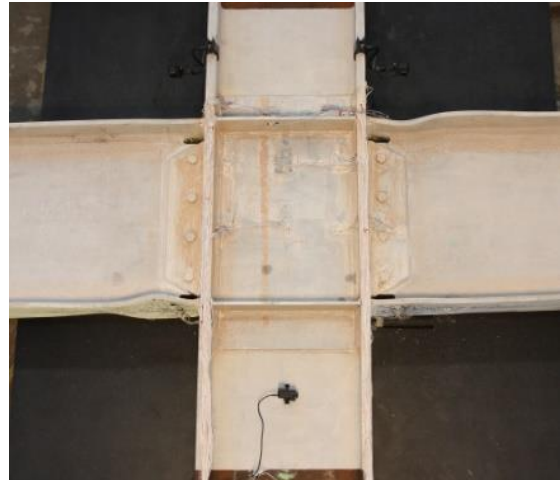
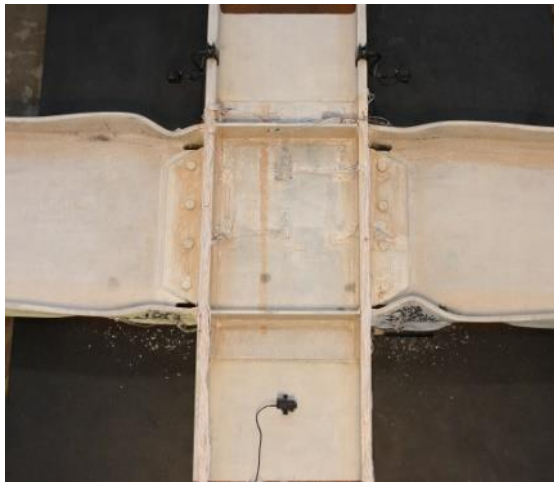
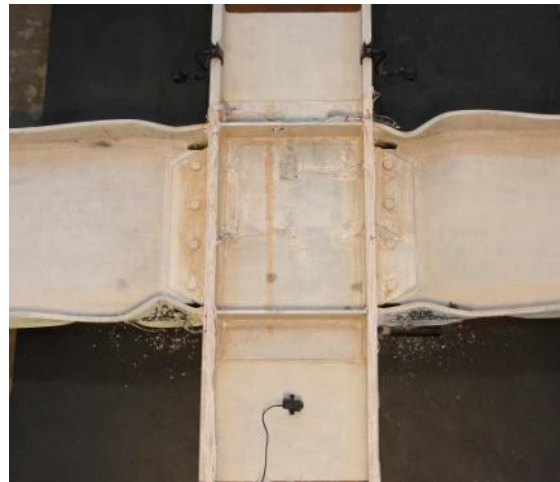
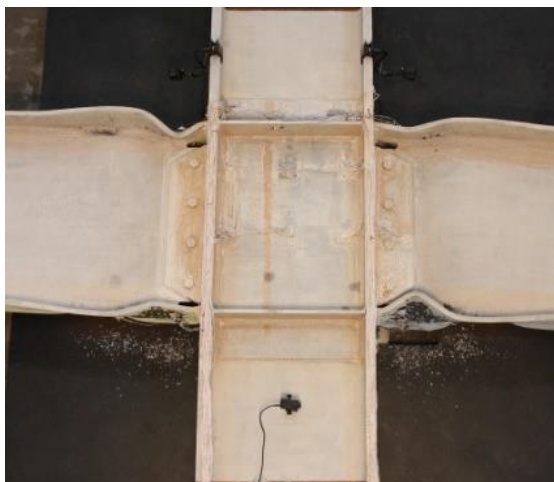
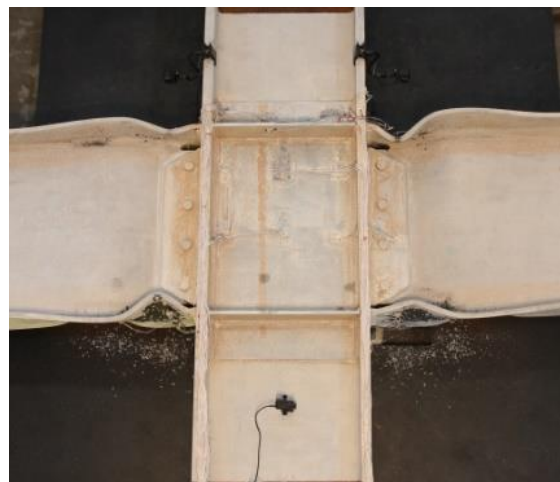
Figure 4.209 Specimen W3: Connection during Testing

- Figure 4.209 shows the connection during testing. The specimen met the AISC acceptance criteria by completing one complete cycle at 0.04 rad drift while the flexural strength at either column face did not degrade below 80% of the beam nominal flexural strength. Beam flange and web local buckling initiated at 0.03 rad drift and progressed throughout testing.

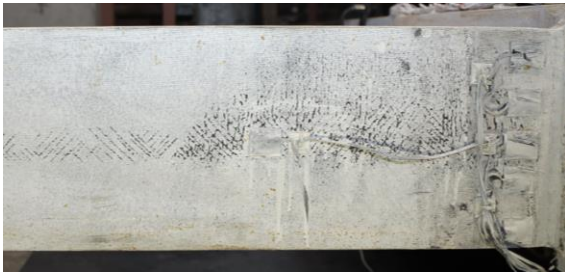
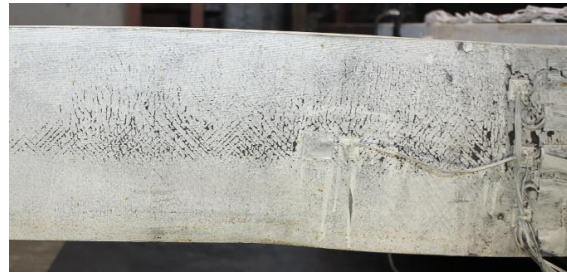
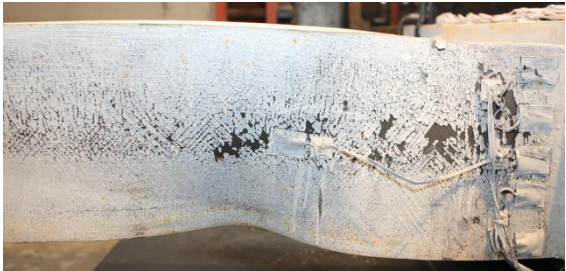
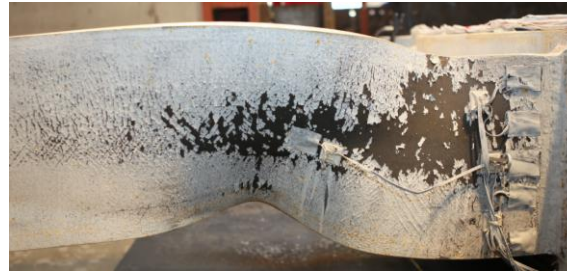
Figure 4.210 Specimen W3: East Beam Bottom Flange Yielding

- Figure 4.210 and Figure 4.211 show the east beam bottom flange and west beam bottom flange during testing. The gradual progression of yielding, flange local buckling, and lateral-torsional buckling is observed. The progression of flange local buckling between the second cycle of 0.03 rad and the first cycle of 0.04 rad is shown in Figure 4.212.

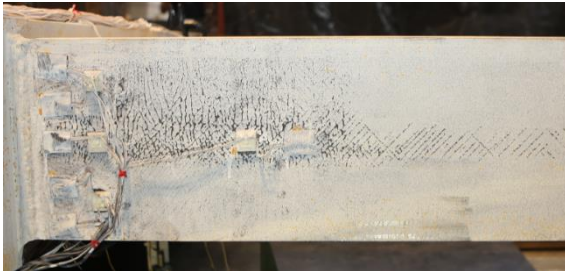
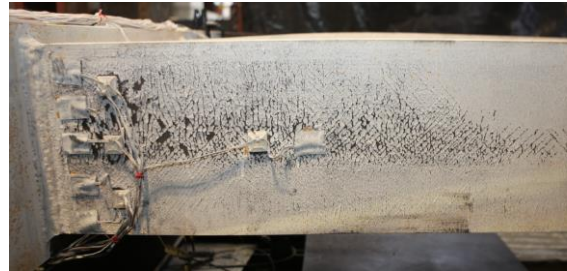
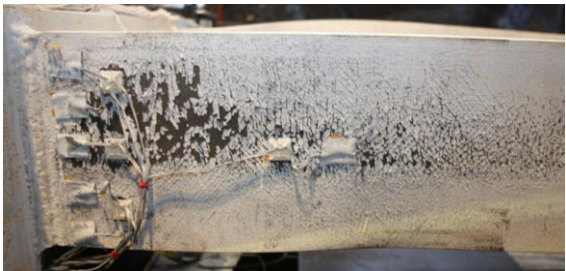
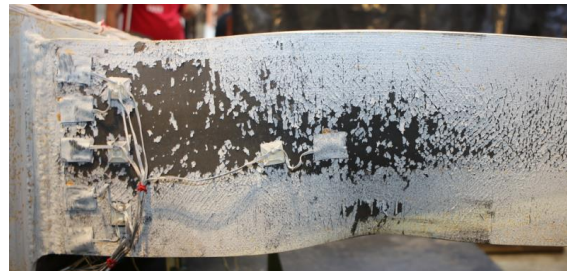
Figure 4.211 Specimen W3: West Beam Bottom Flange Yielding

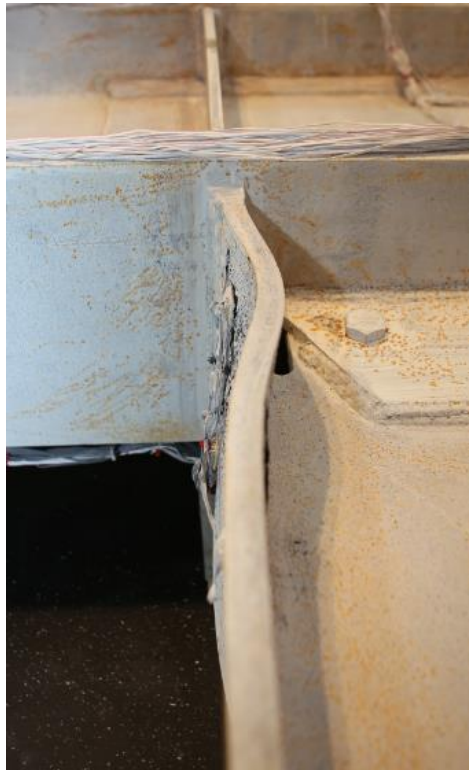
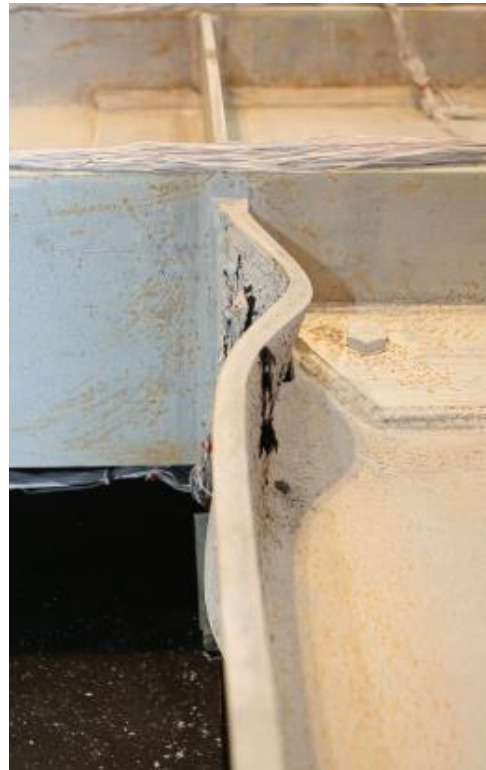
Figure 4.212 Specimen W3: East Beam Top Flange Local Buckling

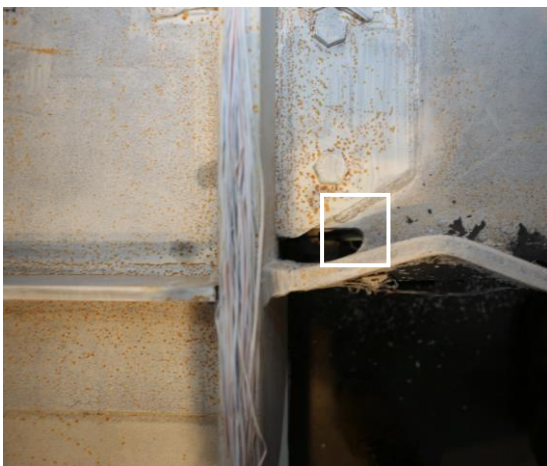
Figure 4.213 Specimen W3: East Beam Top Flange Weld Access Hole Tearing at -0.05 rad (1st Cycle)

- Figure 4.213 shows the initiation of tearing in the weld access holes. All four weld access holes show a similar behavior.
- Severe web buckling develops in both beams during the 0.05 rad drift cycles (see Figure 4.214). Figure 4.215 shows a similar severity of flange local buckling during the 0.05 rad drift cycles.

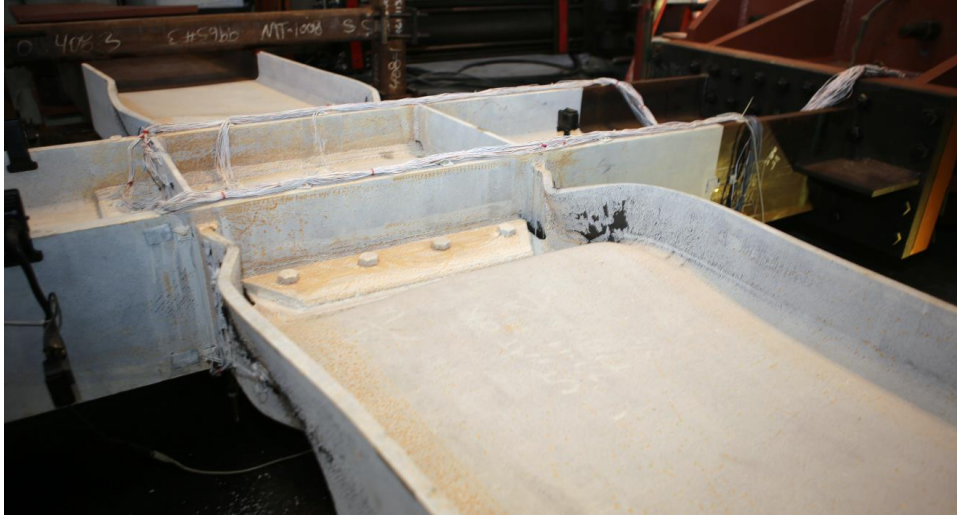
Figure 4.214 Specimen W3: Web Local Buckling at +0.05 rad (1st Cycle)

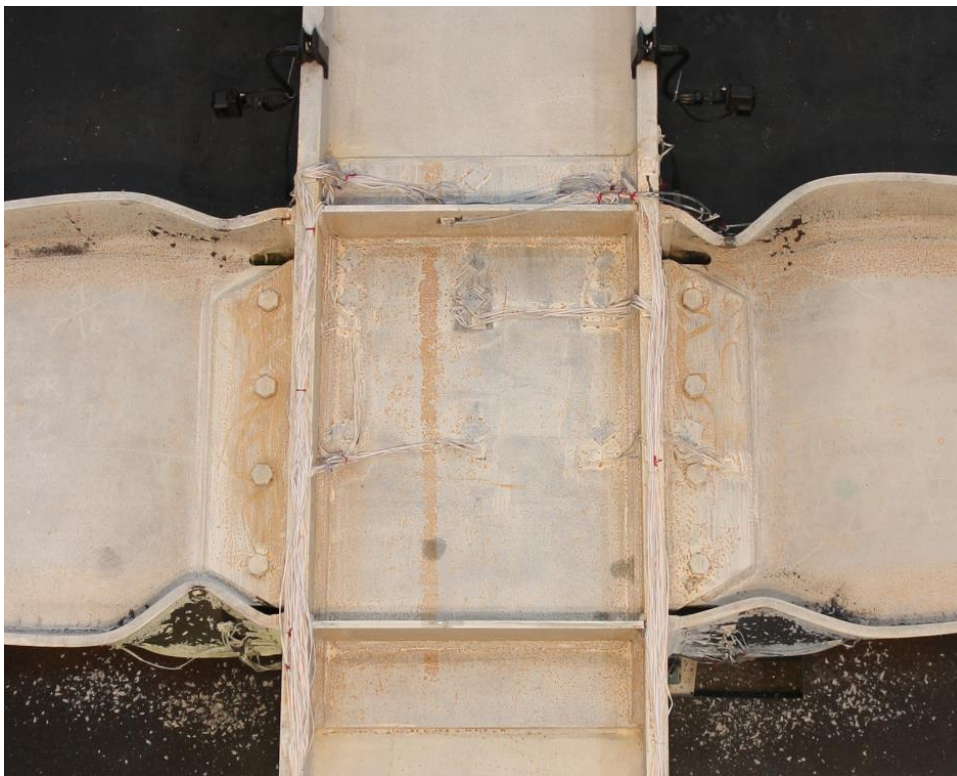
Figure 4.215 Specimen W3: Flange Local Buckling at -0.05 rad (1st Cycle)

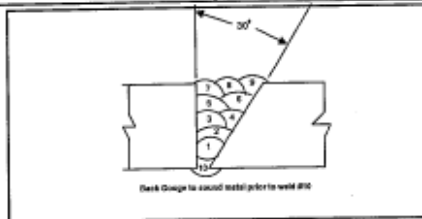
DETAIL

Pass or Weld Layer (s)	Process	Filler Metals		Current		Volts	In/Min Travel Speed
		Class	Diam.	Type & Polarity	Amps		
1-9 *10	FCAW-G	E70T-9	3/32	DCEP	460	30	16"
	FCAW-G	E70T-9	3/32	DCEP	460	30	16"

* Backgouge to sound metal prior to weld pass # 10
