Axial Capacity of Partially Corroded Steel Bridge Piles

H. Karagah¹, M. Dawood²

Abstract

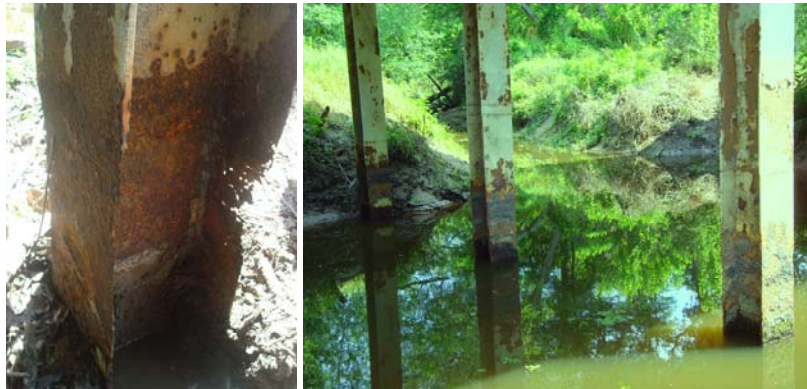
Figure 1: Deterioration of steel bridge piles

Steel 'H' piles are widely used in various states throughout the US. These members are common in older, 'off-system' bridges which cross small creeks or seasonal streams. Many of these structures have been in service for 50 to 60 years. Extended exposure to repeated wetting and drying commonly results in corrosion of these piles as shown in Fig. 1. Typically, this corrosion is localized within a zone a few feet above and below the water or soil surface as shown in the figure. While the corrosion is typically limited in extent, it can be quite severe resulting in near-total loss of cross-section in some cases. Field observations indicate that corrosion occurs in the form of severe reduction of the thickness of the flanges and web of the H piles. In extreme cases this may result in the formation of small perforations or voids in the web and a reduction of the flange width at some cross-sections along the length of the pile.

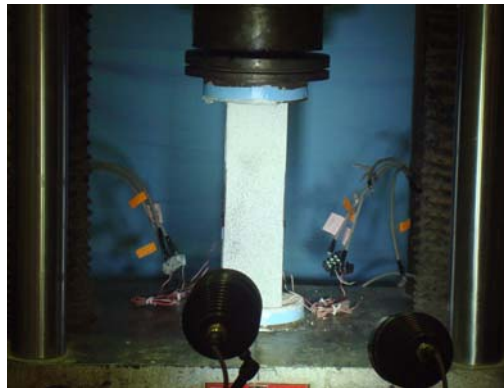
To investigate the sensitivity of the strain measurement achieved by the DIC system, a preliminary compression test was designed and performed. A 16-inch long W4×13 stub column, shown in Figure 5, was tested. The bottom end of the specimen during the test rested on the base platen which can be considered as a fixed support while the top edge was bearing against the top cross head of the loading machine which can be simulated as a pinned end. Compression force was applied concentrically using the Tinius-Olsen 400-kip universal testing machine, and deformation of the specimen measured using the DIC system. In addition, four strain gauges were mounted at mid-height on the tips of the flanges for comparison and verification purposes. To explore the effect of the DIC measurement parameters, i.e. facet size, facet step, and computation size, on the deformation and strain results, a sensitivity analysis was conducted. The parameters are shown in Table 4.

Figure 5: Stub column test setup

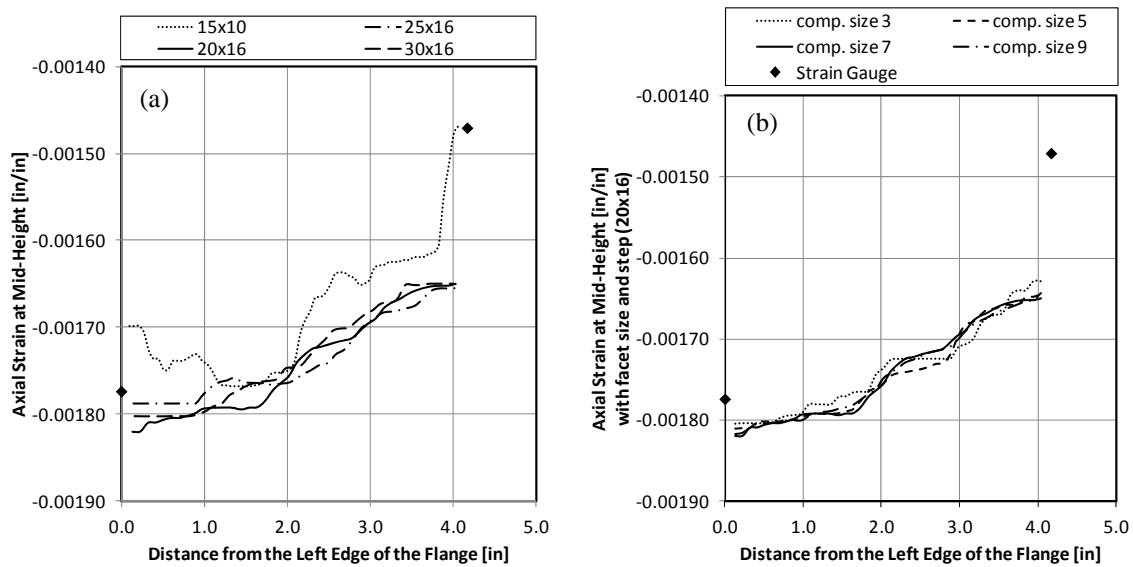
The results of the sensitivity study are shown in Fig. 6. The figures show the measured strain profiles along the outer surface of one flange at a load level of 214 kips. The measured strains from the strain gauges on the tips of the flanges are indicated by the solid diamonds in the figures. The strain distributions along the mid-height of the flange are also shown for different combinations of parameters considered in the study. The figure indicates a slight gradient of strain due to the unintentional eccentricity in the specimen. The effect of the facet size and facet

step is shown in Fig. 6(a). The figure indicates that there was generally a good correlation between the strains measured using the electrical resistance strain gauges and the DIC system. The figure further indicates that changing the facet size and facet step did not have a significant effect on the measured strain profile. Visual inspection indicates that the strain profile with facet size and step of 15×20 exhibited more noise than the strain profiles obtained using other combinations of facet size and step. Among the remaining combinations studied, the strain profile with the facet size and step of 20×16 required the least computational effort. Therefore, it was selected to study the effect of computation size on the measured strain distributions as shown in Fig. 6(b). As can be seen, the various computation sizes provide almost the same strain profile since the local strain gradients were relatively small. Based on the results of the sensitivity study, facet size, facet step, and computation size of 20, 16, and 7 respectively were selected to process the data from the remaining short column tests. All of the columns were painted with a black and white speckle pattern and a pair of cameras was setup to measure strain profiles on the outer face of one of the flanges for the duration of the tests.

Figure 6: Comparison between the strain gauges and DIC results with (a) different facet sizes and steps, and (b) different computation sizes with the fixed values of facet size and step of 15×10 .

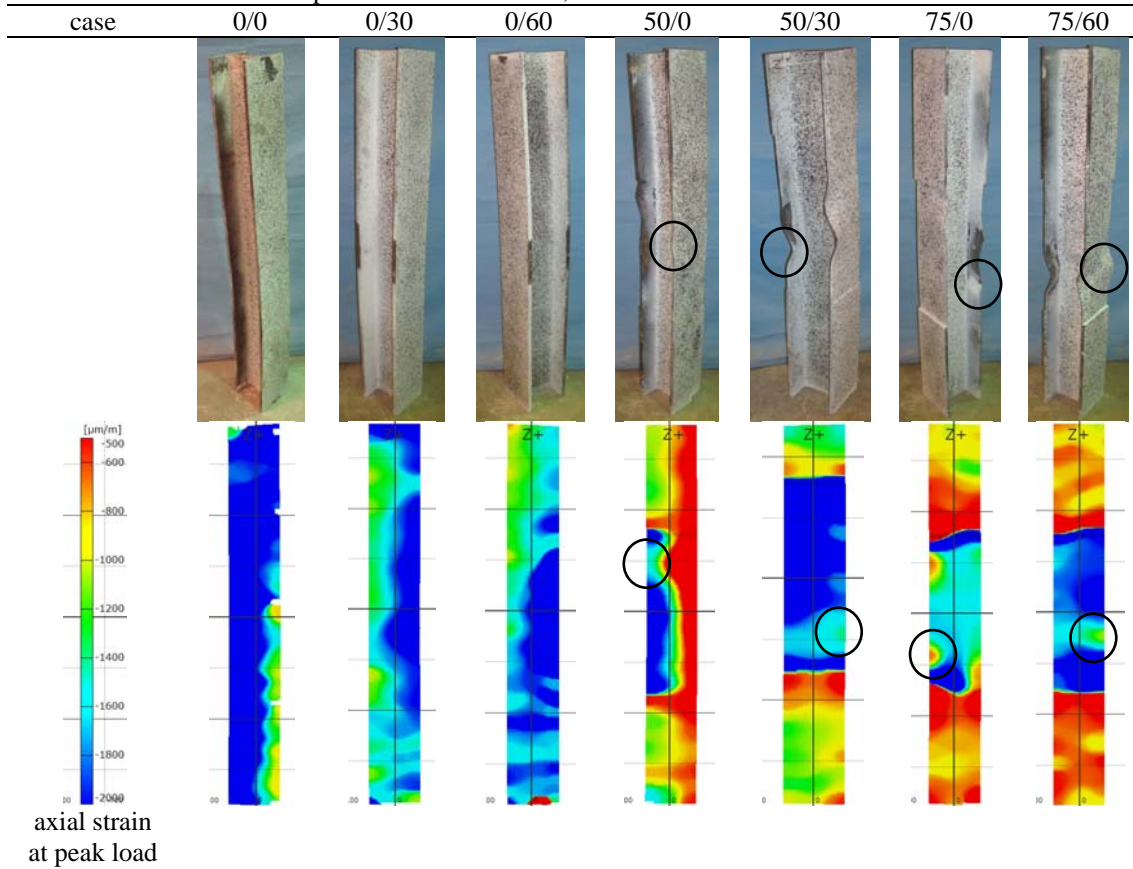
Table 5: Test Specimens of Phase One, Failure Characteristics and DIC Results

Table 5 and Table 6 summarize the failure modes and the maximum attained axial compressive load, P_{cr}^e of the tested specimens in phase one and phase two respectively. The measured axial strain contours on the outer face of one flange are also given at the peak load for each column. The table also gives the ratio of the measured peak load, P_{cr}^e of each specimen to the measured peak load of the un-damaged control specimen, P_{cro}^e and the ratio of the minimum reduced cross sectional area, A_{min} , to the undamaged gross cross sectional area, A_g . The observed failure modes of the different specimens are also listed in the tables. As expected the failure modes varied from global buckling to flange and web local buckling as the thickness of the cross sectional

elements decreased. Inspections of the measured strain contours also indicates that in many cases, strain concentrations could be identified as localized ‘hot spot’ strains at the locations where flange local buckling was about to initiate prior to the observation of any visible sign of distress in the specimens.

Comparison of the measured buckling loads for the specimens tested in phase one indicated that corrosion of the flanges had a more significant effect on the overall specimen capacity than corrosion of the webs. The capacity of the cases with only deterioration in the web, “0/30” and “0/60”, indicated a reduction of capacity of up to 17% compared to the un-damaged specimen. For the cases with only degradation in the flanges, “50/0” and “75/0”, this decrease was up to 57%. It should be noted that the maximum web slenderness, h/t_w , for the specimens with 60% reduction of the web thickness was 24.6. This is well below the limit of 32.6 for slender webs as outlined in the AISC and AASHTO specifications (AISC 2011; AASHTO 2012). Thus, none of the specimens had slender webs and therefore, web local buckling was not expected as a dominant failure mode.

Although web local buckling was not expected as a failure mode based on the web slenderness, several of the specimens with combined reduction of the flange and the web exhibited a combined failure mode which included both flange and web local buckling. Comparing test columns “0/30” with “50/30” and “0/60” with “75/60” indicates a distinct shift in failure mode. For the specimens with flange and web corrosion, the failure mode was dominated by flange local buckling followed by web local buckling. This was attributed to the fact that buckling of the flanges led to localized distortion of the more slender webs. Inspection of Table 5 generally indicates that reducing the cross-sectional area of the section resulted in a corresponding reduction of capacity. One notable exception is a comparison between test columns “50/0” and “50/30”. Although column “50/0” had a greater cross sectional area, column “50/30” demonstrated roughly 10% greater capacity. This can be explained by inspecting the full-field axial strain profile for column “50/0”. The strain profile clearly indicates high levels of compressive strains on the left face of the column and much lower strains on the right face indicating weak axis bending of the column. This was attributed to an unintentional eccentricity in the column which is expected to have slightly reduced the measured column capacity.

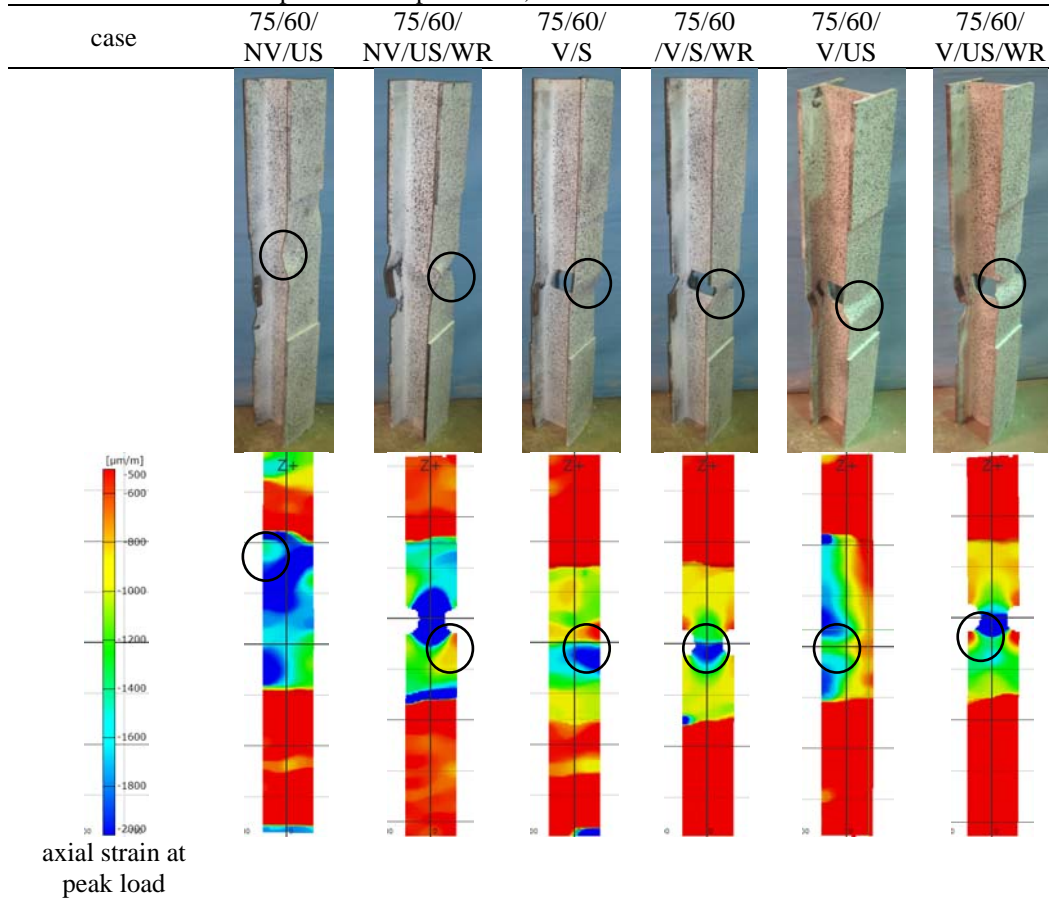
Table 6: test specimens of phase two, failure characteristics and DIC results

Four of the columns tested in phase two included a void in the web. All four of these columns demonstrated the same failure mode; namely buckling of both flanges adjacent to the void in a beam buckling mode rather than a plate buckling mode. All four of these test columns also exhibited comparable failure loads between 36 and 40 kips regardless of the amount and configuration of degradation in other parts of the cross section as shown in Table 6. The results suggest that the loss of support of the flange due to extensive corrosion of the web has a major impact on the overall capacity of the columns.

Unsymmetric degradation of the flanges had a minimal effect on the column capacity compared to symmetric degradation. For example, columns “75/60/NV/US” and “75/60” were similar except that the flange degradation of the former was unsymmetrical while the flange degradation of the latter was symmetrical. Comparison of the failure loads indicated a minimal reduction from 70 kips to 57 kips due to the unsymmetry of the flange corrosion. Similarly test columns “75/60/V/S” and “75/60/V/US” failed at equal peak loads as did test columns “75/60/V/S/WR” and “75/60/V/US/WR”.

The test results indicated that reduction of the flange width had a negligible effect on the column capacity. This can be explained by comparison of the measured strain profiles given in Table 6. The measured strains indicate that size of the buckled region of the flanges was similar to the size of the 2-inch diameter semi-circle that was removed from the edges of the flanges. Since reduction of the flange width reduced the slenderness of the flanges, this deterioration pattern simply shifted the flange local buckling failure mode away from the location of the void as can be seen in Table 6. Comparison of the results in Table 6 further indicates essentially no change in capacity due to the reduction of the flange width.

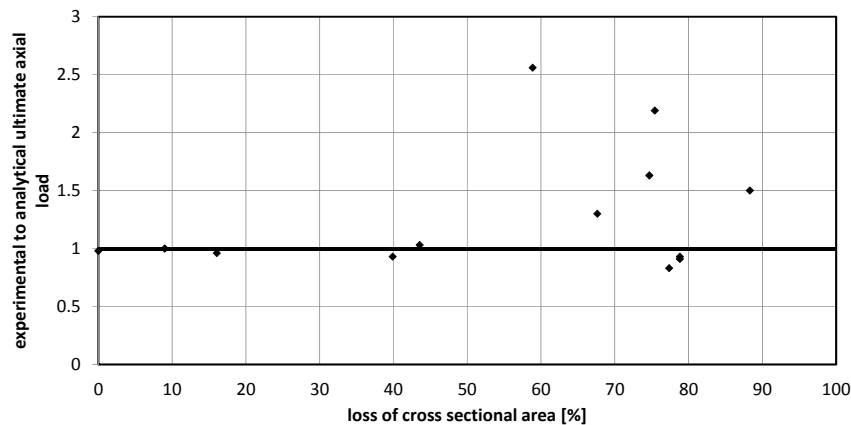
Fig.8 illustrates the variation of the experimental over predicted axial capacity ratio versus the percentage of the cross sectional area loss. Generally, it can be concluded that if the loss of cross section is less than 50% the design approach in the current specifications, which requires the assumption of uniform corrosion along the entire length of the member, predicts the reduced capacity of the deteriorated columns relatively accurately. Similarly, in the case of a void or 100% loss of the web at a localized cross-section, the capacity of the deteriorated column can be calculated by treating the two remaining portions of the flanges at the corroded cross-section as short, prismatic columns with fixed ends. In this case, the existing design approach predicts the capacity well. However, for other cases when the loss of cross section exceeds 50% the existing design models may be overly conservative.

Figure 8: Variation of experimental to analytical capacity ratio by decreasing the cross section

- Existing provisions in current design specifications were used to predict the capacity of the tested columns by assuming uniform corrosion along the entire length of the columns. The current provisions accurately predicted the capacity of columns for which the loss of cross section was less than 50%. For columns with severe corrosion the existing design provisions were safe but overly conservative.

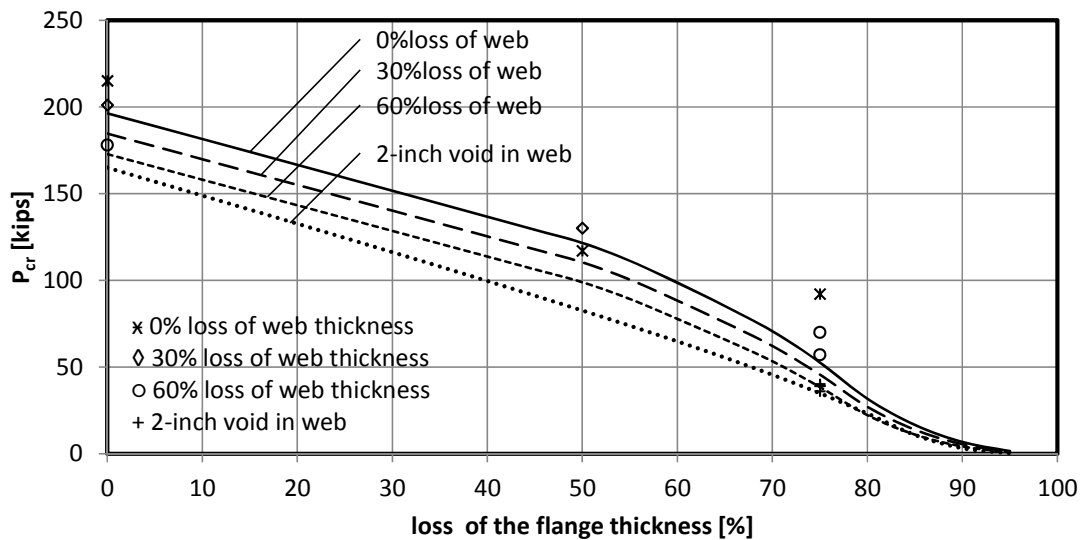
Although the existing design equations were found to be quite conservative for cases of extreme corrosion, they were employed to investigate the effect of flange and web corrosion on overall column capacity. The capacity of the tested W4x13 section was predicted for different amounts of flange and web corrosion range from no corrosion to total corrosion of the flanges or web as illustrated in Fig.9. Since the majority of the out of plane buckling stiffness of the section comes from the flange stiffness, the modulus of elasticity and yield strength of the flange obtained from steel coupon test were used for this evaluation. The dotted line in Fig.9 shows the case with a 2-inch void in the web and treating the two flanges as two short, fixed ends columns which buckle in a beam bending mode. The measured capacities of the tested beams are also plotted for comparison purposes.

Inspection of the figure indicates that the axial capacity is much more sensitive to flange corrosion than to the web corrosion. As illustrated in Fig.9, the experimental data points are very close to the analytical curve for the cases with low percentage of flange degradation, however, deviation increases by increasing the level of the flange thickness reduction.

Figure 9: Variation of maximum axial strength of W4x13 and comparison with experimental results

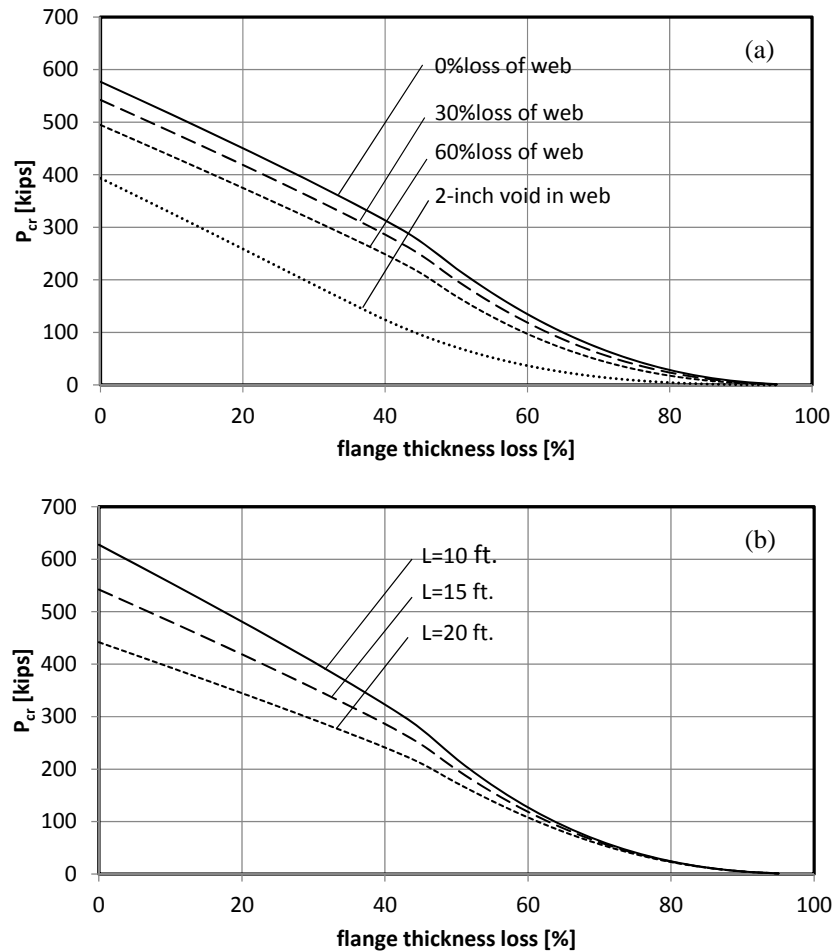
The analytical approach was subsequently extended to investigate the behavior of full-scale steel 'H' piles. A 15 foot long, simply supported HP12x53 pile was selected for the parametric investigation. This pile geometry was selected in consultation with state bridge engineers and is representative of the geometry and assumptions used in the design of these types of piles. The predicted capacities of the corroded piles using the existing design codes and the associated simplifying assumptions are given in Fig.10. The figure emphasizes that the behavior of the piles is dominated by the flange corrosion rather than by the web corrosion. Such design charts could be easily used in the field to conservatively provide a quick estimate of the capacity of a corroded pile based on the known dimensions of the corroded and uncorroded sections of the pile.

The effect of column slenderness on the capacity of the corroded piles was evaluated by varying the length of the HP12x53 piles from 10 ft. to 20 ft as illustrated in Fig.10(b). In this illustration, since web corrosion was found to play a secondary role, corrosion of the web was assumed to be constant and equal to 30%. The length of the piles had a significant effect on the pile capacity

for piles with minor loss of section in the range where global buckling dominated the failure. However, as the degree of corrosion increased, and as flange buckling began to dominate the failure, the length of the piles had little effect on the capacity as one might expect.

Figure 10: (a) Effect of web and flange corrosion on axial capacity of HP12x53 piles with $kL=15$ ft. (b) Effect of effective length on axial capacity of deteriorated HP12x53 section with 30% reduction of the web thickness
