## **Instability of Solar Power Tower Structures during Construction**

Cliff D. Bishop<sup>1</sup>, Morgan Griffith<sup>2</sup>, Brian McDonald<sup>3</sup>

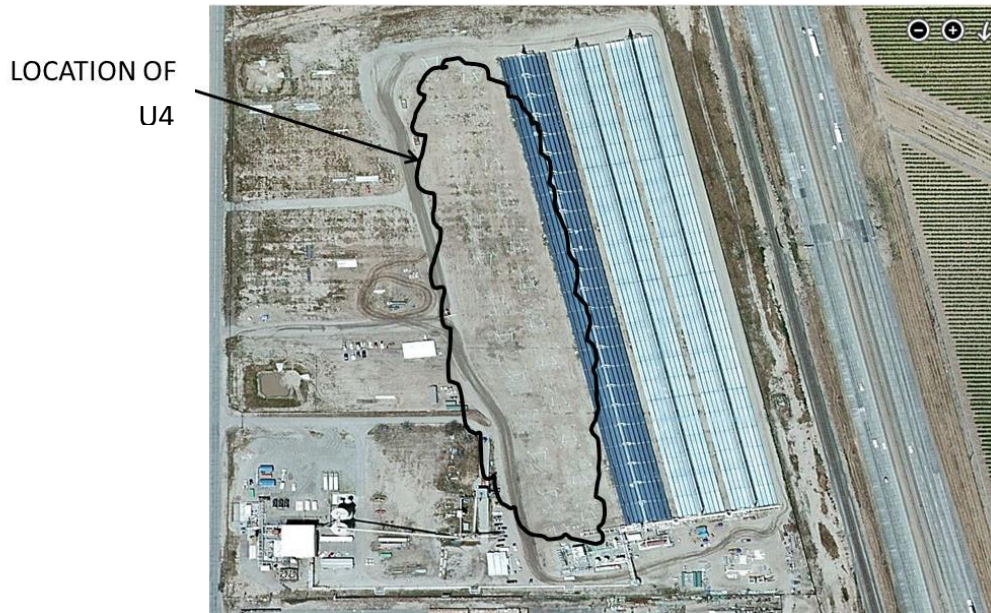
Figure 1: Aerial view of solar plant with U1 - U3 in place

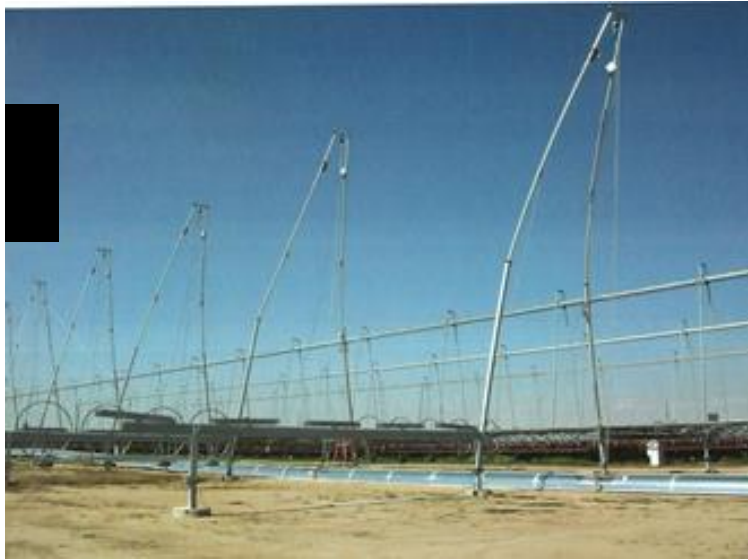
During installation, the U4 towers failed during assembly of the receiver units. All towers were erected and the receiver was suspended a couple of feet off the ground from the lifting weldment at the top of the tower. As the final section of piping was being loaded into the receiver shell between towers #24 and #25, the towers buckled out-of-plane, collapsing the receiver assembly to the ground. Photographs of the failed towers are shown in Figure 3. Local distortion of the tower legs and failure of the welded connection between the upper and lower portions of the tower legs are apparent at multiple locations.

Figure 3: Post-incident photograph of bent towers

Table 2 is consistent with reports that the collapse initiated after the receiver piping was installed along the suspended receiver; in a condition where the full receiver and piping weight was present without adequate out-of-plane bracing. Furthermore, the shape of the buckling mode is associated with out-of-plane movement along the height of the tower, which is consistent with the tower deflections shown in post-incident photographs (Figure 3).

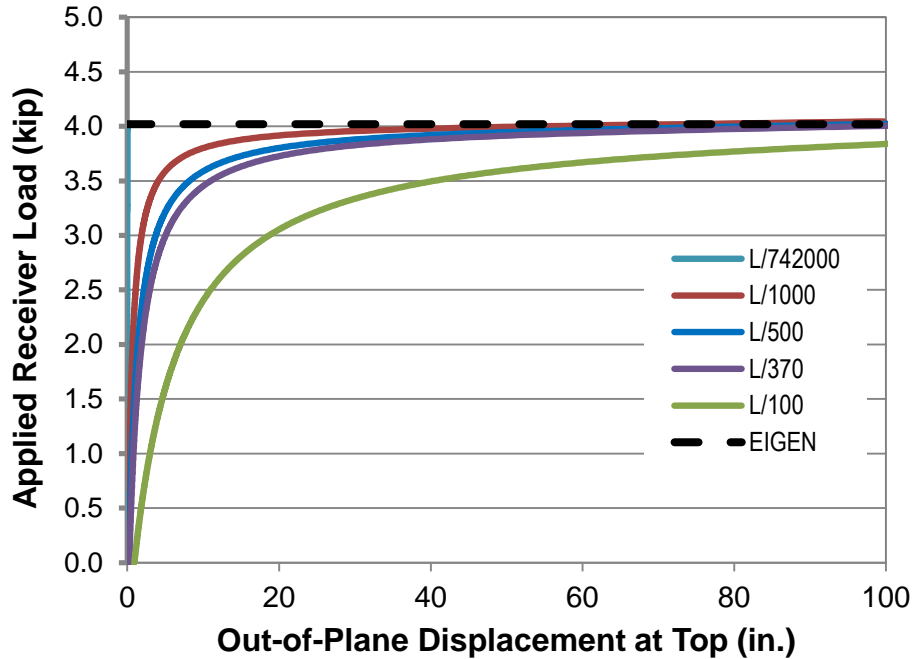
dimension. Next, the tower self-weight is applied in a primary step and an analysis is performed. Subsequently, a unit load is applied at the upper weldment corresponding to the location of the receiver lift point. A geometrically nonlinear analysis is now performed and a plot of receiver load versus tower top deflection is recorded. The results of five different load-deflection analyses are shown in Figure 6. The eigenvalue solution is also included in the plot for direct comparison.

Figure 6: Receiver load versus tower top displacement for various initial imperfections

The results of the analyses are consistent and indicate tower deflections can start to become excessive at an applied vertical load around 3.0 to 4.0 kips (in addition to the tower self-weight), which is well below the specified receiver weight and its piping of approximately 4.8 kips. Also, as expected, as the magnitude of the initial imperfection increases (moving from the upper left of the plot toward the lower right), the displacements increase with less and less applied receiver load.

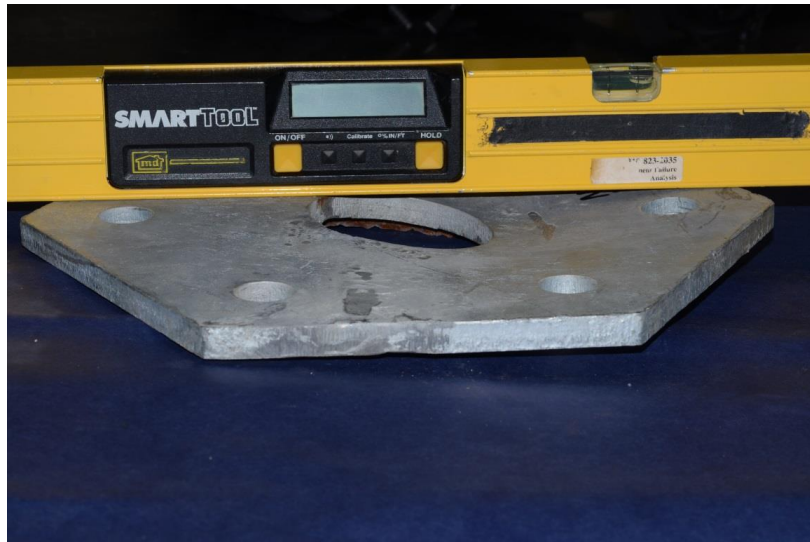
According to a post-incident report of the tower failures, at least one welded connection failed at eleven of the twenty-five towers (there were a total of sixteen mid-tower leg weld failures). All but one of the towers with no weld failure exhibited permanent deformation in the form of residual tower lean upon removal of the receiver load (the tower that exhibited no weld failure or residual lean was the only tower guyed out-of-plane at the time of the collapse). As exhibited by Figure 7, inspections of eleven steel plates at the upper portion of the joint between the upper and lower portions of the tower legs revealed permanent deformation of all plates, which is indicative of significant load transfer across the joint prior to the weld failure.

Figure 7: Permanently deformed plate between weldments

As discussed in the previous sections, after assembly of the tower on the ground, the tower is lifted vertically into position using a crane. It is at this time that self-weight leads to the largest internal force on the connection; around 95 kip-in. Abaqus (Simulia 2013) is employed to perform the connection plate analyses in order to determine the expected capacity of the plates assuming a competent weld. Also, it is important to ascertain what level of forces on the plate would lead to the permanent deformations observed in the plate shown in Figure 7.

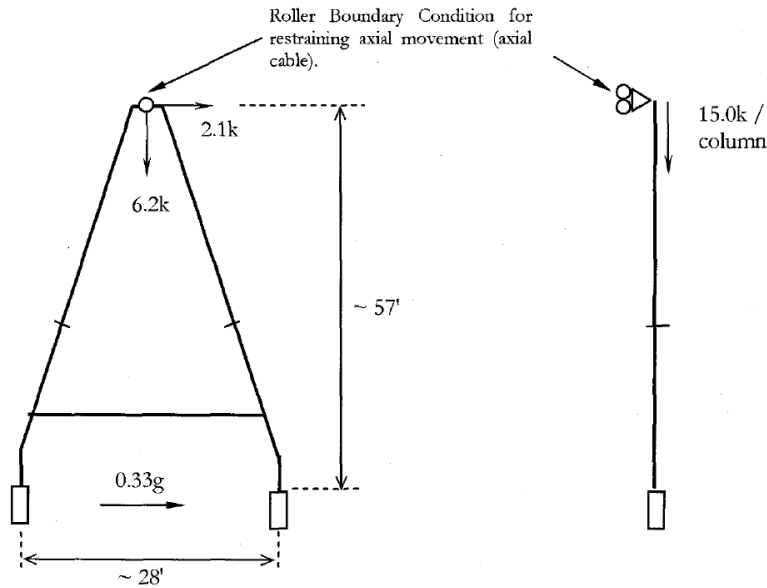
The tower design calculations included in the contract documents from the designer detail multiple loading conditions. A buckling analysis is performed for the tower self-weight and the receiver weight. However, as depicted in Figure 11, the tower is modeled to be restrained against longitudinal movement at its top. While this boundary condition may be appropriate to assess the capacity of the frame in its final configuration after the receiver unit is in place and fully attached or the capacity of a tower that has been guyed prior to supporting the receiver unit, it is not appropriate for the erection of U4, where only the center tower was guyed and no lean-on bracing was installed.

Figure 6.1 – Tower Buckling (G + Seismic X)

Figure 6.2 – Tower Buckling (G + Seismic Y)

Figure 11: Engineer's tower model for buckling analysis (note the top restraint indicated)
